SURFACE TREATMENT FOR ALUMINUM BONDING.(U)

SURFACE TREATMENT FOR ALUMINUM BONDING

FINAL REPORT FOR THE PERIOD
July 28, 1978 through July 15, 1979

T. Smith
Principal Investigator

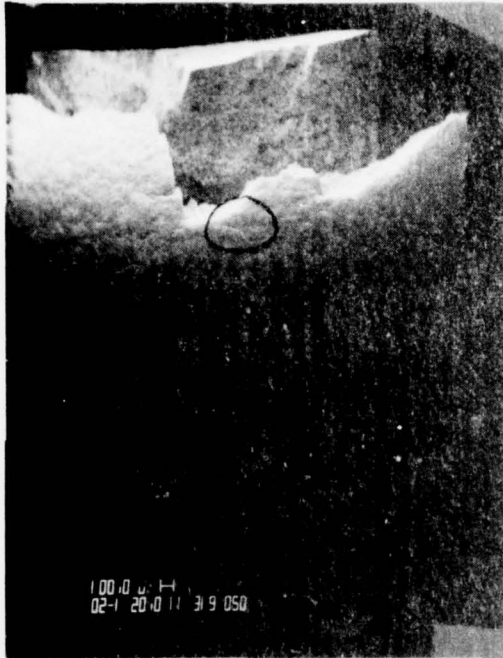
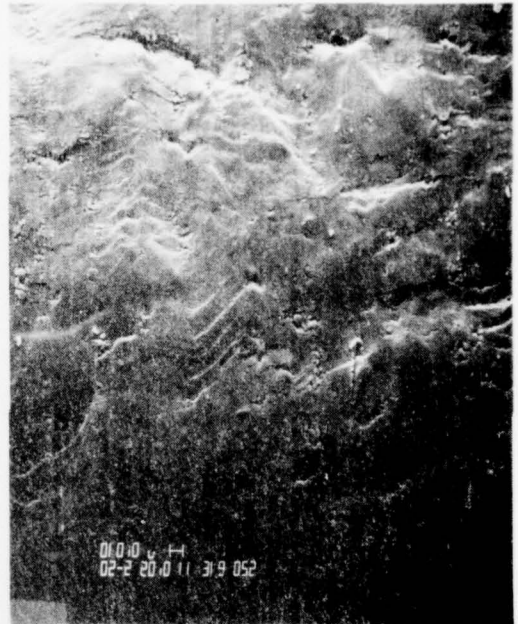
Fig. 2 SEM micrographs of Al 2024-T3 after STAB(1).

tion of region 20 at the left of Fig. 17e. The main feature is the layers of hydroxide along with large particles of adhesive. Failure appears to be primarily in the hydroxide lamellae. Figure 17i reveals a small piece of primer (circled in Fig. 17e). A larger magnification of part of the primer particle is seen in Fig. 17j, it is very smooth on top and indicates delamination at the primer-adhesive interface. Figures 17k and l are larger magnifications of the region around the primer, i.e., hydroxide that has appeared to have failed between lamellae. Note that the surface structure does not appear as in Figs. 2c and d.

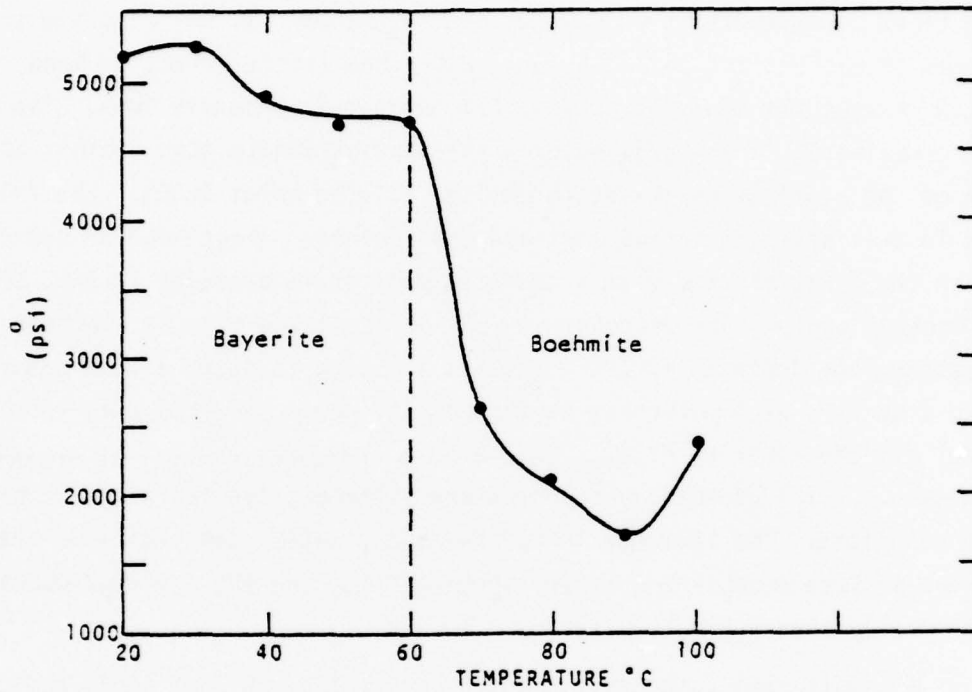
Fig. 13 Lap shear strength as a function of the crystalline form of the aluminum oxide layer on the adherend before bonding.

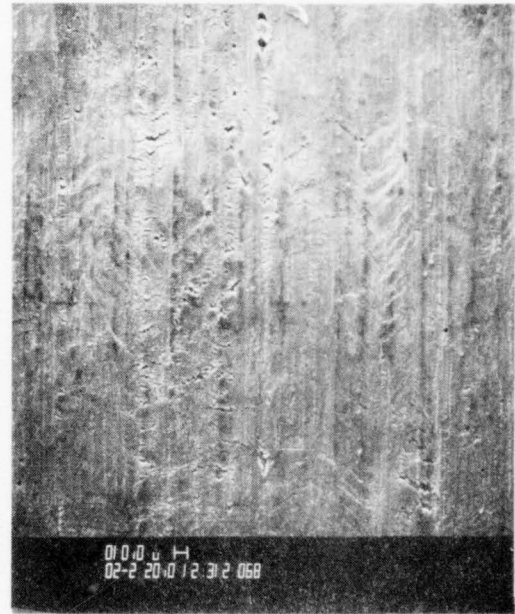
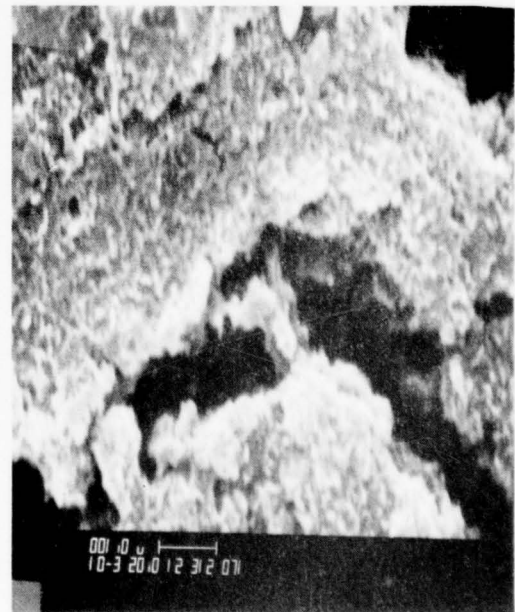
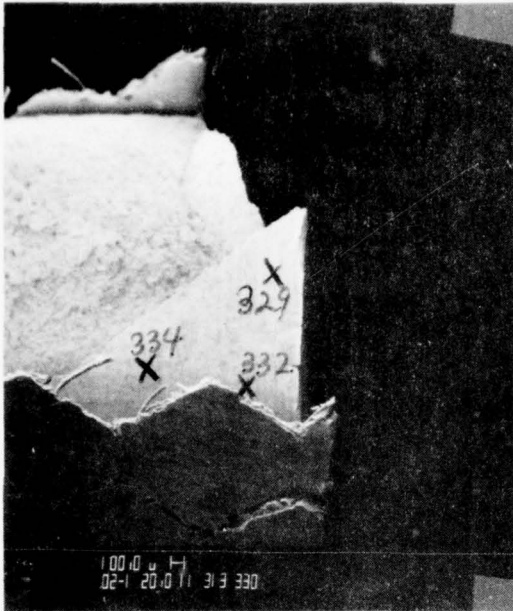
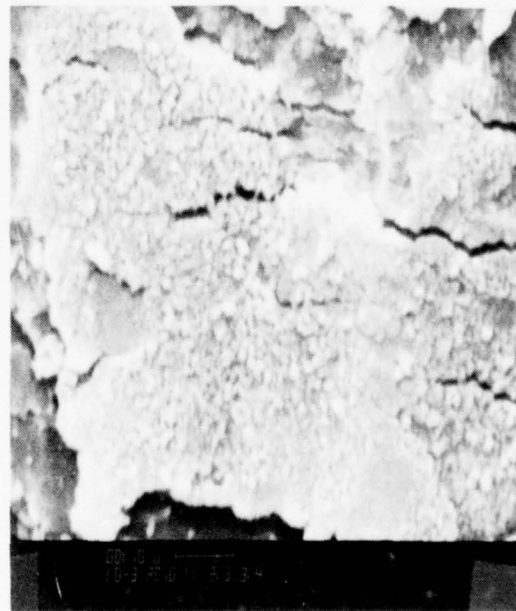
Fig. 16 SEM pictures of the debond region of a good wedge test joint (STAB(1)).

Figures 16a-d are SEM pictures of the metal debond region of a wedge test that was good (~1.78 cm (0.3 in)/24 hr) after STAB(1). Figure 16a is X10, b is X200, c is X2000 and d is X10,000. The hydroxide film is seen to be layered and is fractured due to bending of the cut out piece. The X10,000 picture (d) reveals the cellular porous structure of the hydroxide, and when compared to Fig. 2, appears to have failed in the primer-hydroxide interface. Figures 16e-h show the metal surface that did not debond during the wedge test but fractured during metal bending. Again the failure is at the hydroxide-primer interface, the layered film is observed but in this case it is obvious that failure had occurred in the primer, leaving primer embedded within the hydroxide.

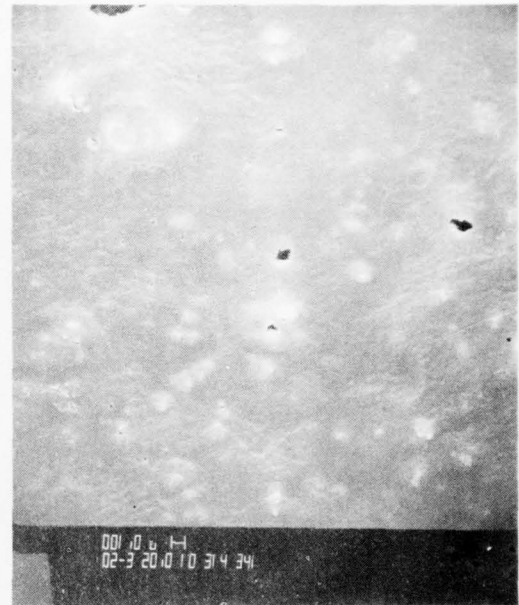
Fig. 18 SEM pictures of debond region for a medium wedge test joint (STAB(1)).

Figure 18 shows the debond region of the metal for another medium wedge test. Debonding has occurred at the metal-primer interface. Patches of primer are left where bubbles had formed leaving a smooth polymer surface (Fig. 18b). Figure 18b is of the primer surface and Figs. 18c and d are of the hydroxide surface. The layers of hydroxide can be seen and failure again appears to be between lamellae.

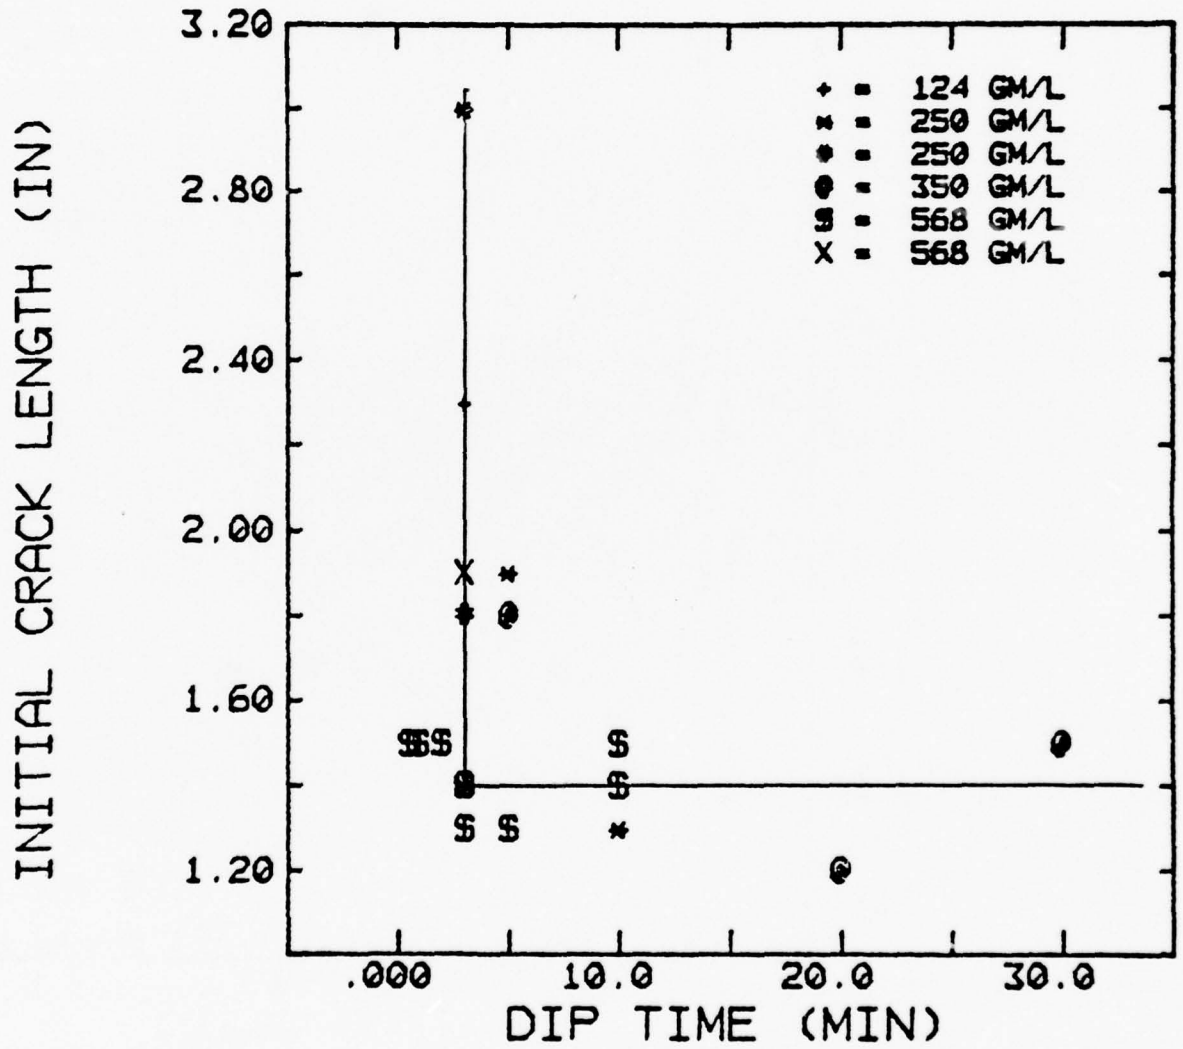
Fig. 43 Effect of NaOH conc & dip time on stab(3).
