# ION-PLATED COATING ON TITANIUM ALLOY

Pratt & Whitney Aircraft Group  
Government Products Division  
Box 2691, West Palm Beach, Florida 33402

Technical Report AFML-TR-79-4109  
Final Report for Period 1 September 1978 through 1 May 1979

Air Force Materials Laboratory  
Air Force Wright Aeronautical Laboratories  
Air Force Systems Command  
Wright-Patterson Air Force Base, Ohio 45433

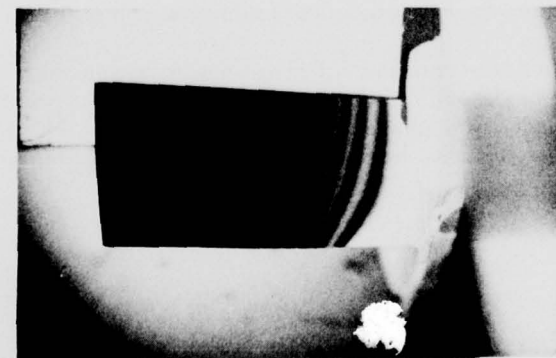
80% Pt/20% Rh  
675 Hz

Pt  
665 Hz

Au  
661 Hz

B/M  
657 Hz

Figure 1. Reconstructed Time Average Holograms of Ion-Plated and B/M Compressor Blades

Various modes of vibration (usually the modes lowest in frequency; first bending, first torsion, second bending, etc.) can be determined by an electrodynamic shaker with the blade secured in a broached block attached to the shaker head. Stresscoat (brittle lacquer) analysis of the blades was conducted to establish high stress locations for the mode of interest. The blades were then strain-gaged (Figure 12) at these identified locations, vibrated at a given amplitude, and the stress ratios measured. The maximum stress location and stress ratio depend upon which mode was excited. The purpose was to identify the maximum stress location of the coated blades and the ratio of stresses at different locations for various modes of vibration.

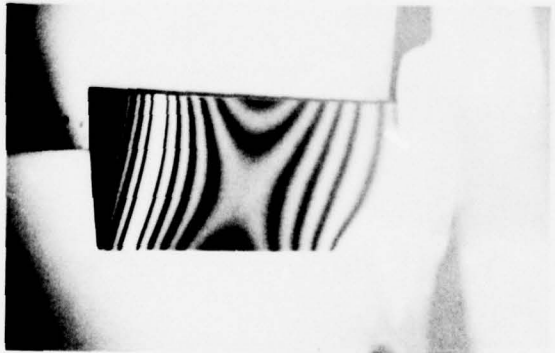
**B/M**  
4830 Hz

**AU**  
4659 Hz

**Pt**  
4791 Hz

**80% Pt/20% Rh**  
4606 Hz

*Figure 4. Reconstructed Time Average Holograms of Ion-Plated and B/M Compressor Blades*

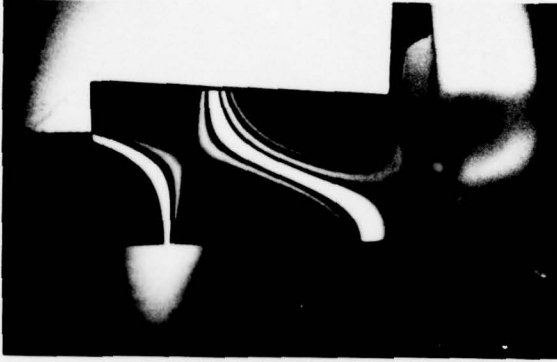
**B/M**  
9586 Hz

**Au**  
9285 Hz

**Pt**  
9530 Hz

**80% Pt/20% Rh**  
9730 Hz

*Figure 6. Reconstructed Time Average Holograms of Ion-Plated and B/M Compressor Blades*

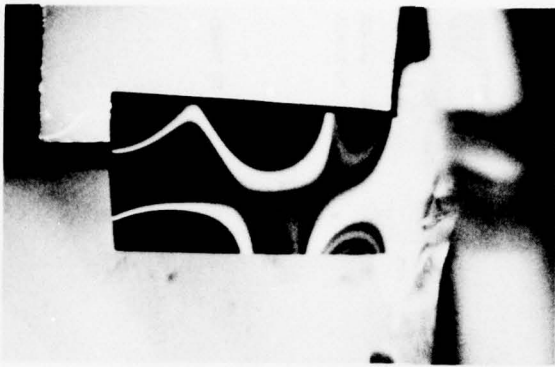
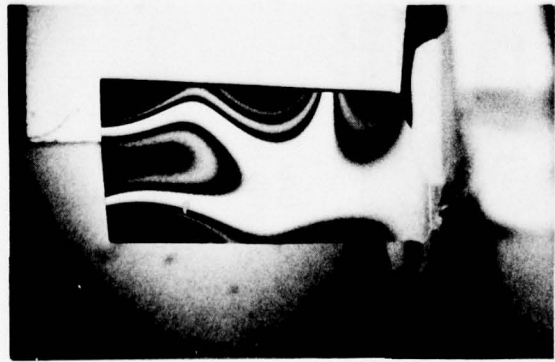
80% Pt/20% Rh  
21143 Hz

Pt  
21179 Hz

Au  
21200 Hz

B/M  
21368 Hz

Figure 10. Reconstructed Time Average Holograms of Ion-Plated and B/M Compressor Blades
