SRI INTERNATIONAL MENLO PARK CA  
MODEL TESTS OF MISSILE WITH HARD LINK.(U)  
JUN 79 R E EMERSON

6 MODEL TESTS OF MISSILE WITH HARD LINK,

By: R. E. Emerson

Contract No. DAAK10-78-C-0158  
SRI International Project PYU-7422

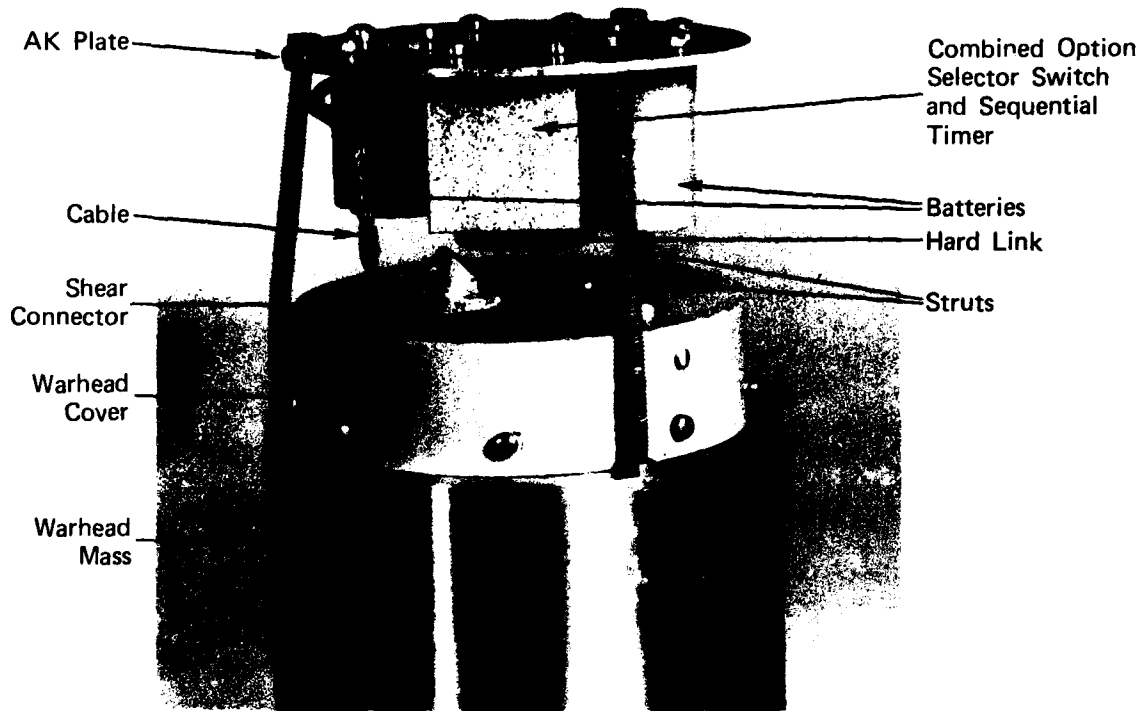
MP-7422-2A

Scale Model of Missile Section. The model structures were fabricated in 2/9-scale (4-inch-diameter mock warhead) and consist of idealized models of the missile elements. Figure 1 shows one of the models before testing. The wall structure of the missile--and, in aft impacts, the shipping container--absorb very little of the kinetic energy at the

FIGURE 1 SCALE MODEL OF MISSILE SECTION

In the scale model, the following components are fabricated as deformable structural elements: the cable and cable connection, the warhead aft covers, and the AK mounting plate. Rigid masses are used to model the remaining elements, such as the warhead, batteries, arm-safe device, hard link, combined option selector switch, and sequential timer. (The combined option selector switch and sequential timer are modeled as a single mass; in early tests the arm-safe device and hard link are modeled as a single mass, but in later tests they are modeled as separate masses as discussed below.) In addition, several components located under the warhead covers were modeled as rigid elements (not visible in Figure 1).

The warhead and AK are positioned relative to each other by struts, shown in Figure 1. The struts are threaded brass rods and are shaped to buckle outward on impact, thereby absorbing minimal energy. In Tests 1 through 5, 0.164-inch-diameter rods were used. A force of 500 lb is needed to collapse the struts. An upper bound on the energy absorbed by the struts on impact is 42 ft-lb. This value is an upper bound because it is the product of the maximum measured collapse force and the maximum displacement of the struts. This upper bound is equal to about 40% of the kinetic energy of the model warhead at 50 ft/sec and less than 5% of warhead kinetic energy at 150 ft/sec.\* In Test 6, 0.190-inch-diameter struts were used. The force needed to collapse these struts is 1150 lb, and an upper bound on the energy absorbed by the struts is 97 ft-lb. This upper bound is less than 3% of the warhead kinetic energy at the 290 ft/sec velocity used in Test 6.

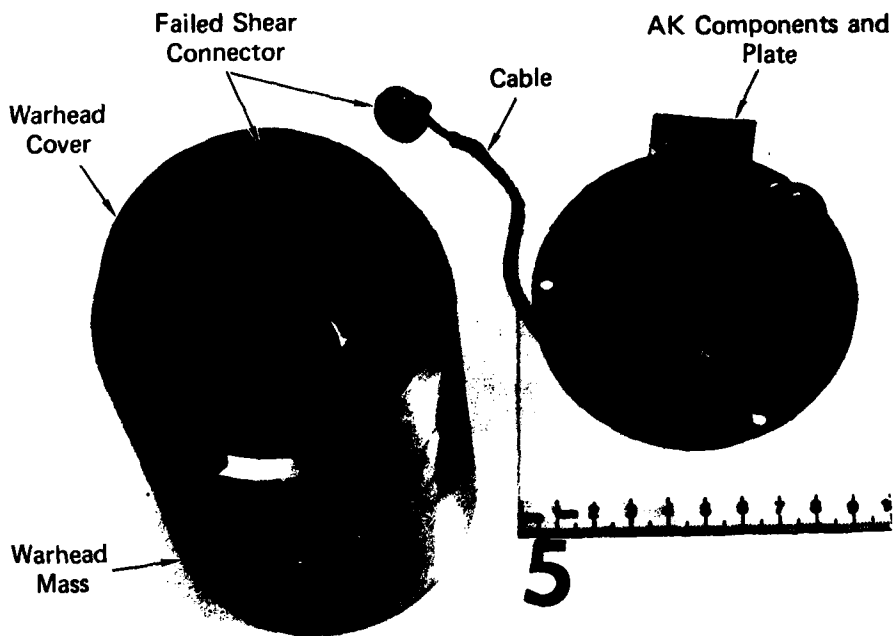
MP-7422-7

Figure 2 shows the damage to the model from Test 5. (The AK plate and components have been positioned so that the forward end of the components is shown in the photograph). The two parts of the shear connector have separated and the cable is intact. The two parts of the

FIGURE 2 MISSILE MODEL DAMAGED IN TEST 5 (50 ft/sec)

hard-link model, which were held together by a weak adhesive, did not separate. The AK components are deformed only slightly.

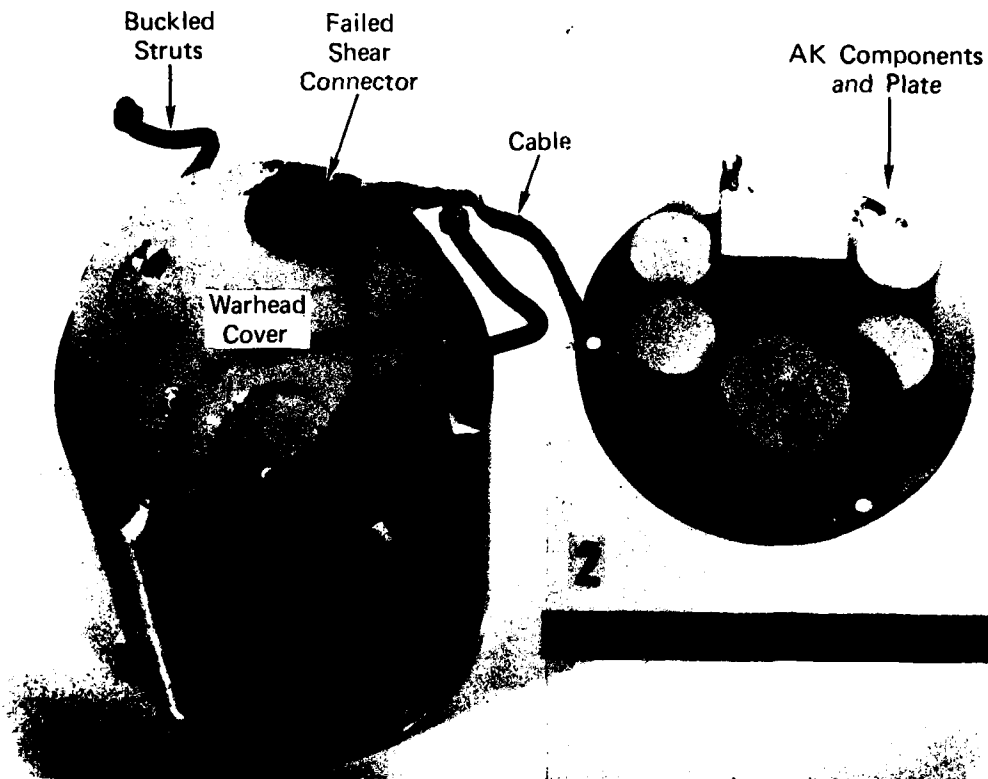
MP-7422-3

The dynamics of Test 2 (70-ft/sec impact velocity) and Test 1 (100-ft/sec impact velocity) were very similar to those of Test 5. Figure 3 shows the damage to the model from Test 2. The failed shear connector is embedded in the warhead cover, and the cable between the connector and the hard link is intact. Fractures in the warhead cover can be seen. The damaged model from Test 1 is shown in Figure 4. The relative displacement of the two parts of the shear connector is greater than in Test 2, and the warhead cover is more severely deformed. Also, one of the model components under the warhead cover made a deep dent in the model of the hard link. In Tests 1 and 2, the brass struts did not fracture.

FIGURE 3 MISSILE MODEL DAMAGED IN TEST 2 (70 ft/sec)

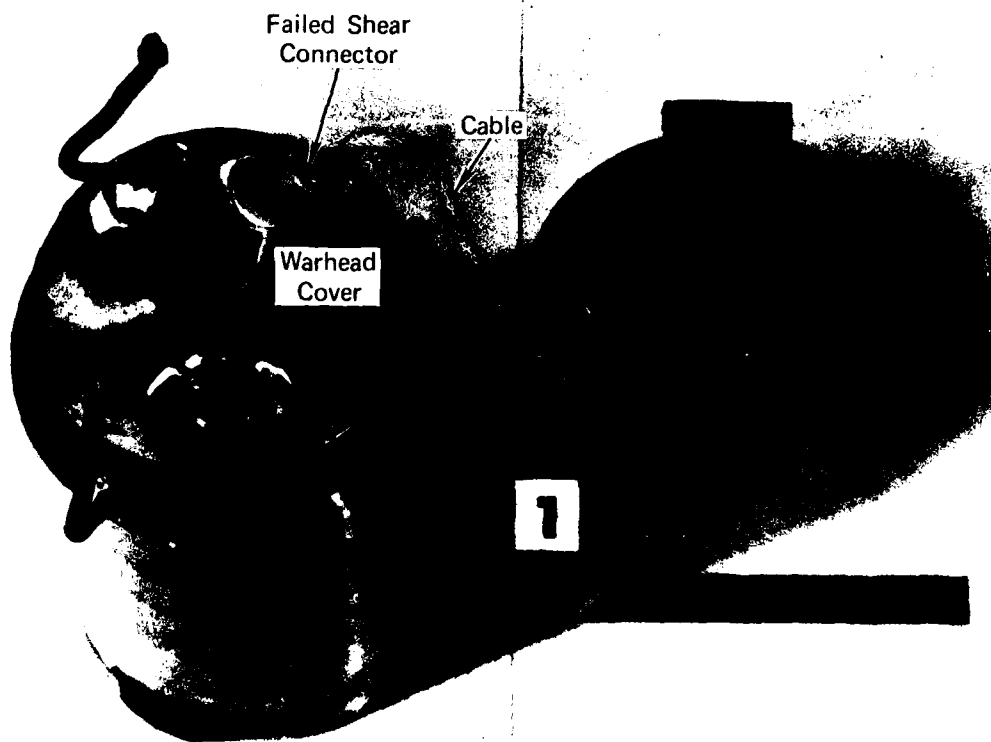
MP-7422-4

FIGURE 4 MISSILE MODEL DAMAGED IN TEST 1 (100 ft/sec)

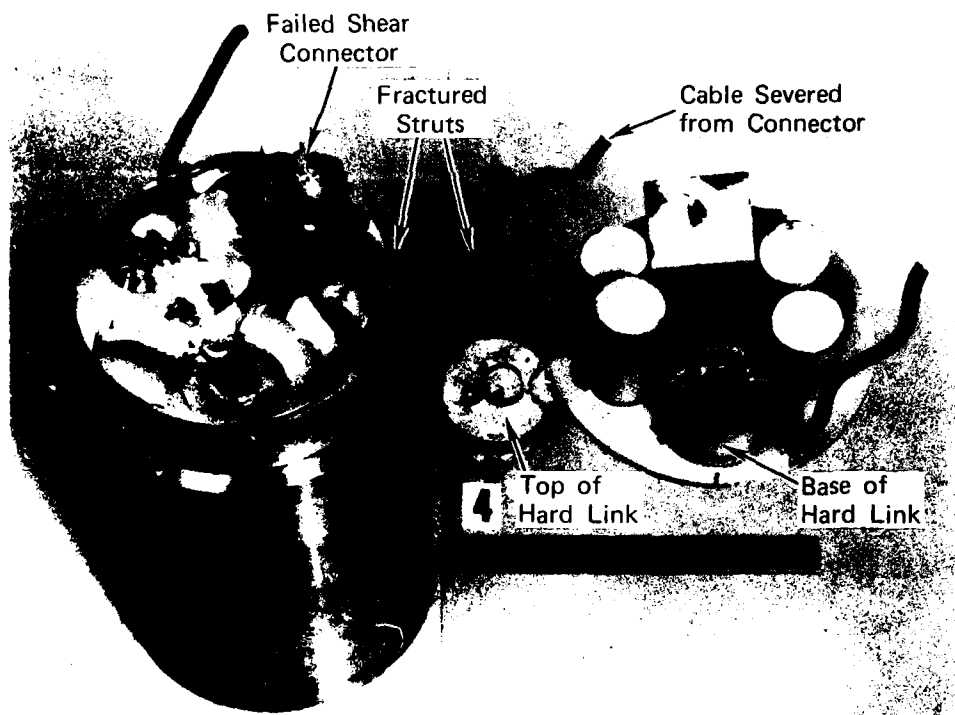
MP-7422-5

The damaged models from Tests 4, 3, and 6 are shown in Figures 5, 6, and 7, respectively. The severed cable and the separated hard-link pieces are visible. In Test 4, the part of the cable connector attached to the cable remained embedded in the warhead cover. In Tests 3 and 6, however, this part separated from the cover completely. In Test 6, the deformation of the AK components was severe. The warhead cover fractured

FIGURE 5 MISSILE MODEL DAMAGED IN TEST 4 (125 ft/sec)

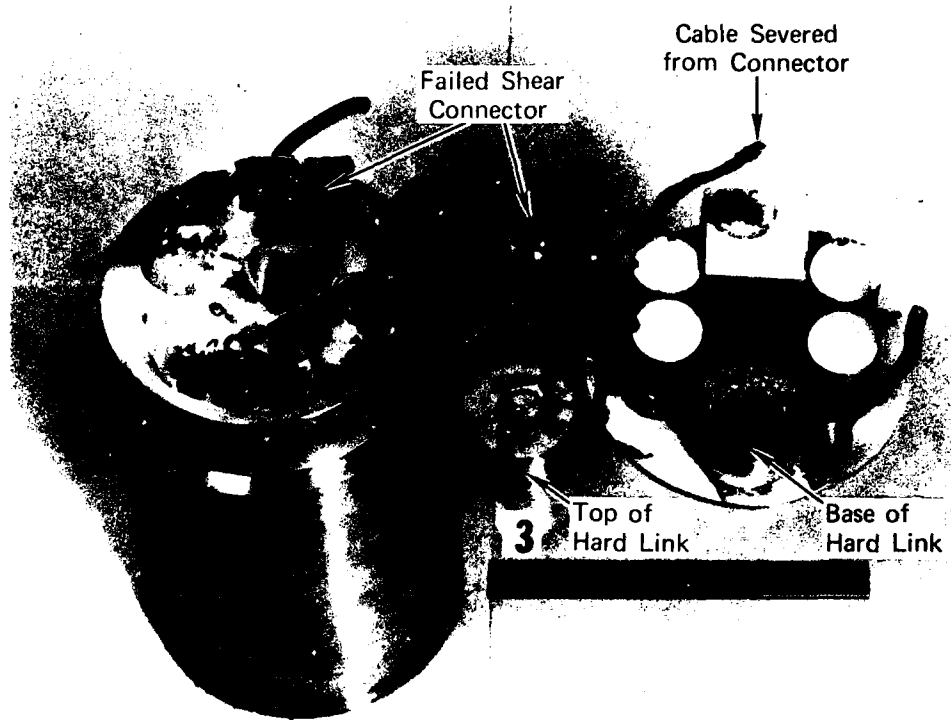
MP-7422-6A

FIGURE 6 MISSILE MODEL DAMAGED IN TEST 3 (150 ft/sec)

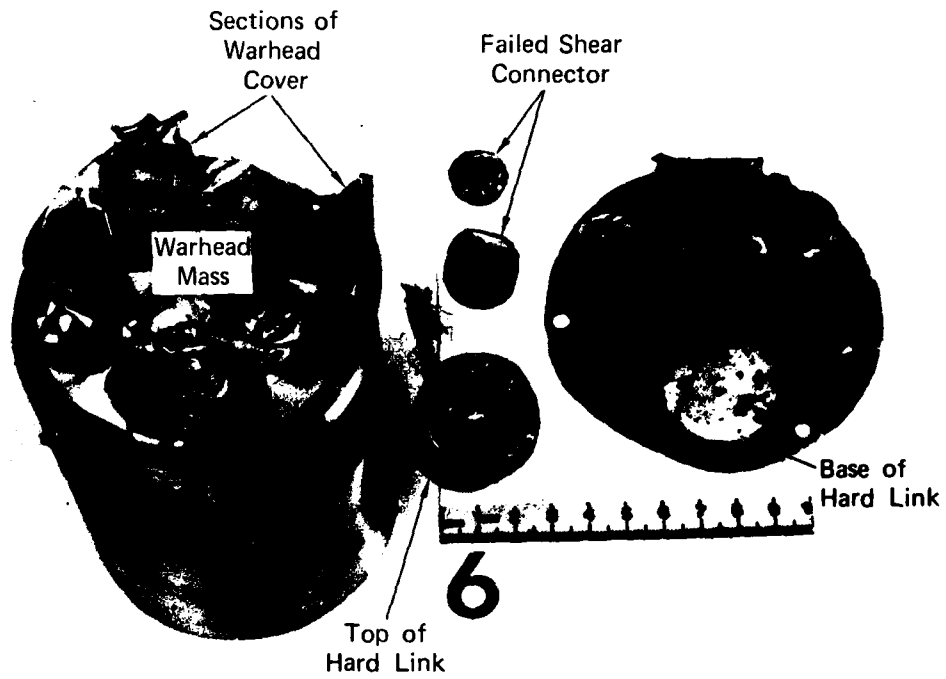
MP-7422-8

FIGURE 7 MISSILE MODEL DAMAGED IN TEST 6 (290 ft/sec)

into several pieces and the model of the hard link absorbed enough energy to be hot after the test.
