NORTON CO. WORCESTER MASS INDUSTRIAL CERAMICS DIV  
SEVERE ENVIRONMENT TESTING OF SILICON NITRIDE ROLLING ELEMENTS.--ETC(U)  
NOV 79 J W LUCEK, L B SIBLEY, J W ROSENLIB N00019-77-C-0551

| REPORT DOCUMENTATION PAGE | | READ INSTRUCTIONS<br>BEFORE COMPLETING FORM |
|---|---|---|
| 4. TITLE (and Subtitle)<br>SEVERE ENVIRONMENT TESTING OF SILICON<br>NITRIDE ROLLING ELEMENTS | | 5. TYPE OF REPORT & PERIOD COVERED<br>FINAL rept.<br>30 DEC 77 - 2 MAR 79 |
| 10. PERFORMING ORGANIZATION NAME AND ADDRESS<br>Norton Company<br>Industrial Ceramics Division<br>Worcester, MA 01606 | | 11. REPORT DATE<br>NOVEMBER 1979 |

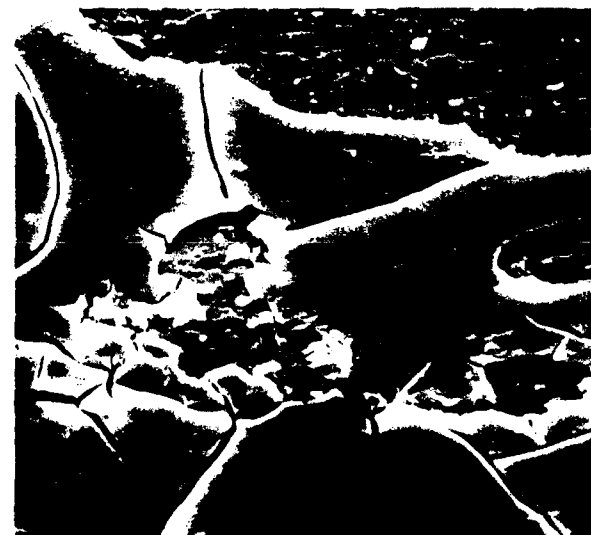
a. Center of ball track from  
Test 3-1

c. Center of ball track from  
Test 3-2

d. High magnification of  
Figure 3c

FIGURE 13 - Comparison of wear tracks on NC-132 spindle balls  
tested with MoS<sub>2</sub> sputter coated orbital balls  
and graphite cage

Typical scanning electron microscopy (SEM) photographs of the spindle ball wear tracks are given in Figures 11, 12 and 13. The uncoated ball test tracks with low wear are very smooth as shown in Figures 11a and b, whereas the uncoated test tracks with higher wear have an exfoliated appearance, shown in 11c and d. The exfoliated film is extremely thin and semi-transparent to electron-beam. In the low melting point glass bonded molybdenum disulfide solid lubricant (Vitrolube) coated orbital ball tests, the low wear spindle ball tracks were generally rather smooth, as shown in Figures 12a and c, but the high wear spindle ball in Figure 12d was somewhat rougher. Some portions of one low wear spindle ball track run against Vitrolube coated orbital balls had what appeared to be a surface coating (Figure 12b). The molybdenum disulfide sputter coated orbital ball tests also sometimes had a fragmented spindle ball surface layer shown in Figures 13c and d.

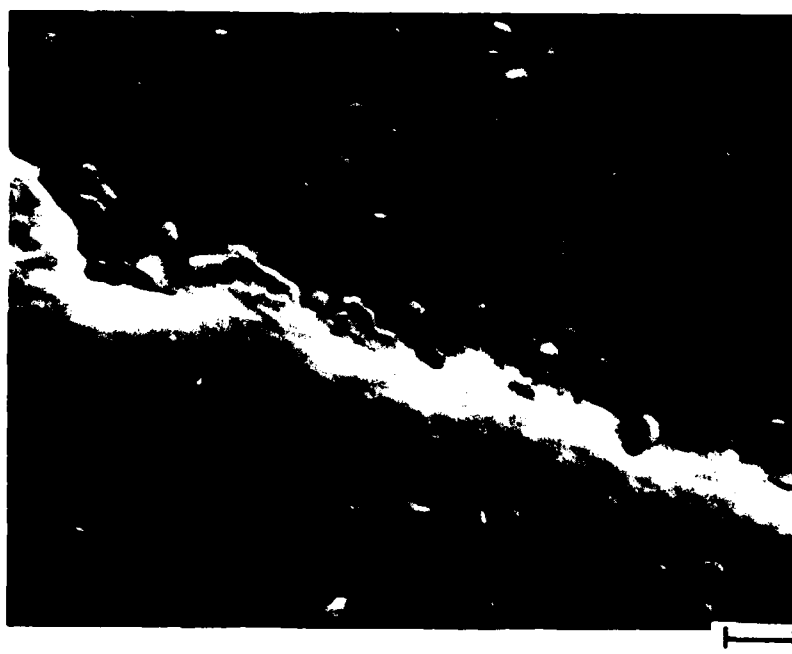
FIGURE 28 - Hertzian crack morphology NC-132  
2 hours @ 900°C (1650°F)

Figures 27 and 28 are secondary emission electron micrographs of the cone crack/specimen surface intersection. The crack is lighter in tone due to local charging. The surface of the NC-132 in Figure 27 is typical of a carefully finished specimen; the microstructure of the material is fairly apparent with details of less than  $2\mu\text{m}$ . The irregularities in the crack front (saw-tooth effect) are, in size, the same general scale as the grain size. Figure 28 shows a typical surface morphology of a lightly oxidized NC-132 silicon nitride surface. The crack front's
