AVRADCOM  
Report No. TR 80-F-2

MANUFACTURING METHODS AND TECHNOLOGY  
(MANTECH) PROGRAM

COMPLEX, PRECISION CAST COLUMBIUM ALLOY GAS TURBINE  
ENGINE NOZZLES COATED TO RESIST OXIDATION

FINAL REPORT

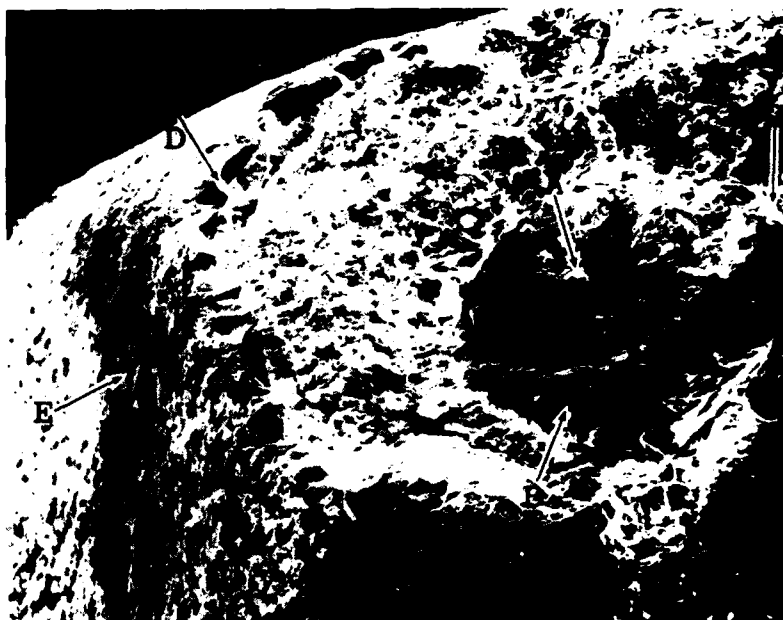
Figure 75. High Magnification (45X) SEM Photograph of Failed Area of Specimen No. 6-2

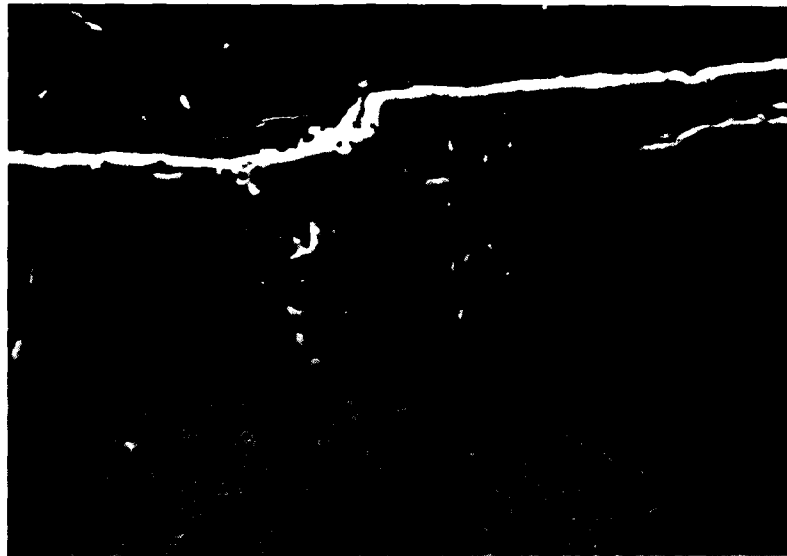
Figure 83. SEM Photomicrograph of Oxidized C129Y Substrate on Leading Edge Failure in Specimen No. 1-3 (Arrows Indicate Hafnium-Rich Areas); Magnification: 1140X

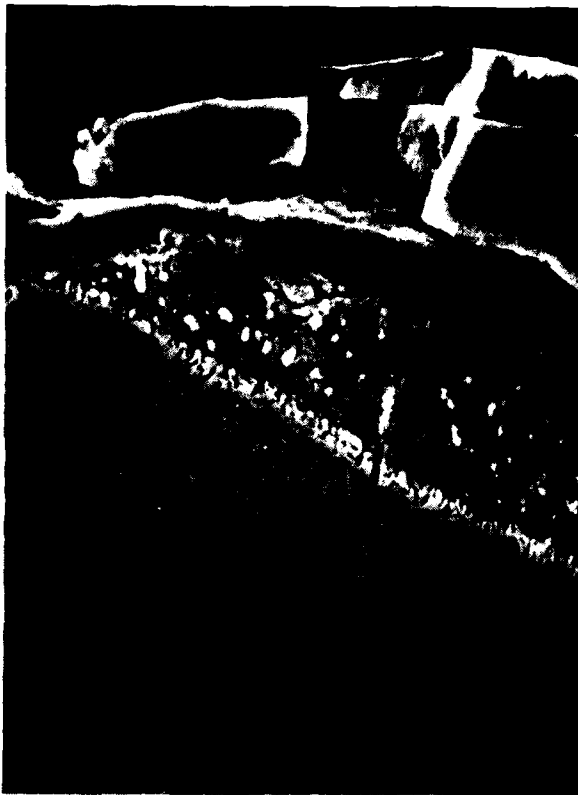
Figure 85. SEM Photomicrograph of Edge of Failed Area on Leading Edge of Specimen No. 1-3

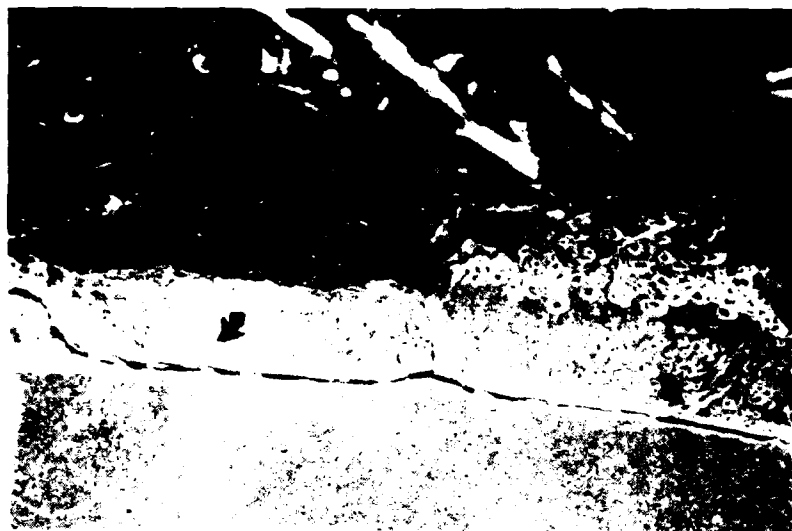
Figure 96. Photomicrographs of Failed Area on Leading Edge of Specimen No. 3-4 Showing Oxide Formation (Arrows Indicate Hafnium-Rich Areas)

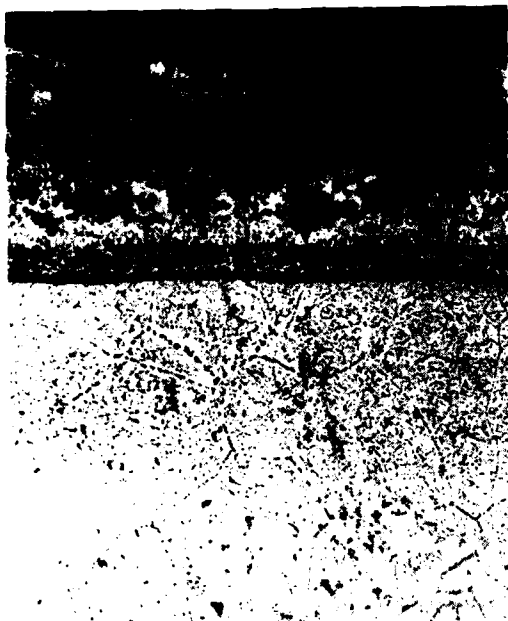
Figure 97.

Figure 97 shows a relatively sound coated area although evidence of oxidation attack can be noted in the outer portion of the coating.
