TECHNICAL REPORT EL-80-4

AREA STRIP MINE RECLAMATION USING DREDGED MATERIAL: A FIELD DEMONSTRATION

Eugene R. Perrier, Jose L. Llopis, Patricia A. Spaine

Environmental Laboratory
U. S. Army Engineer Waterways Experiment Station
P. O. Box 631, Vicksburg, Miss. 39180

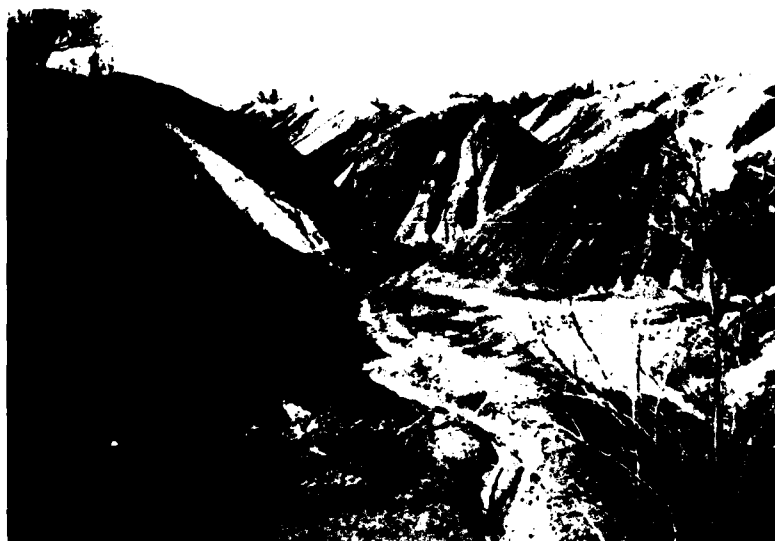
Figure 4. Photograph showing site prior to establishment of the field demonstration

10. Several large tracts of pyritic mine spoil owned by Ottawa Silica Company in LaSalle County were examined as potential sites for the field demonstration. The site selected, as shown in Figures 3 and 4, covered about 25 acres and was located 1 mile east of the city of Ottawa, Ill. The site was abandoned after coal and clay mining operations were completed in the 1930's. The reasons that led to the selection of the site were:⁵

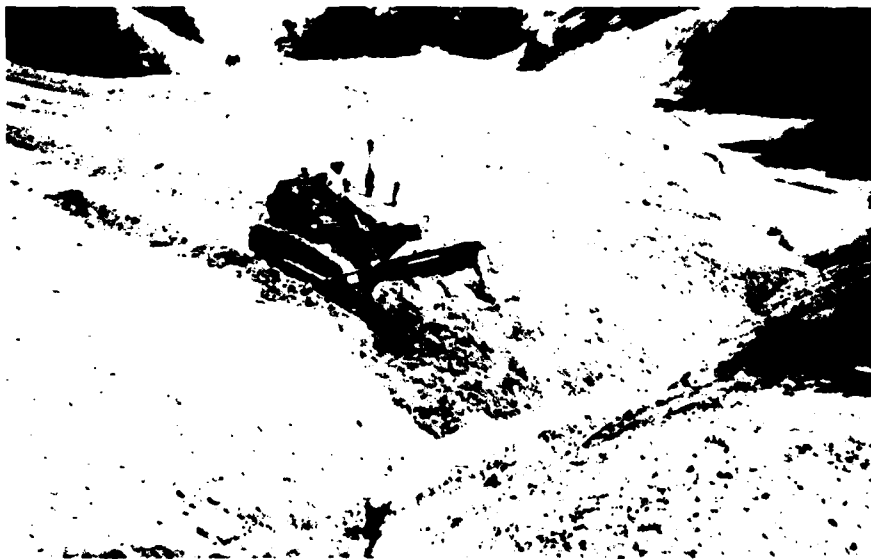
Figure 9. A bulldozer striking off the mine spoil ridges prior to revegetation

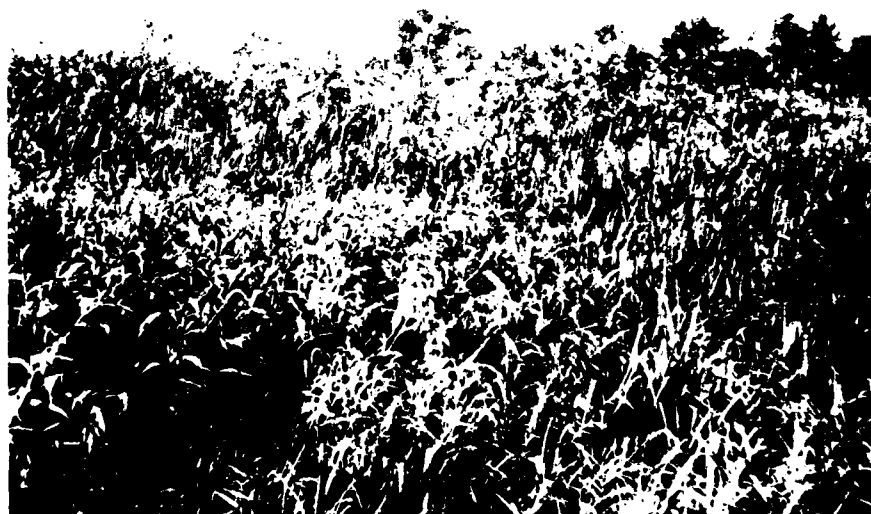
Figure 18. Photograph taken down in the fill area along the edge of a wet trough. Giant foxtail visible in the foreground and cottonwoods in the background

higher elevations, primarily in the eastern end, to domination by cottonwood, common evening primrose, field thistle, Norway cinquefoil, hairy aster, garden sunflower, knee grass, barnyard grass, common orach, green foxtail, giant foxtail, horseweed, and reed canary grass (Figures 17 and 18 in the main text).

6. As mentioned earlier, the southern and western margins are characterized by very wet troughs about 50 ft wide; these are dominated by smartweed, common beggar's tick, purple-stemmed tickweed, rice cut grass, barnyard grass, and nodding burr marigold (Figures 15, 16, and 18 in the main text). The open mudflat areas are inhabited almost solely by red rooted sedge, sprangletop, oak-leaved goosefoot, and knee grass (Figure A1).

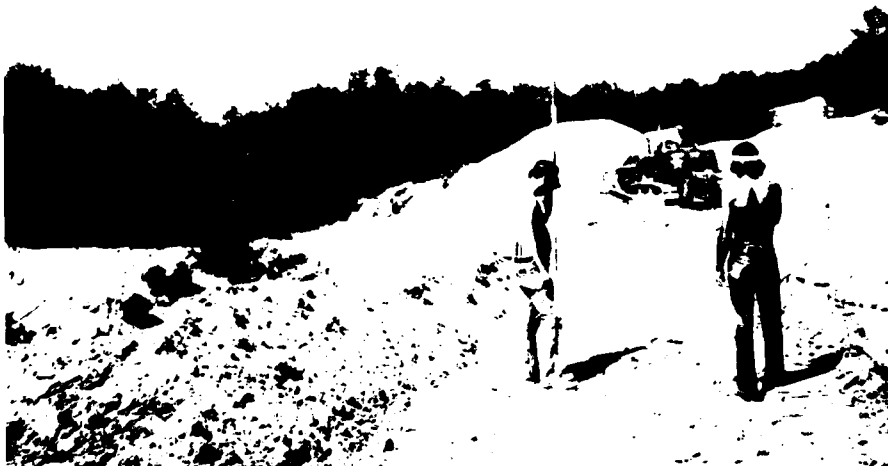
Figure 22. Leveling mine spoil ridges

47. The demonstration site consisted of a series of northwest-southeast trending parallel ridges as shown in Figure 21. The site was constructed as shown in Figure 22 by leveling a section of the center two ridges with dozers and forming a raised plateau. The 5-ft-high dikes were constructed from mine spoil and covered with heavy-duty polyvinyl chloride (PVC) plastic. The purpose of the dikes was to separate the plots and segregate the surface runoff from each plot for monitoring activities (Figure 20).

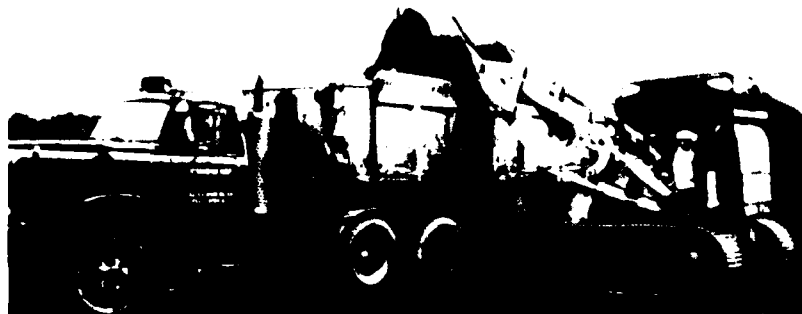
Figure 24. Loading dredged material at borrow area

49. The stockpiled dredged material was loaded by a front-end loader onto trucks, whose capacity was approximately 15 yd³, and hauled to the test site (Figure 24). The Corps used the truck haul method for transporting the dredged material in preference to the seemingly more economical barge haul method because of simplicity and timeliness.³ Crushed agricultural limestone was spread, as shown in Figure 25, and then disked into the mine spoil in plots III and IV. The dredged material was placed in plots II, III, and IV to the 3-ft depth. A dozer then spread the material to the specified depth of 3 ft (Figure 26) and the finished surface was graded with a front-end loader to the southwest corner of each plot at a grade of approximately 0.5 percent.

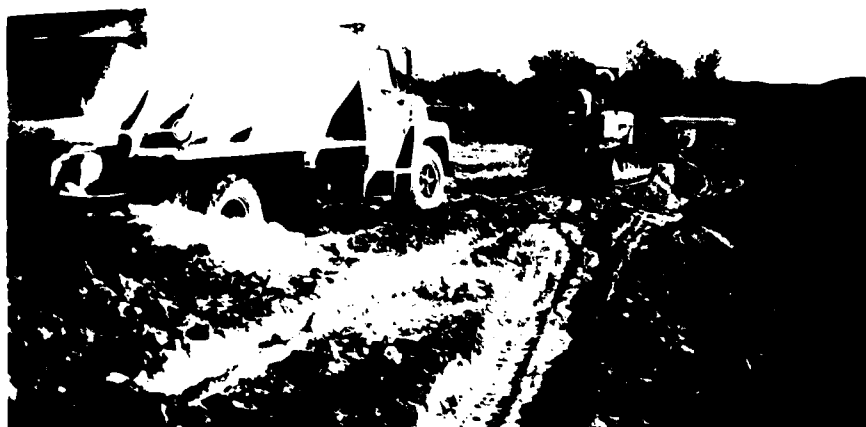
Figure 25. Spreading agricultural ground limestone on the dredged material in plot III

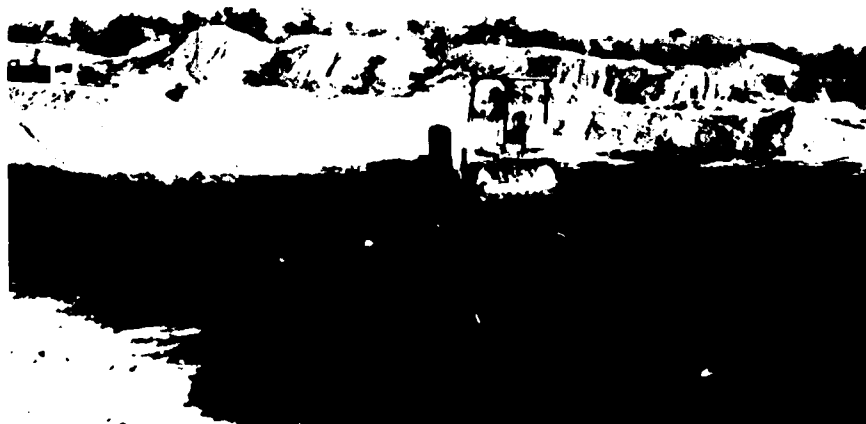
Figure 26. Spreading dredged material on plots

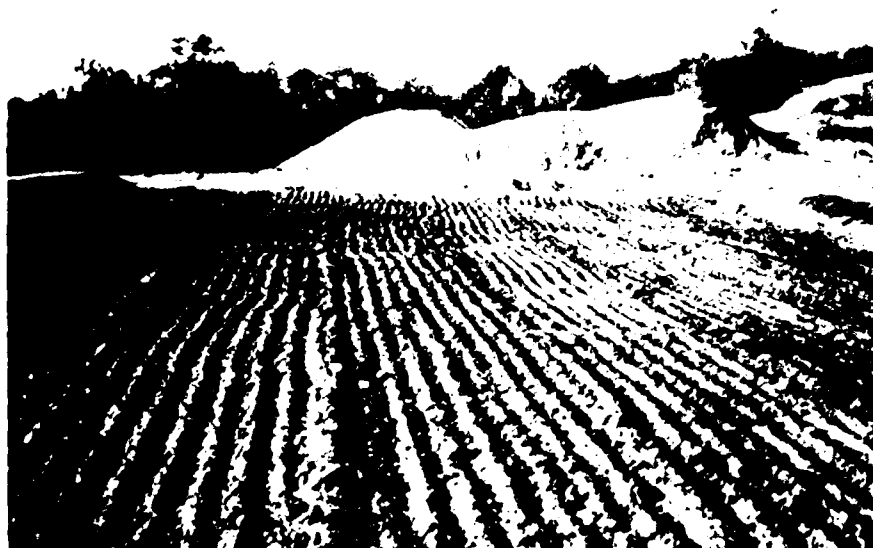
Figure 27. Plot IV scarified and prepared for seeding

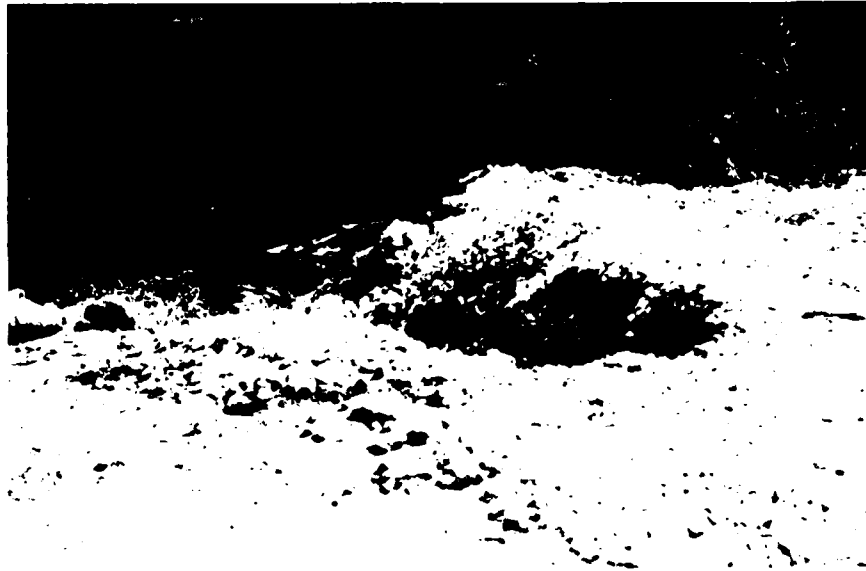
Figure 31. Recurring erosion of the southeastern corner of the demonstration site

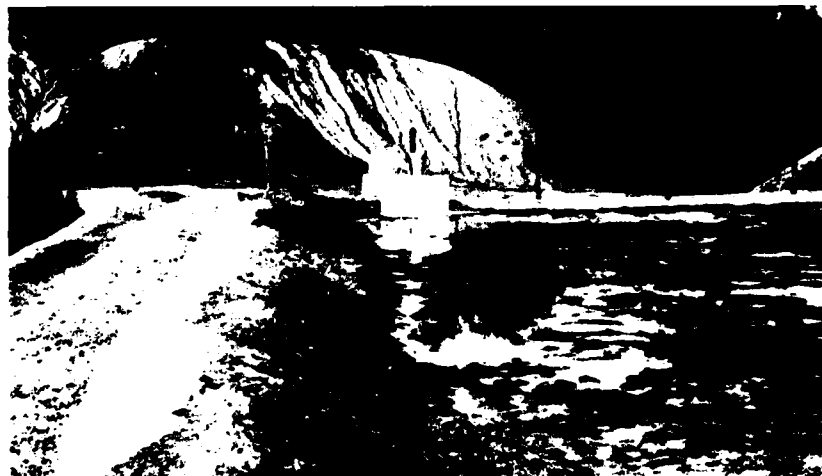
Figure 32. Photograph of plot I looking south showing ponded water following a rain. Note mine spoil hills in background

60. As the material in the demonstration plots continued to settle, correction of the grade by adding thin layers of material to the surface required constant attendance to ensure that all the water ran off the plots and that puddling and stagnation did not persist (Figure 32).

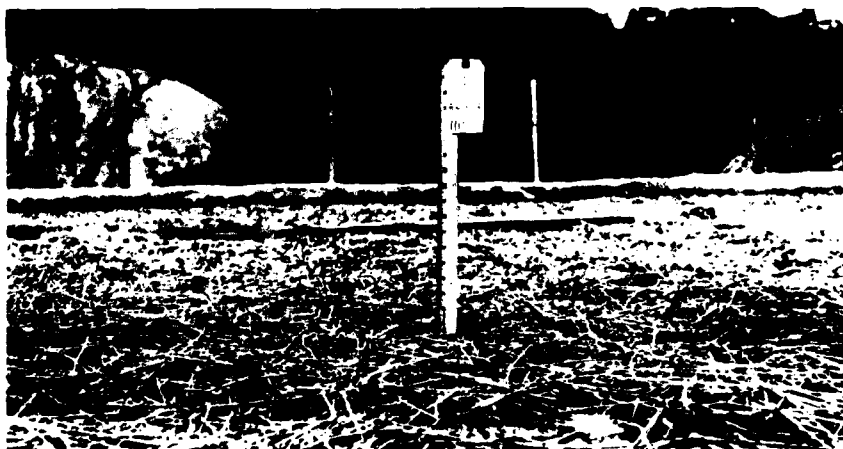
Figure 34. Photograph of plot I (control) showing that none of the seed mixture germinated on the plot as of 8 June 78

64. The height of the plants as of 8 June 1978 is shown in Figures 34-37. In control plot I, the seed mixture did not germinate and only an occasional grass or weed appeared to be growing in the plot. Plots II, III, and IV produced an excellent cover that was about 8 in. in height as of 8 June 1978. Some of the broad leaves present in the plots were smartweed (Polygonum lapathifolium), an invading species particularly attractive to wildlife, and an occasional head of wheat (the seed was carried in the straw mulch).

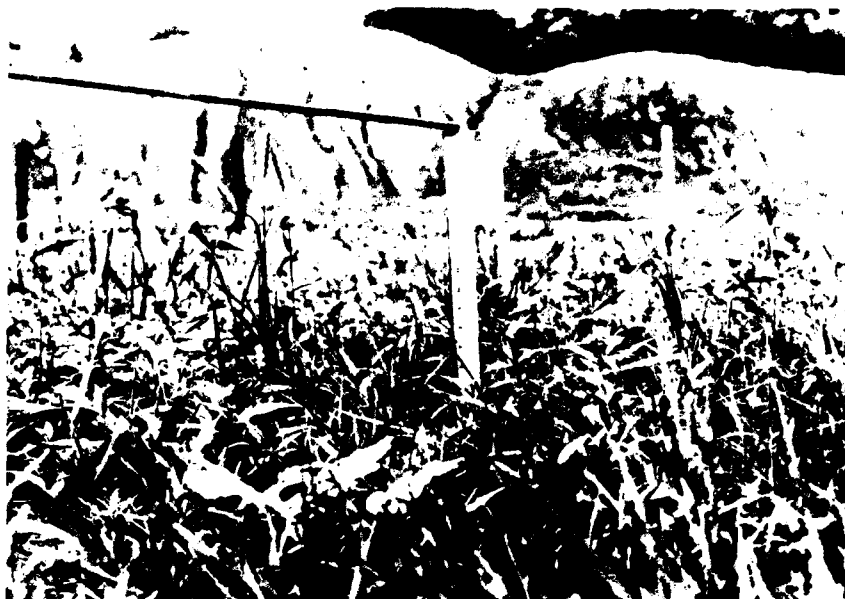
Figure 35. Photograph of vegetative growth of seed mixture plus additional specie on plot II as of 8 June 78

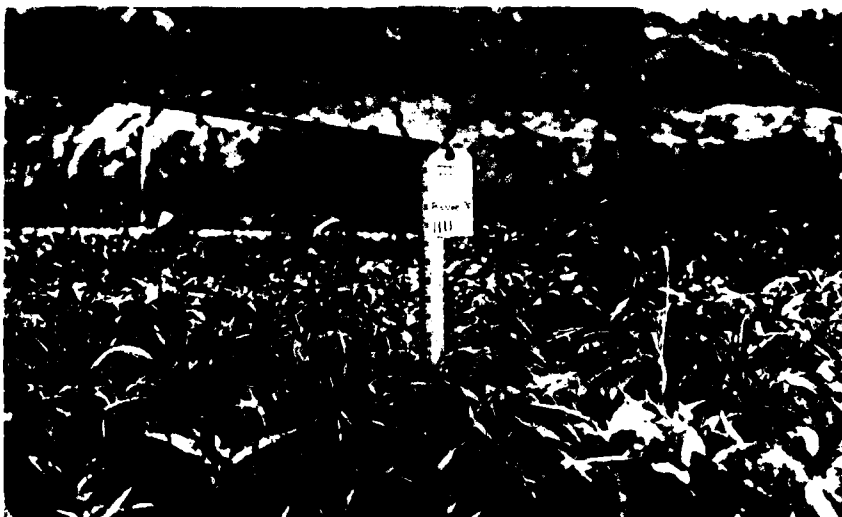
Figure 36. Photograph of vegetative growth of seed mixture on plot III as of 8 June 78

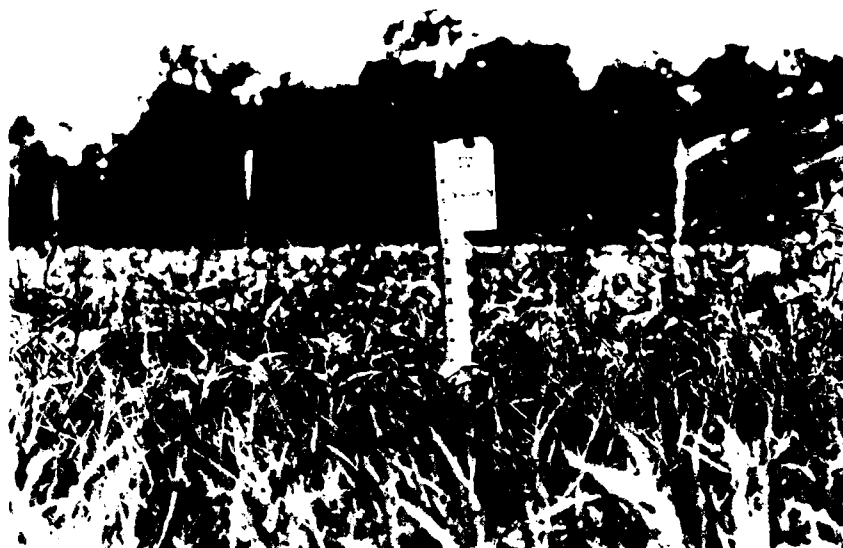
Figure 37. Photograph of vegetative growth of seed mixture on plot IV as of 8 June 78

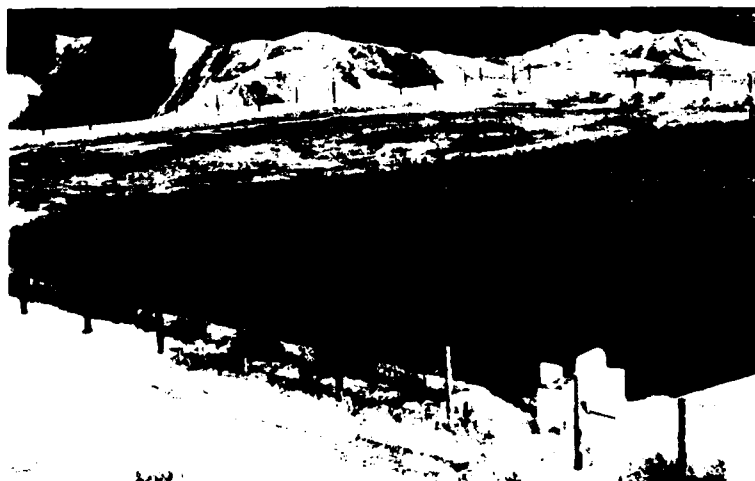
Figure 38. Photograph taken on 22 August 1978 showing how smartweed dominated the plots

65. As no weed control practices were initiated at the study site, smartweed, which germinates from rhizomes and seed, was transported with the dredged material and eventually took over the plots as shown in Figure 38. The rank growth of smartweed dominated all other species by the end of June and eventually reached 7 to 8 ft in height as shown in Figure 39. By 9 July 1978, the plant species associated with the fall-planted seed mixture had died and only those species of plants carried by the dredged material survived.

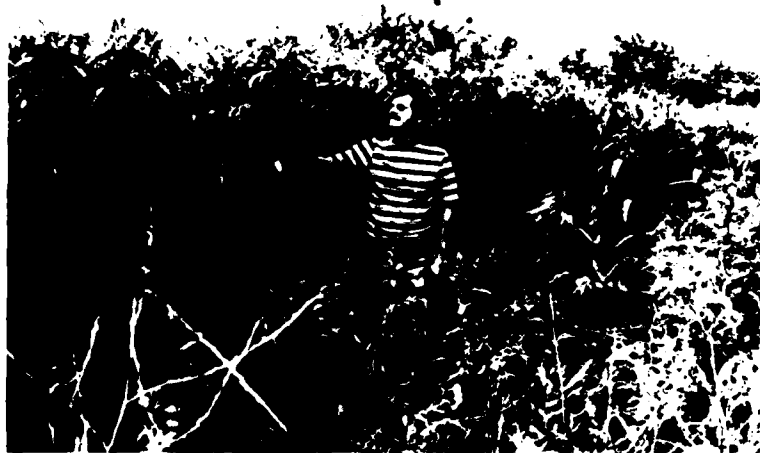
Figure 39. Photograph of the plots showing the rank growth of smartweed which was 7 to 8 ft in height

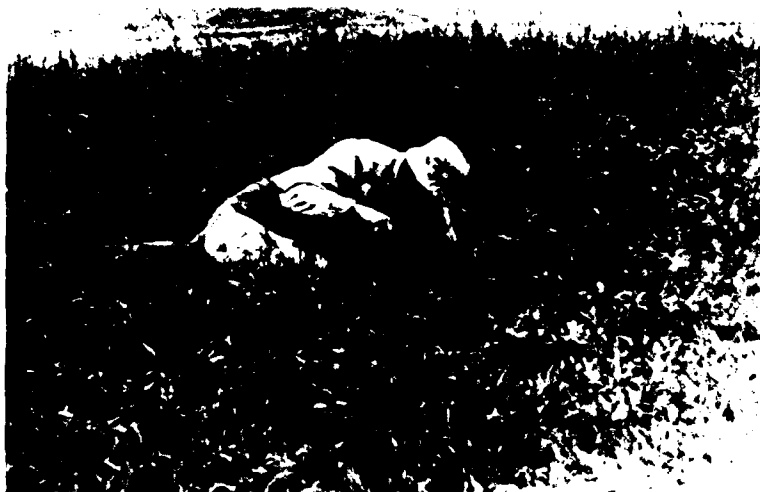
Figure 40. Plant identification of vegetation at the area strip mine site

66. A species identification study (Figure 40) was completed on 11 July 1978 and complete details are presented in Appendix B. The control plot was essentially barren with only scanty vegetation in one corner. However, prolific growth of native species brought into the

basin with the dredged material appeared to be identical in the three dredged material treatments. The planting of the seed mixture, shown in the tabulation in paragraph 55, resulted in germination and growth of only four species: perennial ryegrass, smooth brome, tall fescue, and birdsfoot trefoil. Only the perennial ryegrass reached populations considered to be significant. No specimens of the remaining two planted species, Kentucky bluegrass and blackwell switchgrass, were found. The rich growth of the native species was made up primarily of five species: smartweed, black mustard, common ragweed, common beggar's tick, and giant beggar's tick. Smartweed contributed the greatest proportion of the biomass within each of the dredged material treatments.
