FLOOD PLAIN INFORMATION COLORADO RIVER-ONION CREEK TO MONTOPOLIS BRIDGE AUSTIN, TEXAS

PREPARED FOR THE CITY OF AUSTIN, TEXAS

CORPS OF ENGINEERS, U.S. ARMY FORT WORTH, TEXAS, DISTRICT SEPTEMBER 1976

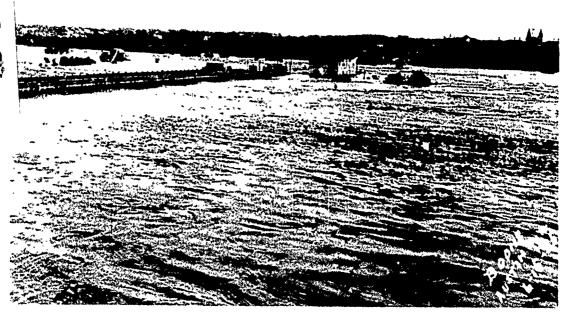
PHOTOGRAPH OF SOUTH CONGRESS AVENUE BRIDGE DURING FLOOD OF JUNE 1935. VIEW IS TO THE SOUTH. (PHOTO COURTESY AUSTIN-TRAVIS COUNTY COLLECTION, AUSTIN PUBLIC LIBRARY)

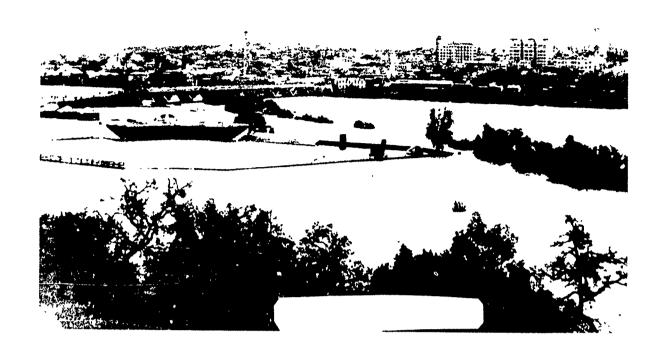
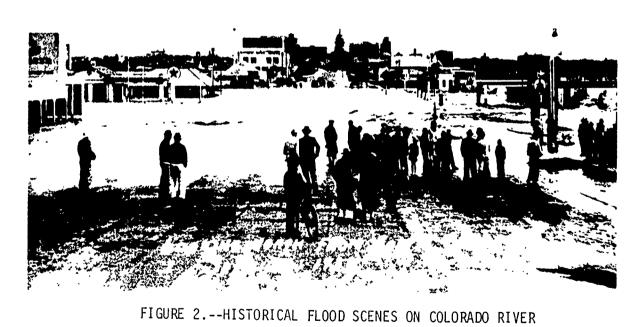
Upper photograph is view of Congress Avenue Bridge from south bank during December 1913 flood. Lower photograph is scene during September 1936 flood looking north from south bank. (Photos courtesy of Austin-Travis County Collection, Austin, Texas, Public Library.)

Scenes of damages inflicted by historic floods in Austin are shown in Figures 2 and 3 on pages 20 and 21.

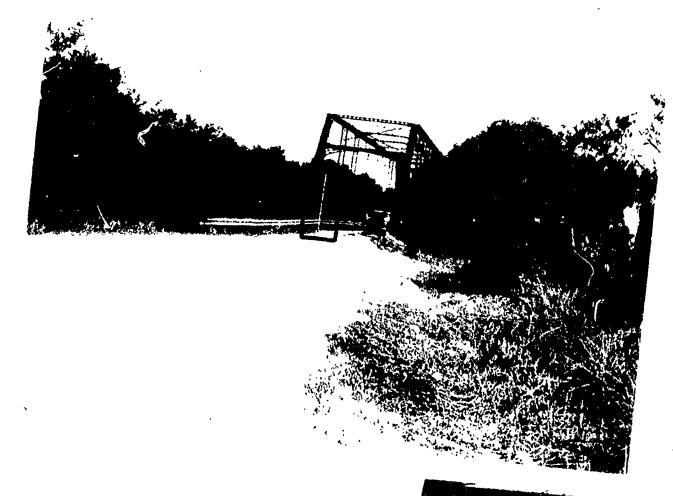
FIGURE 4. -- FLOOD HEIGHTS

This figure shows the potential 100-year frequency flood height at the F.M. 973 bridge over the Colorado River at river mile 280.46.
