DEFENCE RESEARCH ESTABLISHMENT ATLANTIC DARTMOUTH N.S. D. R. E. A. REPORT 80/2 12. 31 1 EFFECT OF ZINC ON THE SULPHIDATION REACTION IN MARINE GAS TURBINES, 10) R. S. Hollingshead June 1980 11: 34  $\langle \rangle$ Approved by J. R. BROWN A/Director / Technology Division Jac Jun-DISTRIBUTION APPROVED BY CHIEF D. R. E. A. RESEARCH AND DEVELOPMENT BRANCH DEPARTMENT OF NATIONAL DEFENCE CANADA

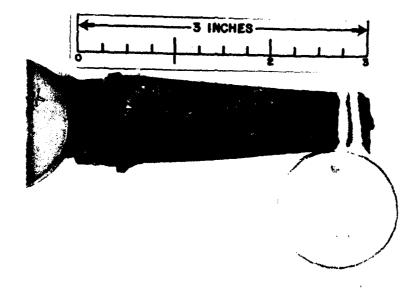
FIGURE 2: FT-12 first stage turbine blade after 3038 running hours. White deposit is  $2nSO_4$ .

In order to evaluate the effectiveness of these safeguards, several specimen not section parts such as nozzle guide vanes and turbine blades were examined after varying lengths of service. Although some of these showed deterioration, none have showed any sign of sulphidation or other form of degradation attributable to operation in the marine environment. Figure 1 shows a nozzle guide vane and Figure 2, a first stage turbine blade from an FT-12 engine after 3038 hours of operation.

These parts, made of diffusion coated AMS 5385 alloy (Table I) exhibited only a slight erosion of the coating, probably due to carbon particles. The white deposit was identified by X-ray diffraction as zinc sulphate. Similarly the Solar "Saturn" turbine blade shown in Figure 3, which is made of S-816 alloy (Table I), suffered erosion damage during 11,200 hours of service but no sulphidation. Again the white deposit was identified as zinc sulphate.

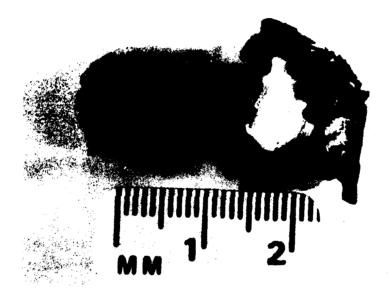
FIGURE 5: Left - Fir tree before exposure Right - Fir tree after exposure to 90% Na<sub>2</sub>SO<sub>4</sub>, 10 % NaCl for 25 hours.

The extent of attack for each exposure was determined by measuring the cross-sections of the specimens before and after the exposure (Figure 5).

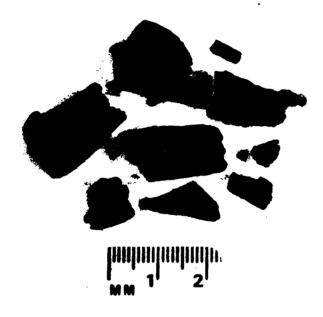
FIGURE 6: Solar "Saturn" 1st stage turbine blade completely oxidized after 30 hours.

Table II, which shows the results of exposure to a 90/10 mixture of Na<sub>2</sub>SO<sub>4</sub> and NaCl, indicates that 12 of 18 samples were completely oxidized in exposure times of 16 to 90 hours (Figure 6). Only two blades showed no deterioration after exposure times of 40 and 70 hours although several others displayed a low level of sulphidation. In marked contrast, the results of Table III, for exposures to mixtures containing either 2.5 or 5.0 percent  $2nSO_4$  for times from 30 to 112 hours, show nil or little wastage in all 20 cases and the wastage that occurred was ascribed to normal high temperature oxidation.
