DELET-TR-80-16

RELIABILITY EVALUATION OF PLASTIC ENCAPSULATED HYBRID
MICROCIRCUITS DEVELOPED FOR ARMY FUZE APPLICATIONS

Edward B. Hakim
John Erickson
ELECTRONICS TECHNOLOGY & DEVICES LABORATORY

August 1980

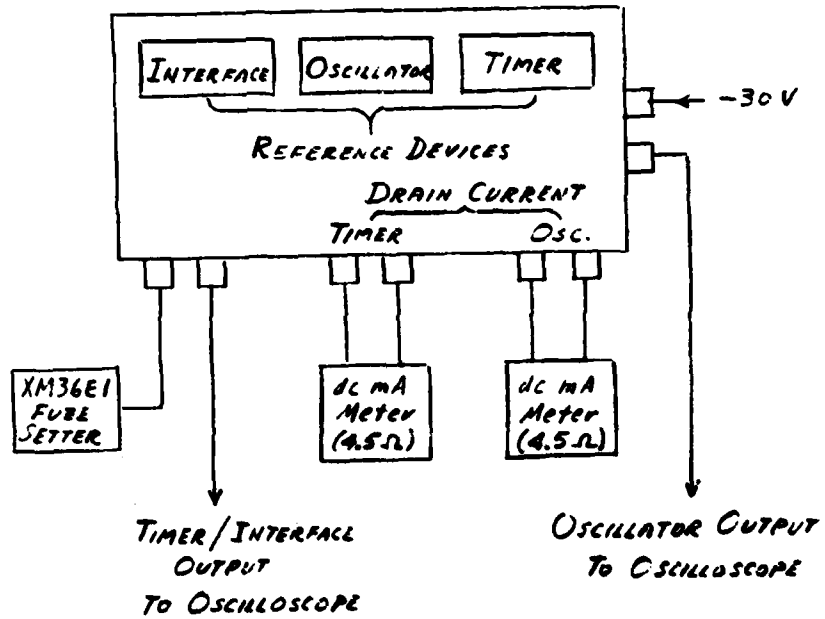
Figure 6. End Point Measurement Test Circuit

The end point measurement test circuit is shown in Figure 6. A "Static-Safe" work station was developed for handling the MNOS timer. The work surface was covered with conductive foil and grounded. Test personnel at the work station were equipped with a wrist band in direct contact with the skin and grounded. Figure 7 shows the "Static-Safe" work station including the test fixture which simulates the fuze timer circuit, the XM36E1 Fuze Setter and test meters. The fuze time is manually set using the XM36E1 Fuze Setter and the time is presented by a light emitting diode (LED) display. A catastrophic failure in the fuze timer circuit or setter will cause the display to indicate error, "E". The end point measurement procedure follows:

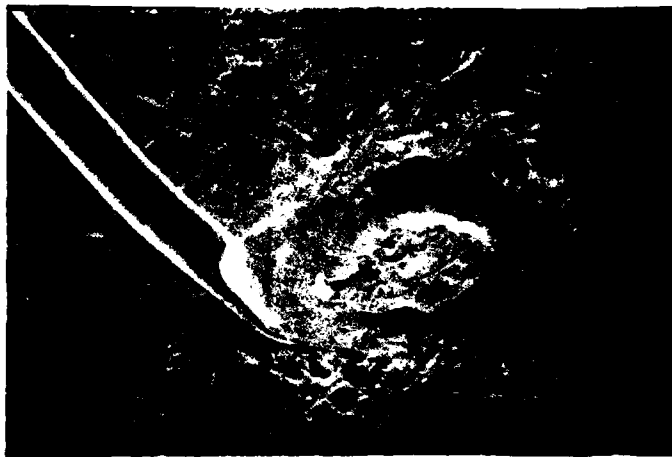
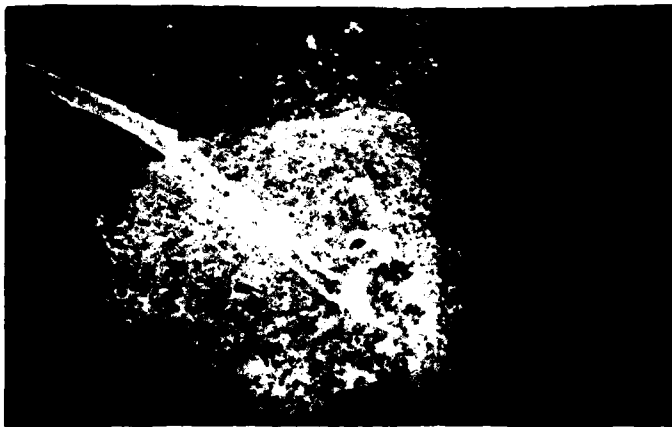
Figure 16. Typical Interface Wire Bonds

A major deficiency with the interface hybrid has been poor quality control, particularly regarding wire bonds. Figure 16 illustrates three different substrate conductor wire bonds. Figure 16a is a 390X SEM photomicrograph of a typical substrate wire bond. Overpressure by the bonding tool has completely flattened the ball and induced neckdown of the wire. Figures 16b and 16c show the same type of bond (130X magnification). This time, only part of the flattened bond exists because of the poor placement of the bond on the conductor. These problems could have been eliminated by precap visual inspection.

- a. Major changes in the assembly of the interface hybrid are required. Changes required include: improvement in wire bonding procedure; elimination of four jumper wires; use of standard lead frame assembly; use of accepted molding procedure and materials.

c. Procurement of these devices should be by a drawing which requires screens, i.e., precap visual and burn-in, and Lot Acceptance Testing.
