RADC-TR-80-236
Final Technical Report
July 1980

**CORROSION OF METAL FILMS
WITH DEFECTIVE SURFACE
PROTECTION LAYERS**

RCA Laboratories

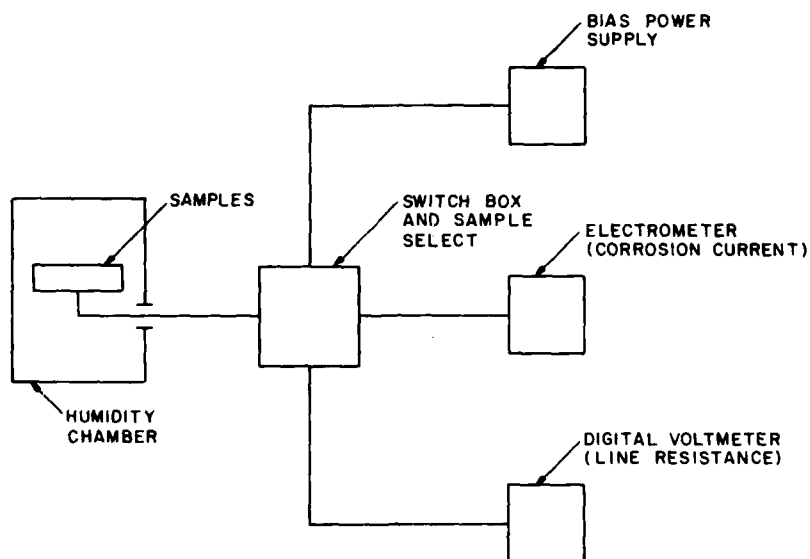
Figure 6. Schematic of electrical apparatus for measurement of devices in humidity cabinet.

The electronic system for applying a corrosion potential to samples in the humidity chamber consisted of a stainless-steel socket holder with five polytetrafluoroethylene (PTFE) sockets mounted in the chamber with wires brought out to a switching system. This switching system permitted application of bias voltage, measurement of corrosion current, measurement of metal line resistance, and detection of substrate shorts for the 15 line pairs involved in one test run of the line pattern devices. For the comb devices, the system permitted application of bias, current measurement between comb pairs, and detection of shorts to the substrate for four test devices mounted in PTFE sockets on a stainless-steel board. A sensitive electrometer was used for current measurements; a digital ohmmeter, for line resistance measurements. A schematic of the measurement system is shown in Fig. 6. Dry-nitrogen flow used in the switching box served to decrease leakage currents. By use of this equipment and ceramic packages without sample chips, leakage currents of 5×10^{-11} A were measured at 20 V and 85°C/85% rh.

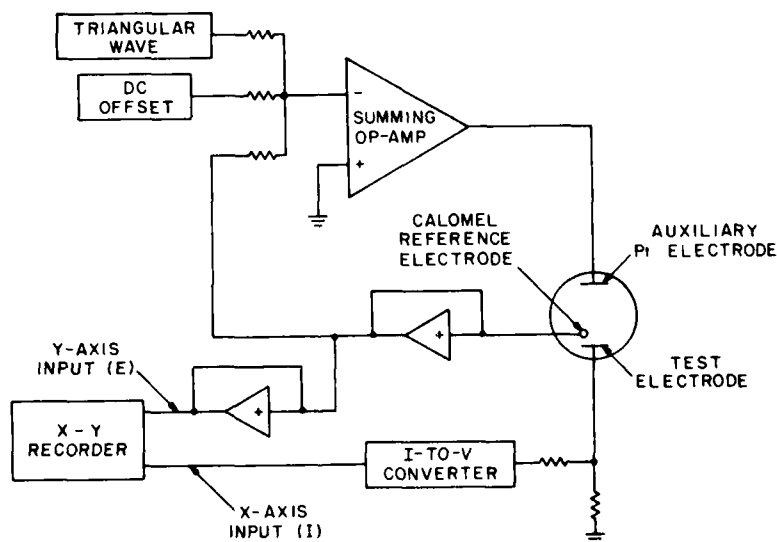
Figure 8. Schematic of corrosion-monitoring electrochemical-cell circuitry for cyclic voltammetry.

A circuit diagram of our corrosion cell apparatus is displayed in Fig. 8. Many valuable aspects of this design were supplied to us by the late G. S. Lozier. A significant feature of this circuit is the summing

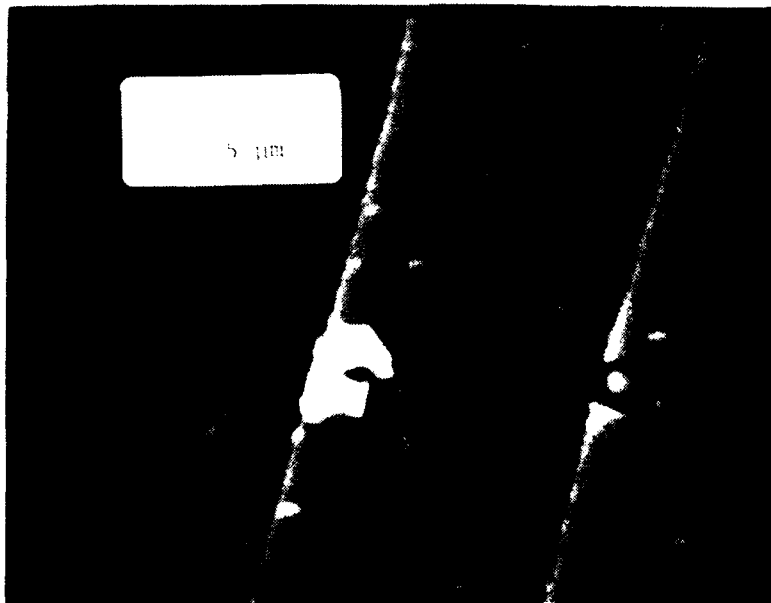
Figure 22. Low-voltage SEM of aluminum line passivated with SINCAP after corrosion at 85°C and 85% rh. Line at left was the cathode.
