AMMRC TR 80-18

CERAMIC LIFE PREDICTION PARAMETERS

REPORT FOR THE PERIOD
JANUARY 1, 1977 - MARCH 31, 1980

R. K. Govila
Ceramic Materials Department
Scientific Research Staff
Ford Motor Company
Dearborn, Michigan

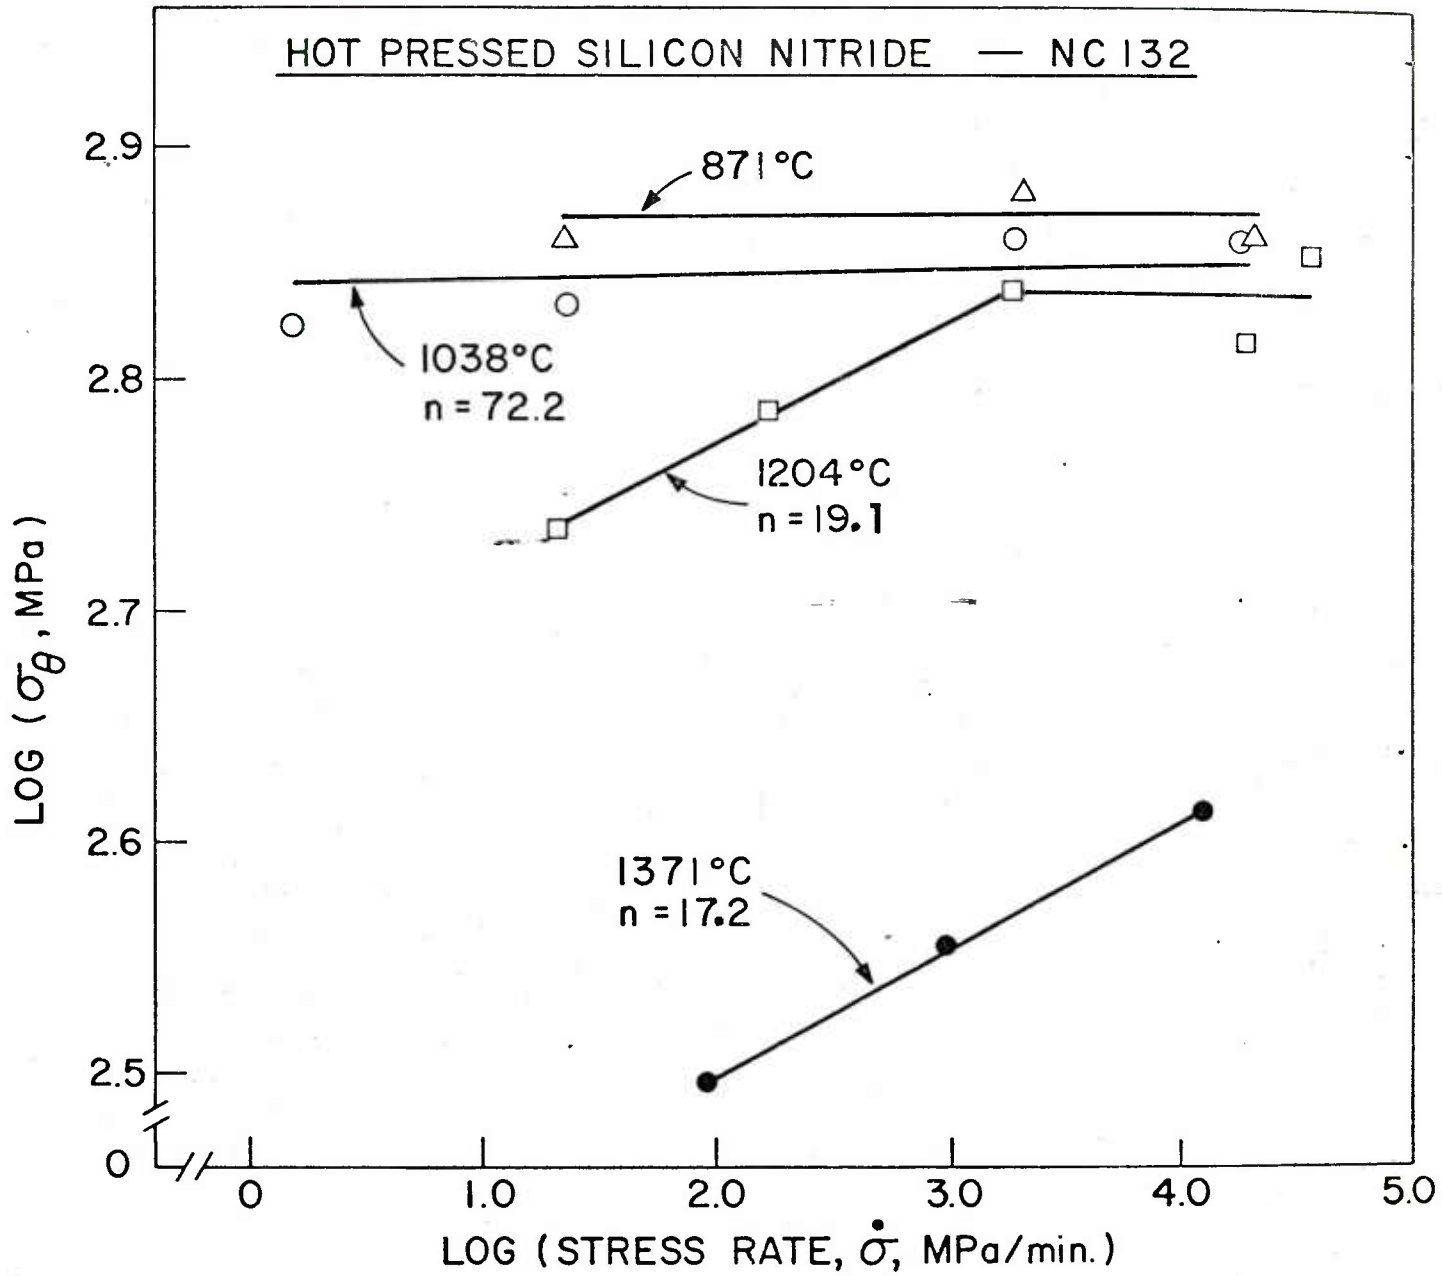
Fig. 2 Log-log plots of flexural strength vs stressing rate at various temperatures for NC-132 Si_3N_4 . Data presented in this figure were obtained by R. M. Williams, Ford Motor Company.

where σ_F is the fracture stress at a stressing rate $\dot{\sigma}_F$ and D is a constant. A log-log plot of σ_F vs stressing rate $\dot{\sigma}_F$ would yield a linear relationship (straight line) and from the slope of the plot, the parameter 'n' can be determined. The temperature dependence of the fracture stress for uncracked (virgin) samples of NC-132 Si_3N_4 as a function of stressing rate on a log-log scale is shown in Fig. 2. Up to about 1040°C, the fracture stress, σ_F , is almost independent of the stressing rate $\dot{\sigma}_F$, suggesting no evidence of SCG. At higher temperatures, the log-log plot showed a clear deviation from the horizontal line indicating presence of SCG, and at 1204 and 1371°C the values of 'n' were 19.1 and 17.2, respectively. Typical fracture surfaces at 1204°C corresponding to the three stress rates (inclined portion of log-log plot) are shown in Fig. 3, and only at the lowest stress rate was the presence of SCG observed, Fig. 3a. Metallographic examination of fracture surfaces for specimens tested at 1371°C (Fig. 2) showed the presence of SCG. It should be noted that the curves at 1204°C and 1371°C are essentially parallel, and the value of 'n' is independent of temperature in the range 1200-1400°C for a given environment. Similar behavior has been observed by Lange [3] in HS-130 Si_3N_4 (specimen configuration, weak direction, Fig. A1 in appendix), and the values of 'n' determined were 12.7, 10.6, and 11.2 at 1200, 1300, and 1400°C, respectively.

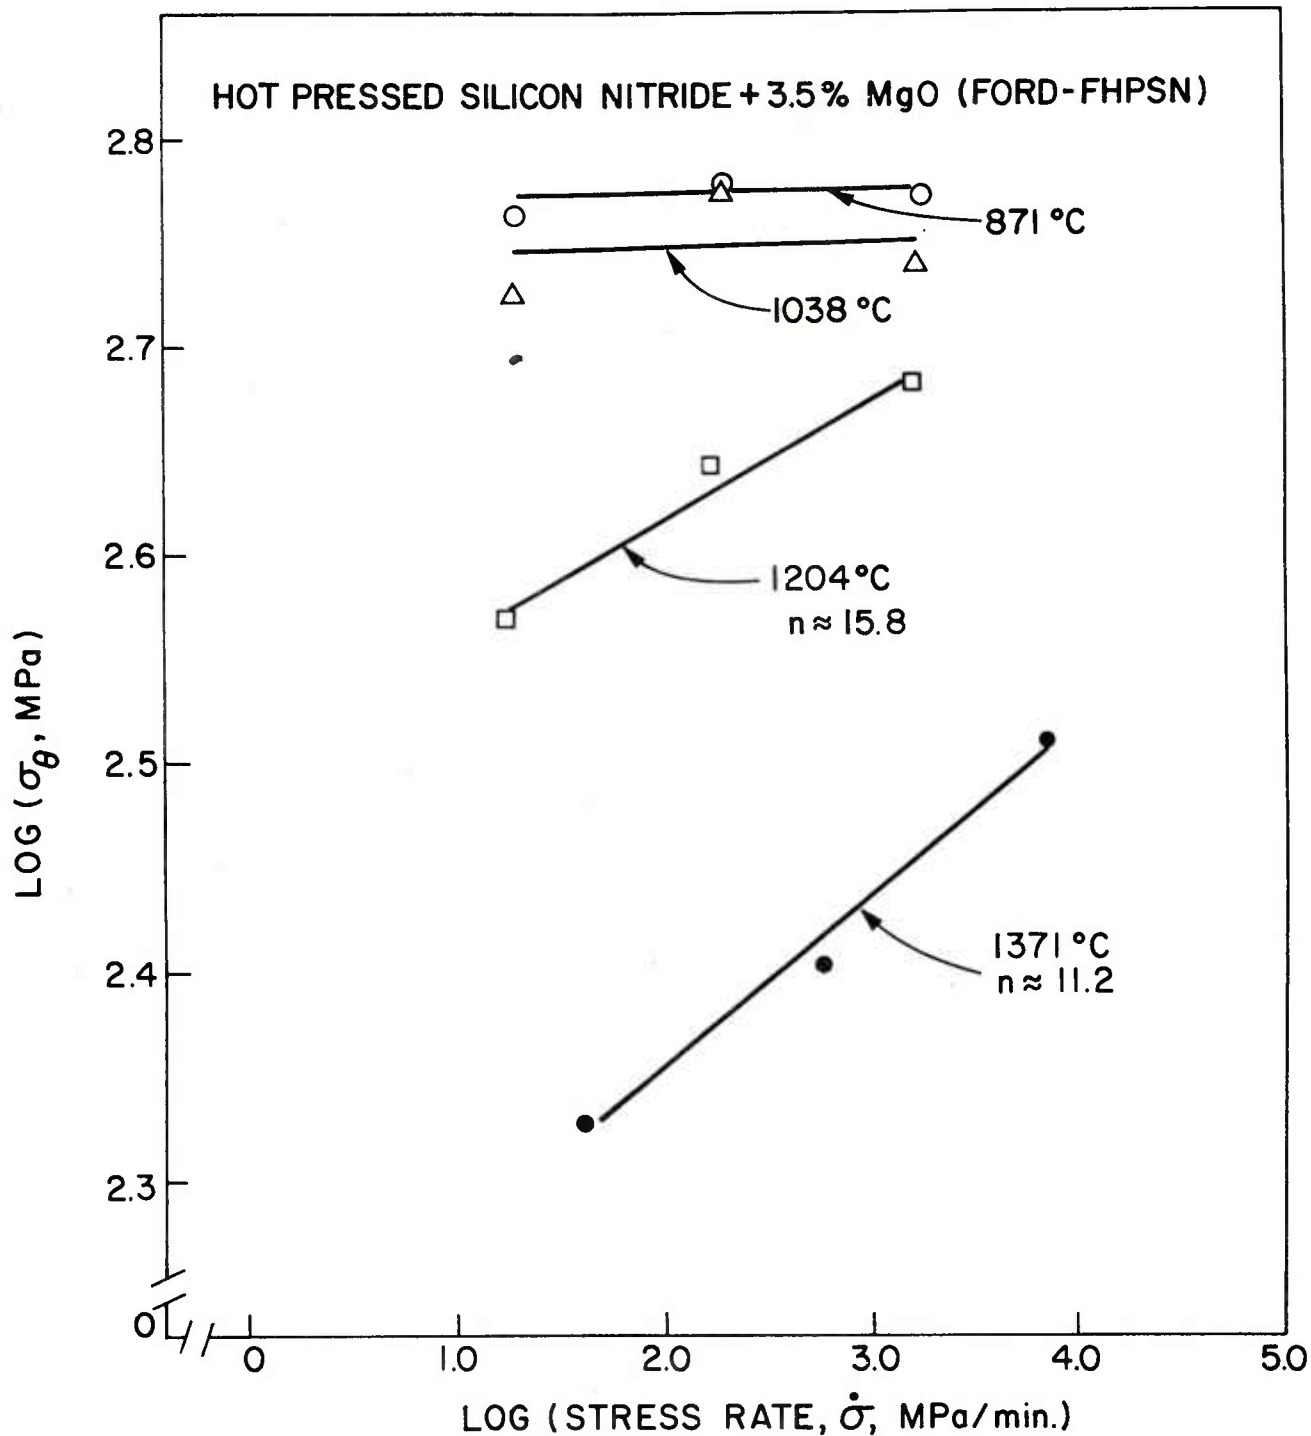
Fig. 4 Log-log plots of flexural strength vs stressing rate at various temperatures for 3.5% MgO + Si₃N₄ (FHPSN) material. Part of the data presented in this figure was obtained by R. M. Williams, Ford Motor Company.

The 3.5% MgO FHPSN material showed similar stress rate dependence, Fig. 4, as the NC-132 Si_3N_4 , and the values of 'n' were found to be 15.8 and 11.2 at 1204 and 1371°C, respectively. Examination of the fracture faces of test specimen revealed significant presence of SCG at temperatures of 1200°C.

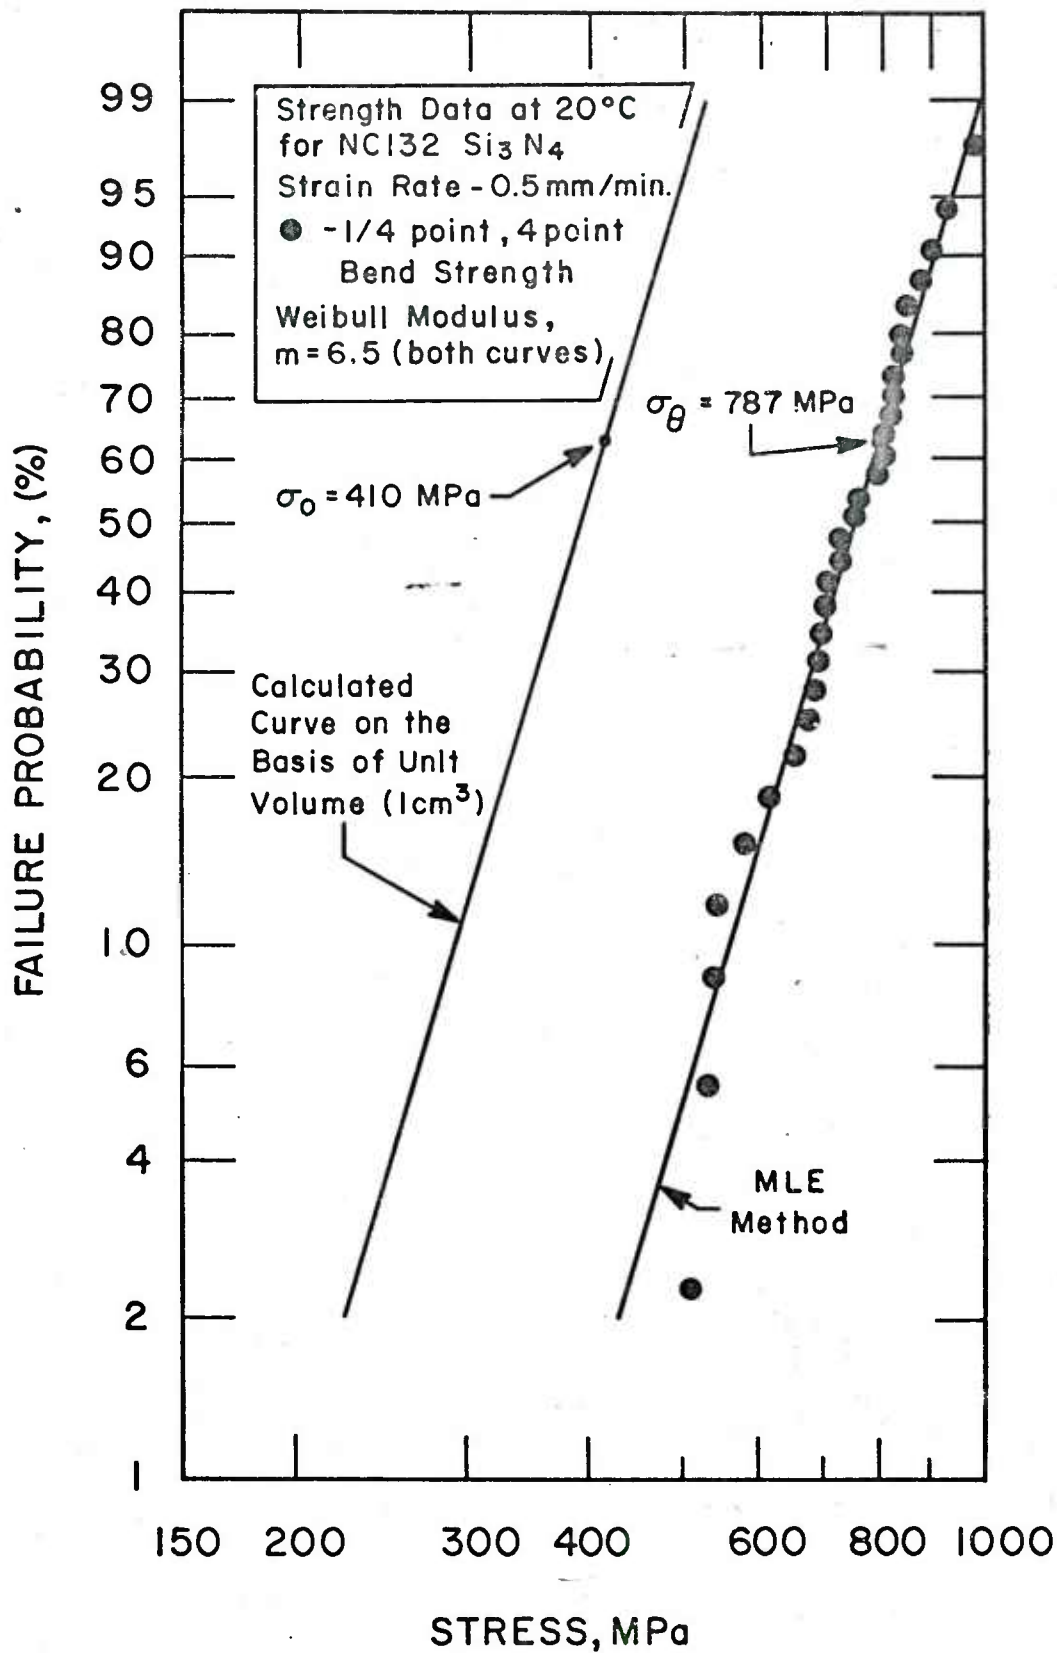
Fig. 8 Statistical variation in fracture strength. Solid line through the data points is drawn using the MLE method.

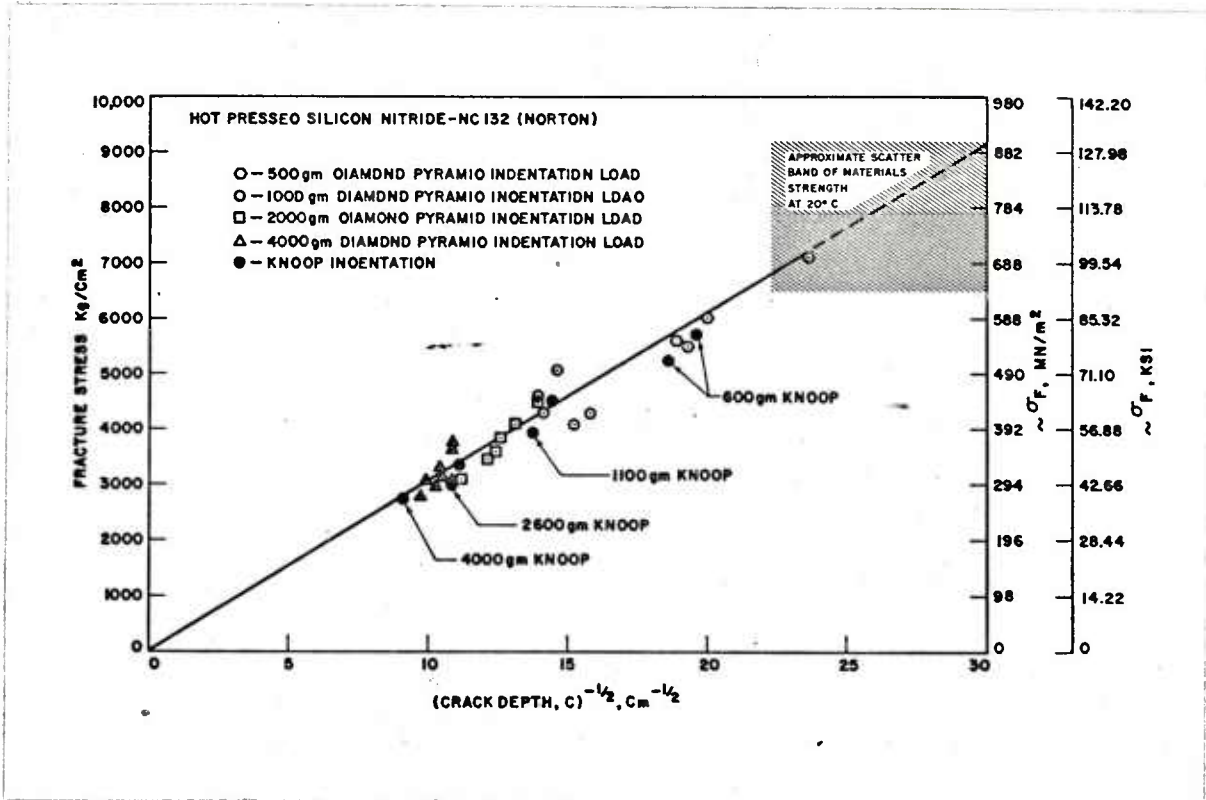
Fig. 17 Variation of fracture stress as a function of inverse square root of crack depth at room temperature for NC-132 Si₃N₄.

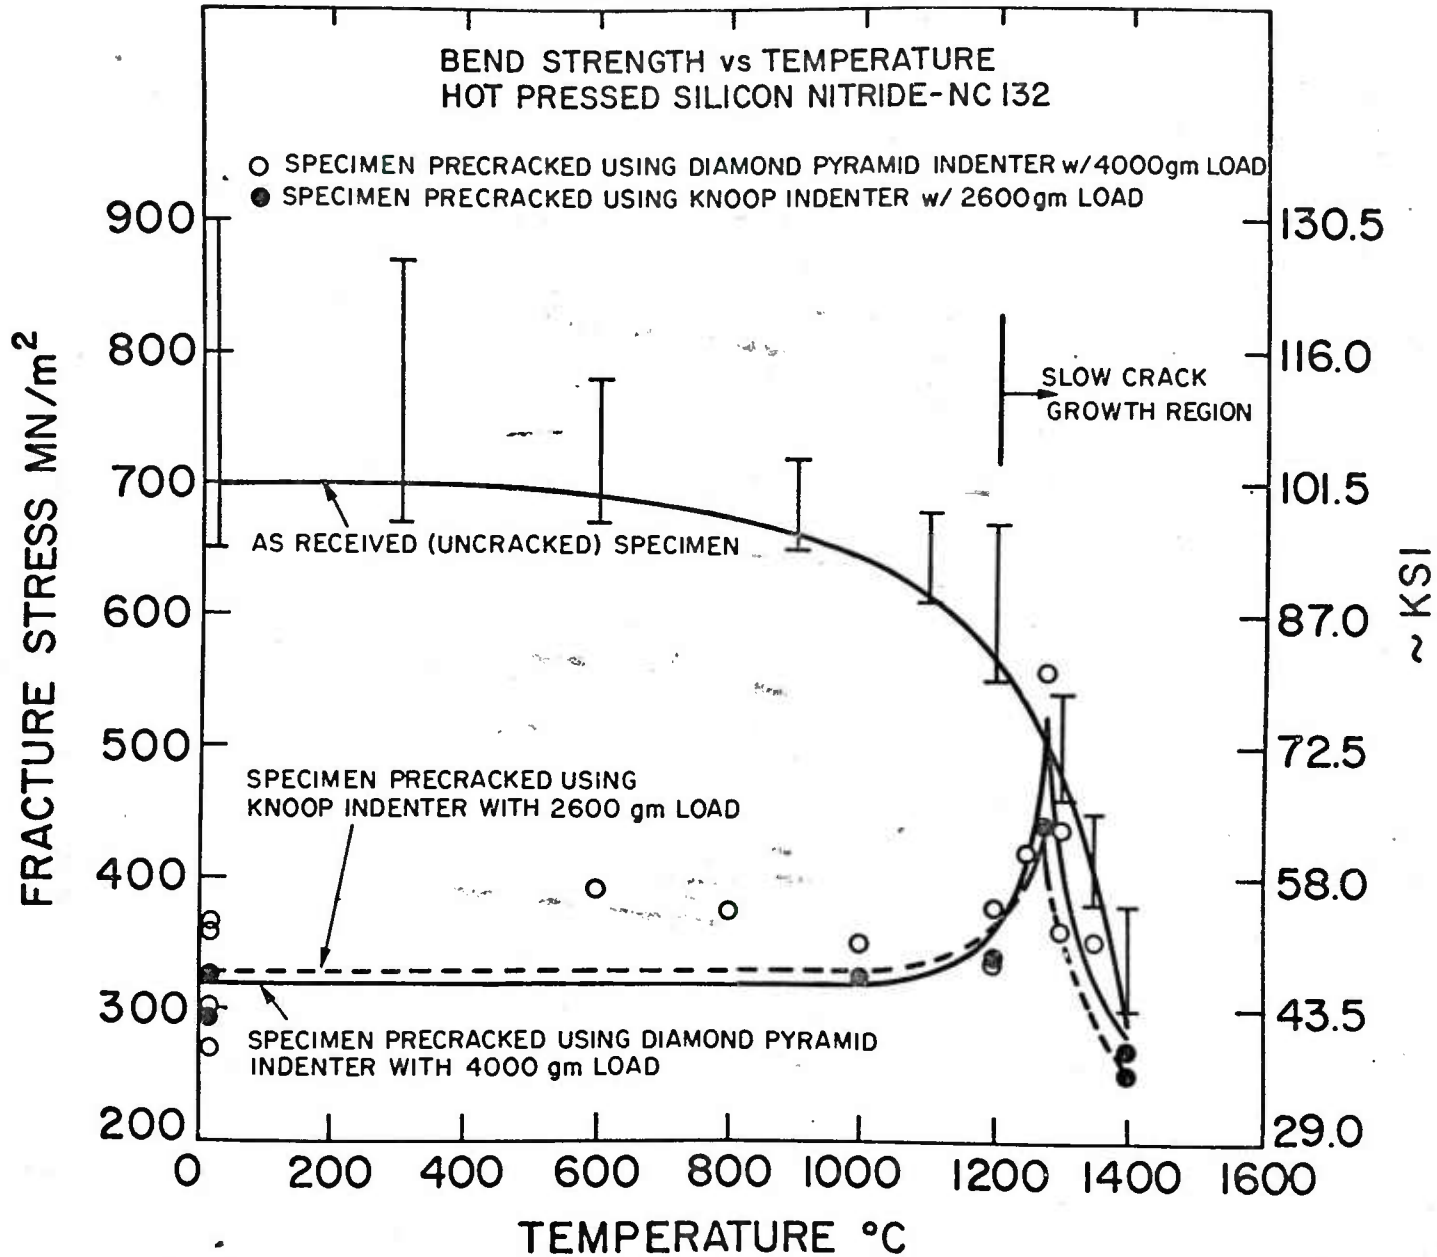
Fig. 24 Temperature dependence of the fracture stress for uncracked and precracked specimens of NC-132 Si_3N_4 . Complete data for as received (uncracked) and precracked specimens are given in Table 9 and Table 8, respectively.

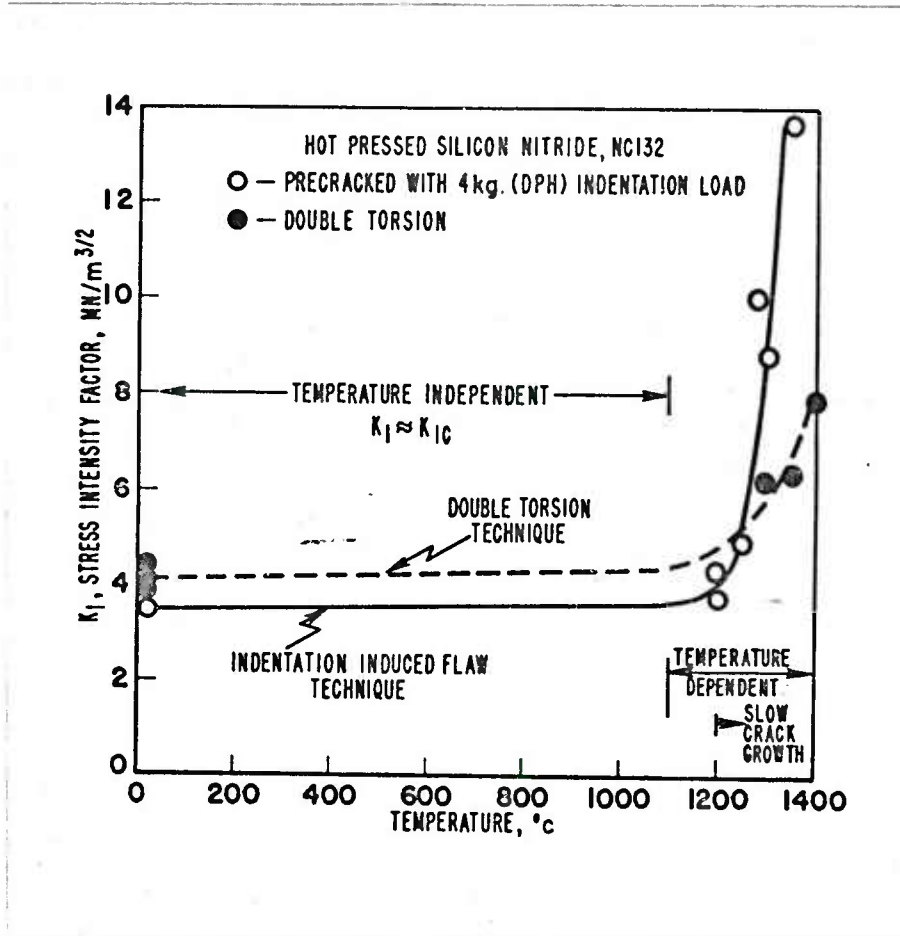
Fig. 30 Variation of stress intensity (nominal fracture toughness), K_{I} , as a function of temperature for NC-132 Si_3N_4 using Indentation Induced Flaw and Double Torsion techniques.

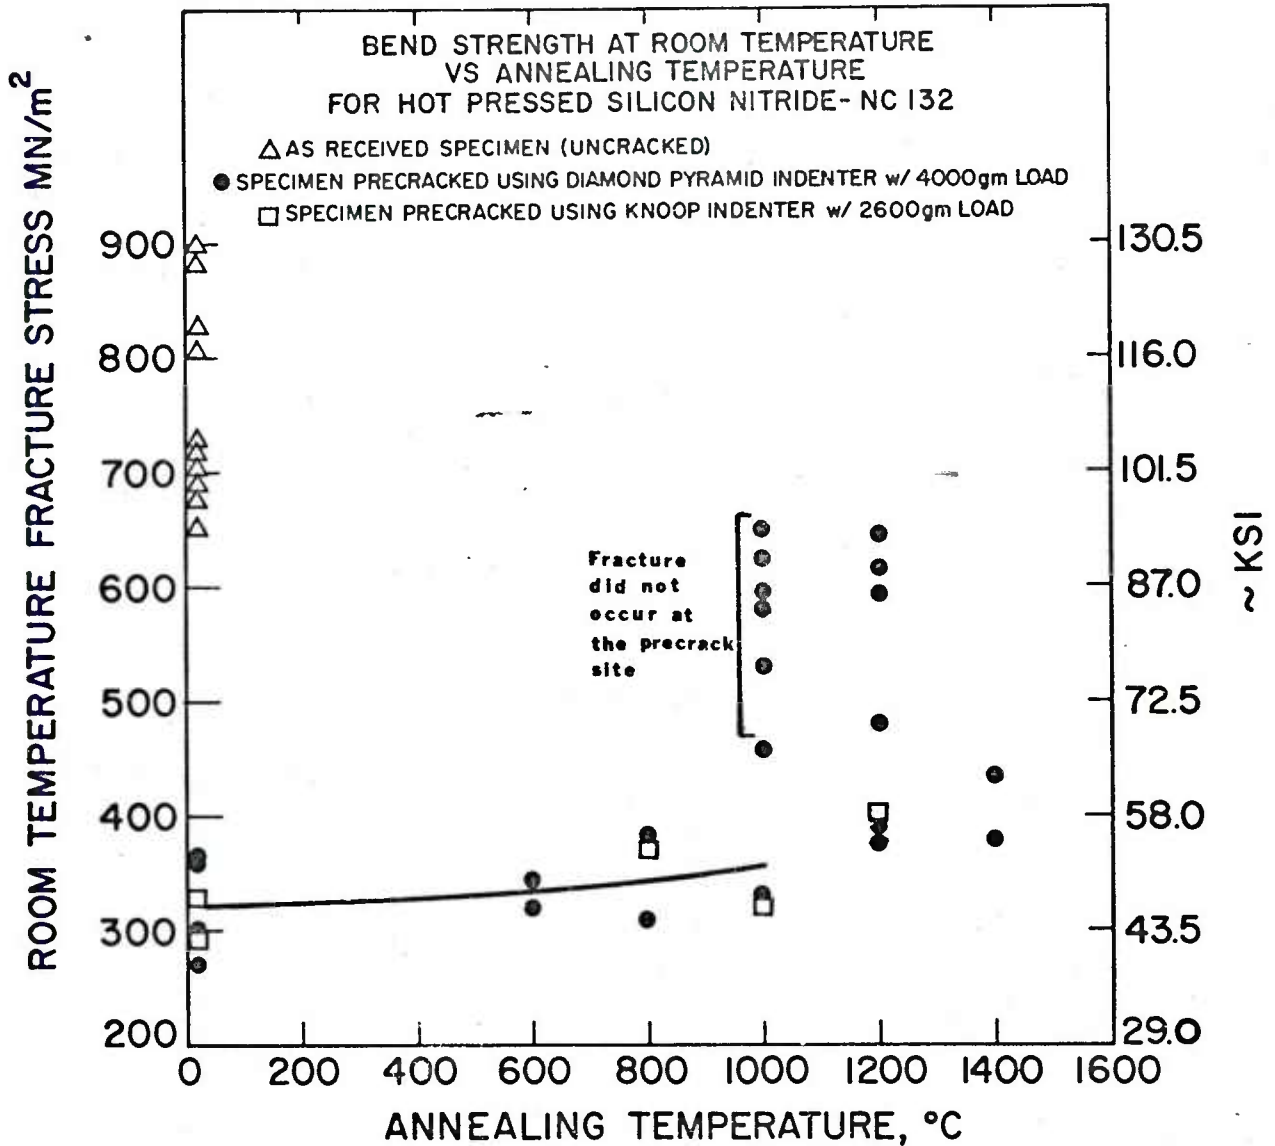
Fig. 31 Flexural strength (four-point bend) at room temperature for precracked specimens of NC-132 Si_3N_4 as a function of annealing temperature. Test specimens were annealed at temperatures (600 to 1400°C) for 4 hrs. in air. Data for as received specimens at 20°C are also included.

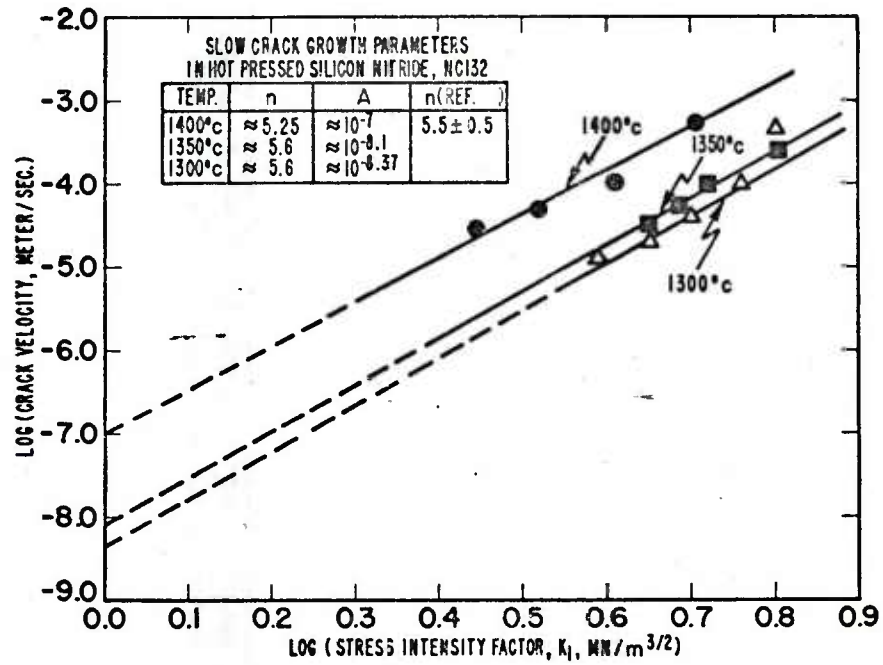
Fig. 42 Subcritical crack growth rate data for NC-132 Si_3N_4 as a function of temperature using the double torsion technique. The value of $n = 5.5 \pm 0.5$ at 1400°C is for HS-130 Si_3N_4 (Ref. 22).

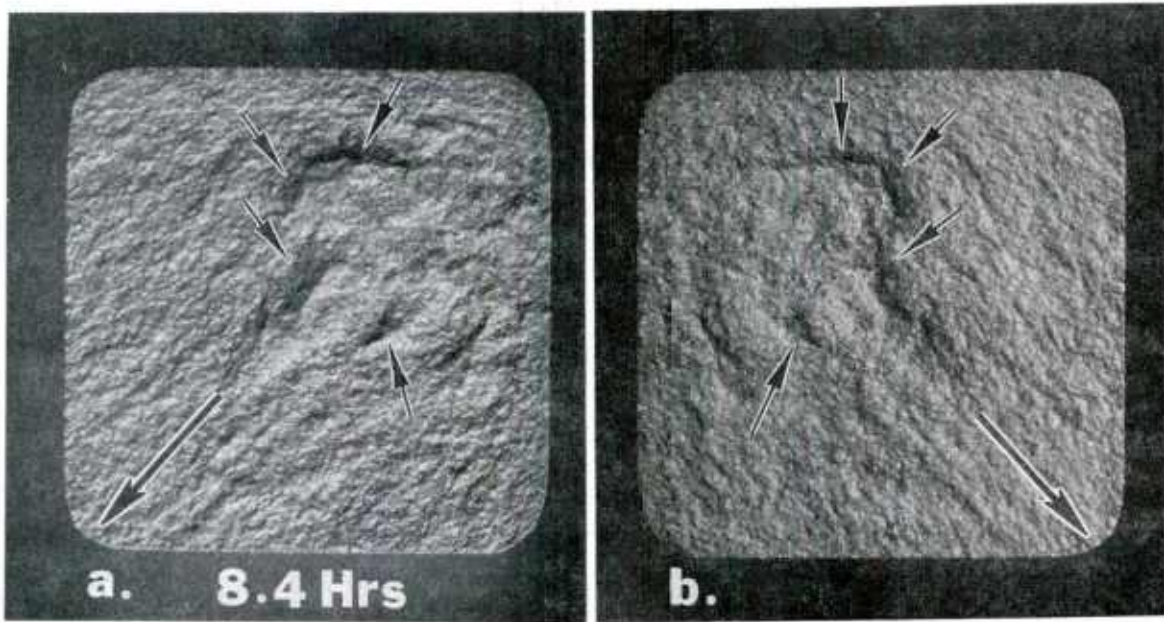
Fig. 49 Fracture surface appearance as seen in matching broken halves of tensile stress rupture specimen of NC-132 Si_3N_4 tested at a stress of 19,200 psi and 1204°C . Arrows identify the region of subcritical crack growth. Micrographs taken in normal white light.

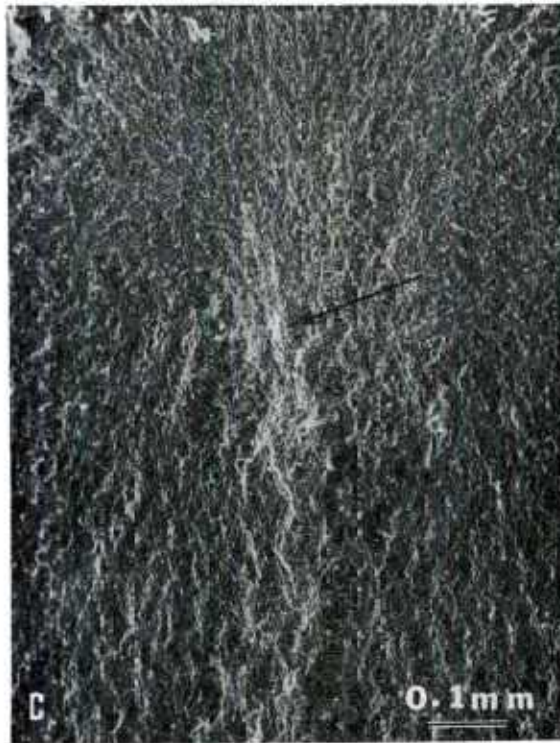
Fig. 59 (c) Slightly enlarged view of the initiation site as seen in SEM.
(cont.) (d) High magnification view of the initiation site showing primarily transgranular fracture. No sign of slow crack growth is visible.

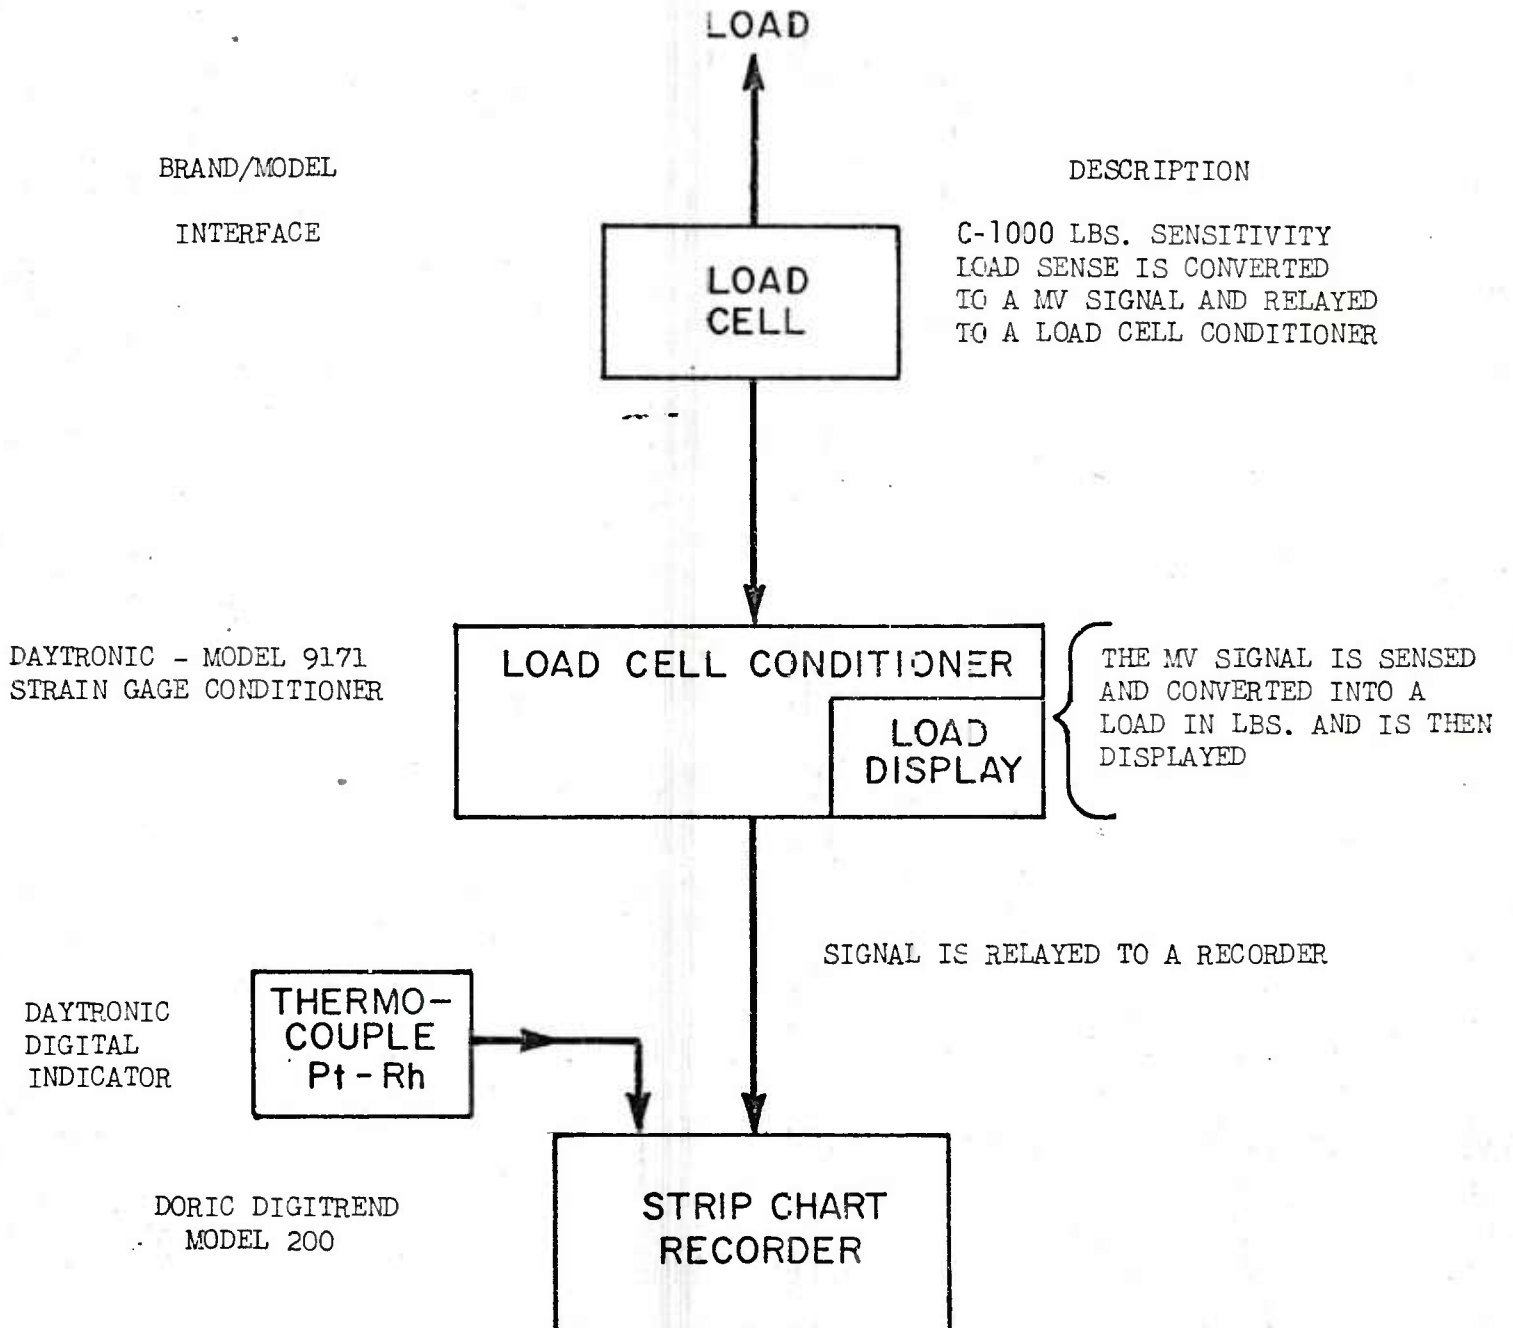
Fig. A₃ A block diagram view of the load sensing and recording equipment associated with load train assembly.
