AGARD Conference Proceedings No.288

Effect of Service Environment on Composite Materials

Papers presented at the 50th Meeting of the AGARD Structures and Materials Panel,
held in Athens, Greece on 14-17 April 1980.

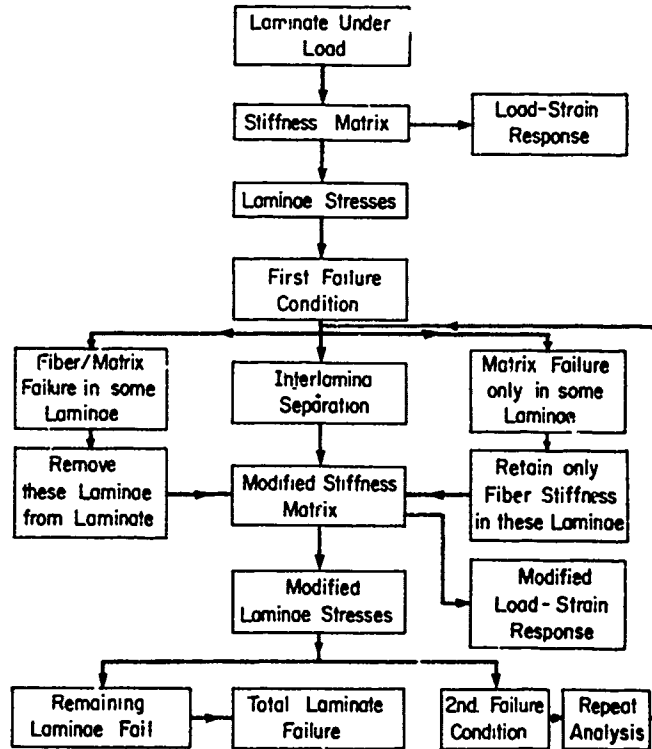
Fig.8 Procedure for calculating the load-strain response and ultimate strength of a laminate

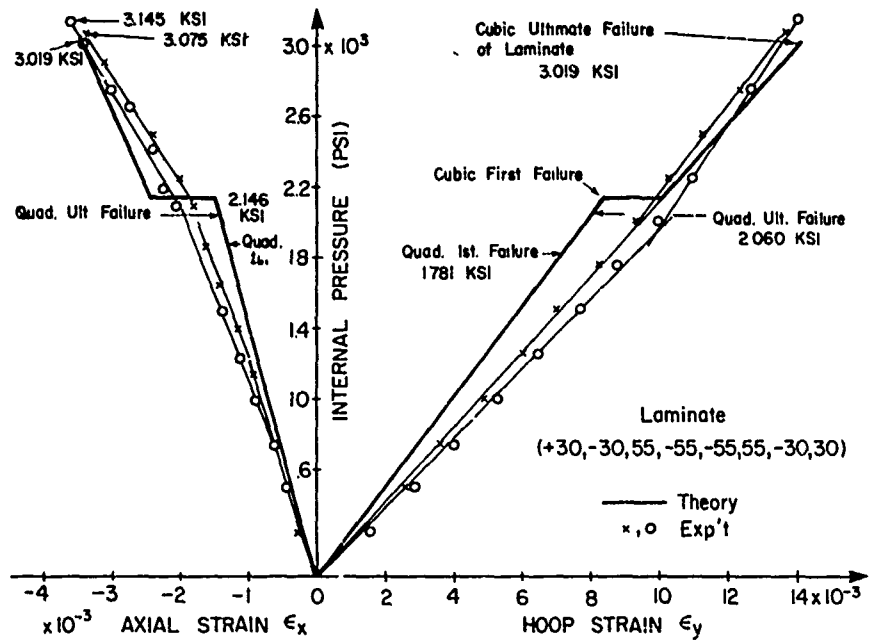
Fig.9 Comparison of cubic and quadratic failure models with experiment (SP-288 T300 3M)
