**DAMAGE MECHANISMS/
FAILURE MECHANICS
OF CARBON-CARBON
COMPOSITE MATERIALS**

INTERIM REPORT

**COMPOSITE MATERIALS RESEARCH GROUP
DEPARTMENT of MECHANICAL ENGINEERING
University of Wyoming Laramie, Wyoming 82071**

Interim Report
UWME-DR-904-101-1

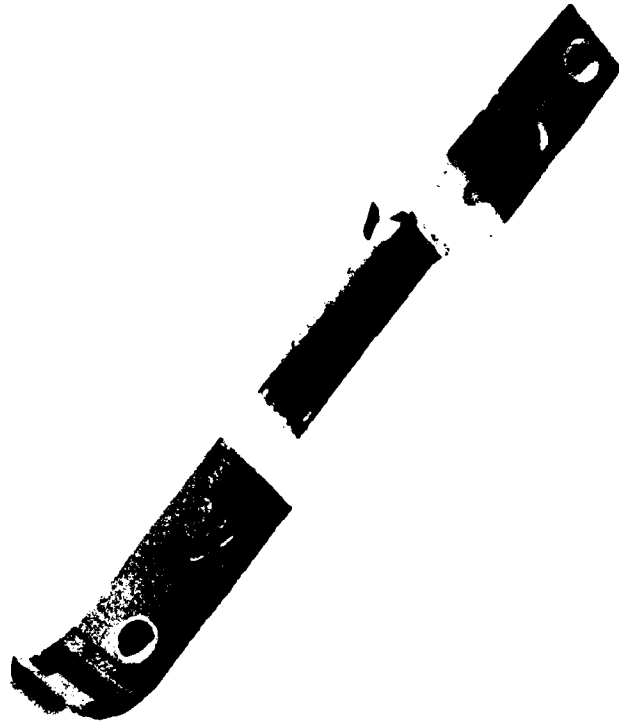
FIGURE 3
EXAMPLE CARBON-CARBON TENSILE SPECIMEN

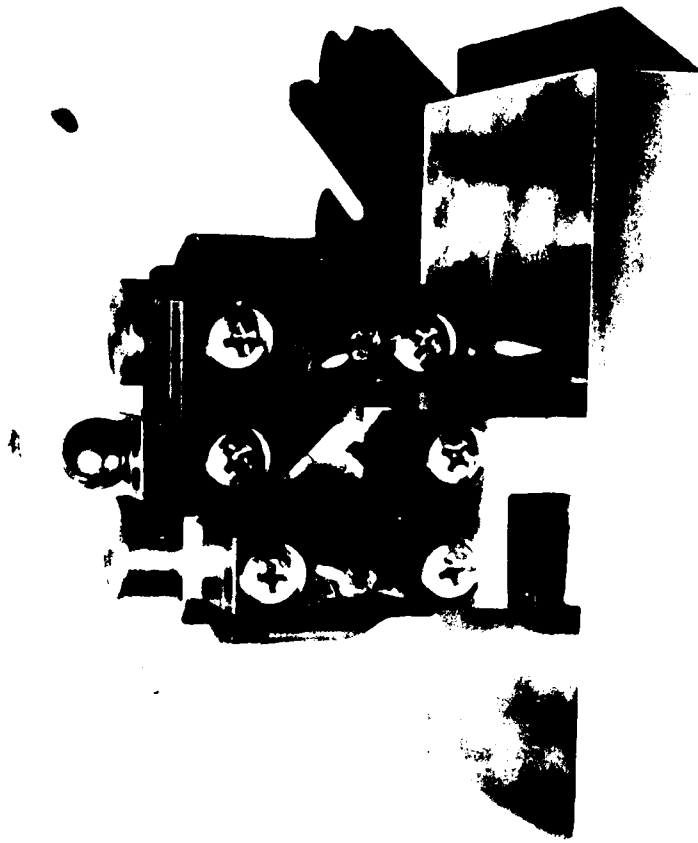
FIGURE 12
IOSIPESCU SHEAR TEST FIXTURE

Specimens tested in this program were 51 mm (2 in) long, 12.7 mm (0.50 in) tall, and 10 mm (0.40 in) thick; a sample is shown in Figure 10. Load is applied as two opposing moments, as shown in Figure 11, which cancel at the center plane of the specimen to produce a state of pure shear. The loading fixture which was built for this program is shown in Figure 12.
