**DoD PHYSICAL
SECURITY TECHNICAL
SUPPORT AT THE
1980 WINTER OLYMPIC
VILLAGE**

4. TITLE (and Subtitle) DOD PHYSICAL SECURITY TECHNICAL SUPPORT AT THE 1980 WINTER OLYMPICS VILLAGE,	5. TYPE OF REPORT & PERIOD COVERED 9 FINAL REPORT

7. AUTHOR(s) 10 MR. SANFORD C. CURCIE MR. ROBERT L. BARNARD	6. PERFORMING ORG. REPORT NUMBER	
9. PERFORMING ORGANIZATION NAME AND ADDRESS ANALYTICS, INC. 766 SHREWSBURY AVENUE TINTON FALLS, NEW JERSEY 07724	8. CONTRACT OR GRANT NUMBER(s) DAAB07-79-G-6201-E101

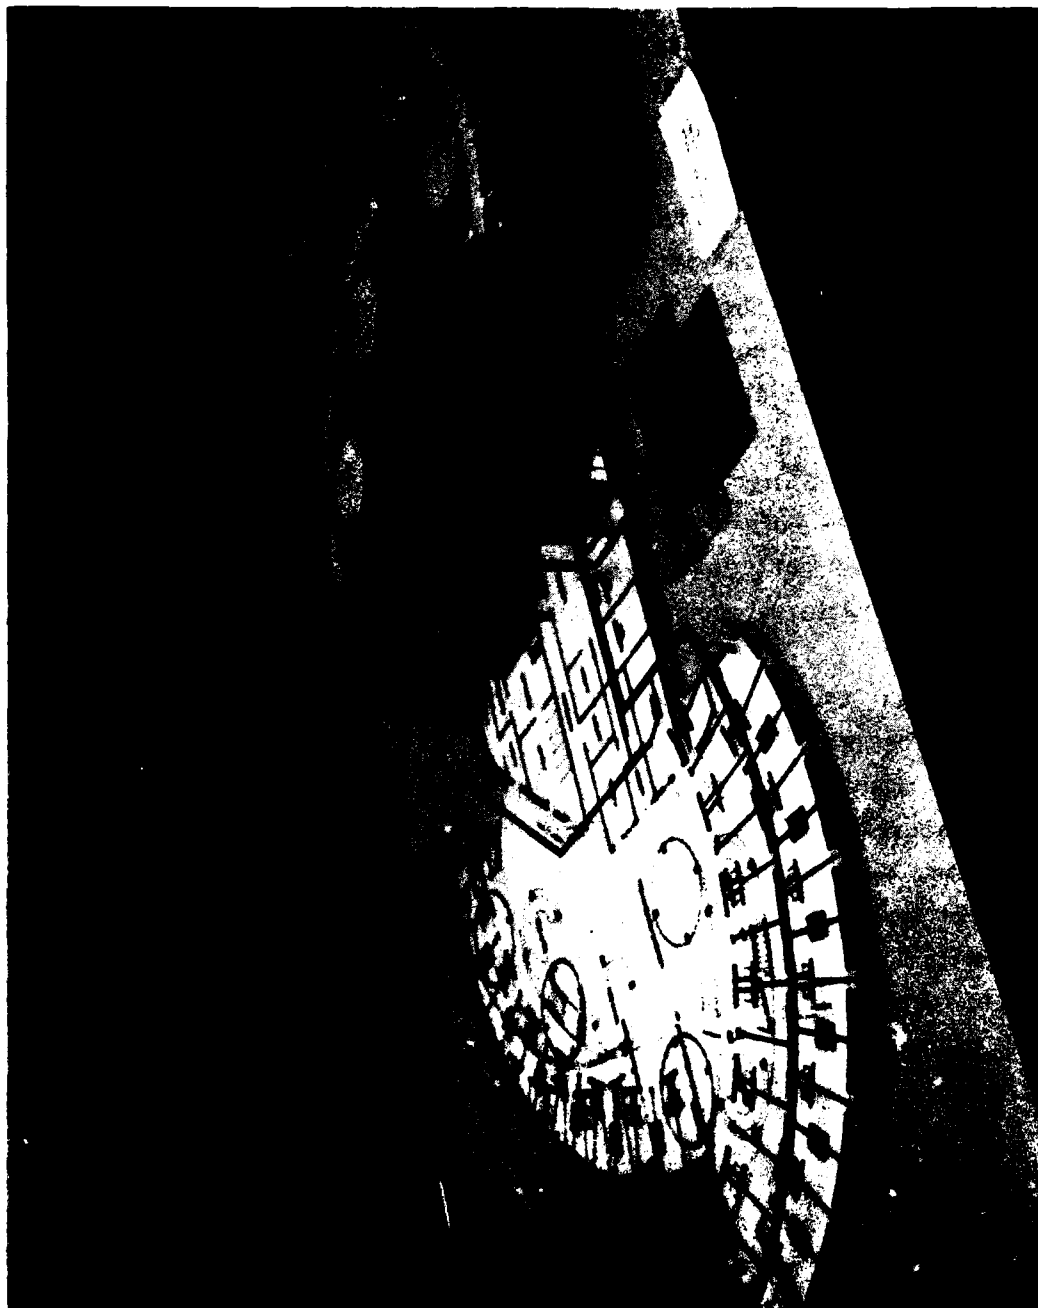
Figure 1-4. Scale Model of Individual Residential Building Constructed by FBI. Model Served as Three Dimensional Plan for Buildings H, I, J, K and L.

Conventional inmate housing was in the five "clam shell" buildings (Figure 1-4); however, to meet the temporarily inflated population, temporary housing was created out of mobile trailers and in a large portion of the facility's main, or central building.

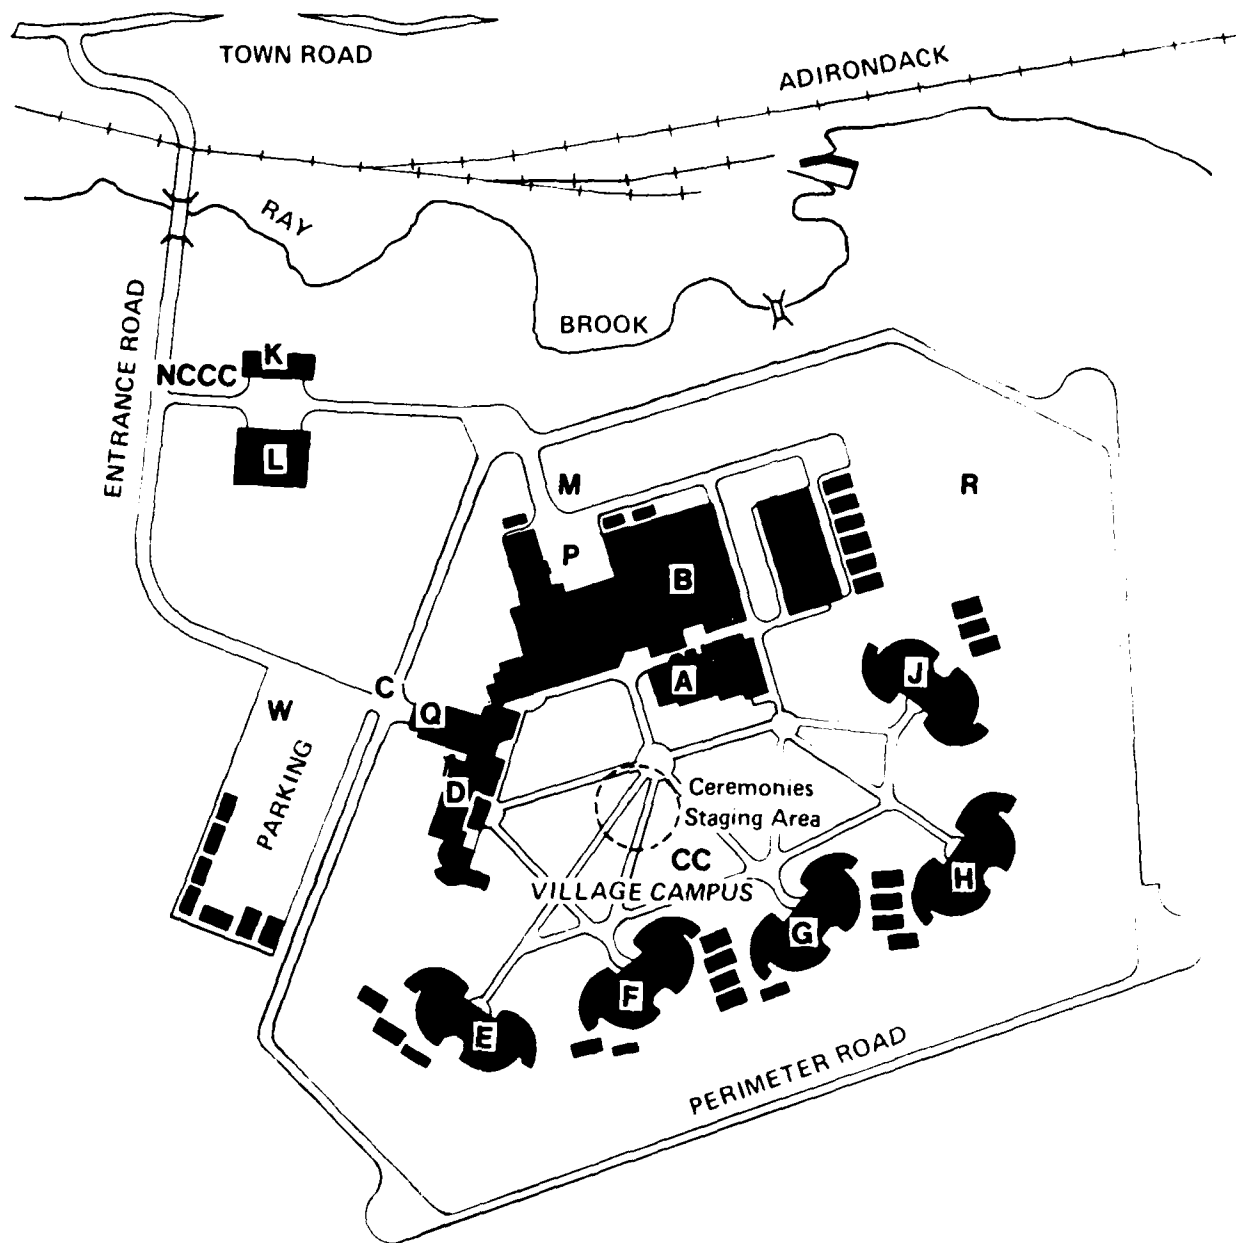
Figure 1-14. Plan Drawing of Olympic Village.

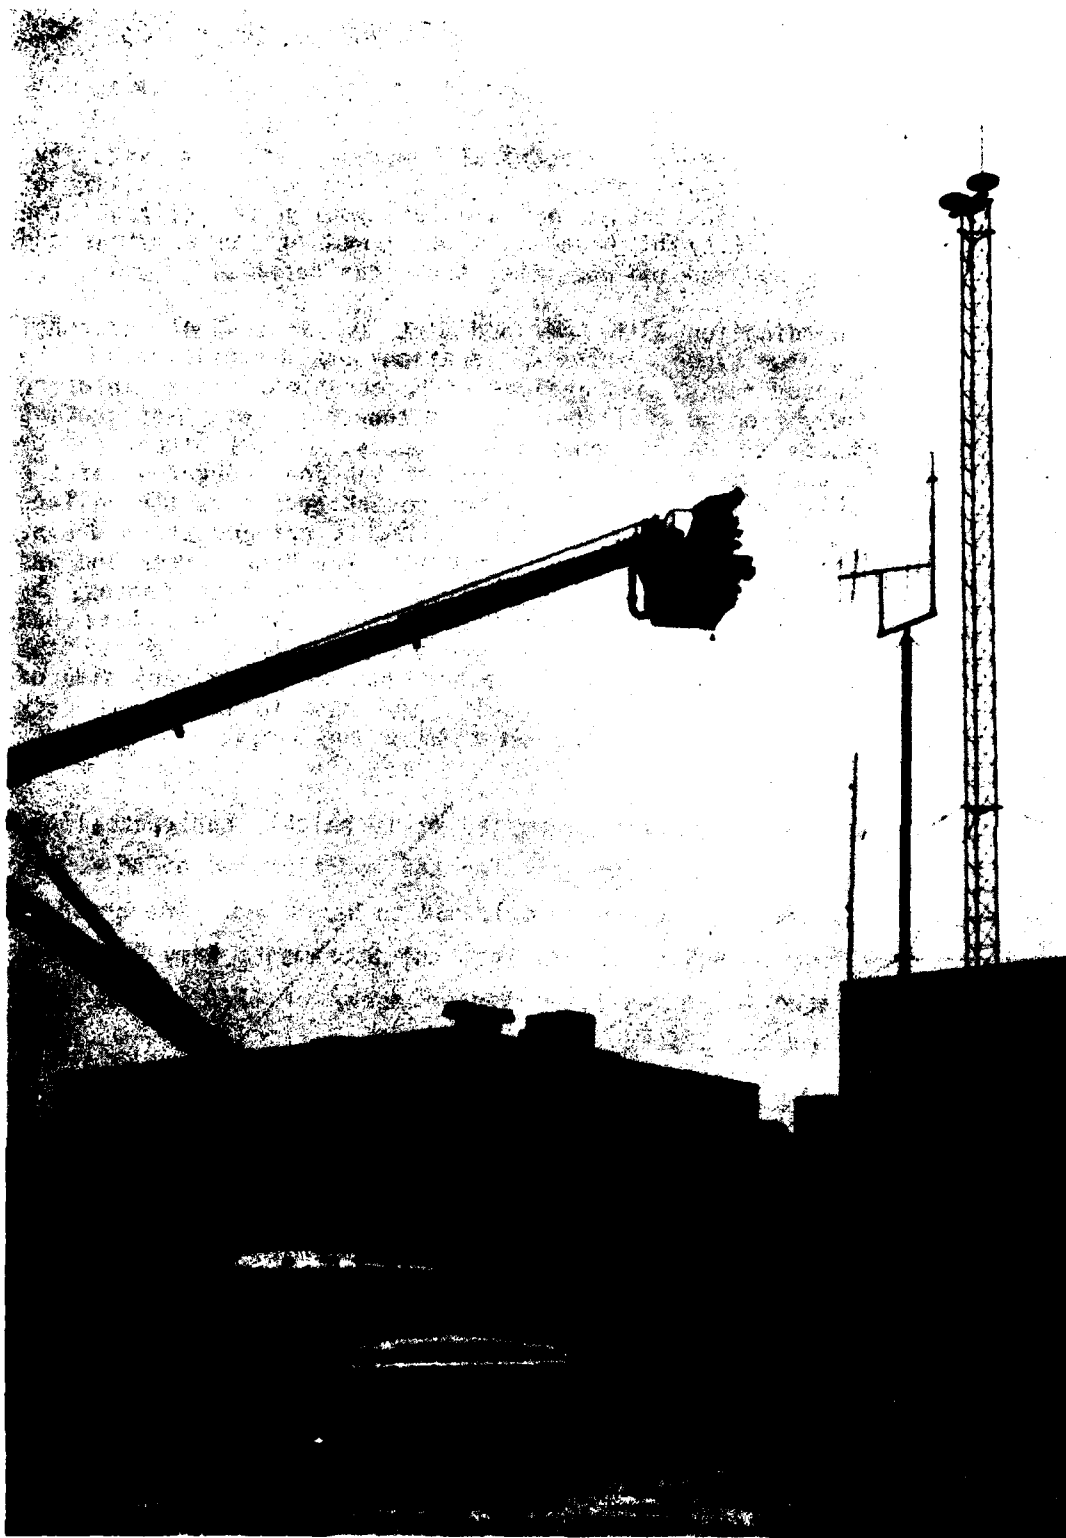
Figure 1-15. Cooperation and Assistance of the Saranac Lake Fire Department was Invaluable in the Siting and then the Installation of AN/PPS-15 Radomes and Other Communication Antennas.

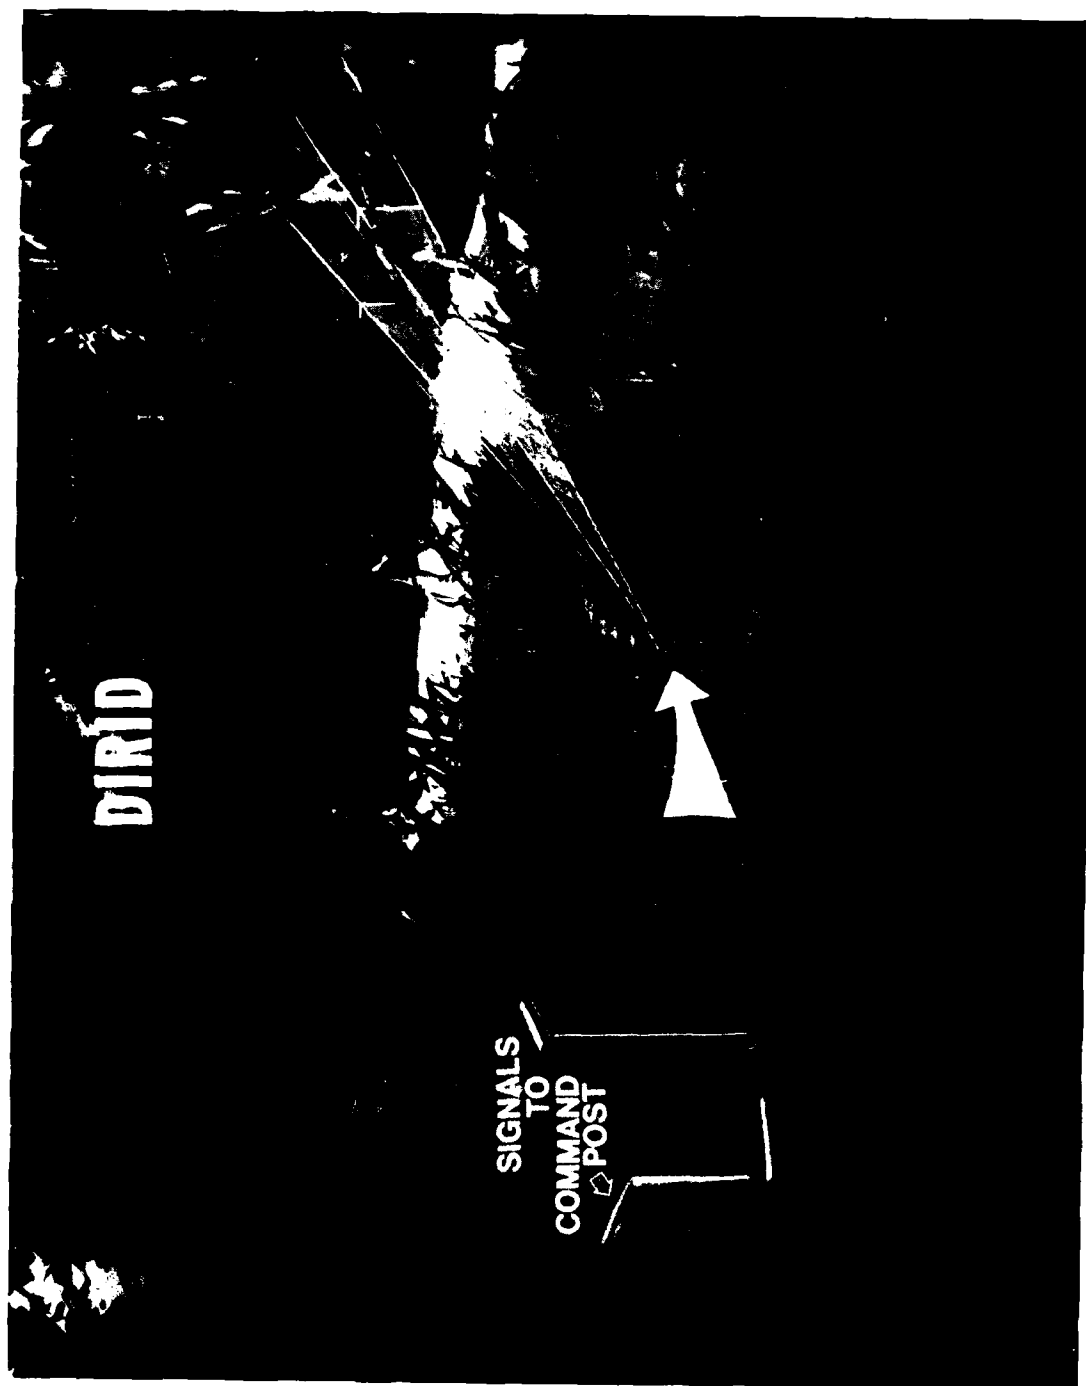
Figure 2-4. Boresighting of the DIRID's IR "Bend" to Obtain Right and Left Relative Target Direction of Travel.

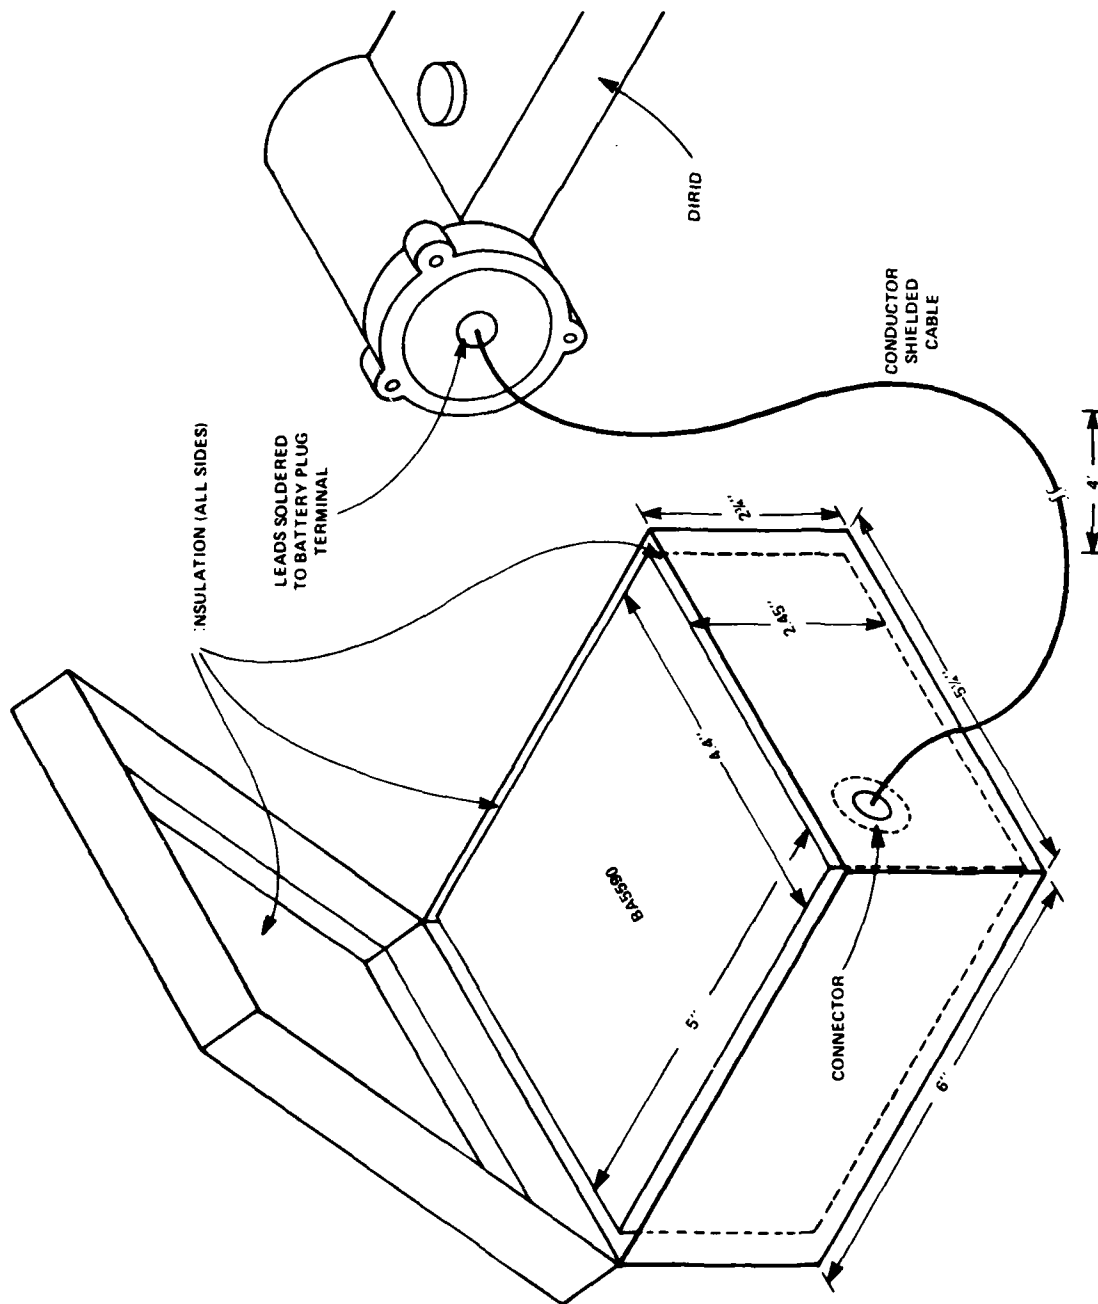
Figure 2-5. Use of Lithium Battery BA5590 Required Fabrication of Special "Outbound" Battery Box with all Phase III Sensors. Fabrication was Performed by CS&TA Labs, Fort Monmouth, New Jersey.

h. Supplemental Materiel. Figure 2-5 illustrates the physical configuration and interconnection between sensors (DIRID case shown) and the battery box used to house the Lithium Battery BA-5590. Special end caps, complete with protective O-rings, feed-through hole, etc., were fabricated so as not to degrade any USMC or Army-furnished sensor assets.

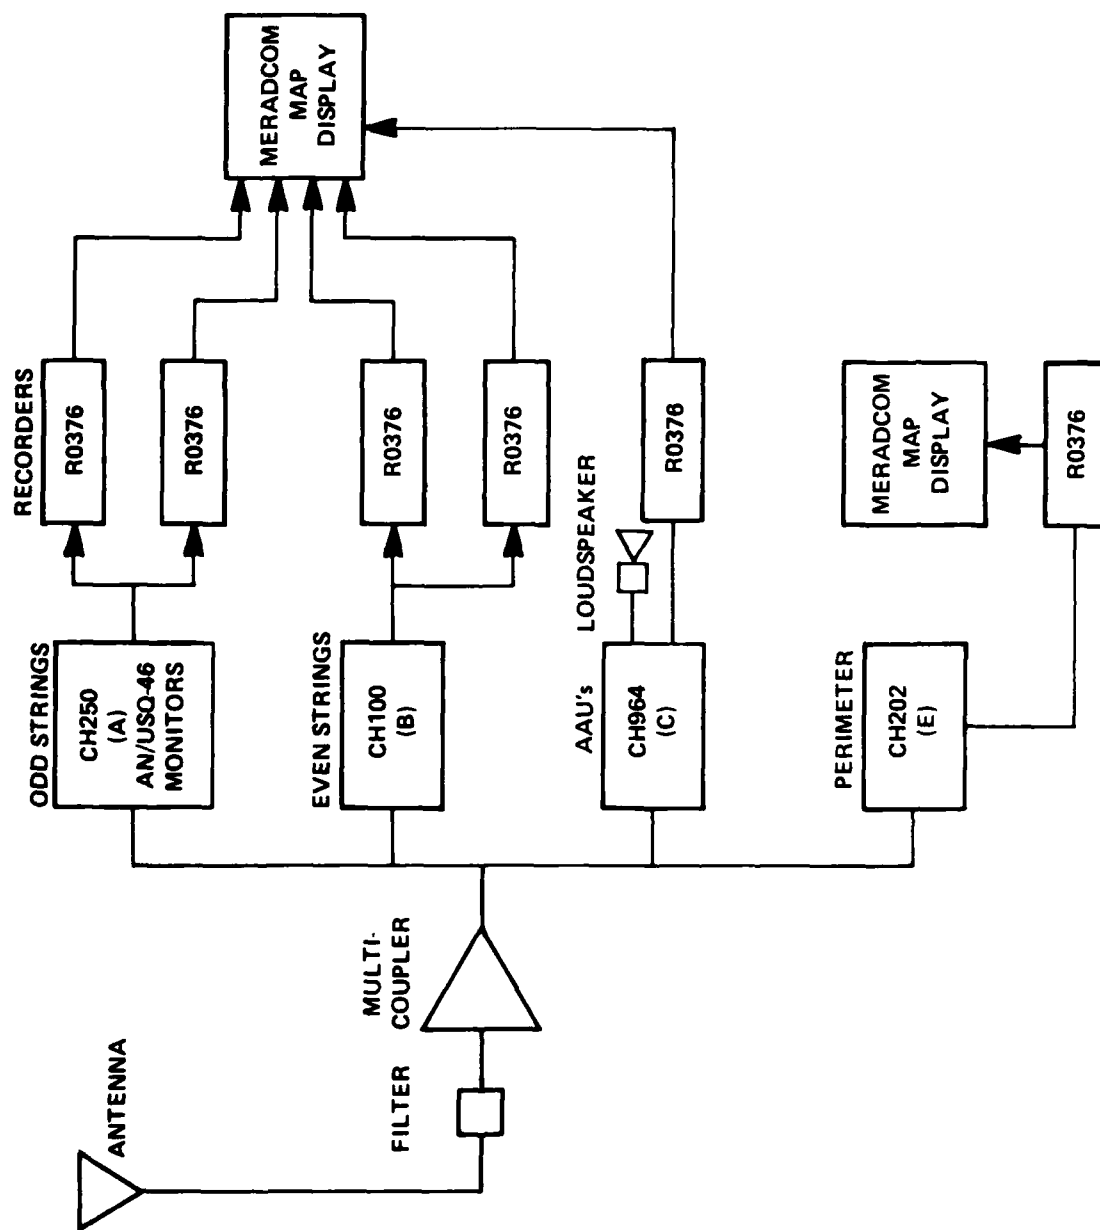
Figure 2-6. Sensor Equipment Functional Interface of all Major Devices.

Figure 2-6 illustrates the functional interface between all major elements of the unattended ground sensor system. Sensor strings were apportioned between rf monitors and each monitor drove an X-T plotter, i.e., a "Tac Recorder". Output of the recorders were then employed as inputs to the USAMERADCOM-furnished Large Area Display Systems (LADS). Additional monitors and recorders were accommodated by rf multicoupler. These, in turn, were used as inputs to the second LADS.

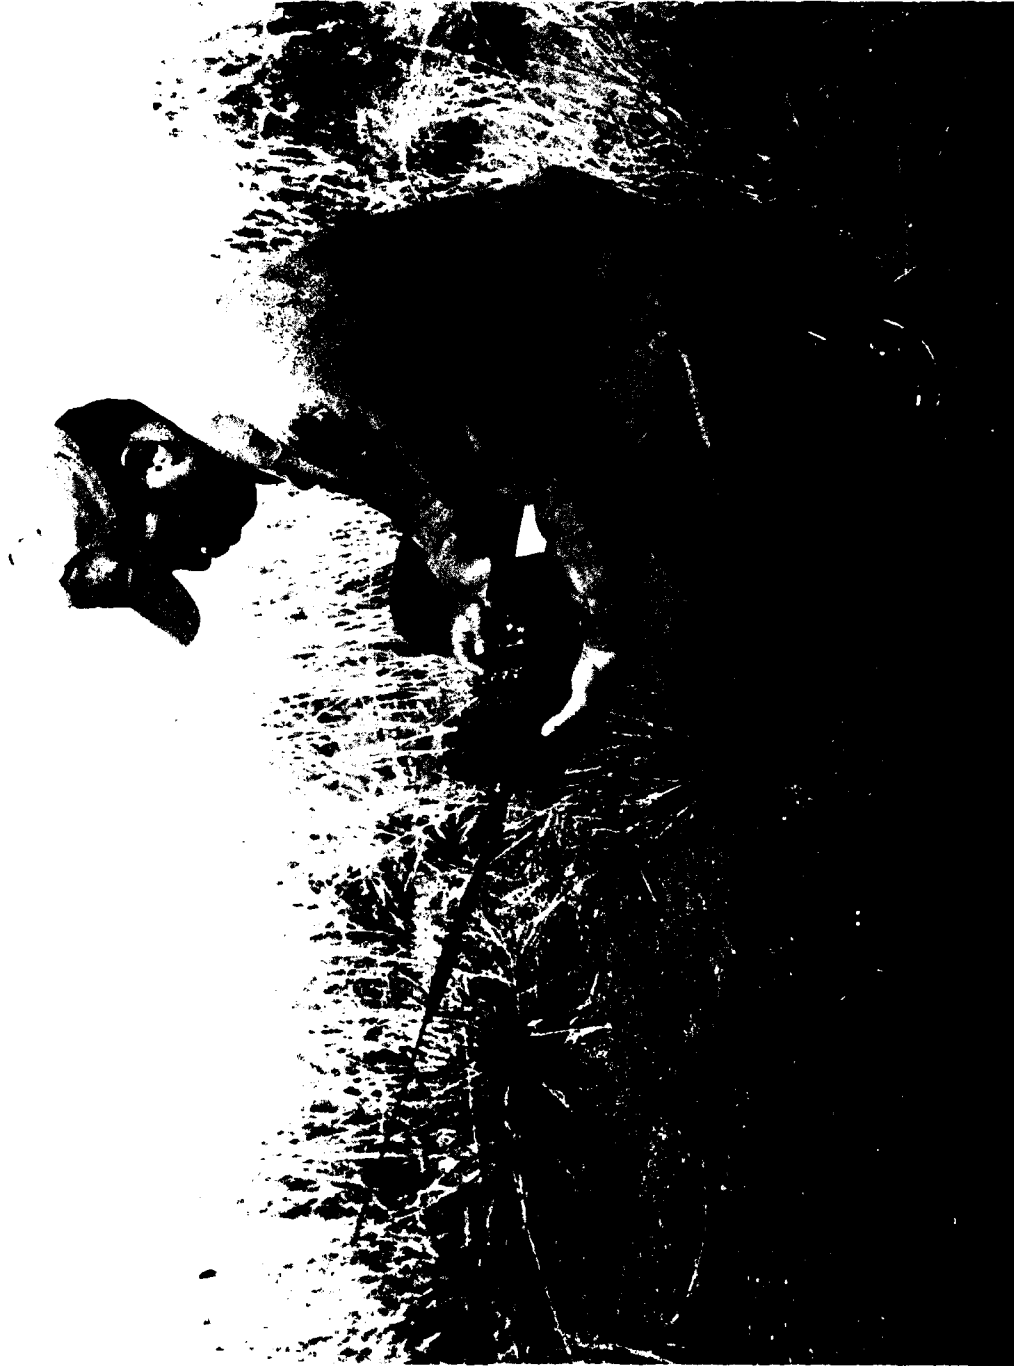
Figure 2-8. Prototype Advanced Development Model of US Army REMBASS
Seismic/Acoustic Hand Emplaced Target Classifying Sensor.

During the latter part of the Winter Olympic Games schedule, arrangements were made with the Office of the Project Manager Firefinder/REMBASS for an informal demonstration, under actual field conditions, of the new prototypes REMBASS sensors supplied to the government by the RCA Corporation. Two types of devices were demonstrated; (a) the hand emplaced sensors shown in Figure 2-8 and the hand-held Portable Monitoring Set (PMS), illustrated in Figure 2-9.

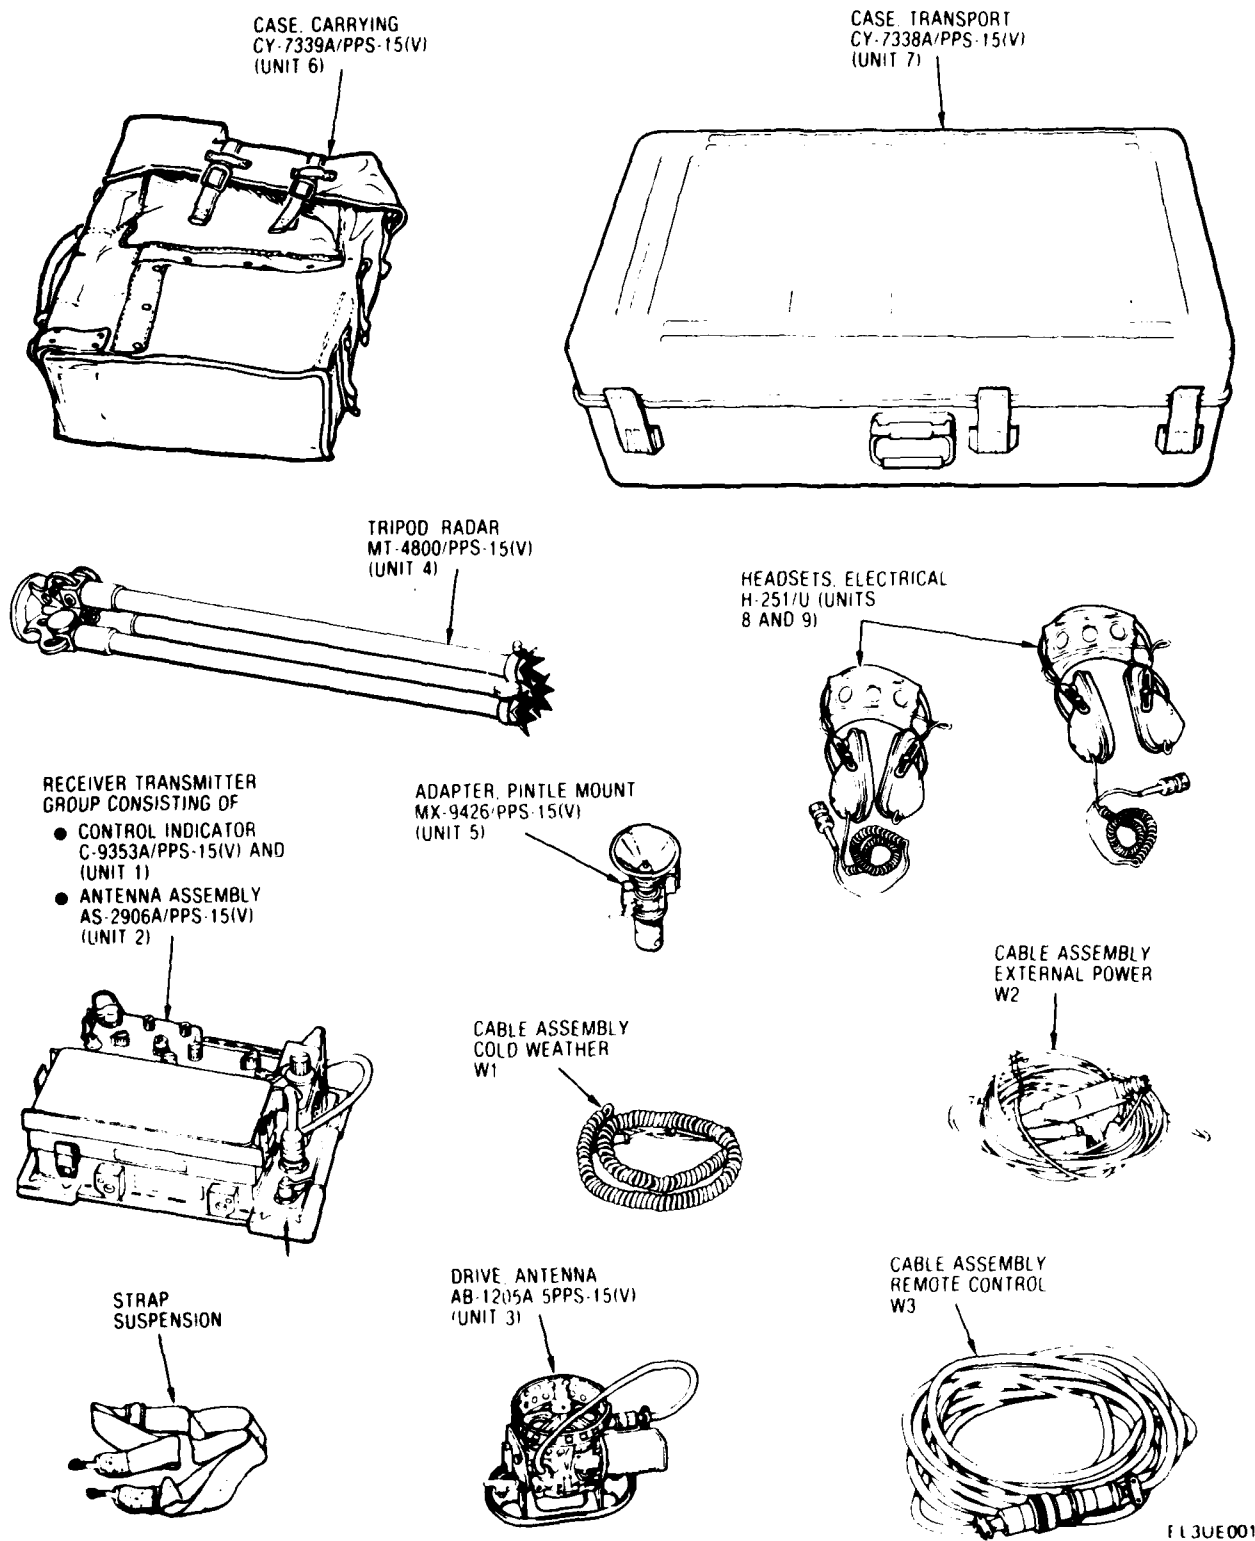
Figure 2-11. Components of Radar Set AN/PPS-15A.

Figure 2-11 shows the components of the AN/PPS-15A(V)1 radar set. Note the receiver/transmitter group (right hand side of illustration) consists of two assemblies: (1) the control indicator, and (2) the antenna assembly. It is between these two assemblies that the remote control cable assembly was used. It should also be noted that the 9-meter remote cable cannot be successfully used on specially modified radars. This is due to impedance differences in the two cables, and compensations which are performed internally to the radar set for modified or unmodified operation.

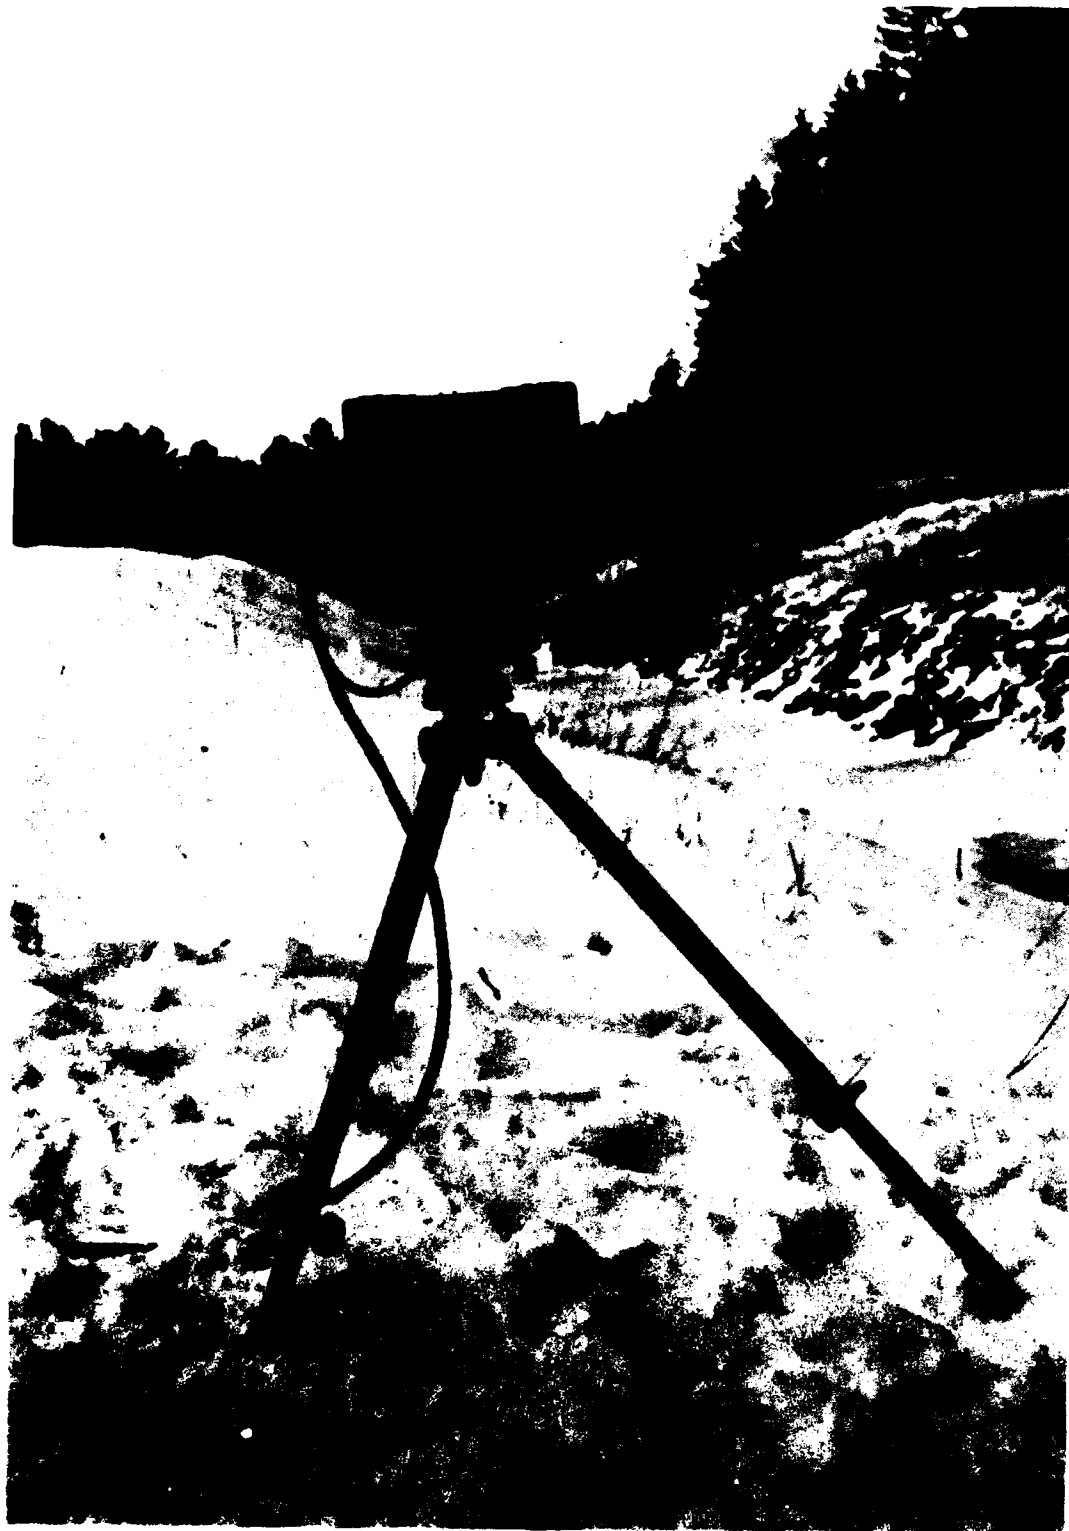
Figure 2-13. Radar Set Used in Northeast Corner Perimeter Surveillance.
Remote Cable Permitted 12 Volt Power from and Trooper to
Remain in Police Vehicle.

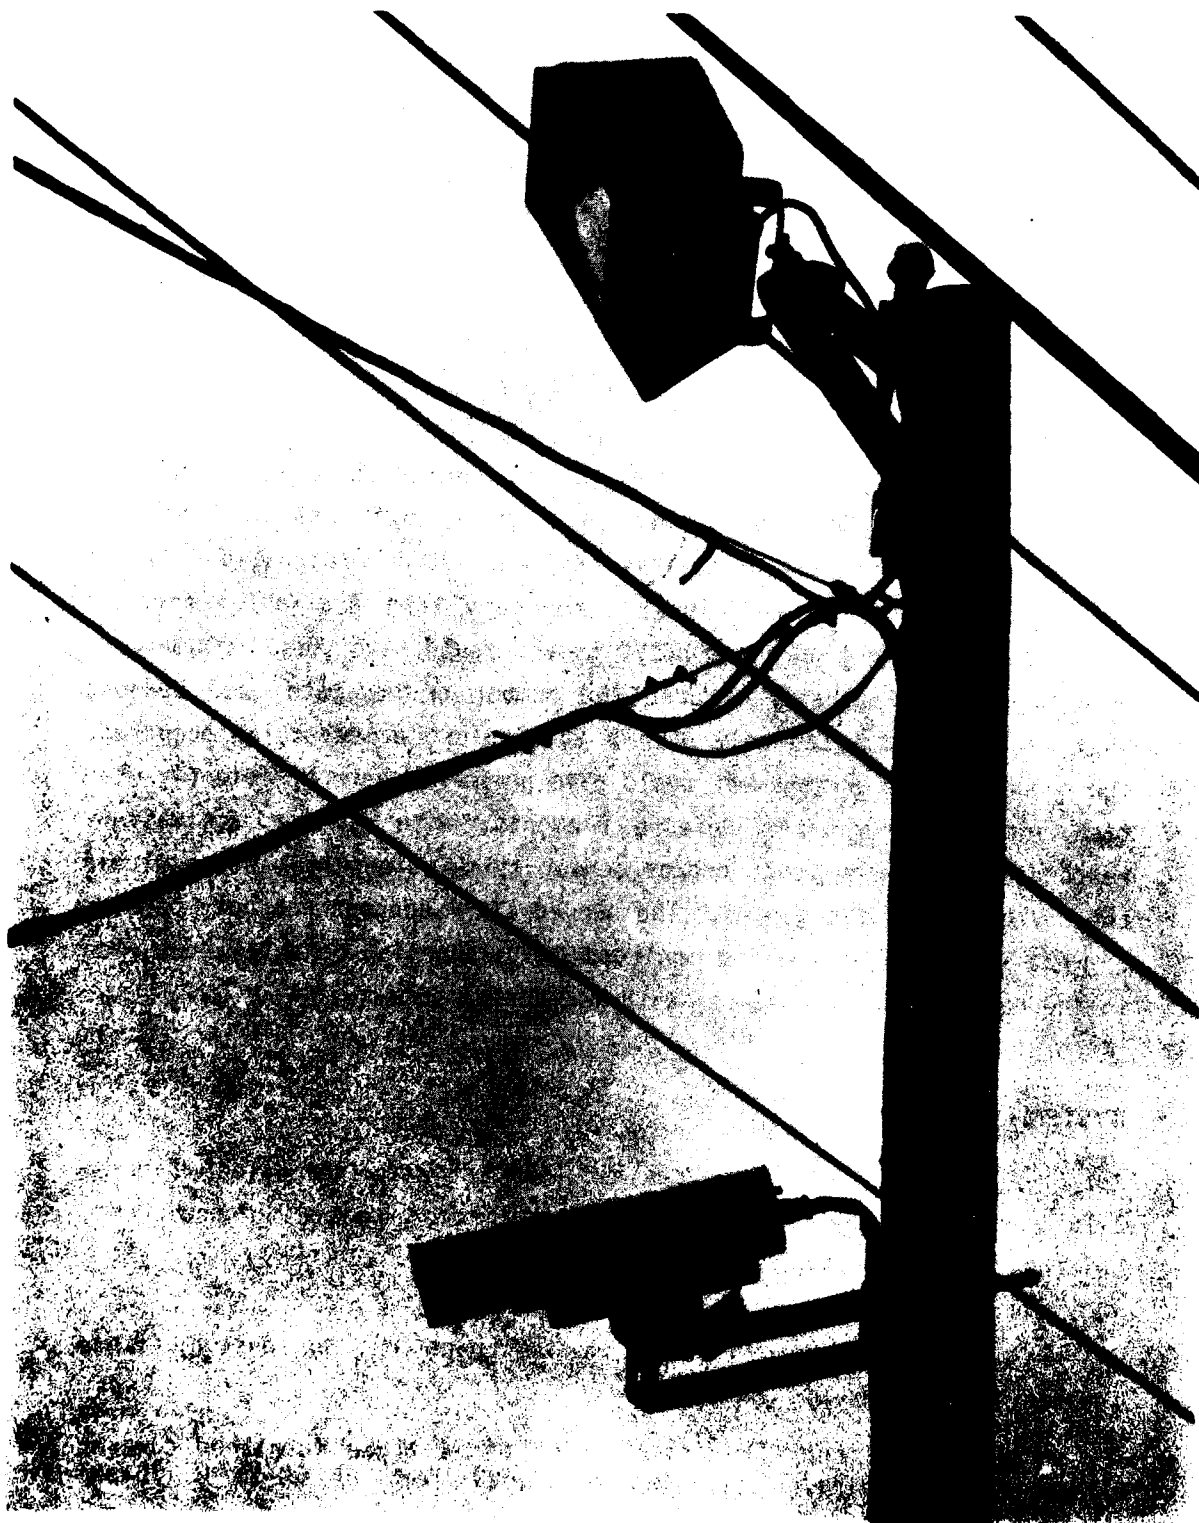
Figure 2-14. DoD Furnished CCTV Surveillance Camera and 150-Watt High Pressure Sodium Vapor (HPSV) Flood Light for Auxiliary Lighting.

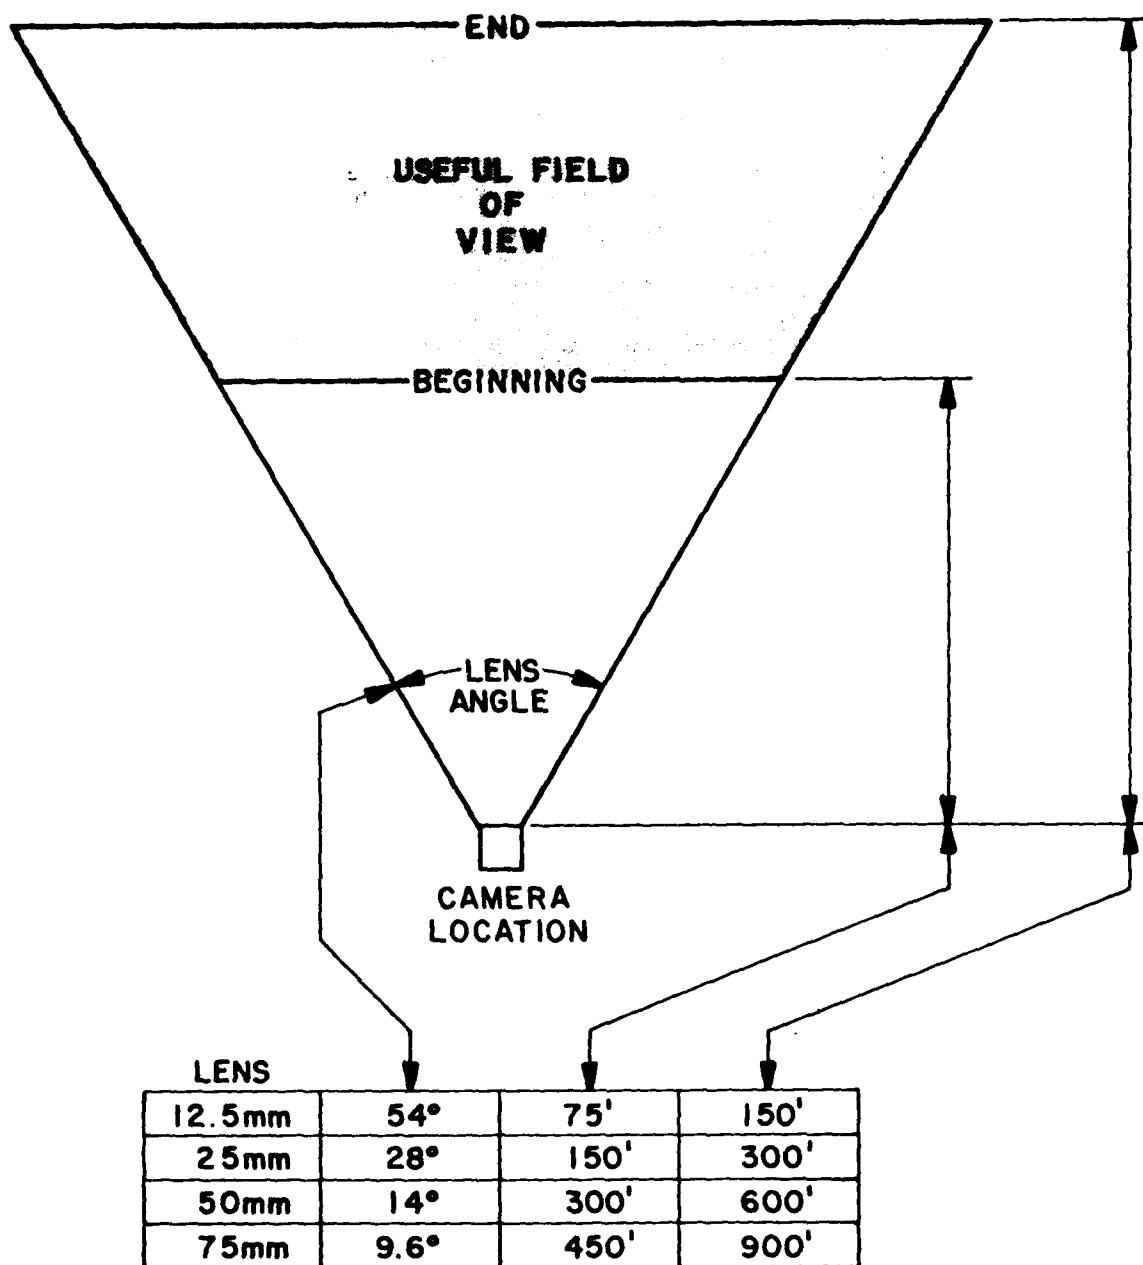
Figure 2-17a. Comparison of Lens Sizes, Field-of-View (FOV) and Depth of Field for Standard CCTV Optics.

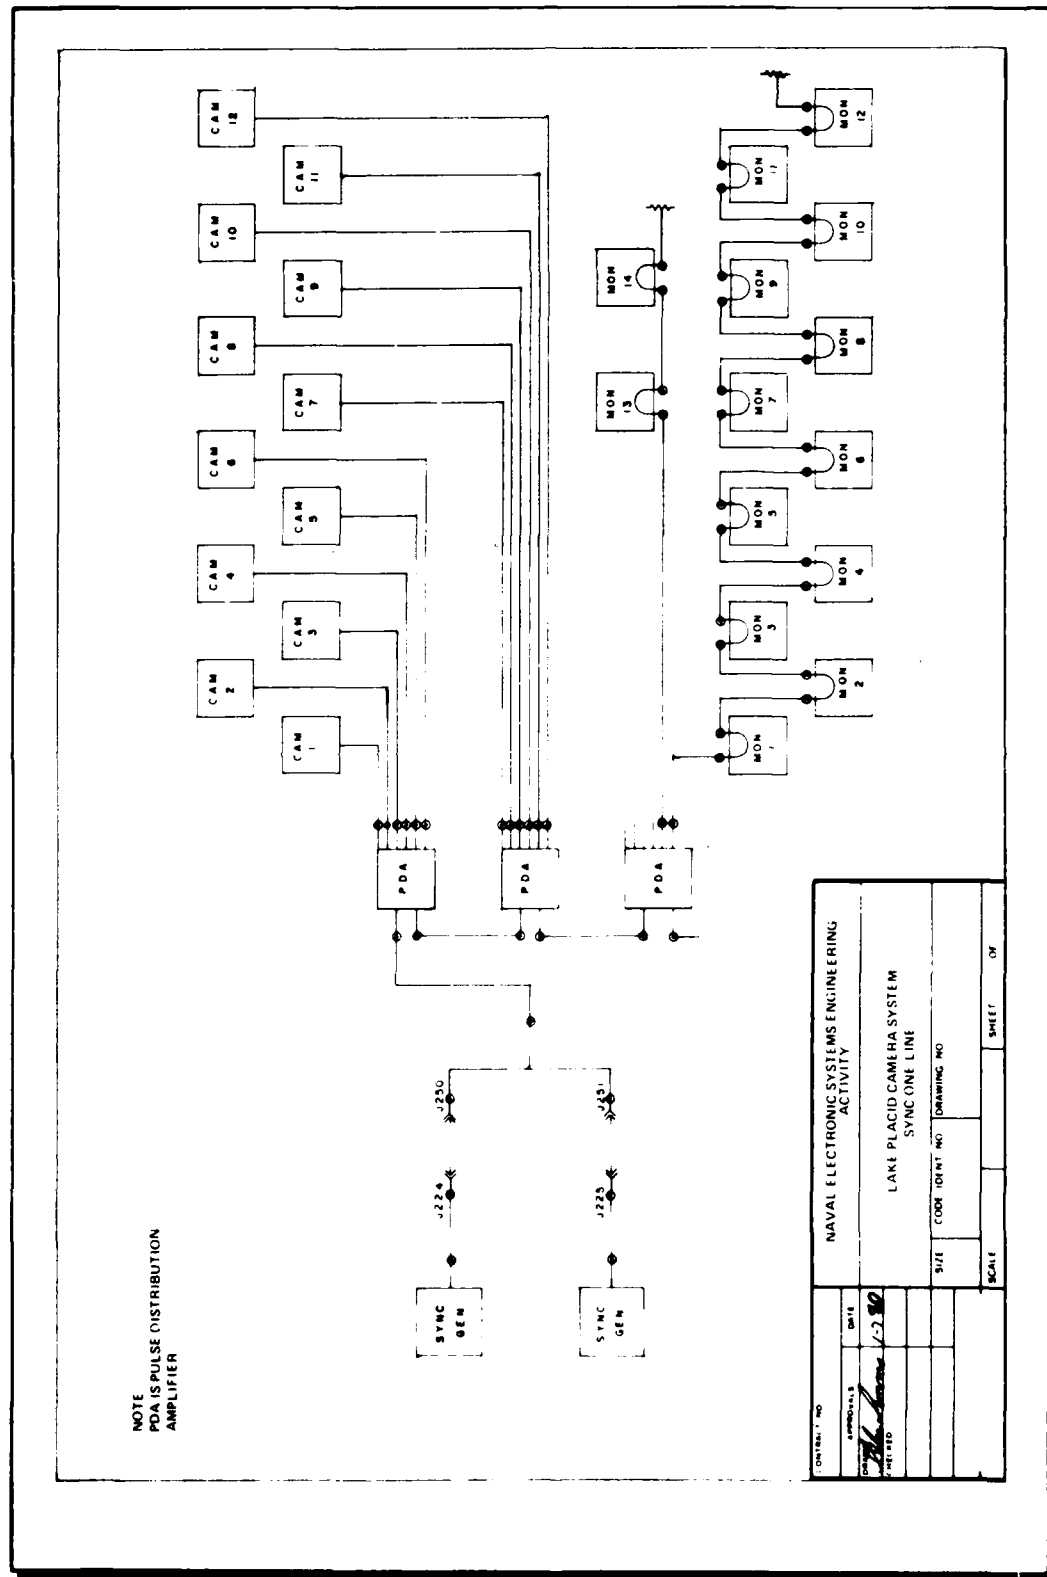
Figure 2-17b. Functional Block Diagram of Closed-Circuit Television System (CCTV).

Signals to the camera consisted of synchronizing pulses from a Pulse Distribution Amplifier (PDA). Video received from the cameras went to a dedicated equalizing Video Distribution Amplifier (VDA), where the video was corrected for line loss, "damped" to reduce hum, and

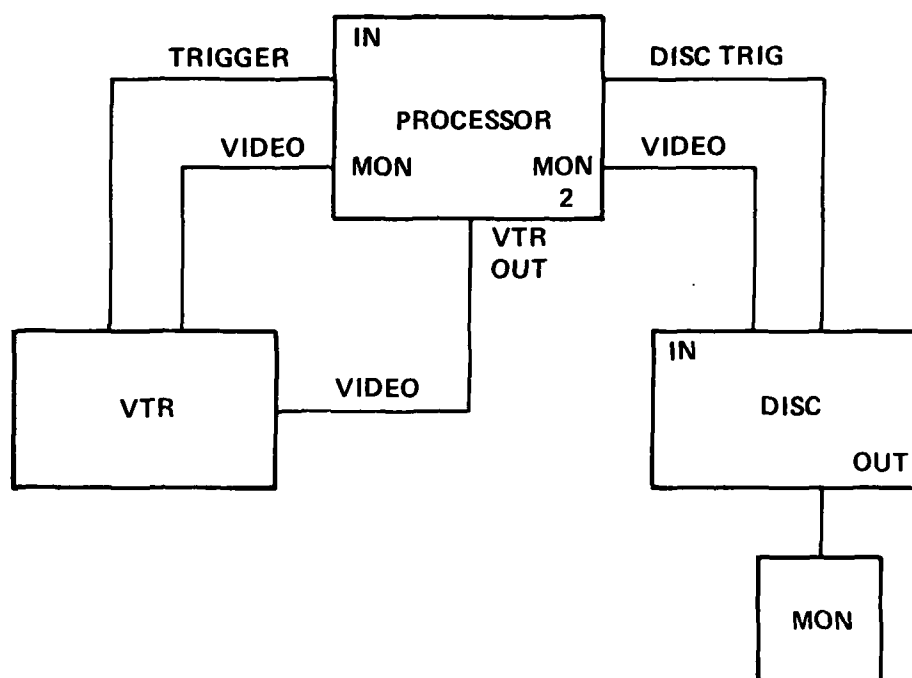
Figure 2-17c. Details of CCTV's Video Tape Recording (VTR) Arrangement.

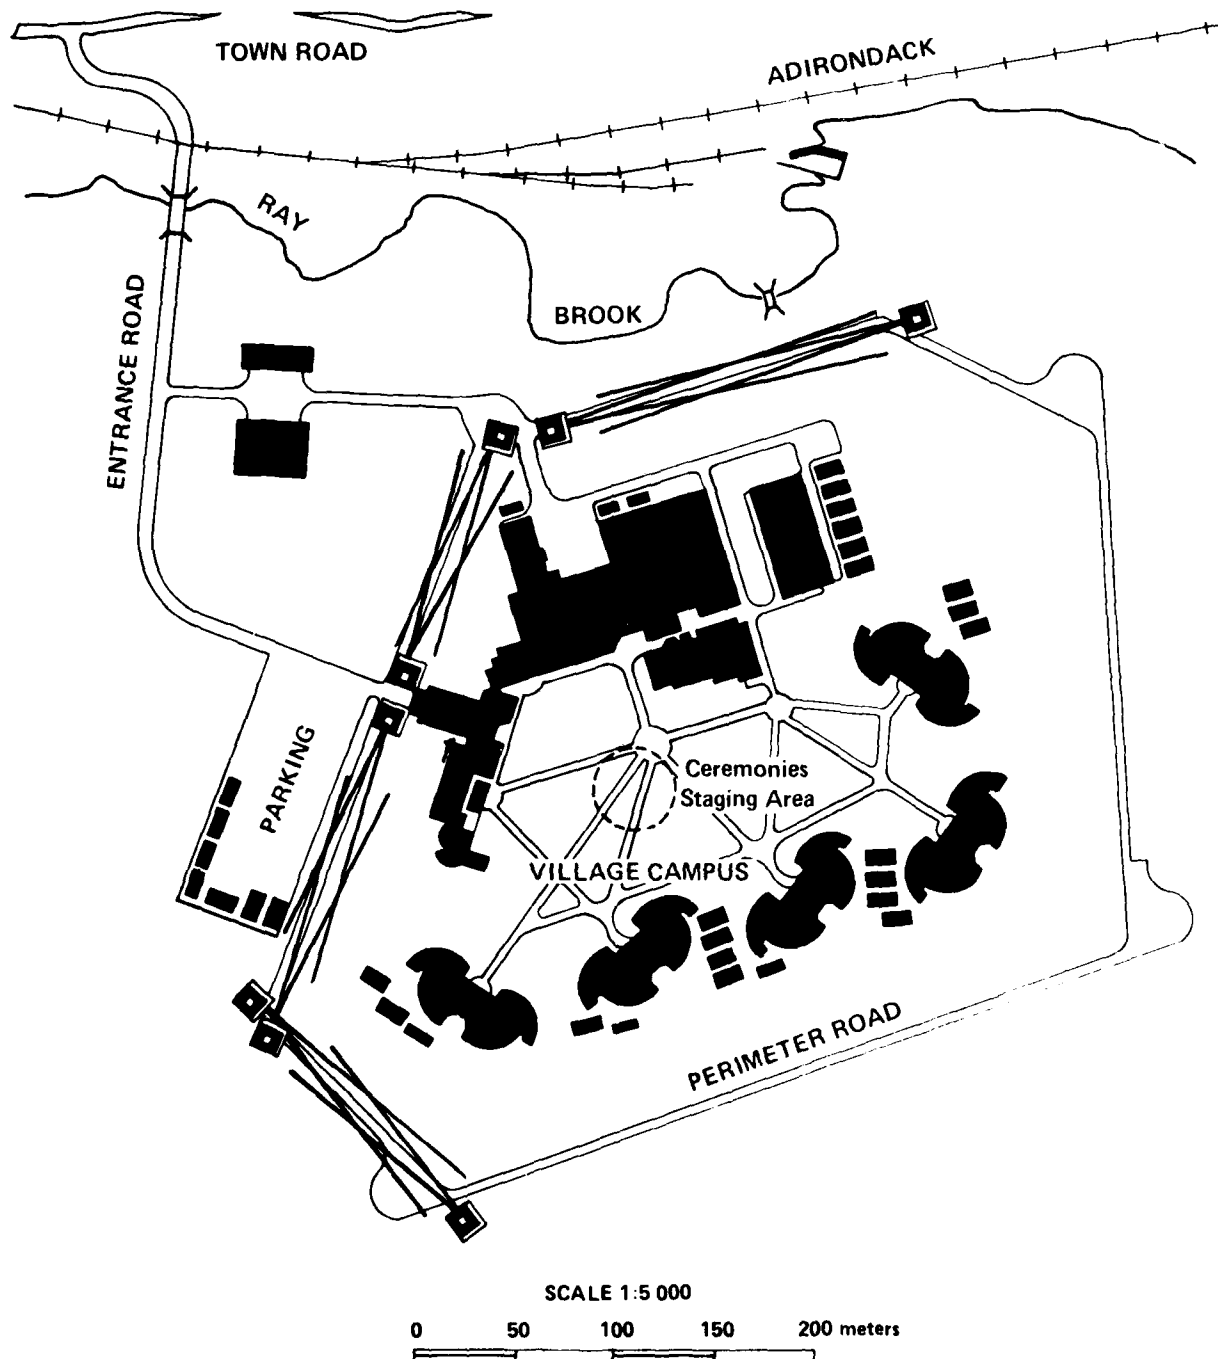
Figure 2-18. Perimeter Fence Surveillance CCTV Camera Locations. Cameras Associated with Pedestrian and/or Vehicular Sallyports, Internal Security, Etc., Not Shown but are Discussed in Text.

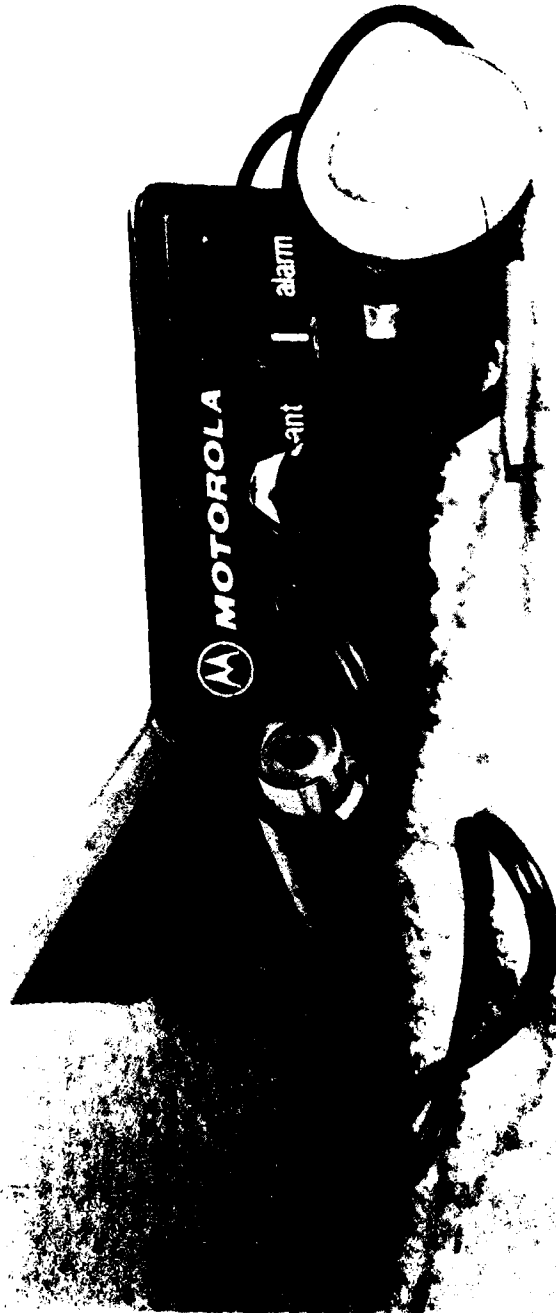
Figure 2-20. Motorola's 1-Watt Overt Duress Sensor Transmitter. This Device Was Employed in Both Fixed and Portable Configurations by Building Guards.
