**DoD PHYSICAL
SECURITY TECHNICAL
SUPPORT AT THE
1980 WINTER OLYMPIC
VILLAGE**

4. TITLE (and Subtitle) DOD PHYSICAL SECURITY TECHNICAL SUPPORT AT THE 1980 WINTER OLYMPICS VILLAGE,	5. TYPE OF REPORT & PERIOD COVERED 9 FINAL REPORT

7. AUTHOR(s) 10 MR. SANFORD C. CURCIE MR. ROBERT L. BARNARD	6. PERFORMING ORG. REPORT NUMBER	
9. PERFORMING ORGANIZATION NAME AND ADDRESS ANALYTICS, INC. 766 SHREWSBURY AVENUE TINTON FALLS, NEW JERSEY 07724	8. CONTRACT OR GRANT NUMBER(s) DAAB07-79-G-6201-E101

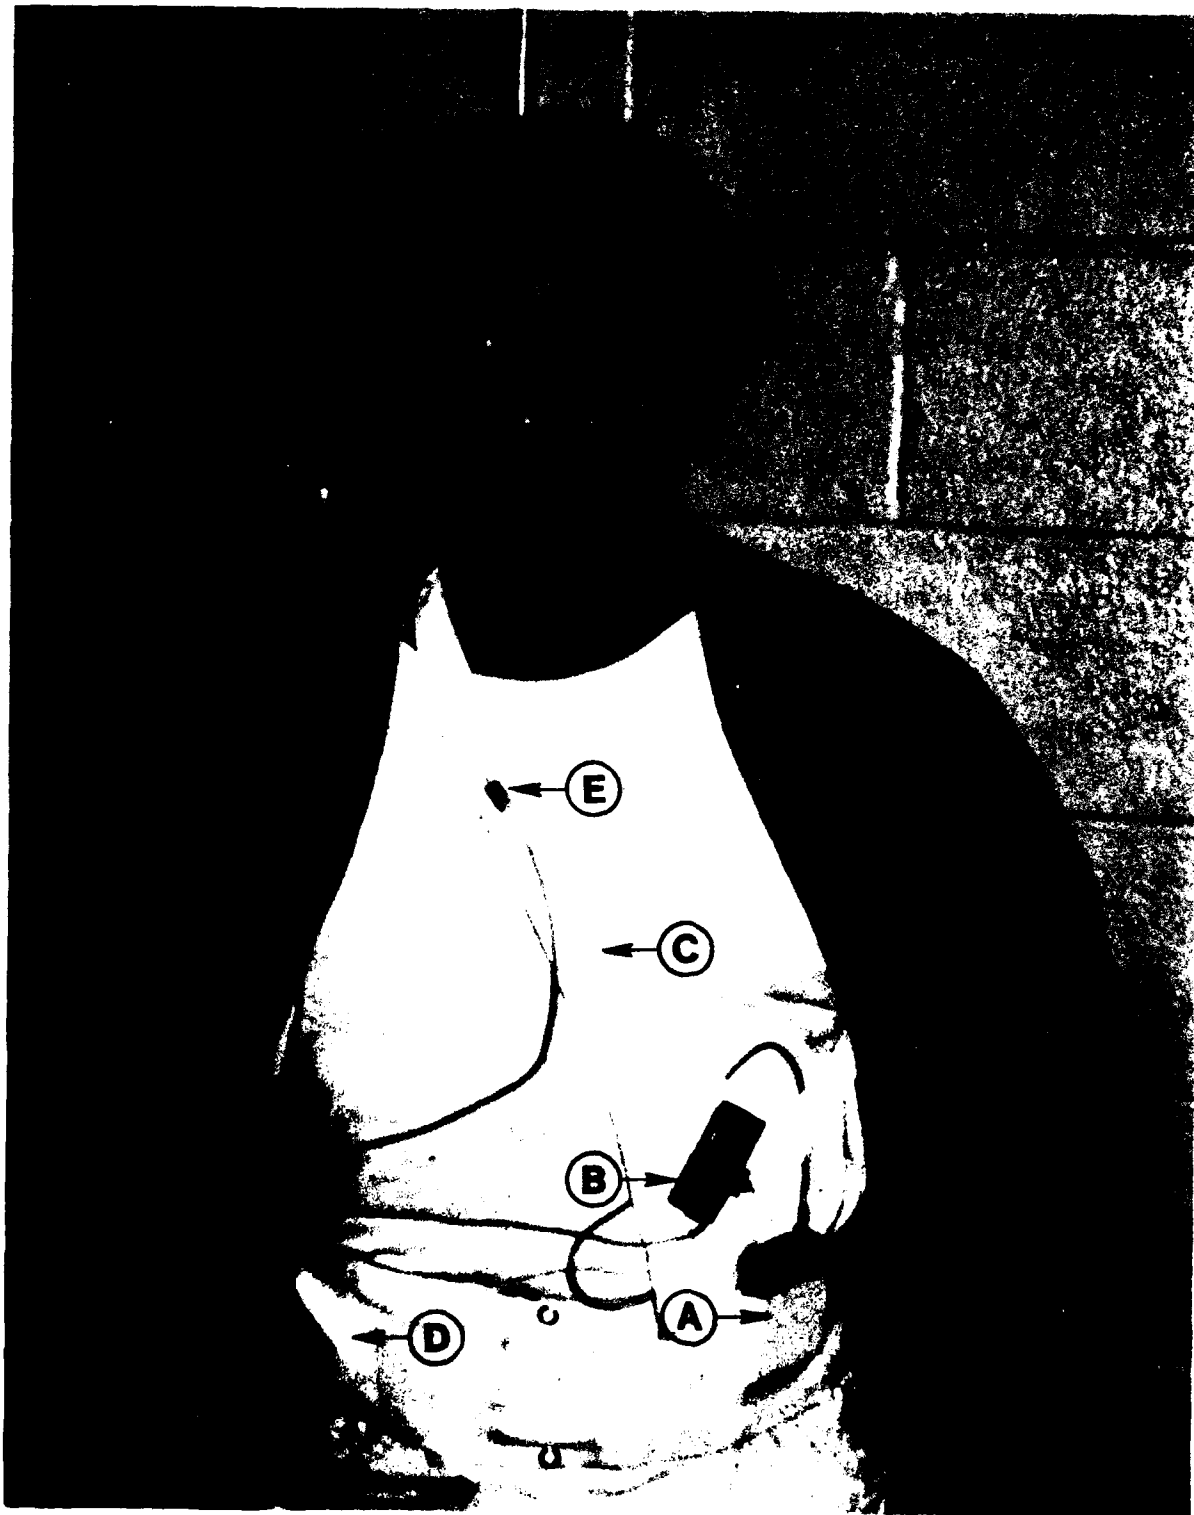
Figure 2-21. Close-up of User-worn Covert Communication Equipment.
(Refer to Text for Keys to A – D.)

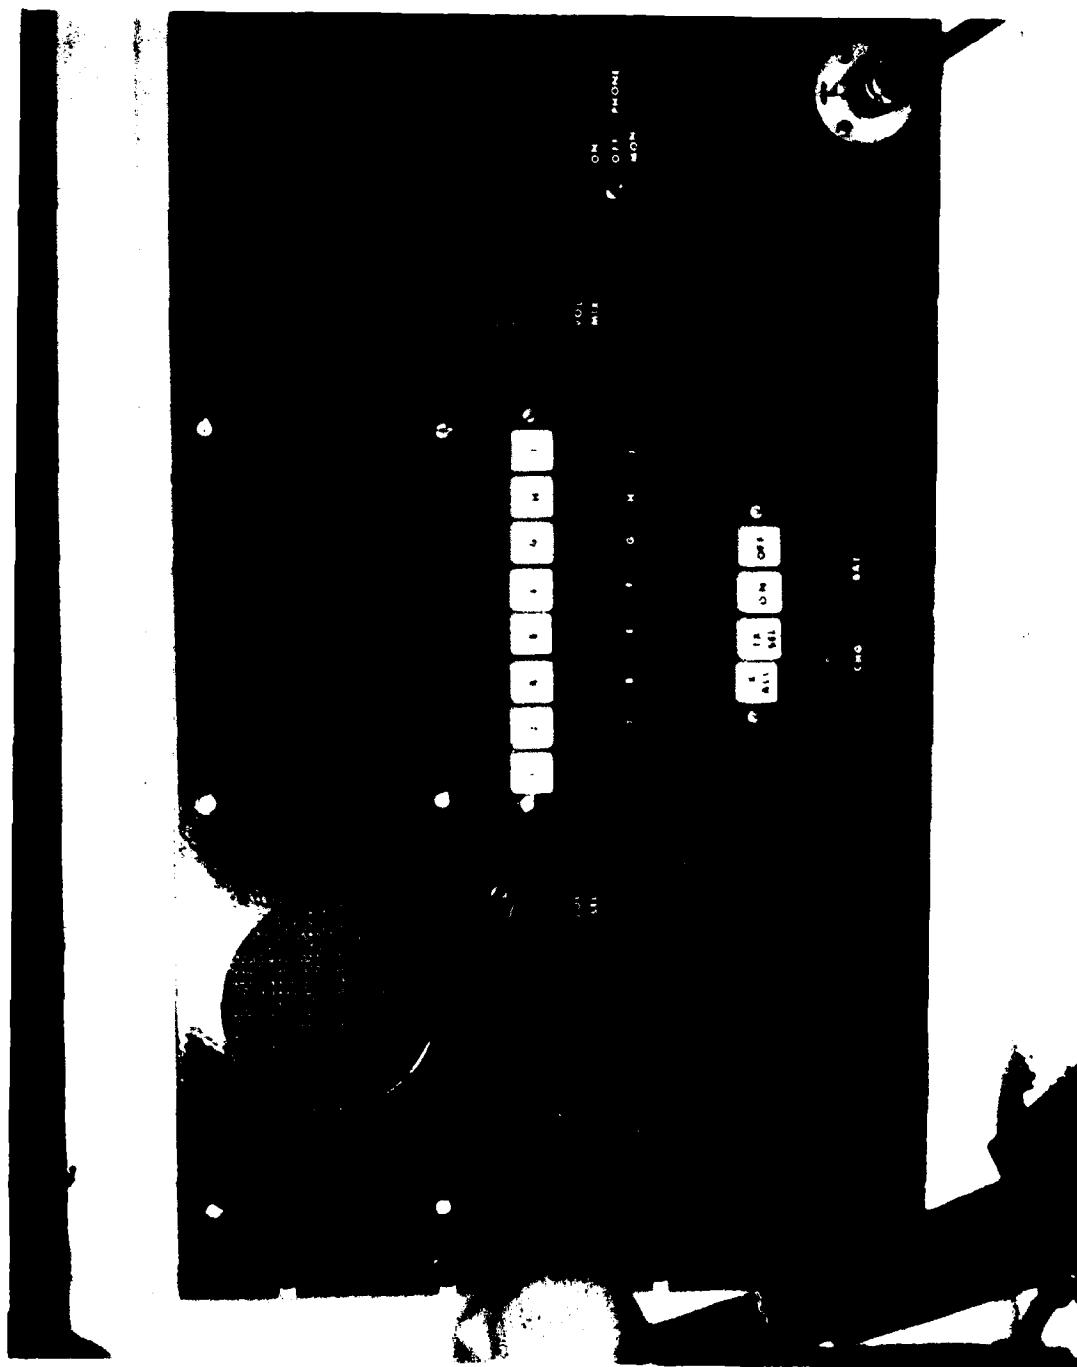
Figure 2-26. Details of COAT-TAILS Communications Control Panel at Security Control Center. Eight 4-Wire 600-Z Phone Lines Terminated Here; a Pair from Each Remote Transceiver.

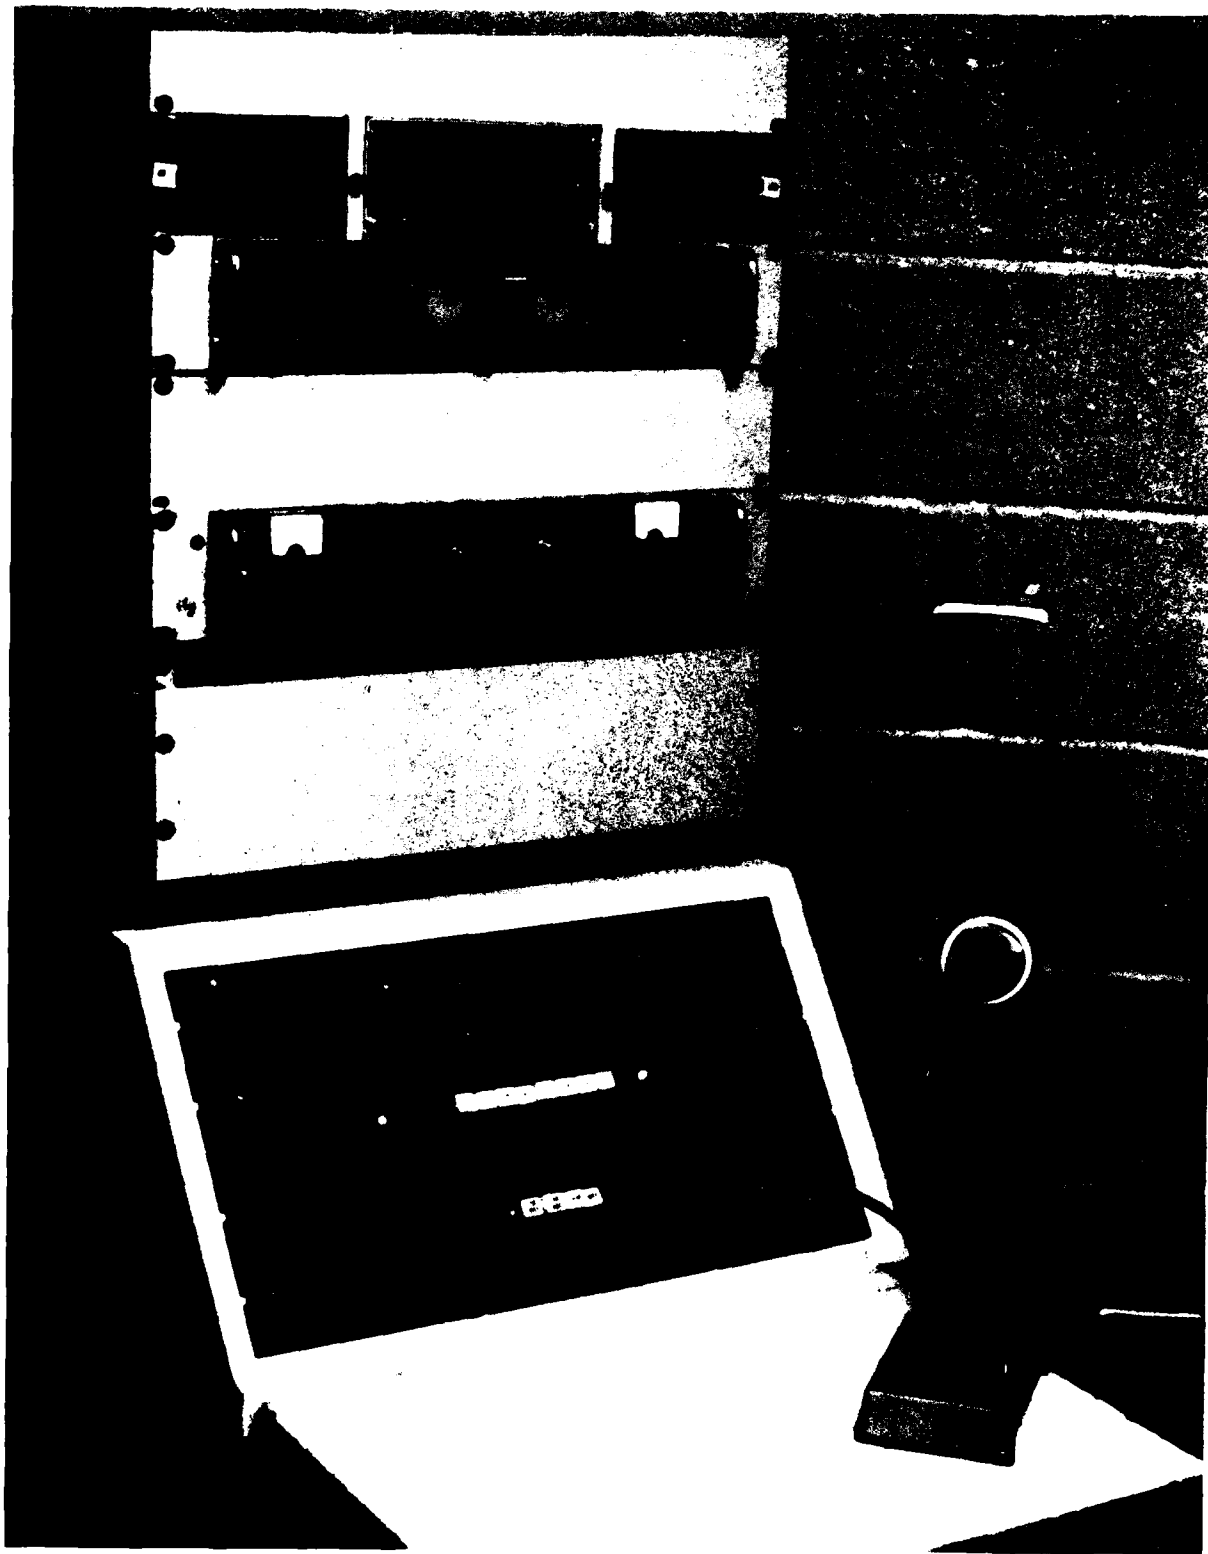
Figure 2-27. COAT-TAILS Control Rack, Spectrum Analyzer (above) Permitted Direct Tuning from 30 MHz to 980 MHz. Synthesized Emission Generator (not shown) Permitted Operation Between 100 KH3 and 1 GH3.

c. Spectrum Analyzer and Wide Band Receiver. Auxiliary (outboard) COAT-TAILS equipment incorporated a precision spectrum analyzer which, with its own signal generator and tone burst generator, could be used to tune-in on, or to emulate the spectral characteristics of any AM, AM/SSB or FM radio between 50 KHz and 1 GHz. This device was employed in the event that it was necessary to communicate with a terrorist who, for example, was using a radio of foreign origin; its tone-coded squelch (CTCSS), frequency deviation, operating frequency, etc., could be matched so as to ensure that a controlled communication link was easily established and maintained.

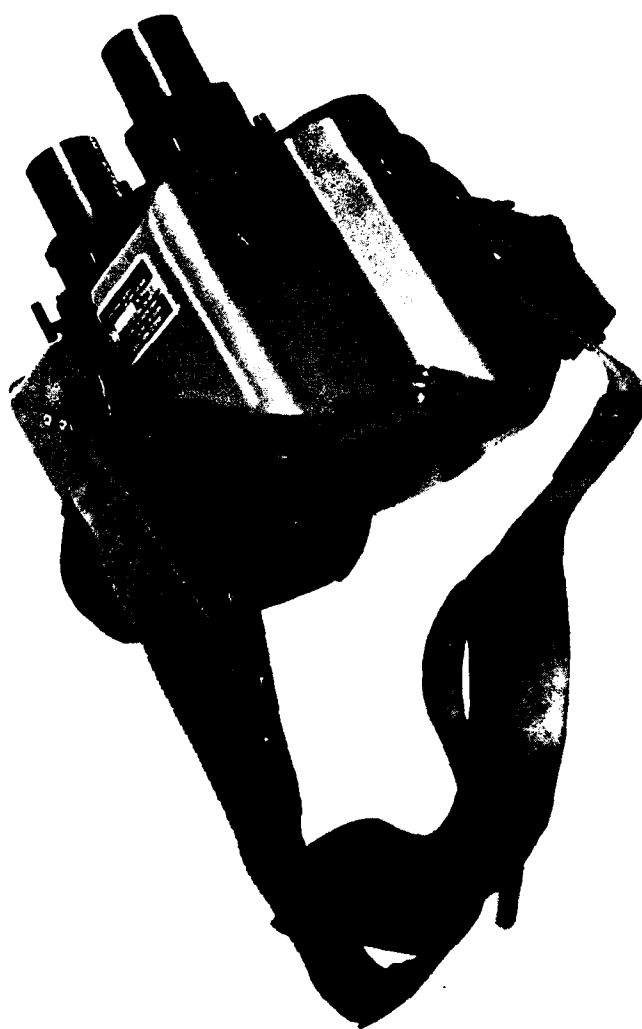
Figure 2-29. AN/PVS-5 Night Vision Goggles.

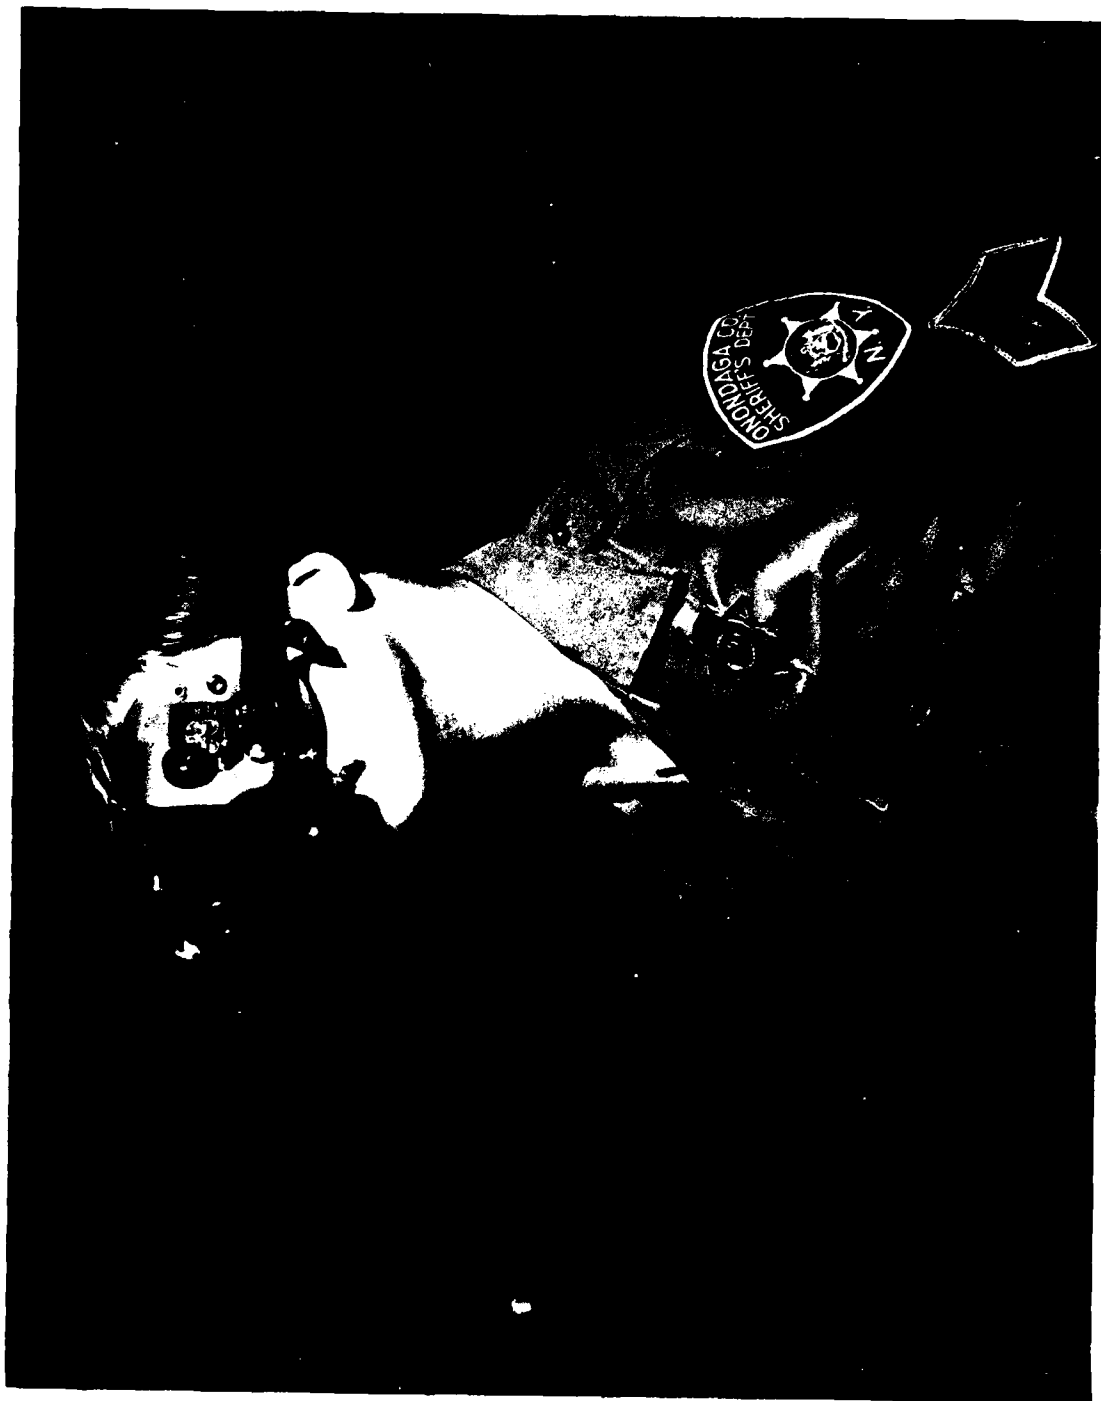
Figure 2-30. Night Vision Goggles Worn by Typical User.

Two types of Night Observation Devices (NOD) were furnished by the Army in support of NYSP physical security mission objectives. One type of NOD was the AN/PVS-5A personal goggles (20 pairs) is shown in Figure 2-29 and 2-30. The second type was the NOD/LR (Night Observation Device/Long Range), consisting of 600mm viewer and tripod assembly (2 units), this is illustrated in Figure 2-31.

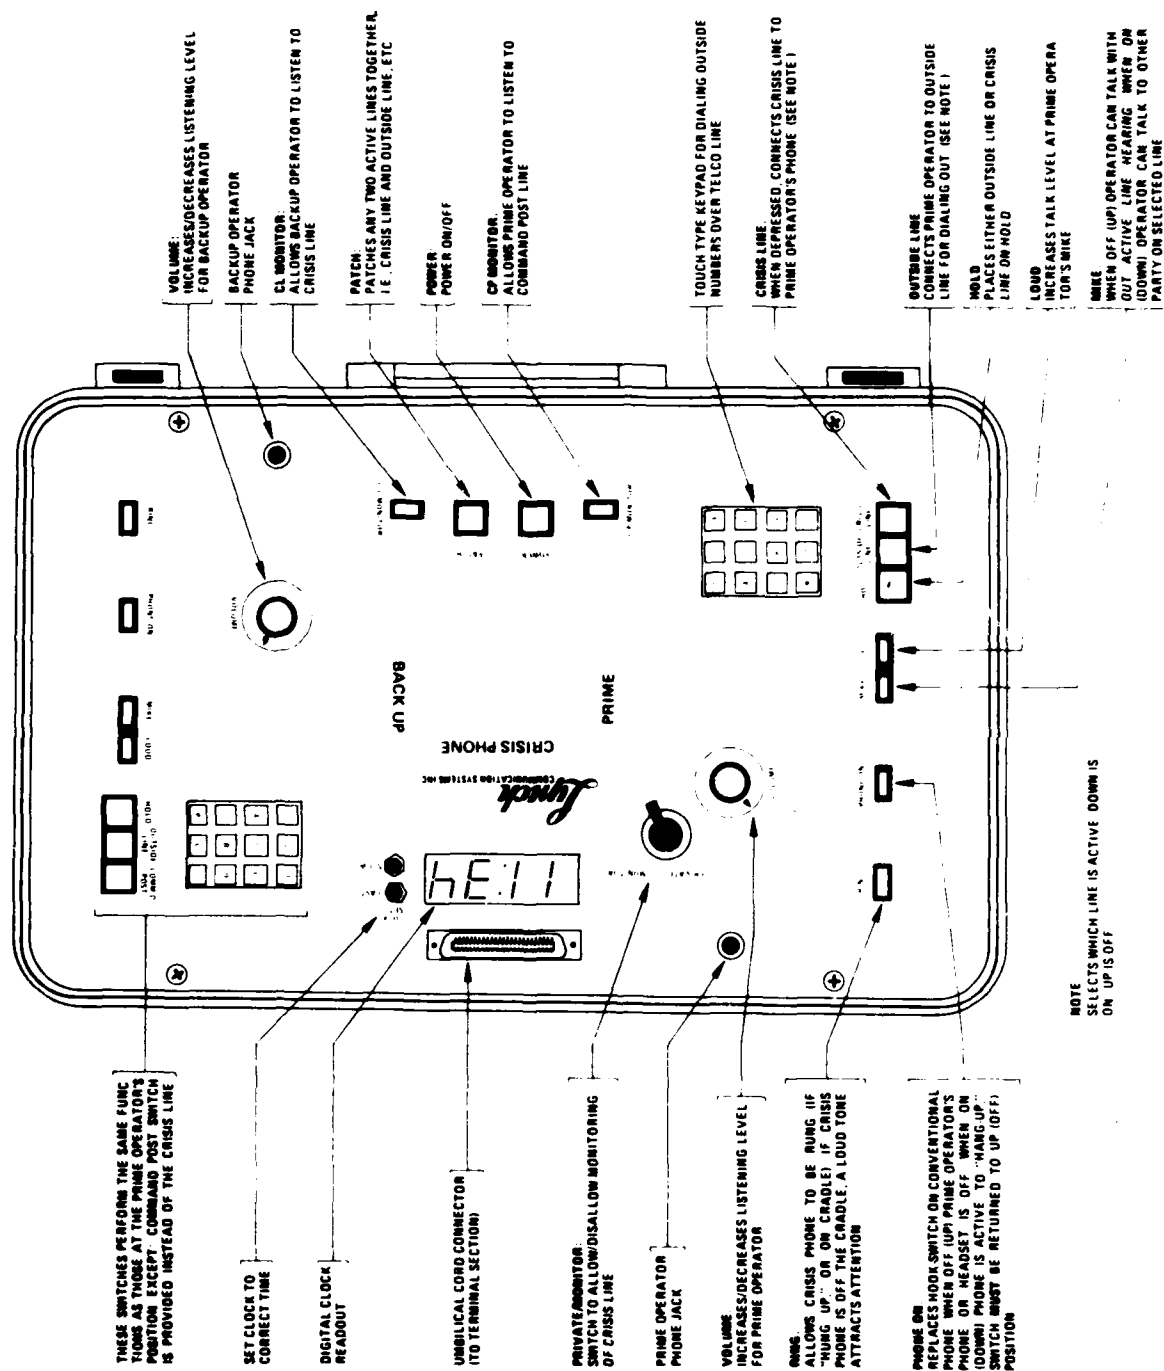
Figure 2-32. Details of Crisis Phone Management Equipment.

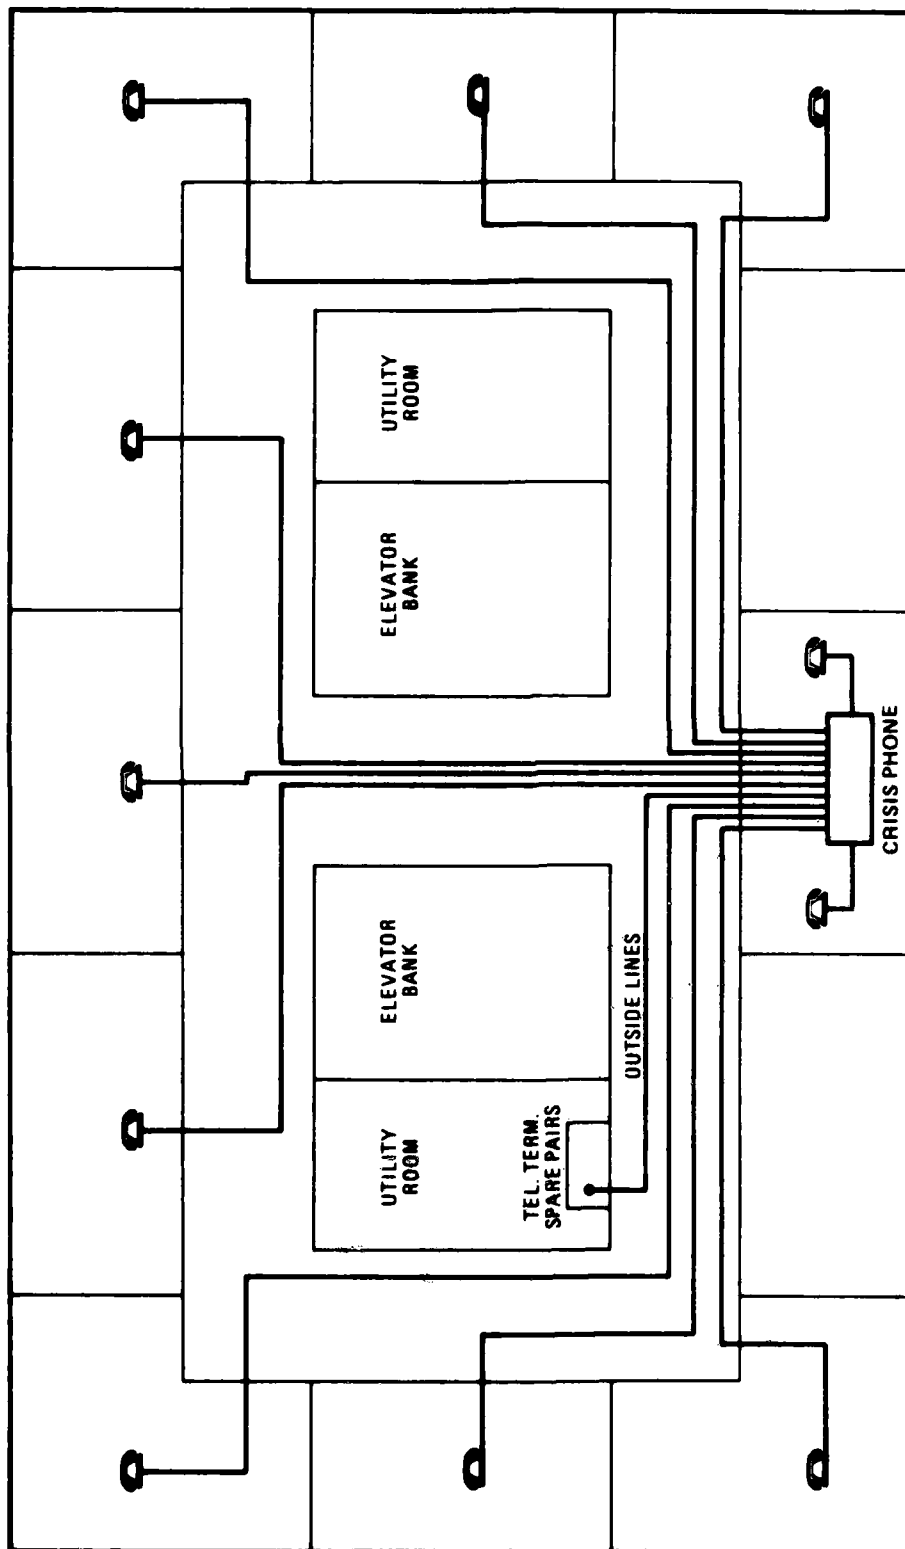
Figure 2-33. Witness or Dignitary Protection — Hotel/Motel.

Actual technical set-up and operation of the equipment was, by plan, limited to the two locally assigned NYSP "wire men". Close, careful coordination and liaison was maintained between these individuals and representatives of the DoD Physical Security Team via portable radios and access to local telephone company installers so that the crisis kit could be quickly set up, and the process of opening lines and isolating selected areas within the Village undertaken. Possible system interconnections arrangements are shown in Figure 2-33.

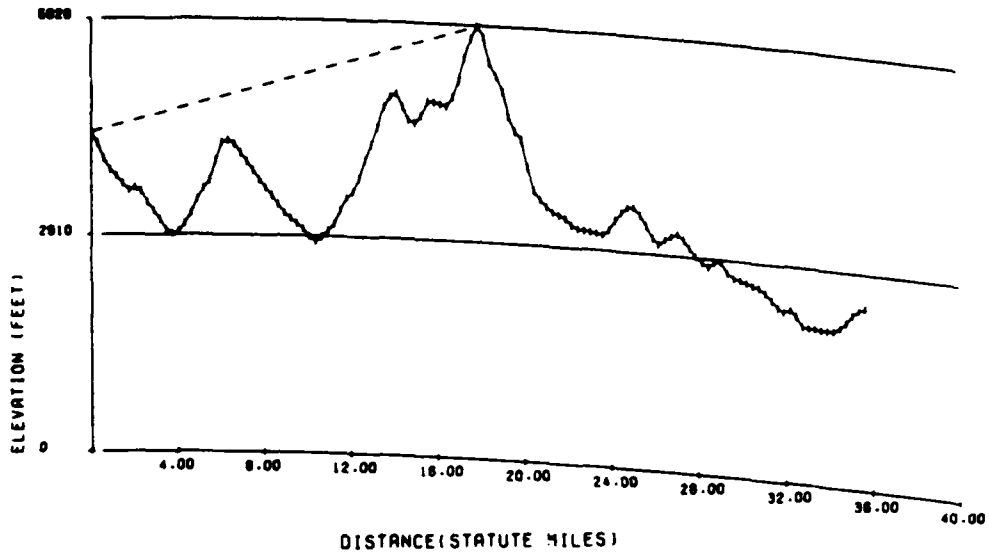
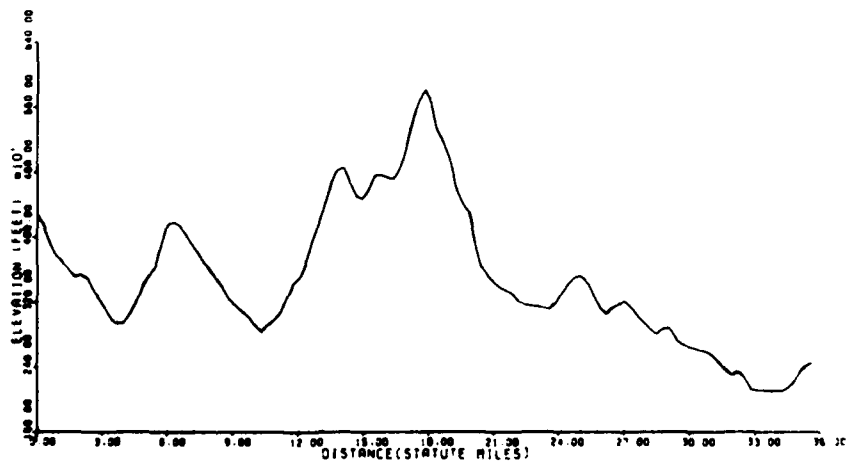
ROLAKE TO HAYSTACK
TERRAIN PROFILE - 4/3 EARTH

TX LAT: 33-46-46 N TX LON: 110-37-46 W RX LAT: 33-46-0 N RX LON: 111-16-0 W
TX ELEV: 4200.01 FT RX ELEV: 2469.99 FT
TX ANT HGT: 16.00 FT RX ANT HGT: 16.00 FT

a. 4/3 Earth

ROLAKE TO HAYSTACK
TERRAIN PROFILE - LINEAR EARTH

TX LAT: 33-46-46 N TX LON: 110-37-46 W RX LAT: 33-46-0 N RX LON: 111-16-0 W
TX ELEV: 4200.01 FT RX ELEV: 2469.99 FT

b. Linear Earth

Figure 2-34. Sample Terrain Profiles Derived from the Digitized Data Base.

Figure 2-34-A and -B illustrate the use of the digitized topographic data base both for microwave systems planning and analysis as well as for simpler, less complex paths such as those employed with unattended ground sensors. The 4/3 earth (Figure 2-34-A) takes into account the differences between the radio horizon and the physical one, due to different refractions associated with microwave frequencies. The linear earth (Figure 2-34-B) is quite adequate for simple Line-of-Sight (LOS) work at the lower frequency bands of between 30 to about 800 MHz.

This is a model which examines multiple profiles extracted in a radial pattern from a specified observation point to develop information about the radio or visual horizon. This is done by projecting a ray at the radio horizon (linear or $4/3$ earth) from the sensor monitor's antenna to the specified altitude (e.g., sensor's transmitting antenna) then calculating the acquisition distance, as illustrated in Figure 2-34.

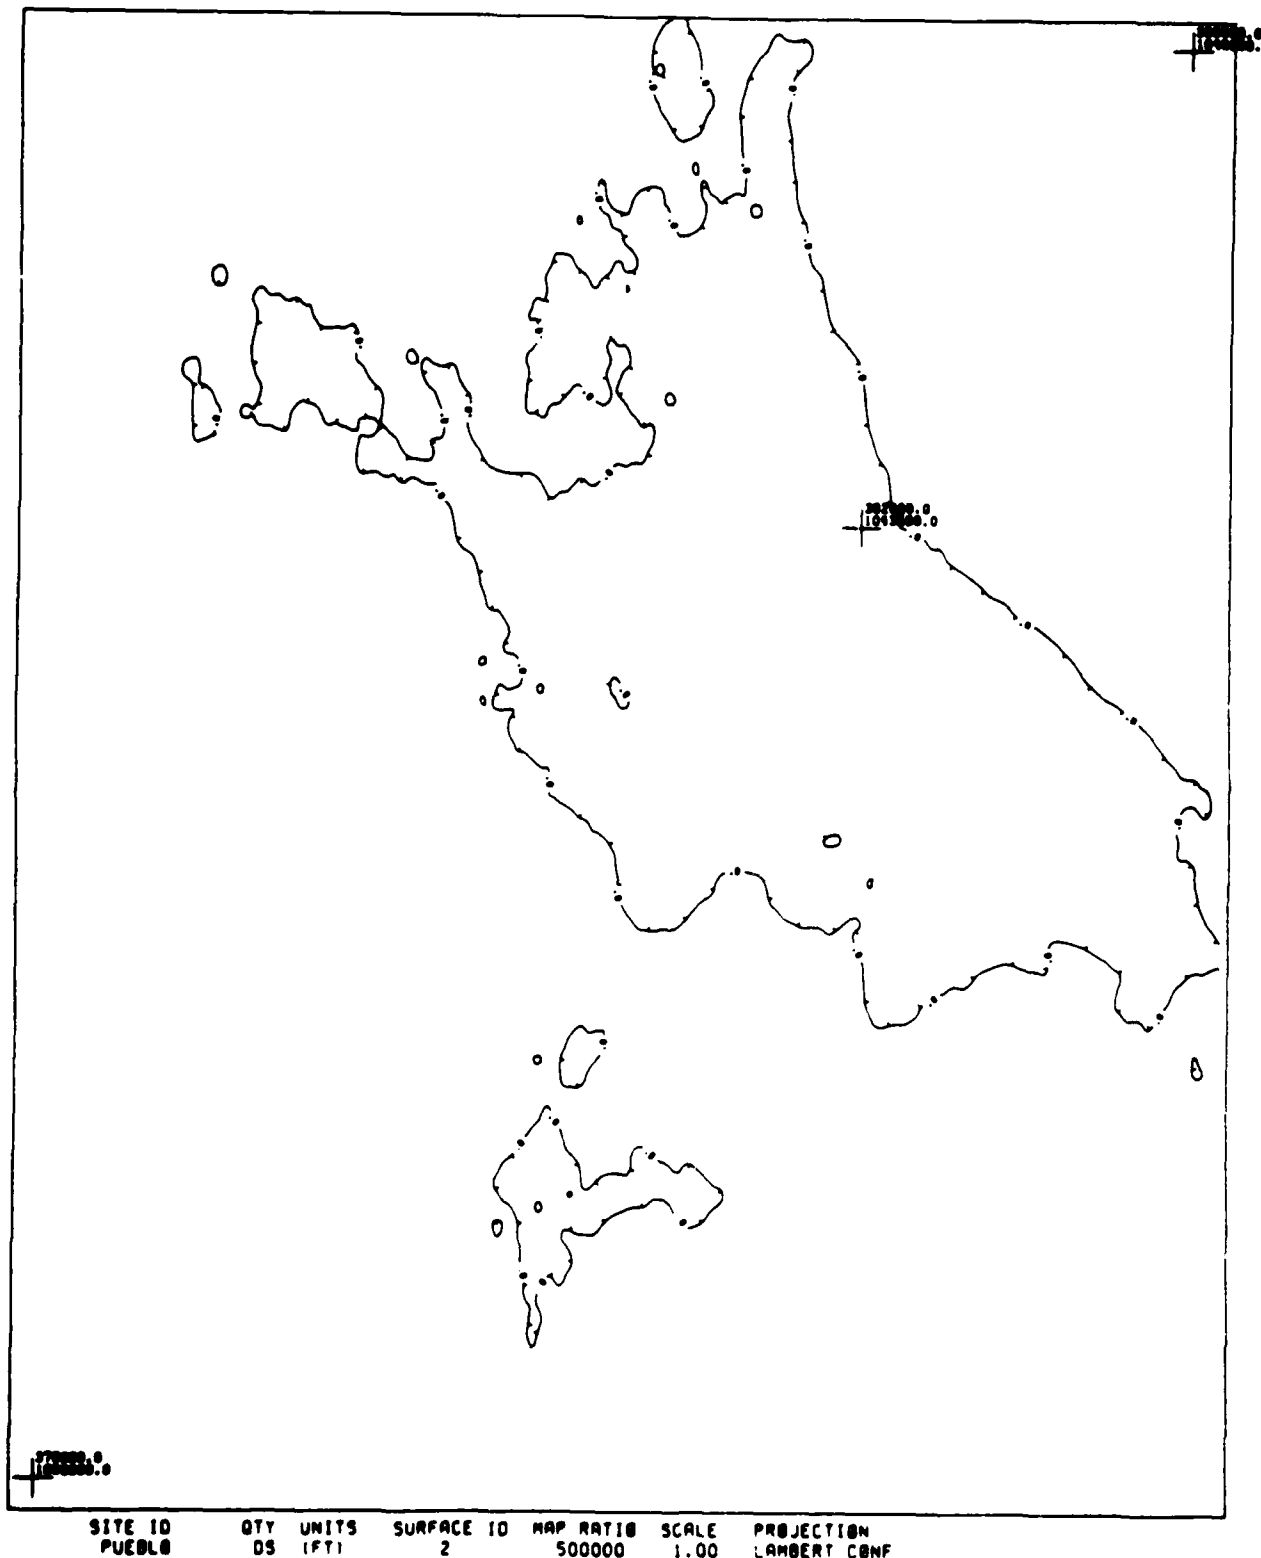
Figure 2-35. PLLM Contour Overlay Depicting Terrain Shielding, in Feet.
