THE EFFECT OF DEFECTS ON THE FATIGUE INITIATION
PROCESS IN TWO P/M SUPERALLOYS

Jack M. Hyzak, Capt, USAF
Metals Behavior Branch
Metals and Ceramics Division

TECHNICAL REPORT AFWAL-TR-80-4063

Final Report for Period November 1977 - November 1979

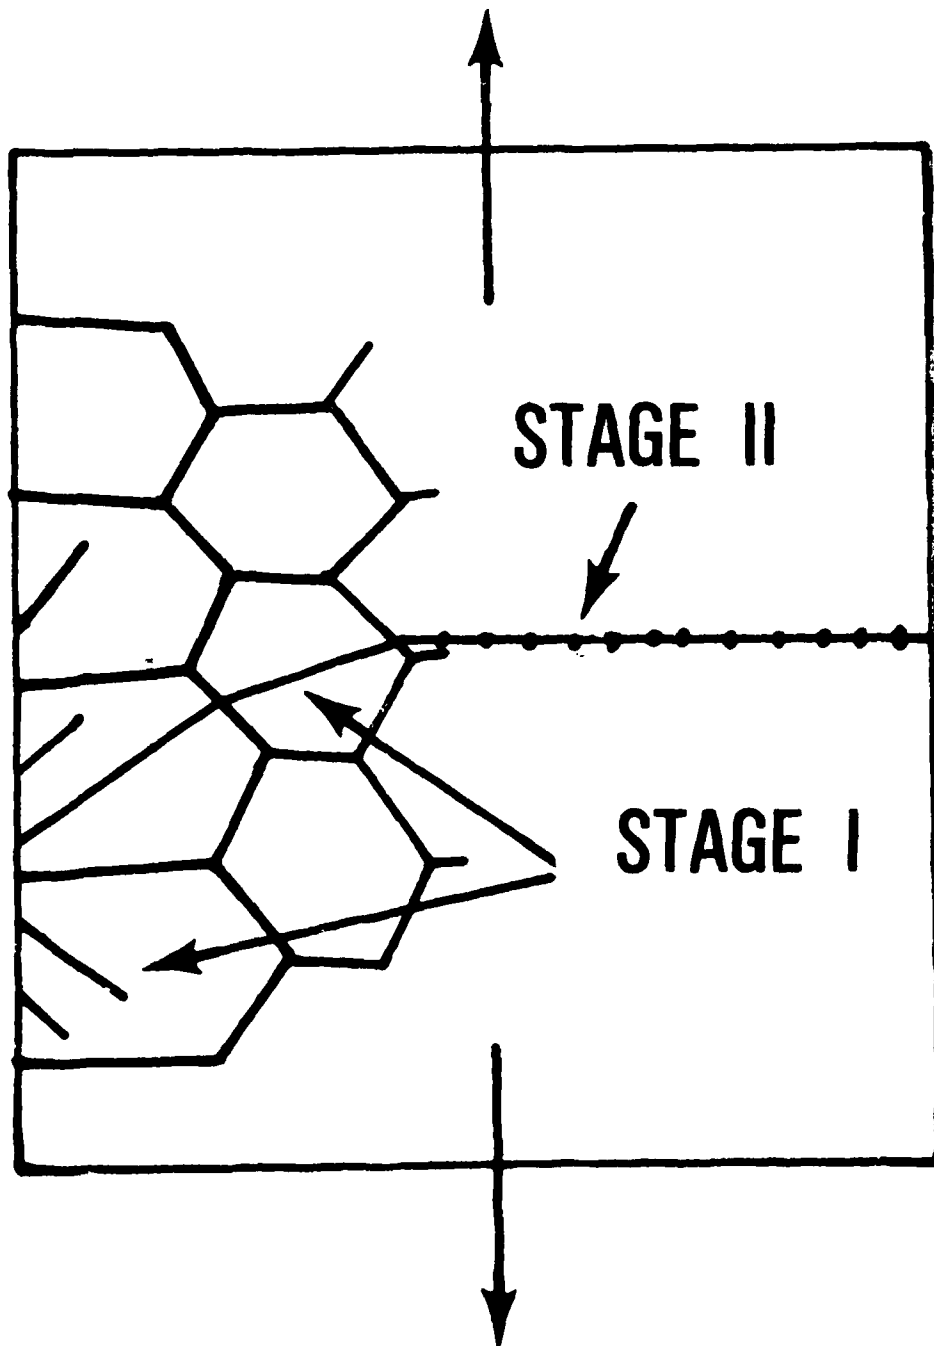
Figure 1. Schematic Illustration of Stage I and Stage II Fatigue Crack Growth (Laird, Reference 7)

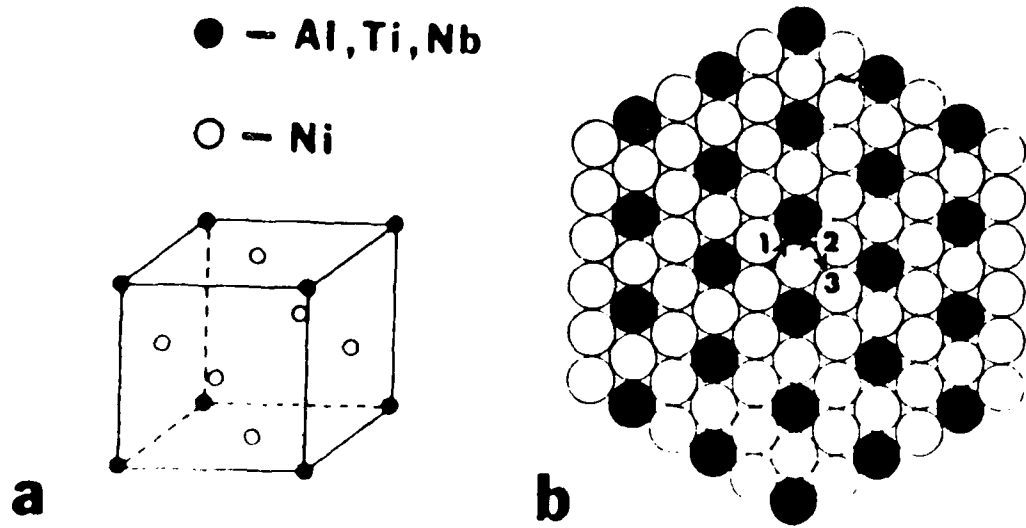
Figure 3. a) L₁₂ Unit Cell; b) Arrangement of Atoms in L₁₂ Closed-Packed Plane

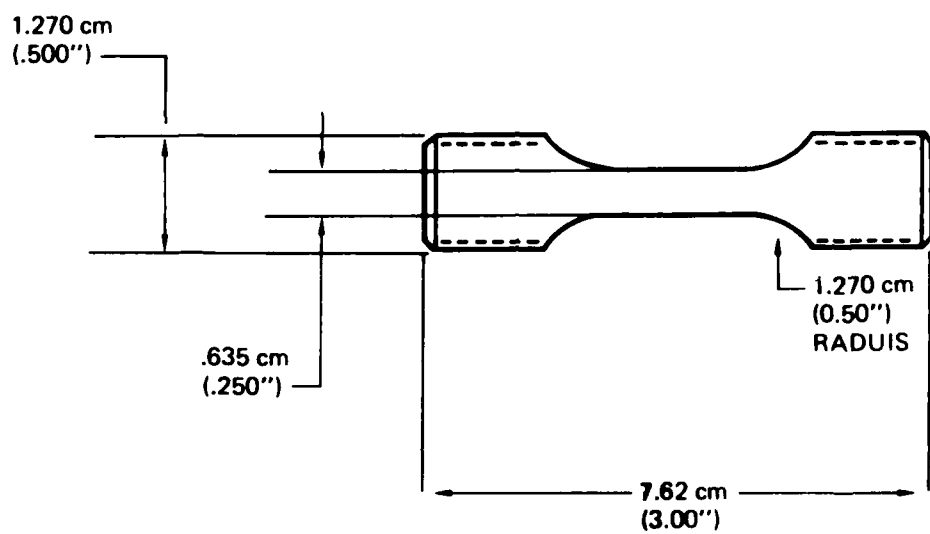
Figure 11. Uniform Section Smooth Bar Fatigue Specimen

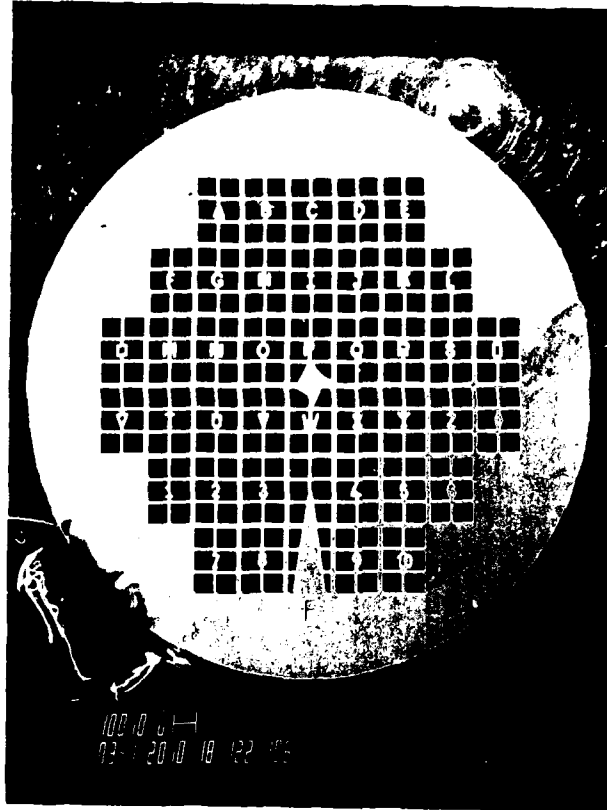
Figure 12. TEM Replica Grid Used to Locate Specific Features While in the Microscope

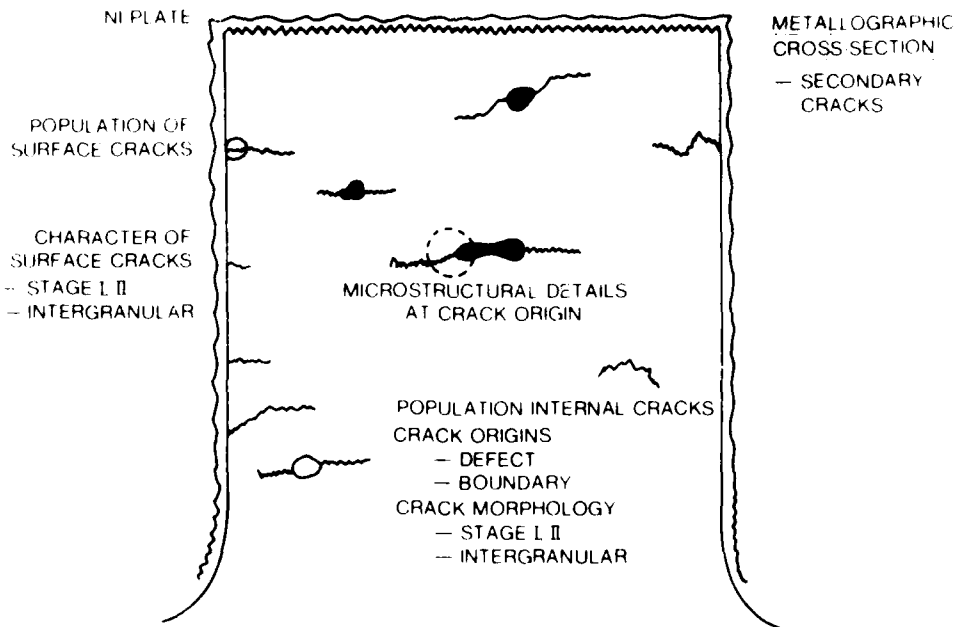
Figure 13. Illustration of the Range of Metallographic Observations Made in Gailed Specimens

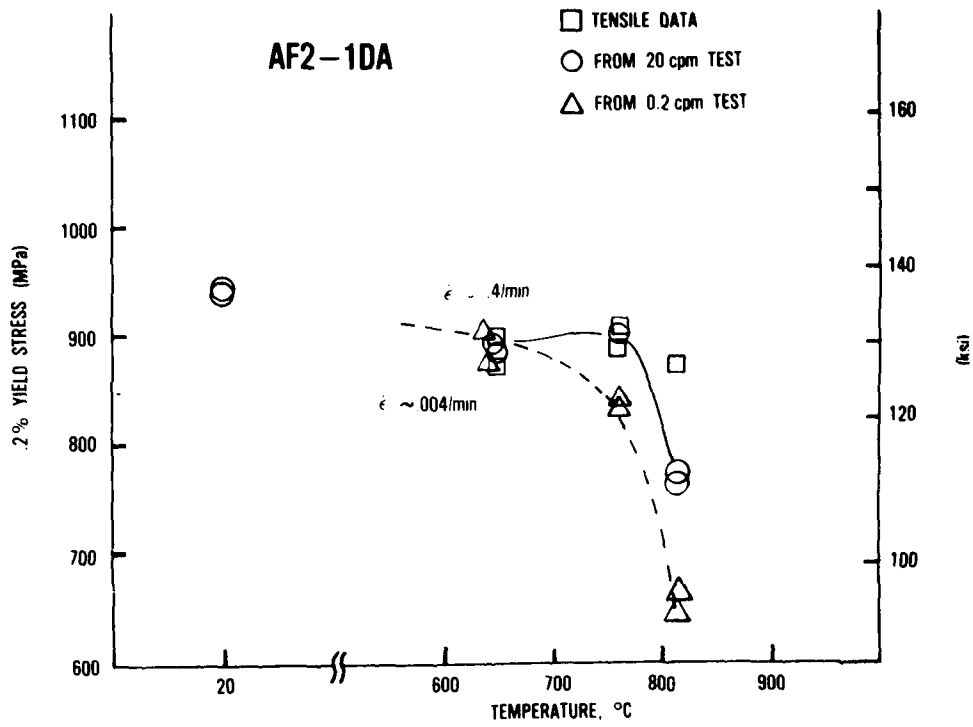
Figure 15. 0.2% Yield Strength vs Temperature for AF2-1DA

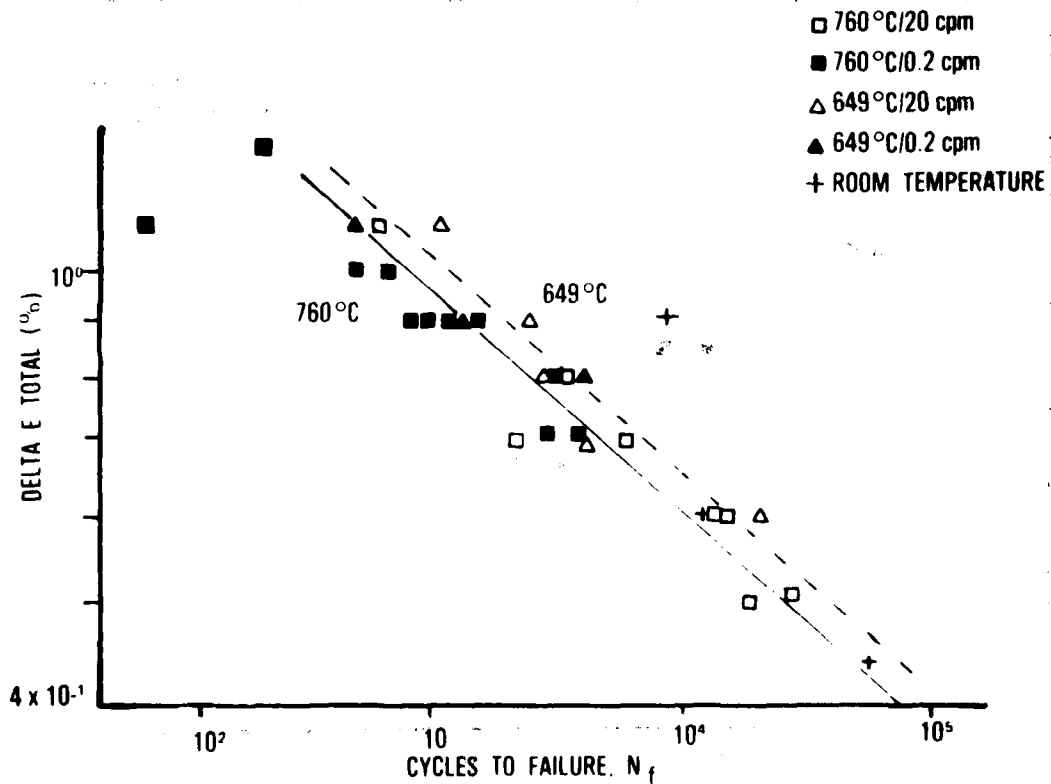
Figure 16. Continuously Cycling Fatigue Data for AF-115, AS-HIP

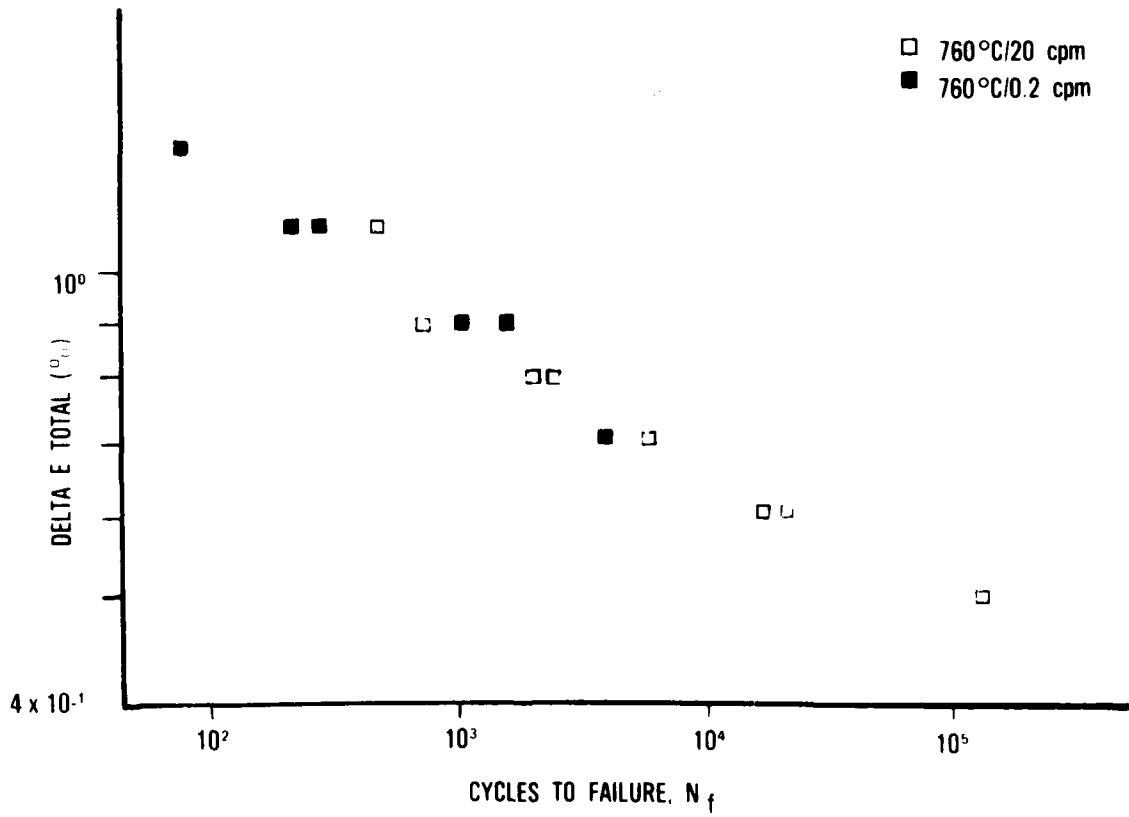
Figure 17. Continuously Cycling Fatigue Data for AF-115, HIP Plus Forged

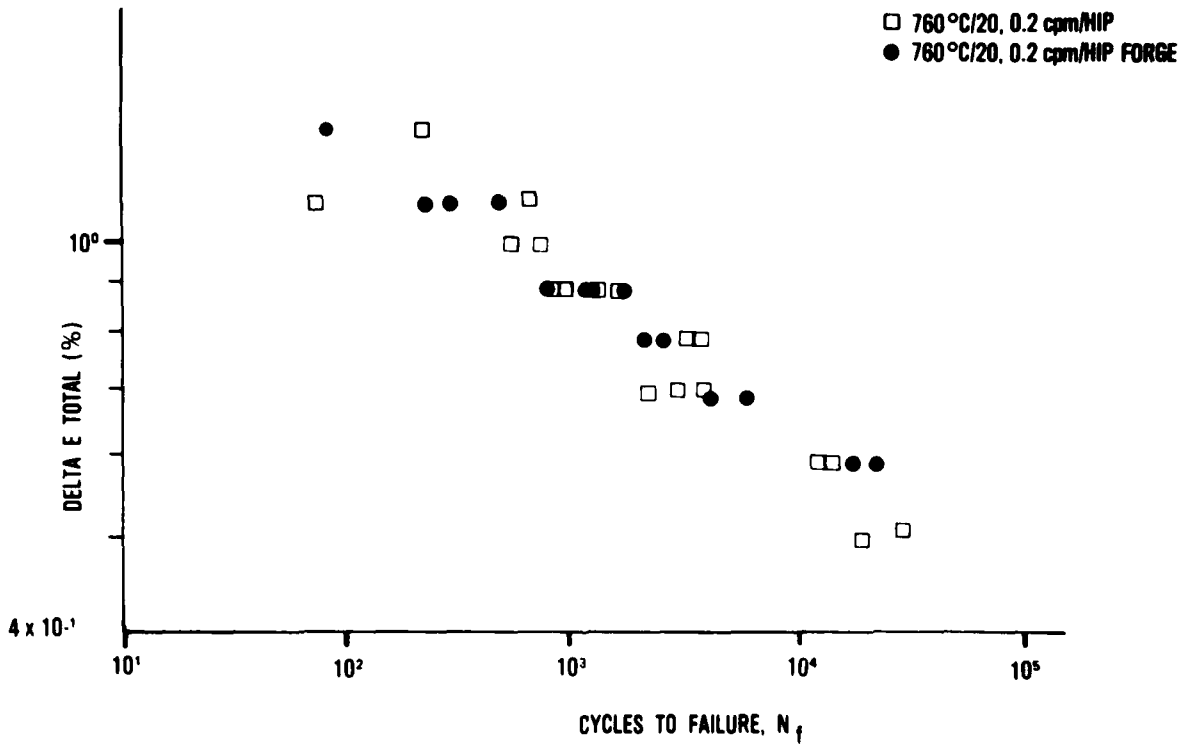
Figure 18. Comparison of the Fatigue Behaviors of the AS-HIP and HIP Plus Forged Conditions of AF-115, 760°C

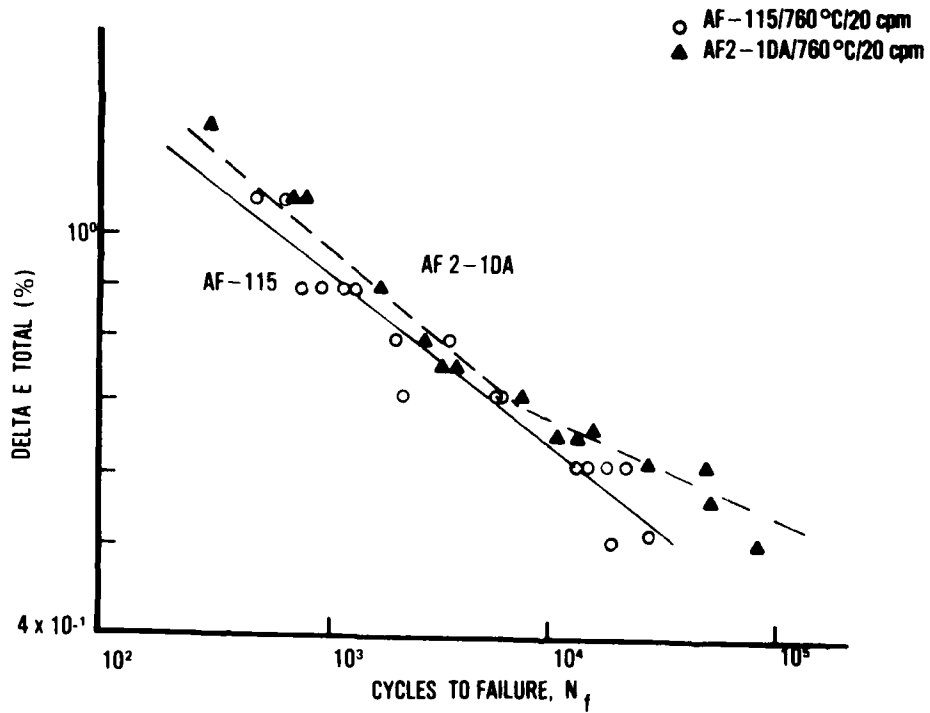
Figure 22. Comparison of the Fatigue Behaviors of AF-115 and AF2-1DA, 760°C and 20 cpm

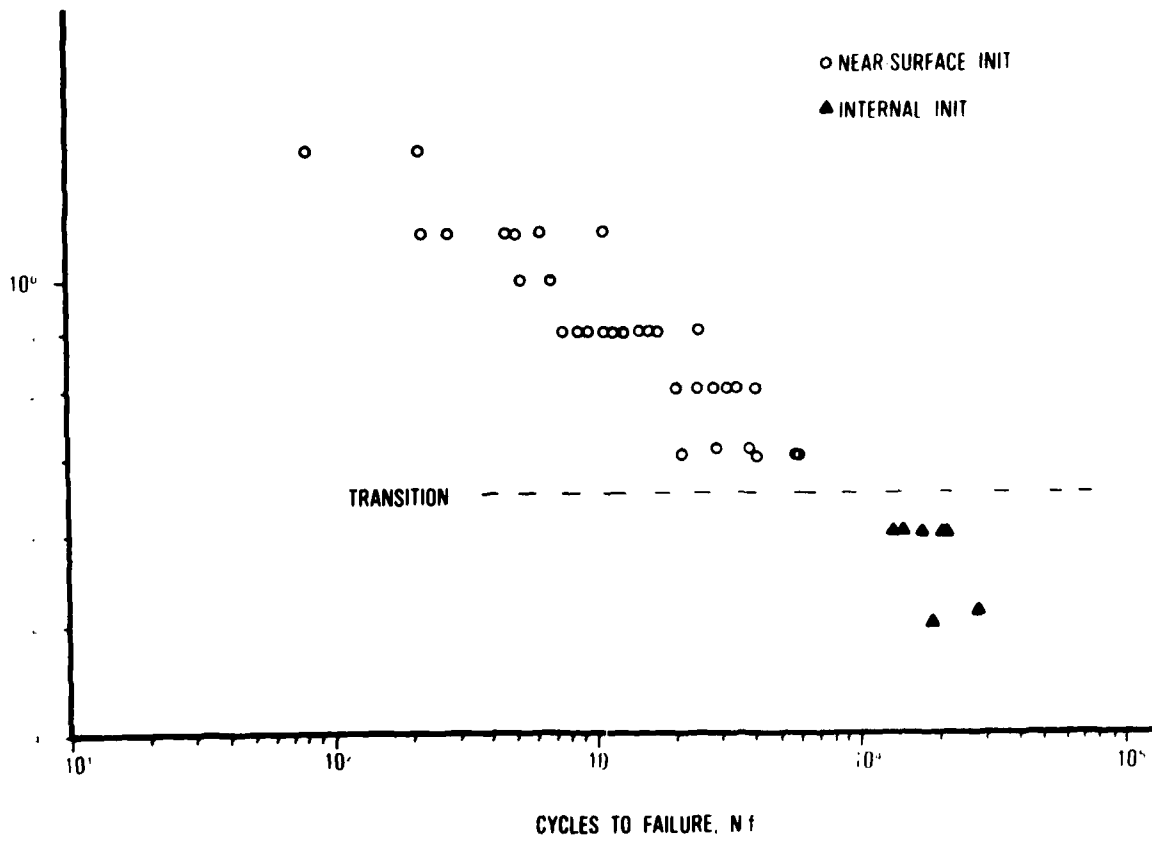
Figure 24. Location of the Dominant Fatigue Origins for the Elevated Temperature AF-115 Tests

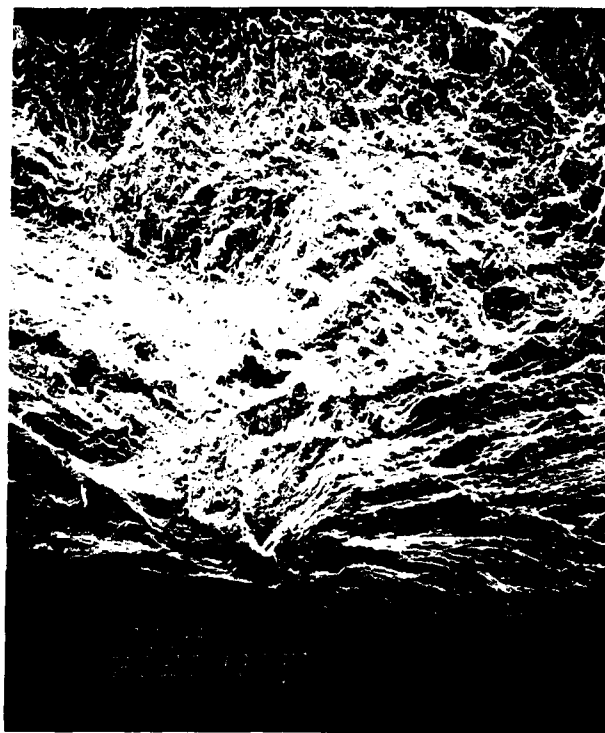
Figure 26. SEM Micrographs of Typical Stage II Surface Crack Initiation Sites on AF2-1DA Fracture Surfaces

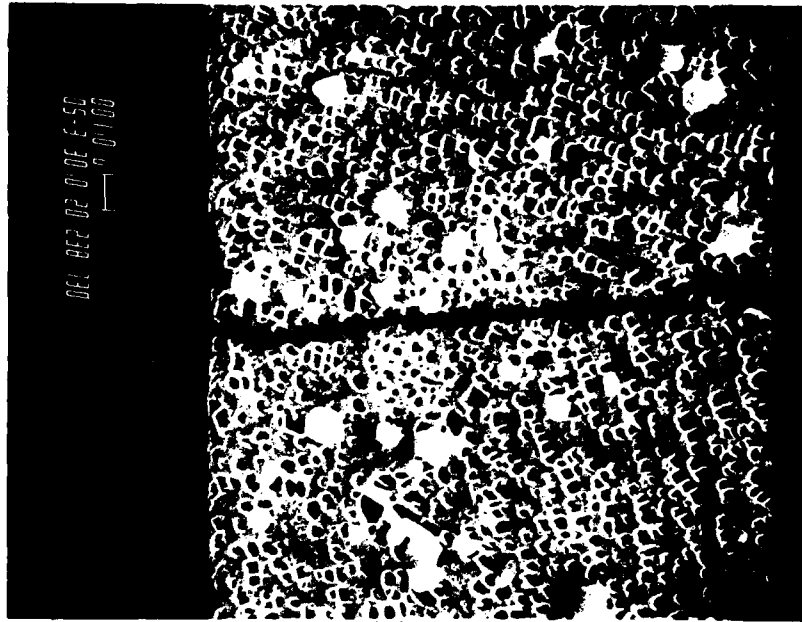
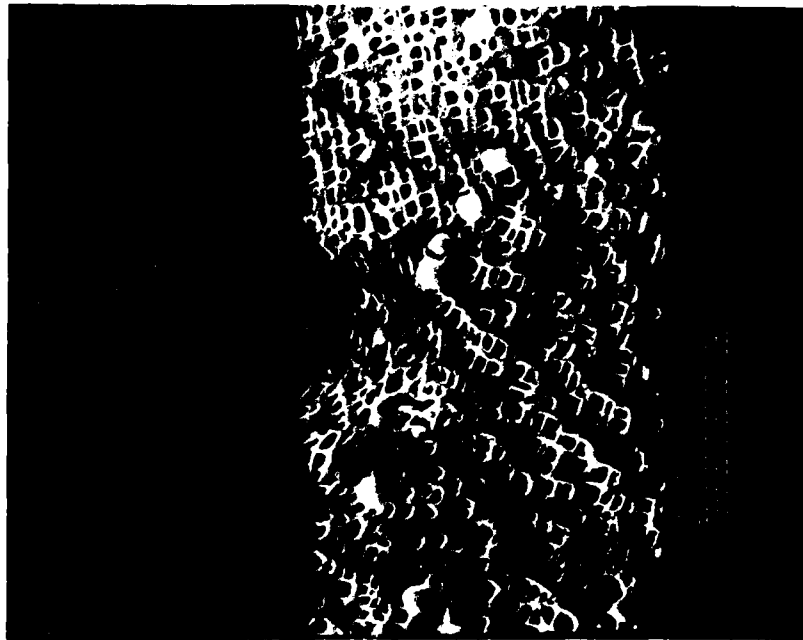
Figure 29. Polished and Etched Cross-Section of a Failed AF2-1DA Specimen. a) Surface Crack Propagating Normal to the Tensile Axis; b) Crack Initiating at a Small Surface Inclusion

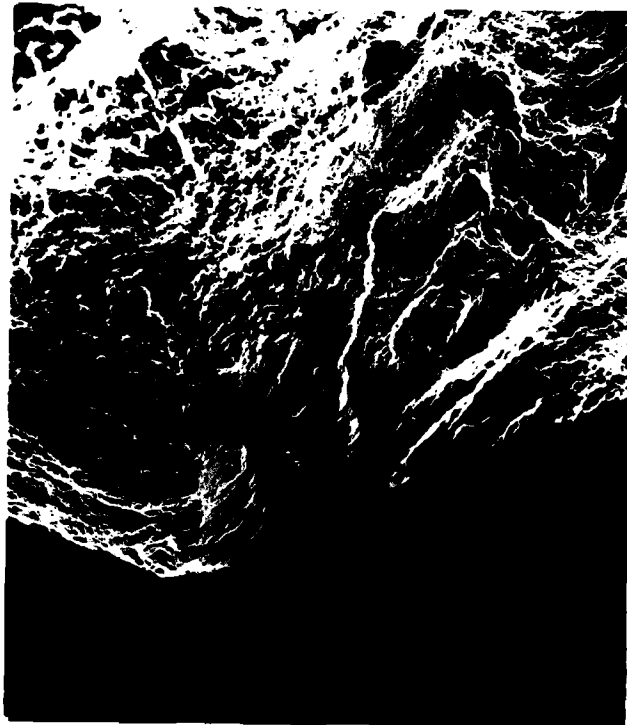
Figure 35. SEM Micrograph of a Stage I Initiation Facet on the Fracture Surface of an AF2-1DA Specimen

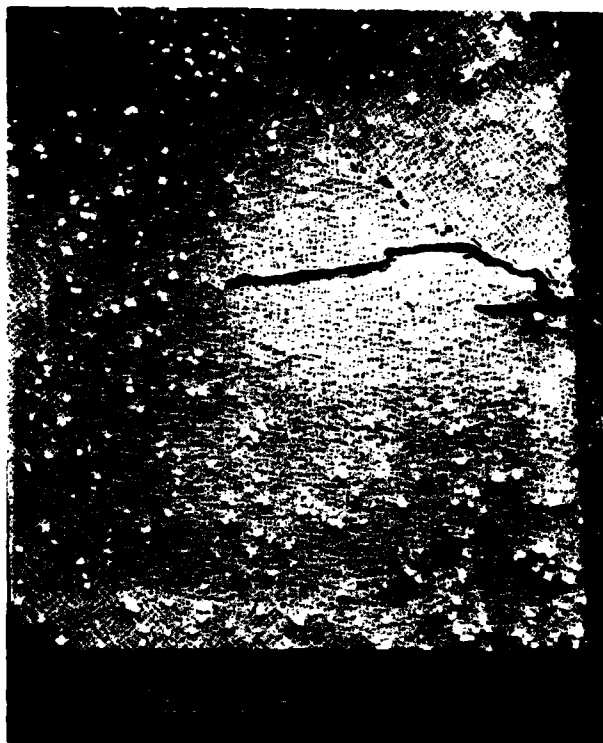
Figure 37. Intergranular Surface Initiation in AF2-1DA at 760°C and 0.2 cpm

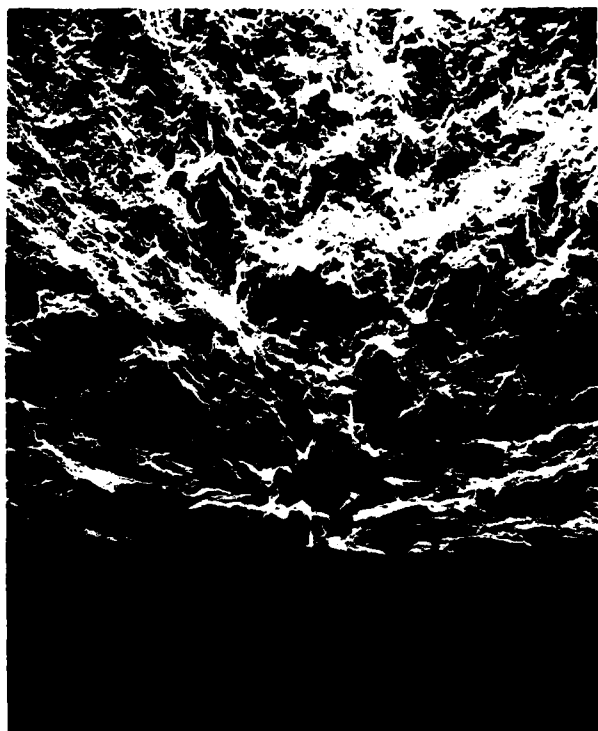
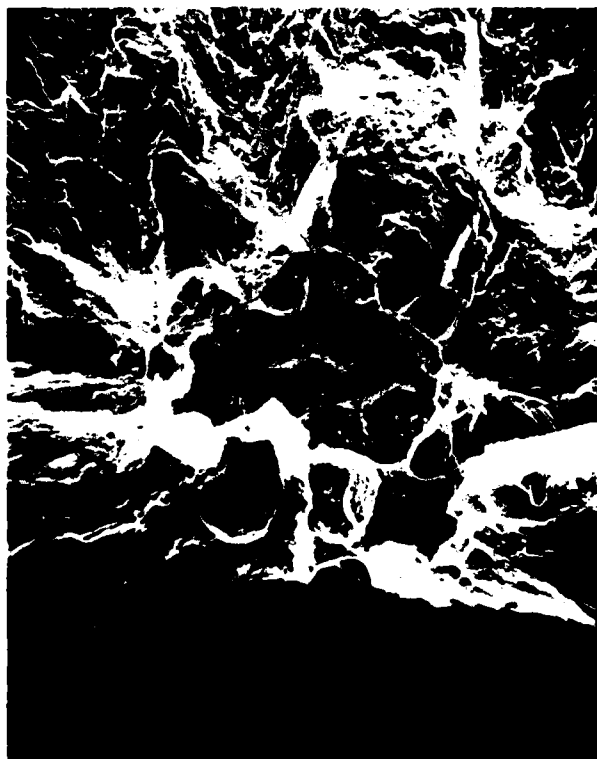
Figure 38. Crack Initiation at AF-115 at a Near-Surface Pore

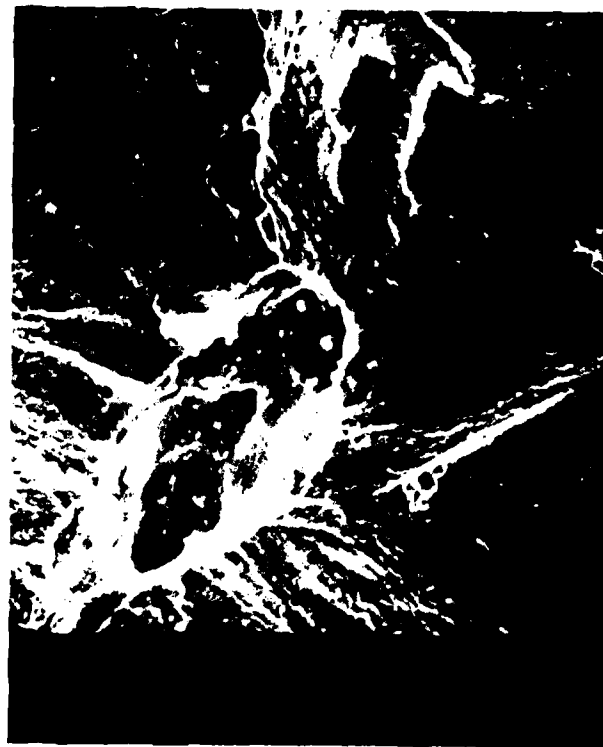
Figure 42. a) Internal Crack Initiation at an Inclusion Cavity in AF2-1DA; b) A Stage I Facet at the Defect's Edge

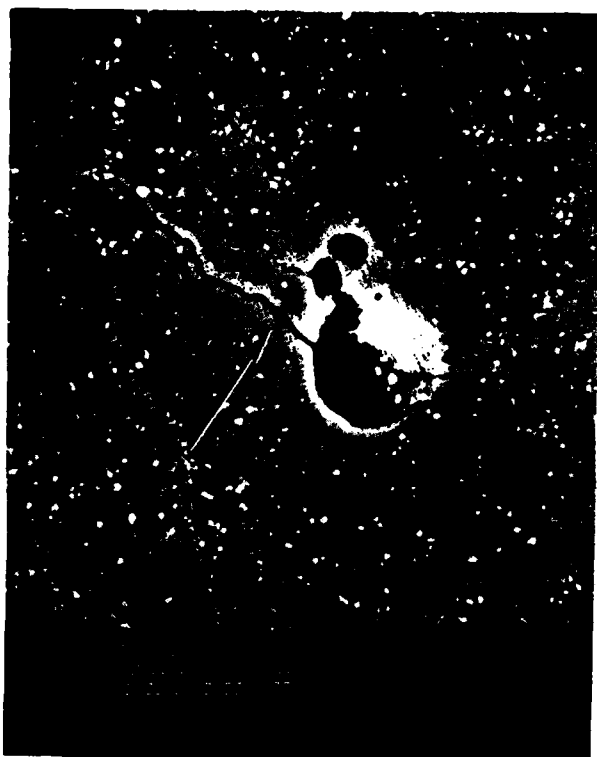
Figure 43. Fatigue Crack Originating at an Internal Cavity in Stage I Mode (Shown by Arrow)

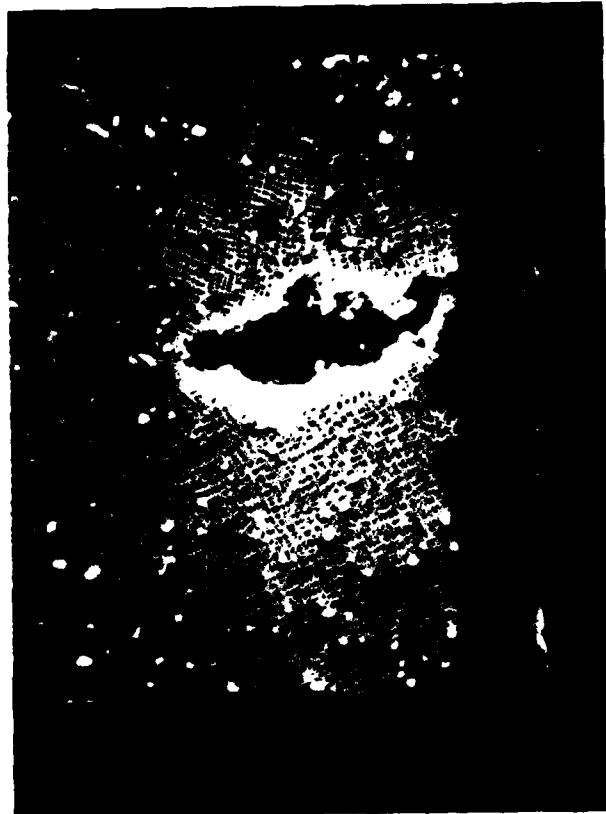
Figure 45. Near-Surface Elongated Cavity Devoid of Crack Initiation

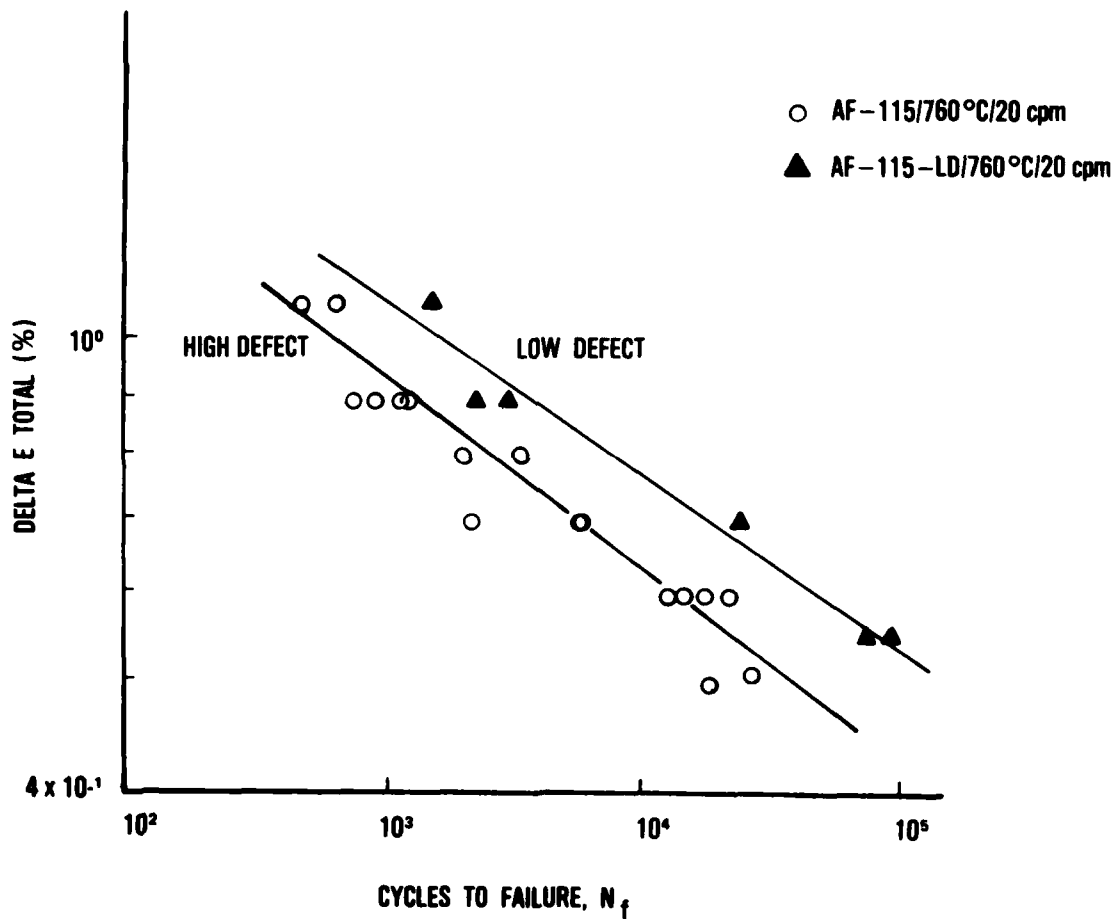
Figure 48. Fatigue Behavior of Low Defect AF-115 Compared to the Primary Heat of AF-115

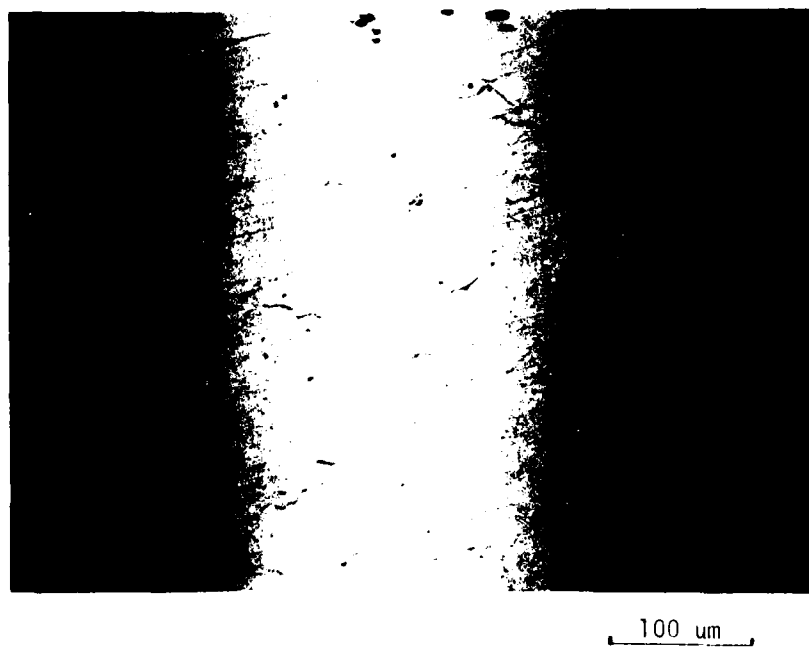
Figure 52. Cracks on the Surface of an AF2-1DA Specimen
Fatigue to 10% of It's Expected Life

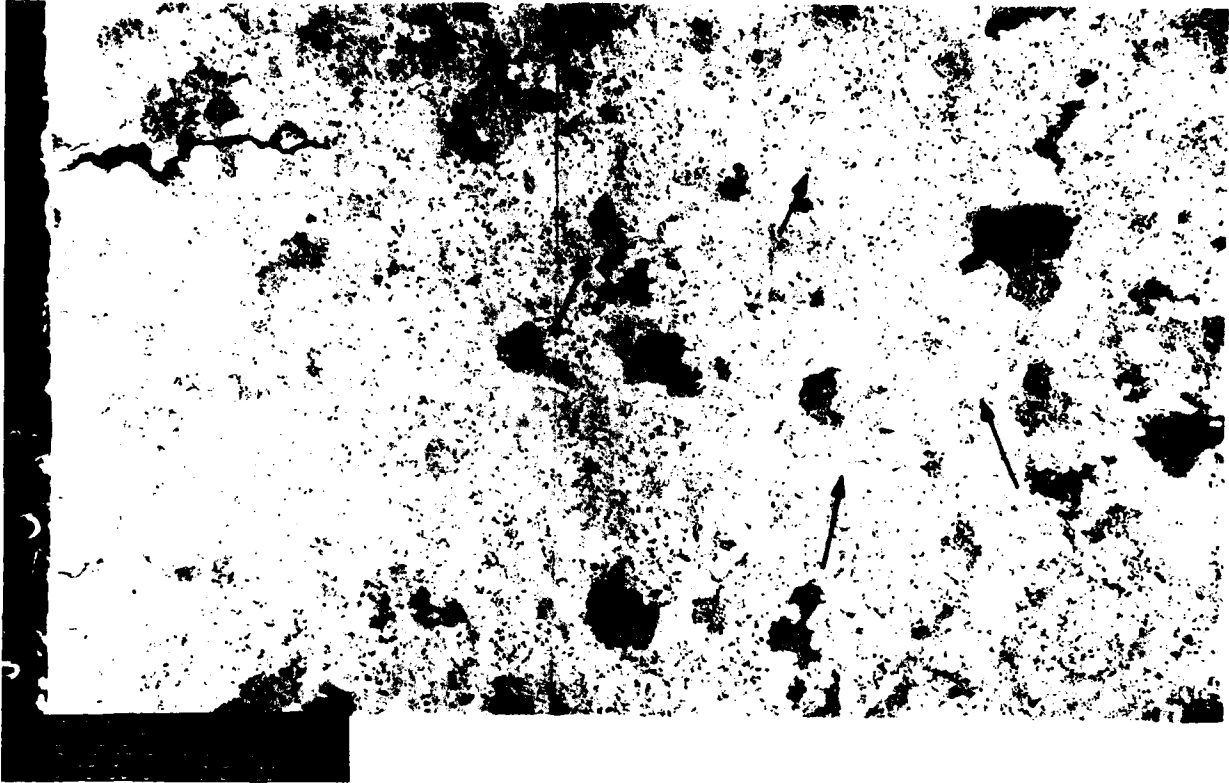
Figure 53. Surface and Internal Cracking in a Tensile Dwell Specimen, Arrows Indicate Some of the Internal Cracks

For the AF-115 alloy, there was a major difference between the initiation mechanism for the continuously cycling tests and tests with a tensile dwell. When a tensile dwell was incorporated in the fatigue cycle, it was found that the process was controlled by the nucleation and growth of intergranular cracks from surface and subsurface locations. Figure 53 shows an example of an AF-115 specimen fatigued under a tensile dwell cycle. Cracks have initiated at the surface, or in some cases at near surface pores, while other cracks have initiated internally well below the specimen's surface. Observations of metallographic sections have shown that cracks initiated internally in two ways; some cracks originated at defects and propagated both transgranularly and intergranularly through the structure, while other cracks nucleated by a creep cavitation process along grain boundaries normal to the tensile stress axis. Figure 54a shows an example of internal cracking

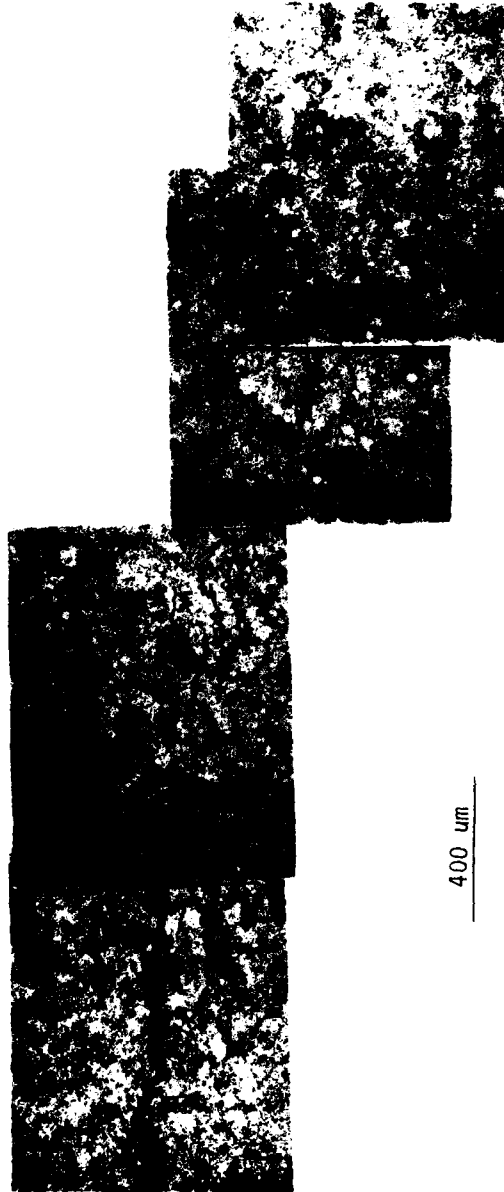
Figure 57. Cross-Sectional View of the Microcarck Link-Up Process in Tensile Dwell Tests

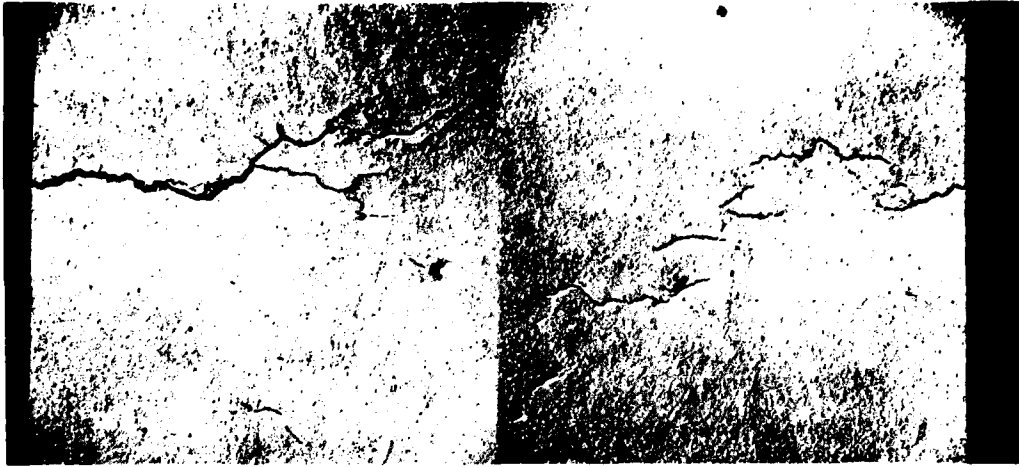
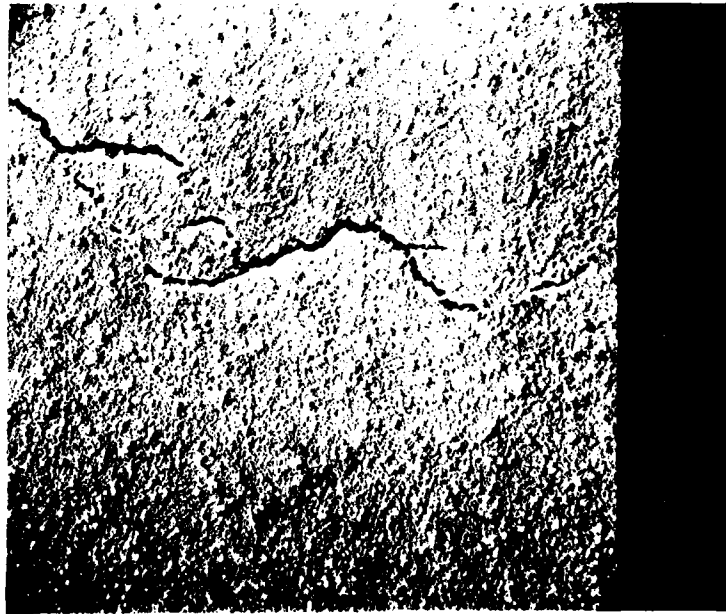
Figure 58. a) Multiple Crack Initiation Ahead of a Major Surface Crack; b) Microcrack in this Cluster Apparently Free of Surface Oxide

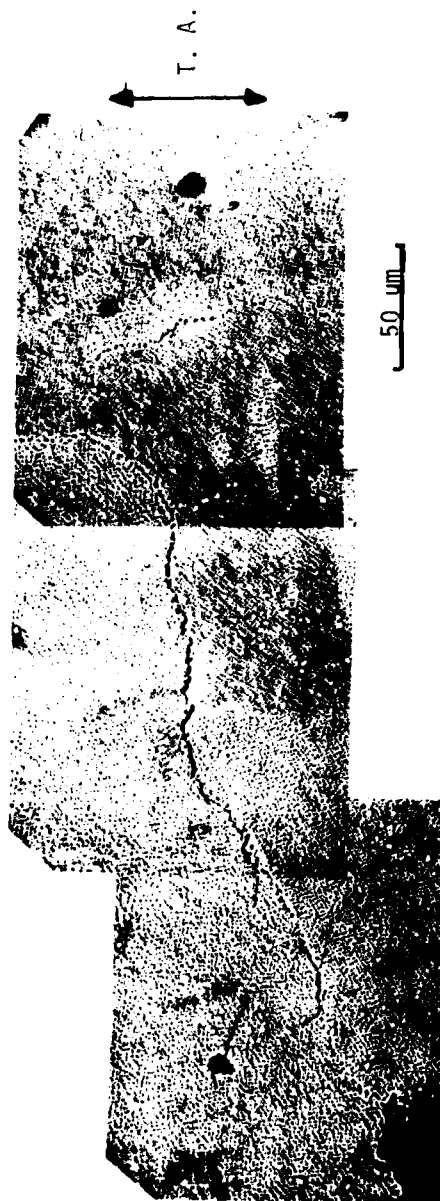
Figure 59. Internal Grain Boundary Cracking in an AF2-IDA Tensile Dwell Test, Tensile Axis (T.A.) as Shown

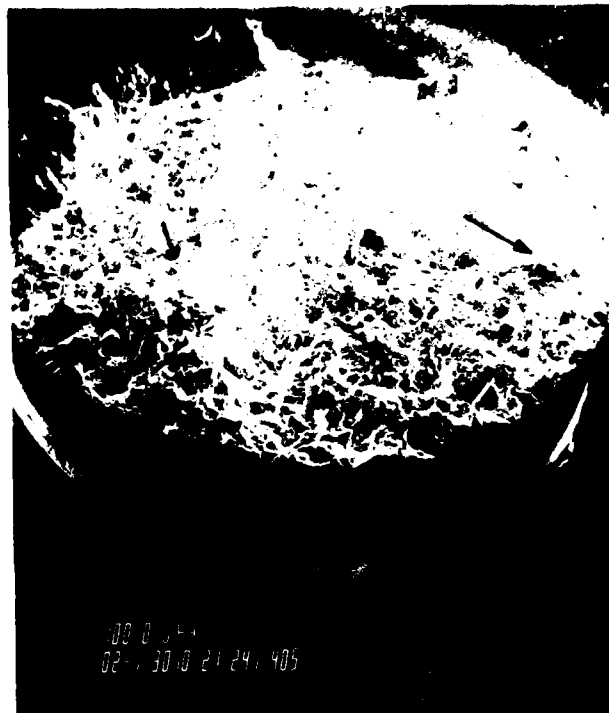
Figure 61. Fracture Surface of an AF2-1DA Tensile Dwell Test with Regions of Internal Crack Initiation

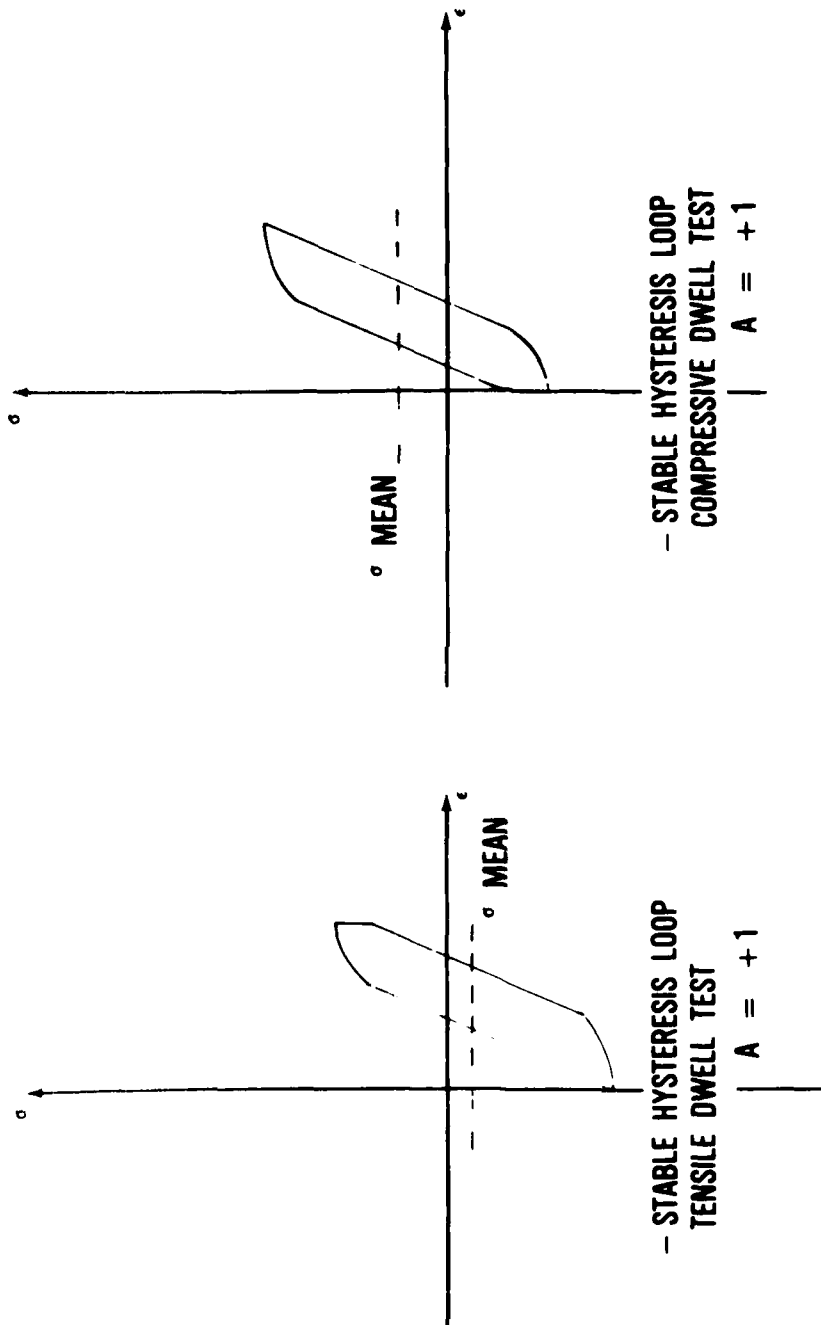
Figure 63. Schematic Illustration of the Stress Biases in Stable Hysteresis Loops of a) Tensile and b) Compressive Dwell Tests

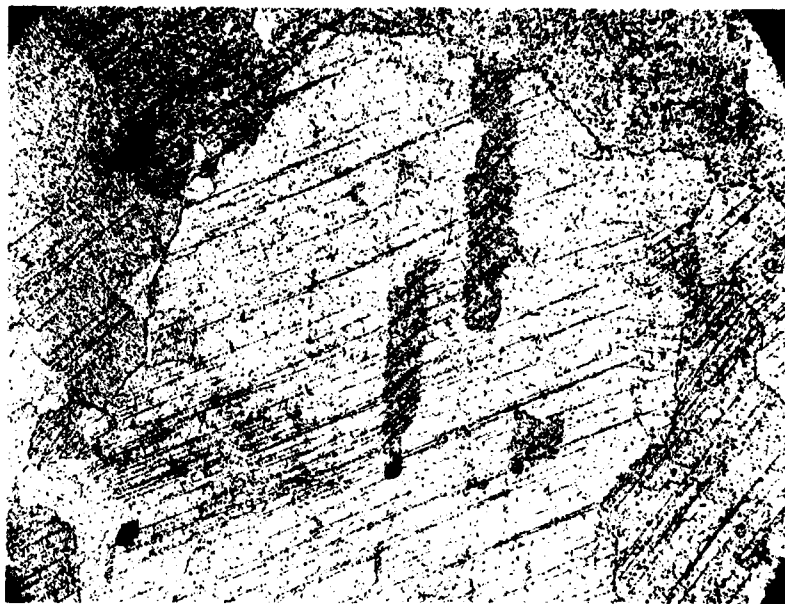
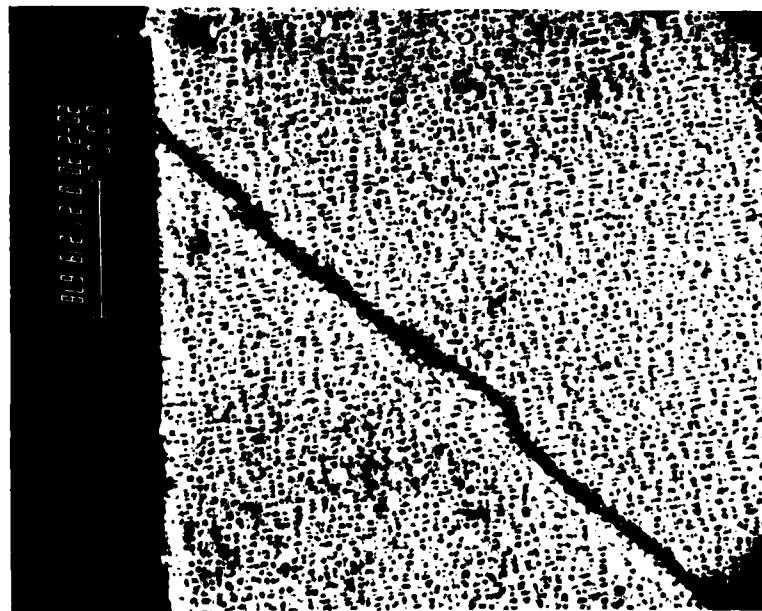
Figure 65. a) Optical Micrograph of Stage I Surface Cracking;
b) SEM Micrograph of the Middle Crack in the
Figure Above

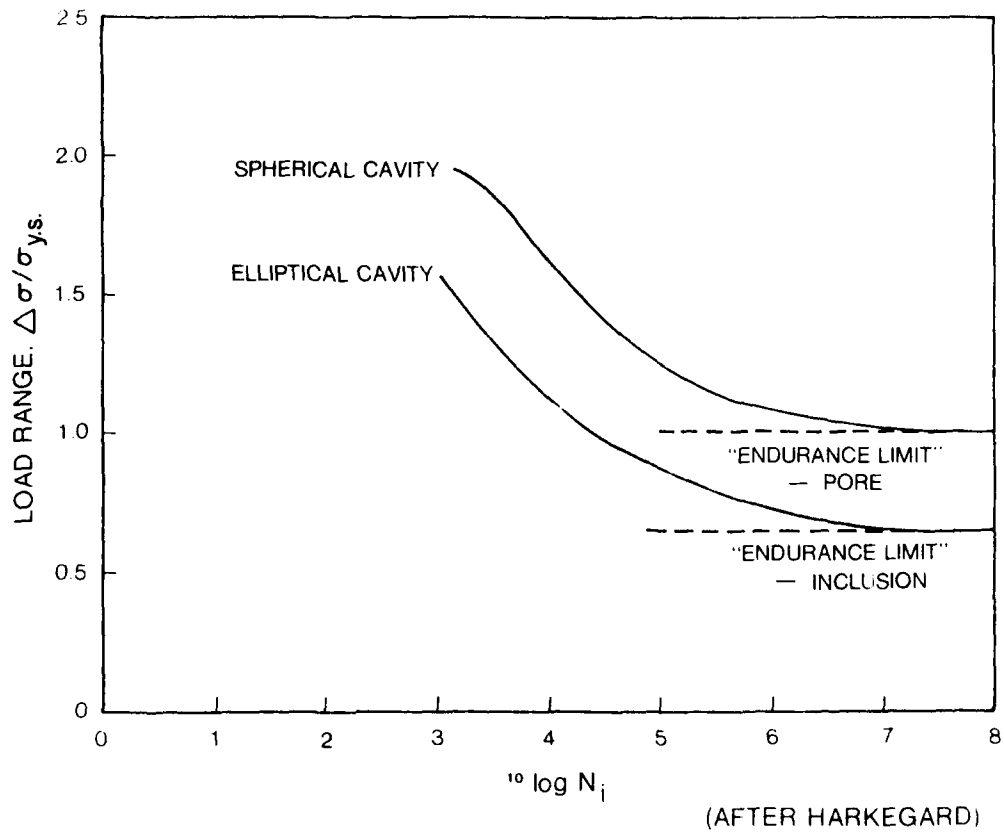
Figure 81. Crack Initiation Life Versus Normalized Stress Range (Harkegard, Reference 65)

Although these quantitative results are not expected to apply directly to the superalloys under study, the importance of Harkegard's work is that it has shown that the magnitude of the localized plastic strain concentration at a defect in an elastic-plastic body is a function of the defect geometry and the far-field stress range, and when the plastic strain concentration at the defect is less than some critical value, crack initiation will not occur. For AF-115, then, these results would predict that at high stress ranges cracking would occur at both inclusions and pores, but as the stress range is reduced there would be a stress level at which cracks would no longer initiate at pores although they would still nucleate at the more acute inclusions. This, of course, is in agreement with the experimental observations reported earlier, where secondary cracking in AF-115 at pores both near the surface and in the specimen's interior was shown to terminate at the same stress range as the SST was observed.

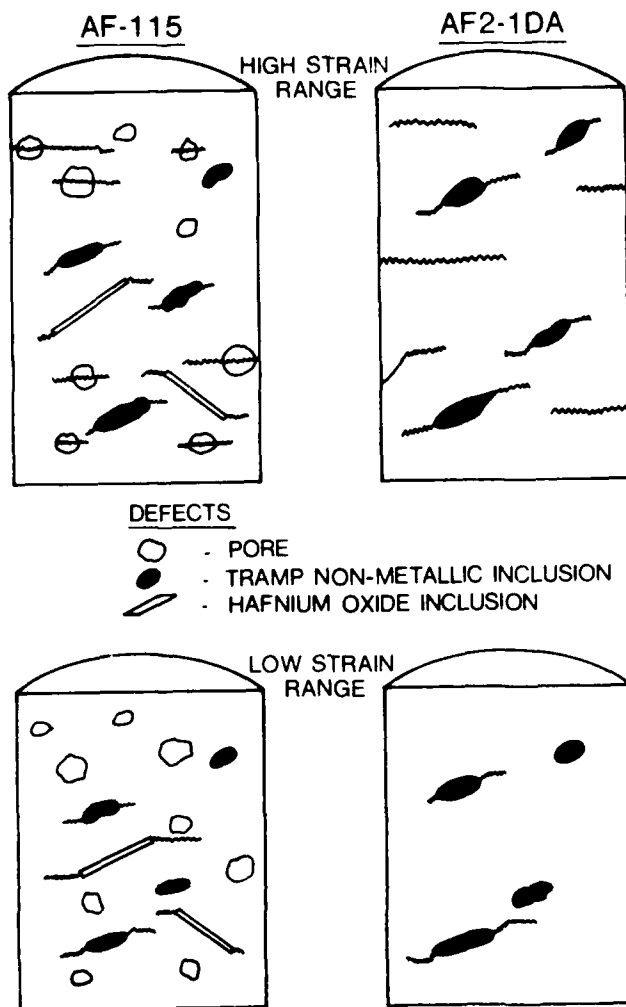
Figure 82. Summary of the Observations of Secondary Cracking in AF-115 and AF2-1DA at Elevated Temperature
