THE EFFECT OF DEFECTS ON THE FATIGUE INITIATION
PROCESS IN TWO P/M SUPERALLOYS

Jack M. Hyzak, Capt, USAF
Metals Behavior Branch
Metals and Ceramics Division

TECHNICAL REPORT AFWAL-TR-80-4063

Final Report for Period November 1977 - November 1979

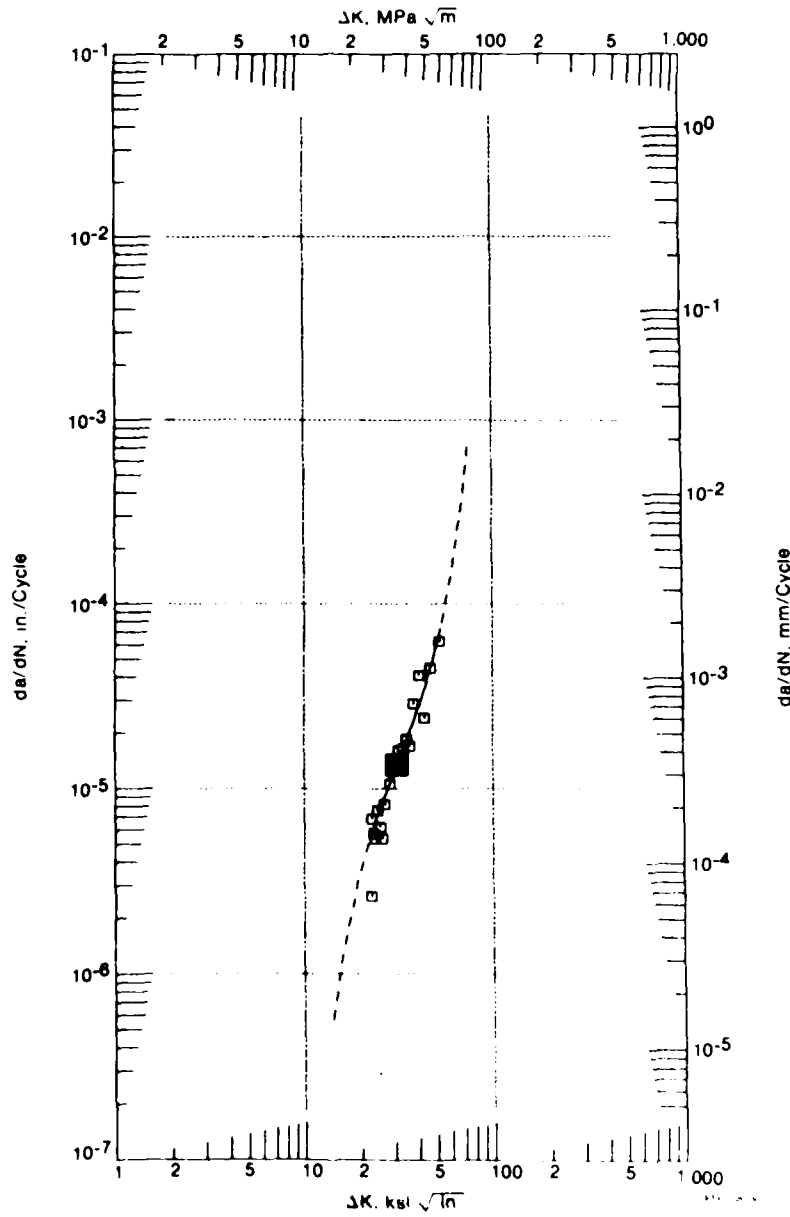
Figure 83. Crack Growth Data for AF2-1DA at 649°C, 0.17 Hz, A = 0.82 (R = 0.1) (Reference 126)

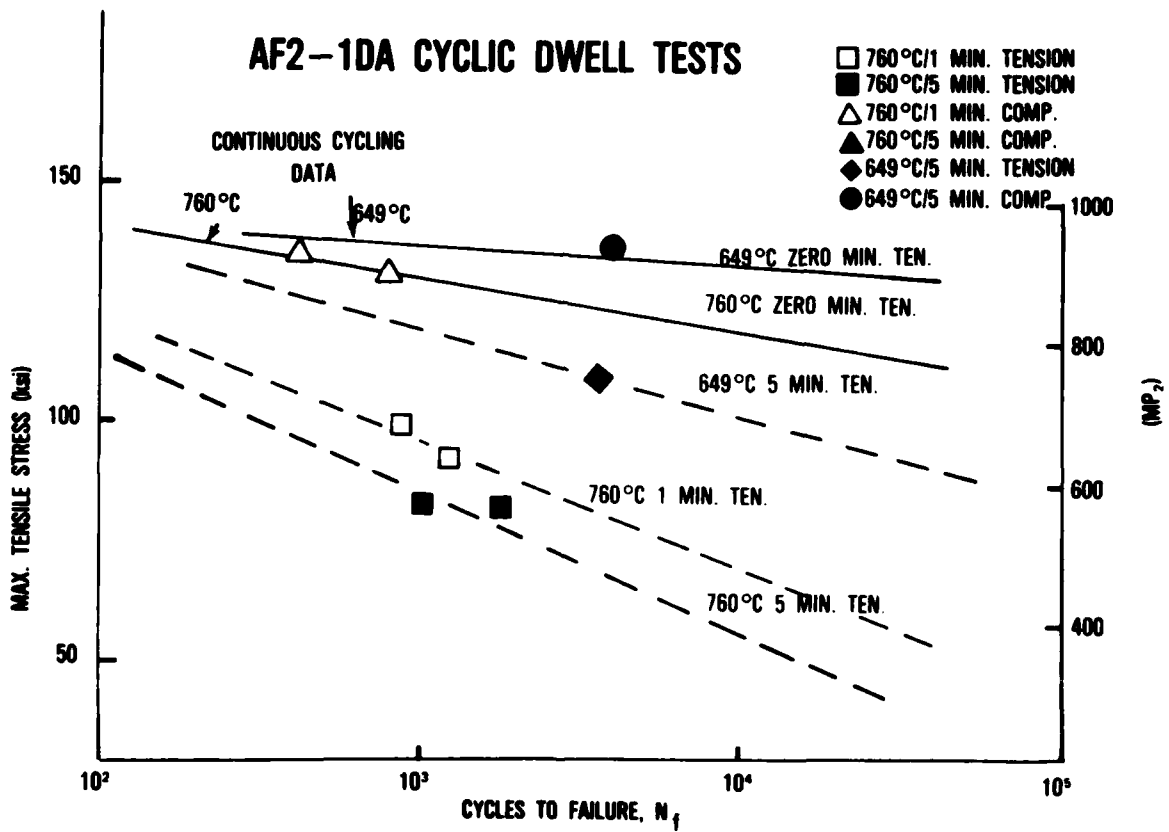
Figure 85. AF2-1DA Cyclic Dwell Data Plotted as Maximum Tensile Stress Versus Cycles to Failure

To better illustrate the effect of dwell periods on the crack initiation phase of the fatigue life, the data in Figures 19 and 21 have been replotted in Figures 85 and 86 as maximum tensile stress versus cycles to failure. Comparing the tests at the same value of maximum tensile stress has the effect of eliminating much of the difference in life due to crack propagation. Figures 85 and 86 show the data plotted in this manner along with the best fit lines for the 760°C and 649°C continuously cycling tests at 20 cpm; at this frequency the occurrence of creep damage was suppressed. When presented in this form the data are more easily understood; the graphs show that at a fixed temperature the fatigue lives decreased as the tensile dwell period increased, and, therefore, exposure to creep damage is shown to reduce the fatigue life, as expected. It can also be seen in Figure 85 that the five minute tensile dwell test at 649°C had a shorter life than the 20 cpm creep-free tests, but that the reduction in life was small compared to that of the five minute tensile dwell test at 760°C. This result, of course, would be expected since creep is a thermally activated process, and

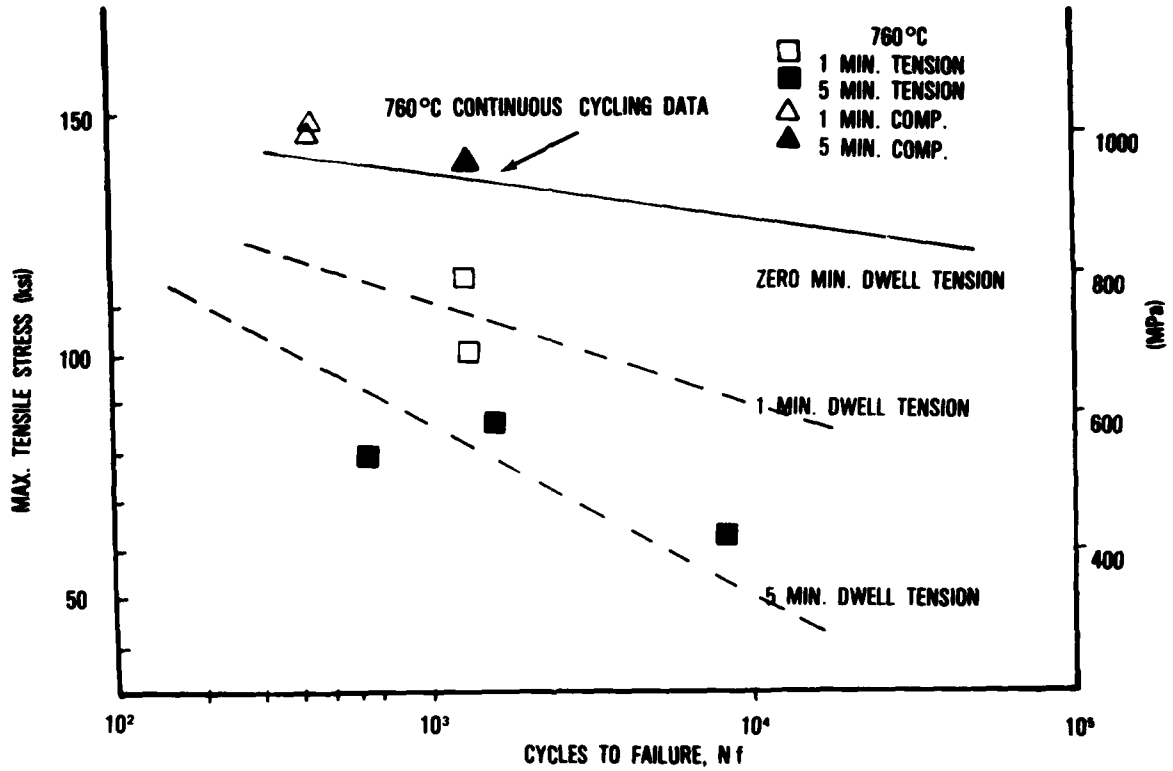
Figure 86. AF-115 Cyclic Dwell Data Plotted as Maximum Tensile Stress Versus Cycles to Failure

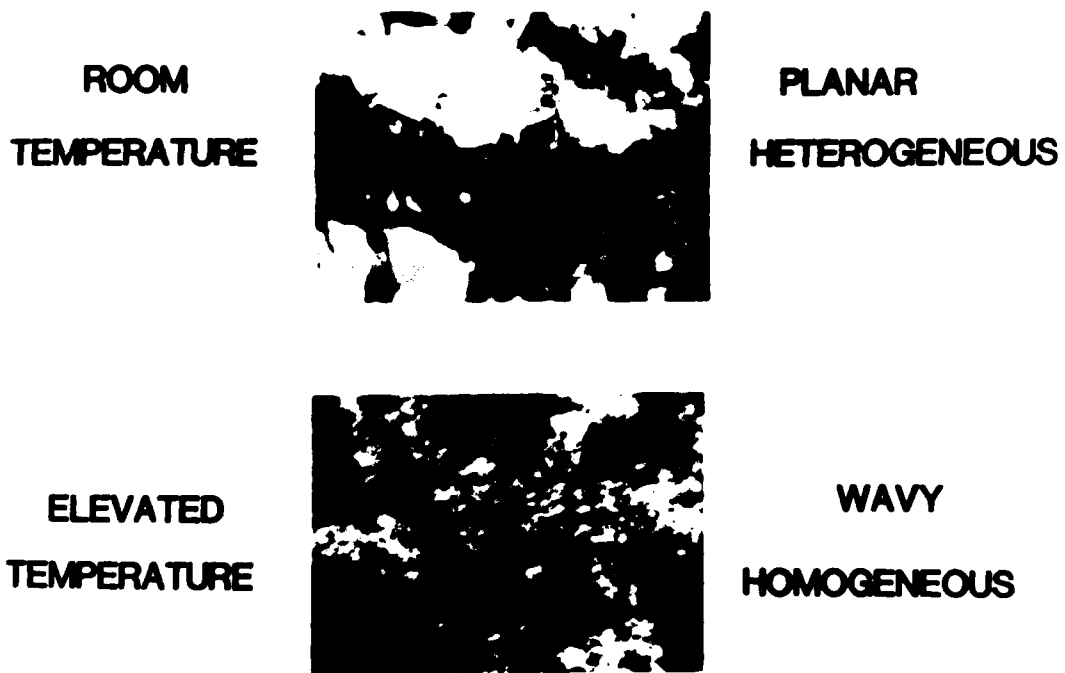
Figure 88. Change in Slip Behavior with Temperature a) Planar Slip at Room Temperature; b) Wavy Slip at Elevated Temperature

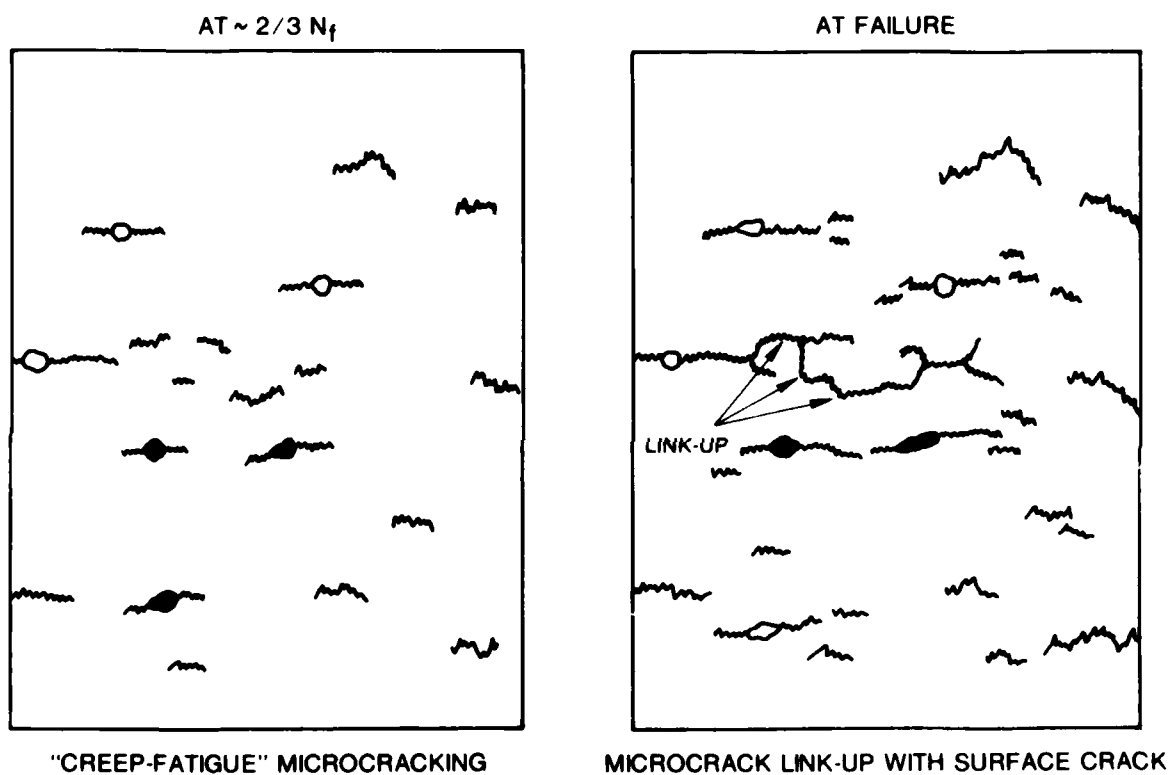
Figure 89. Schematic Illustration of the Failure Process in Tensile Dwell Tests, Microcrack Initiation and Link-Up
