TECHNICAL REPORT M-283
November 1980

PAVEMENT EVALUATION AND
REPAIR RECOMMENDATION
SIERRA ARMY DEPOT, AMEDEE AIR STRIP

M. Y. Shahin

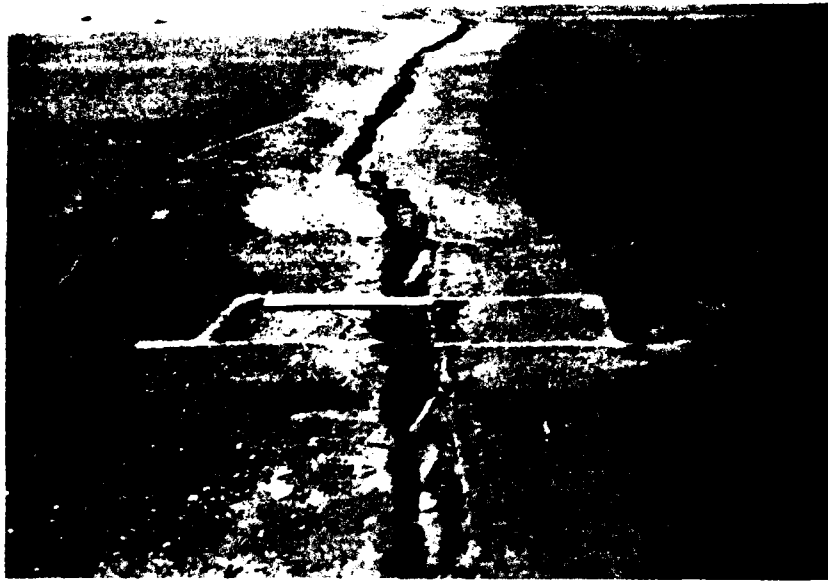
Figure 7. Cut #1.

Cut #1 (Figure 7) was across a 4-inch-wide crack extending through the full depth of the top AC surface. There was no evidence of the crack in the base or on the old AC surface below.

(a) Pavement before cut showing 4-inch wide crack.

(b) Pavement after cut showing crack to extend through the full depth of the top AC surface.

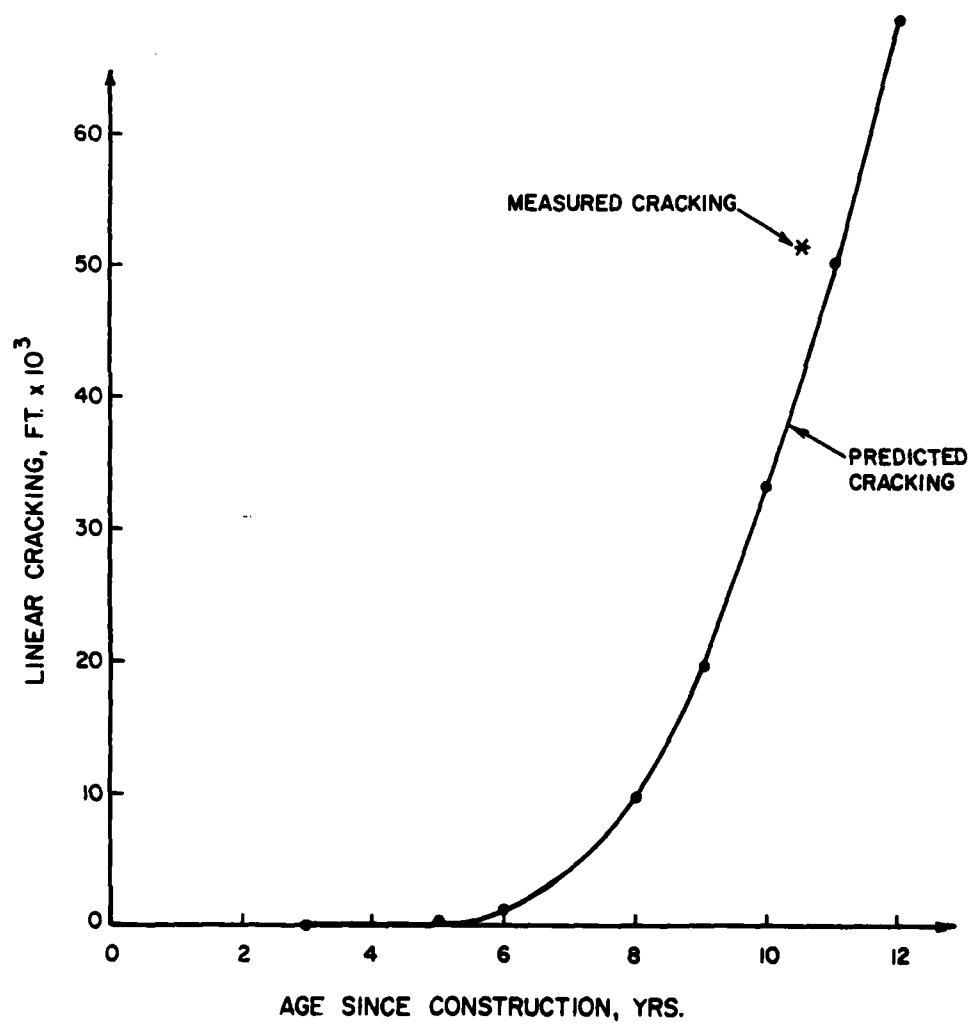
a function of the AC mixture properties and climatic factors. Figure 11 shows the input to the program. Figure 12 is a plot of cracking versus age as predicted from the program. As shown in the figure, there is a close agreement between the measured and predicted amounts of cracking.

Detailed analysis of the program output showed that the cracks are caused by thermal fatigue cracking (resulting from daily temperature cycling) rather than just simple low temperature. The close agreement in prediction is encouraging in that the same program can be used for future mix design and selection of optimum asphalt grade to minimize cracking. It is believed that a careful mix design and careful selection of asphalt grade can increase the pavement life by several years.

Figure 12. Predicted cracking using temperature cracking program.
