Technical Report 587

RESISTANCE OF COATED AND UNCOATED IR WINDOWS TO SEAWATER CORROSION PHASE IV

1 October 1980

Final Report: October 1979-June 1980

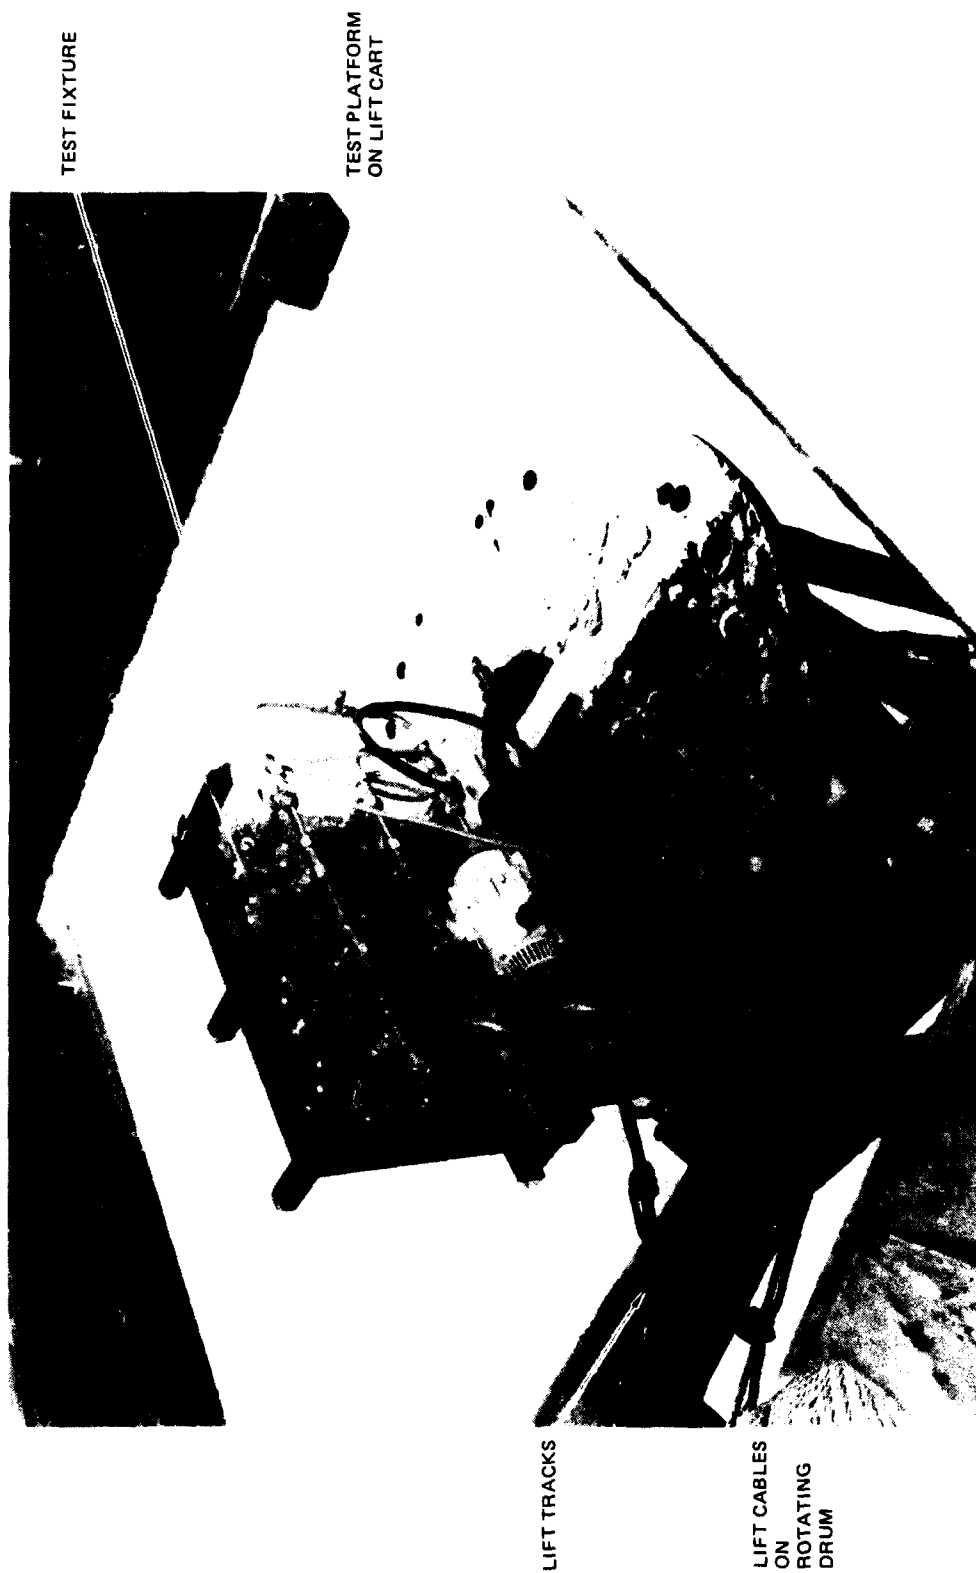
Figure 7. The hydraulic lift platform with the test fixture attached, at the top of the lift tracks.

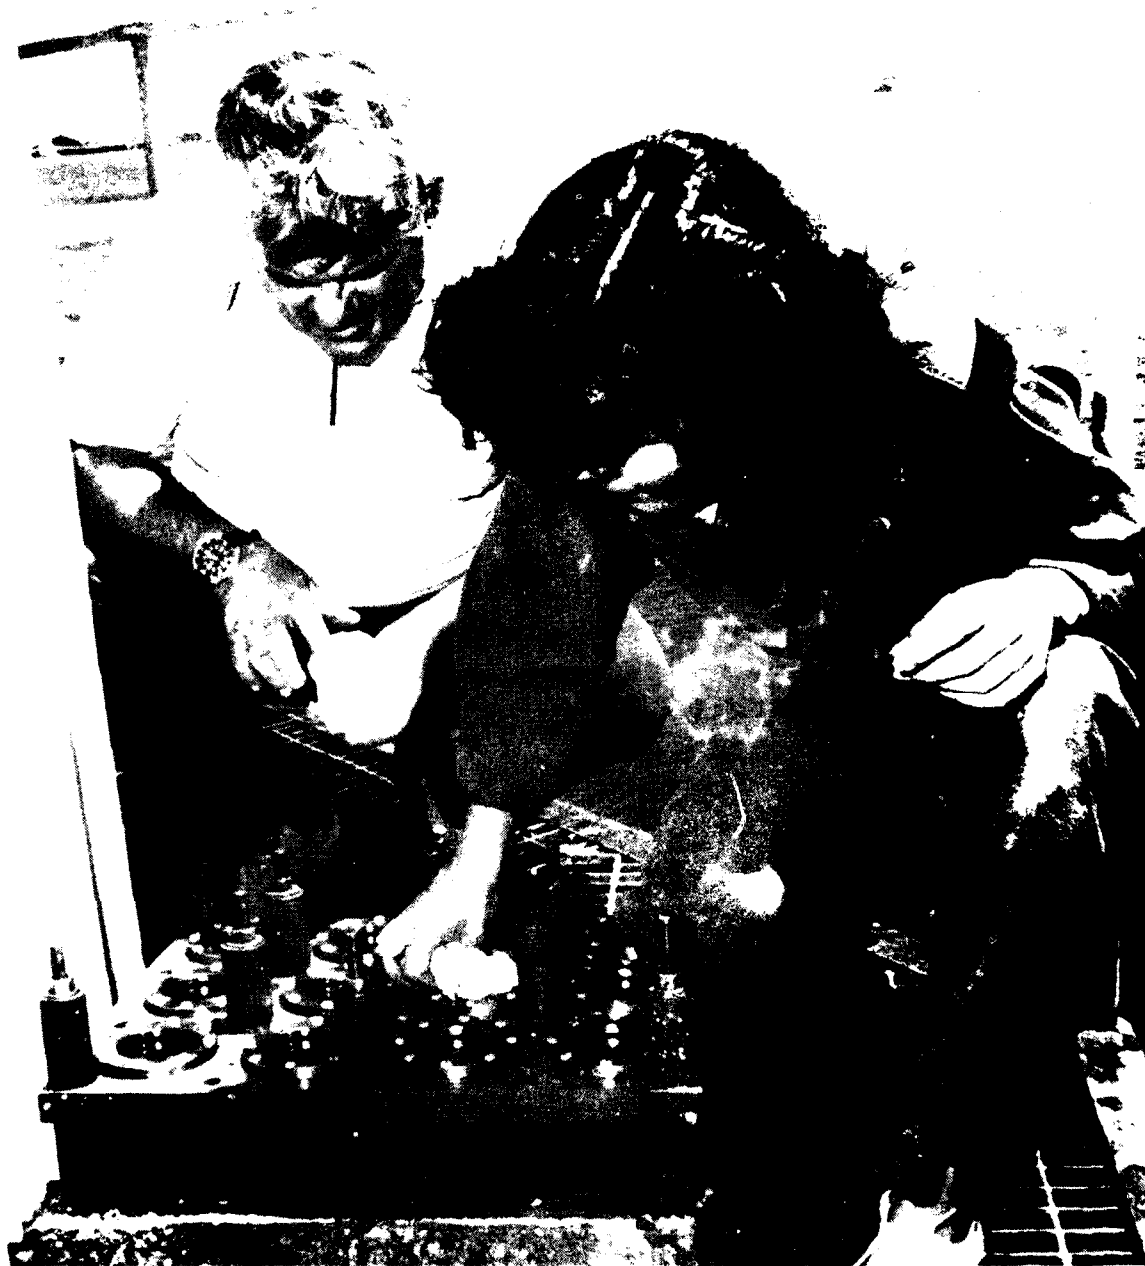
Figure 9. The specimens were periodically removed from the bay and qualitative visual observations were made and recorded.

During the weekly inspections the specimens were not removed from their mountings. These periodic visual inspections focused on the degree of fouling, depth of corrosion pits, and extent of pitting.

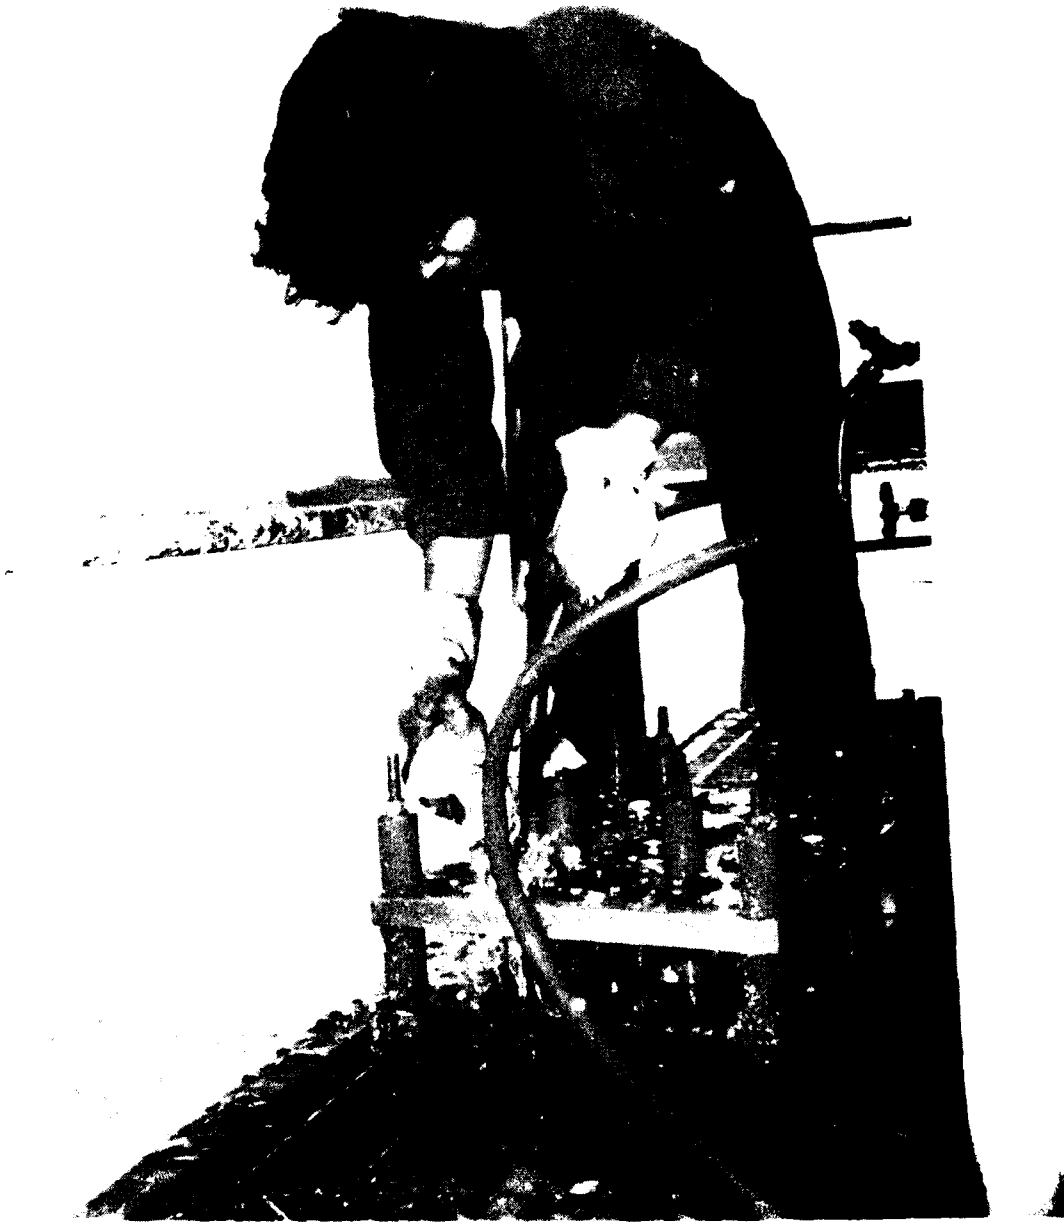
Figure 10. Marine growth was periodically hosed off of the fixtures.

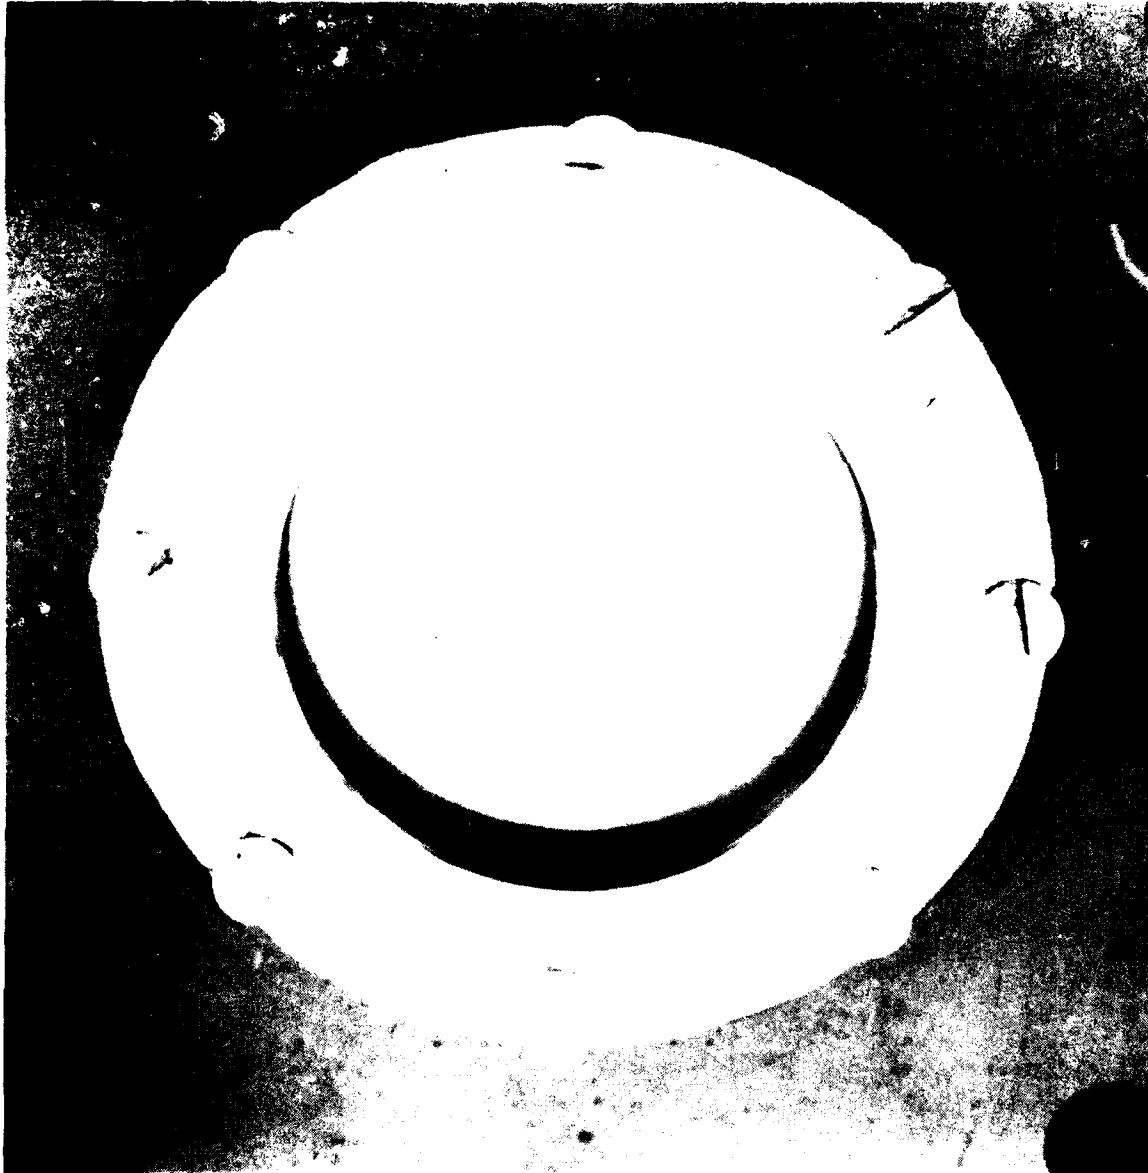
Figure 13. A specimen with the Exotic Materials 40100 AR coating after two months of testing in San Diego Bay.

Showing some minor signs of deterioration, yet still in an outstanding condition after the four-month testing period, were the two germanium specimens protected by multilayer antireflective EM 40100 coating. These specimens had developed some minor pinpoint pitting by the end of the second month, each having approximately one dozen fine pits by that time (figure 13). Only a very slight increase in pitting occurred in the final two months, culminating in several dozen very shallow (≤ 0.001 -inch) pits per specimen. There was no discoloration of the coating (figure 14.)

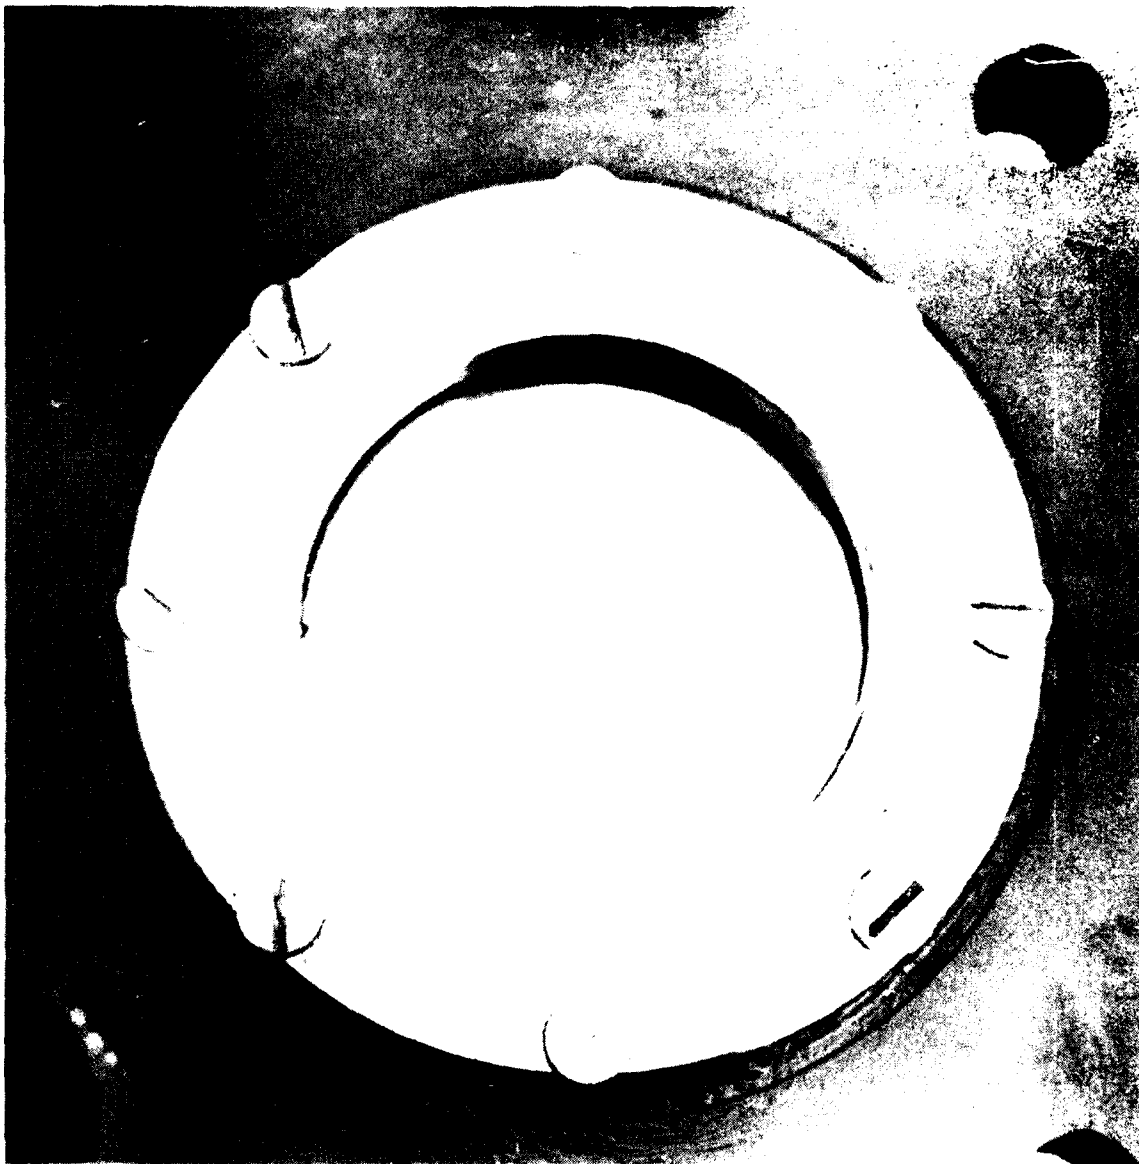
Figure 15. A specimen with the Optic Electronic XF 202 AR coating after two months of testing in San Diego Bay.

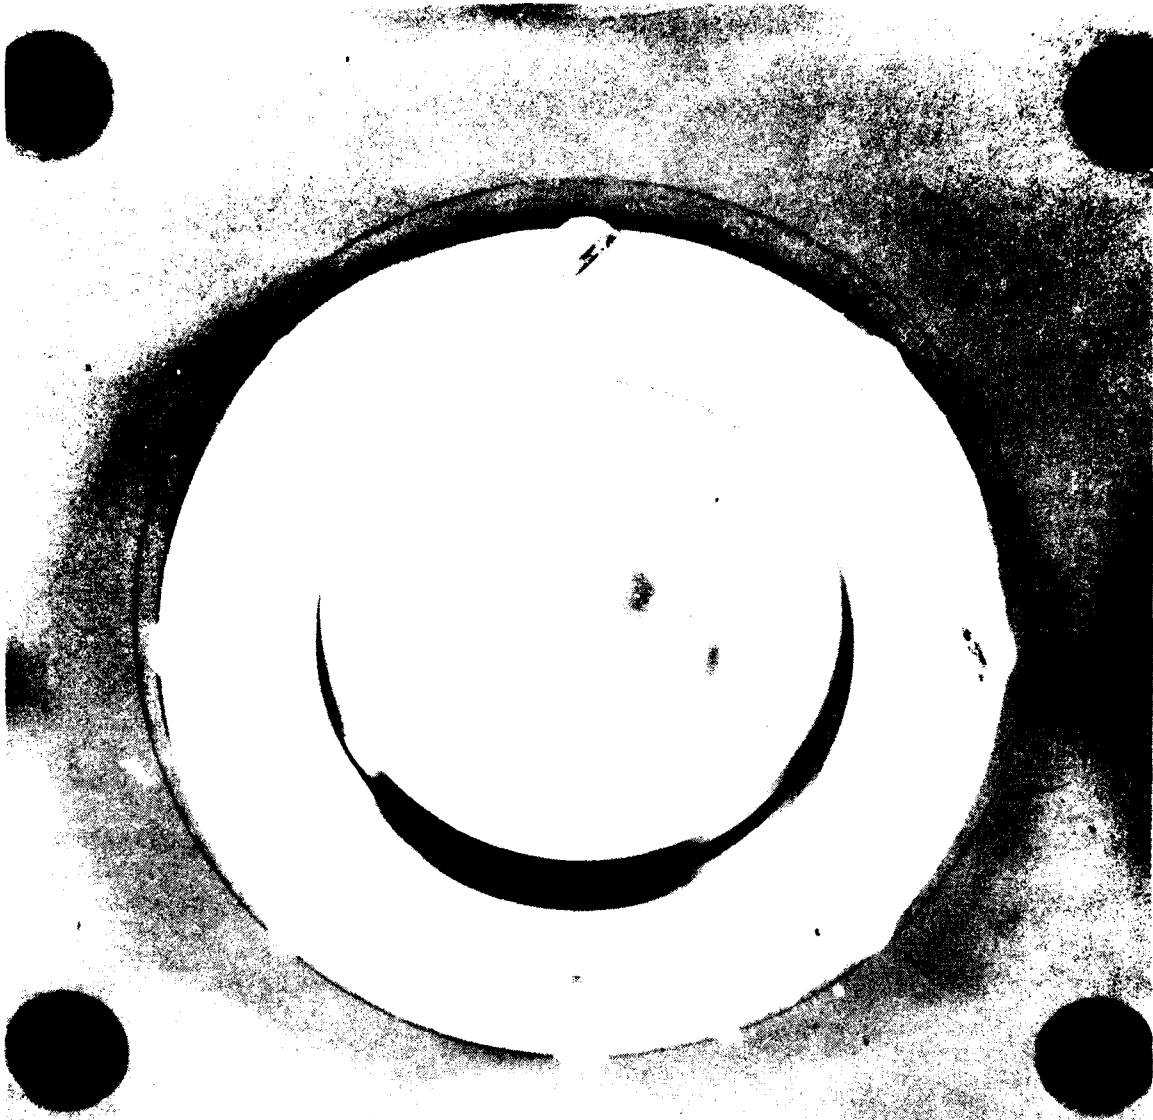
Figure 18. A specimen with the Optic Electronic XF 203 AR coating after four months of testing in San Diego Bay.

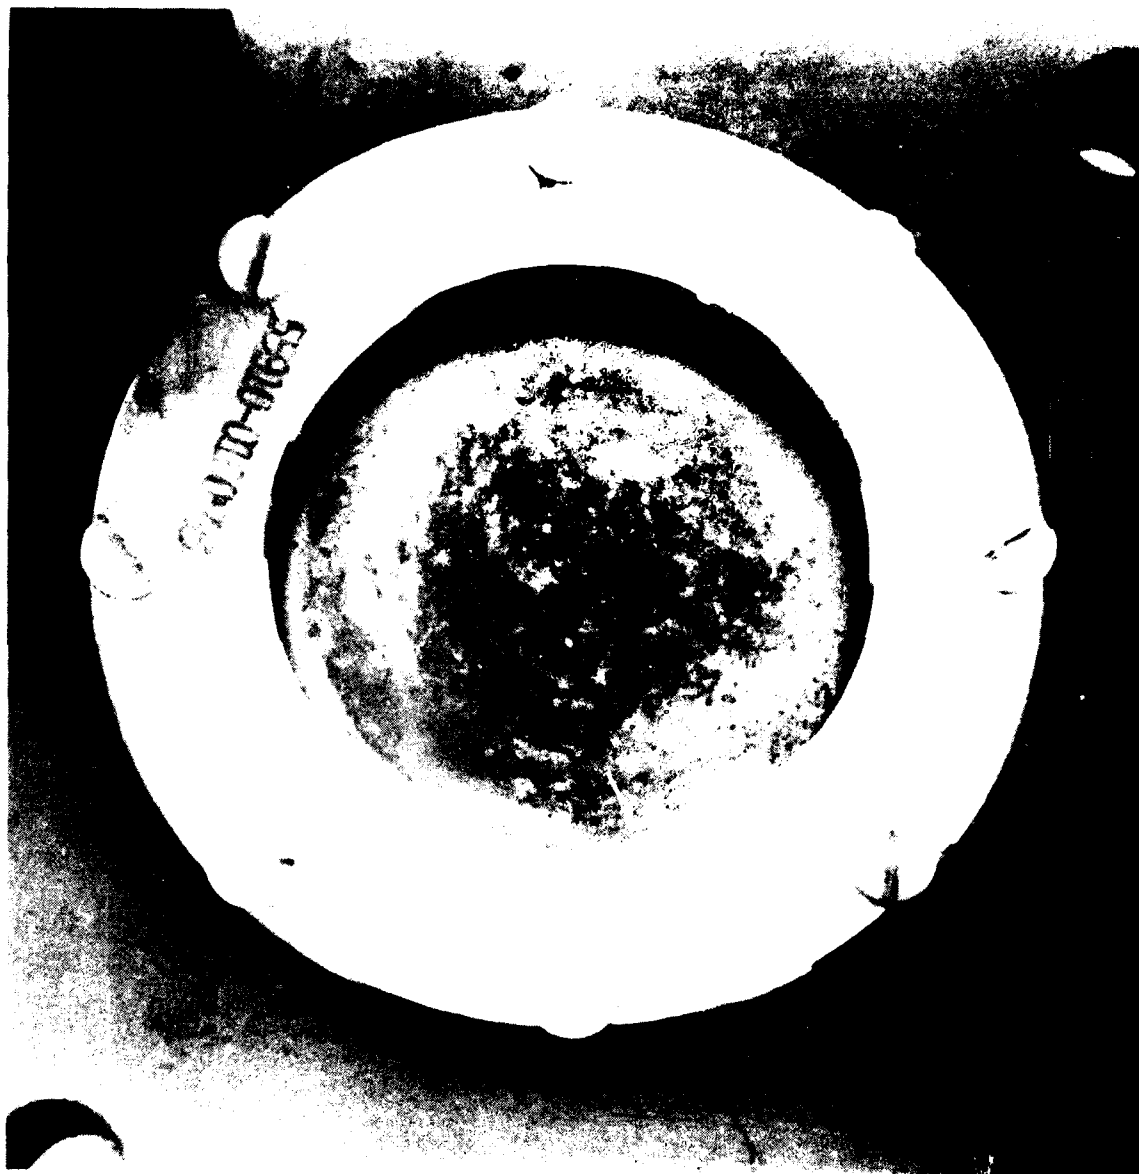
Figure 21. A specimen with the Optic Electronic XF 205 AR coating after two months of testing in San Diego Bay.

The two specimens with the Optic Electronic XF 205 coating were also discolored. They started to discolor within the first month near the centers of the specimens, and discoloration continued into the second month (figure 21). By the end of the third month, one of the specimens had a couple of pinpoint pits starting, and by the end of the testing period the specimens were discolored over 85 to 100 percent of their surfaces, and one of them had three or four small pits (figure 22).

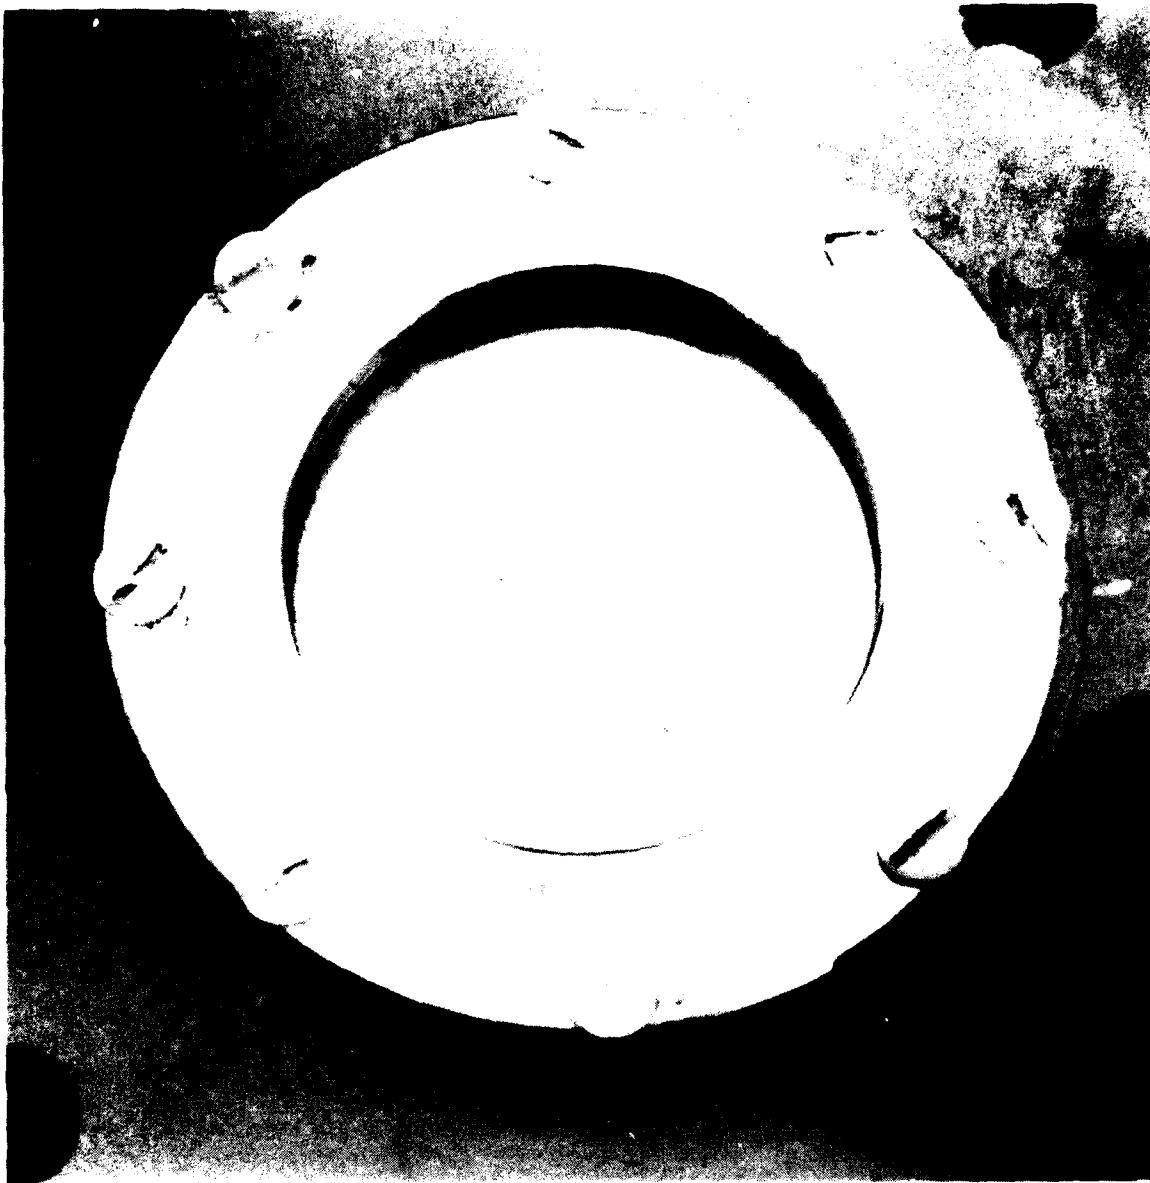
Figure 23. A specimen with the Optic Electronic XF 204 AR coating after two months of testing in San Diego Bay.

The specimen exhibiting the poorest resistance to seawater corrosion was the one coated with Optic Electronic XF 204. The specimen began to discolor shortly after the first month of testing, and by the second month of testing there was extensive pinpoint pitting on the surface (figure 23). By the end of the testing period the specimen had more than 400 craters, the deepest approximately 0.030 inch. This specimen also was discolored over about 50 percent of its surface (figure 24).
