USAAEFA PROJECT NO. 78-09

**PRELIMINARY AIRWORTHINESS
EVALUATION OH-58C HELICOPTER WITH
A MAST MOUNTED SIGHT**

FINAL REPORT

UNITED STATES ARMY AVIATION ENGINEERING FLIGHT ACTIVITY
EDWARDS AIR FORCE BASE, CALIFORNIA 93523

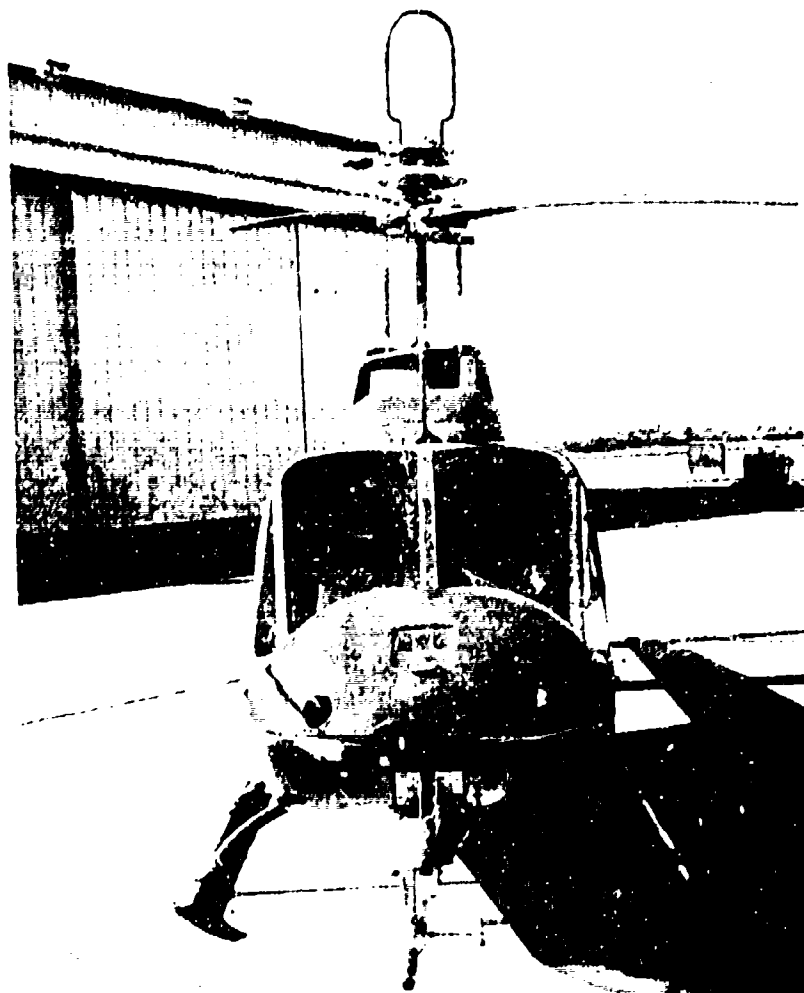
Photo 2. Dummy Mast Mounted Sight

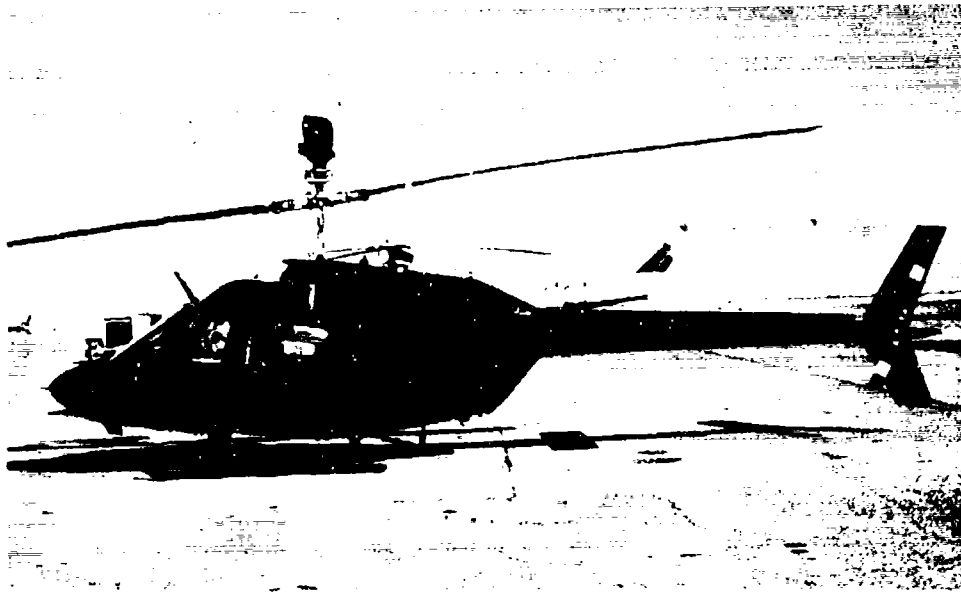
Photo 3. Rockwell International Mast Mounted Sight

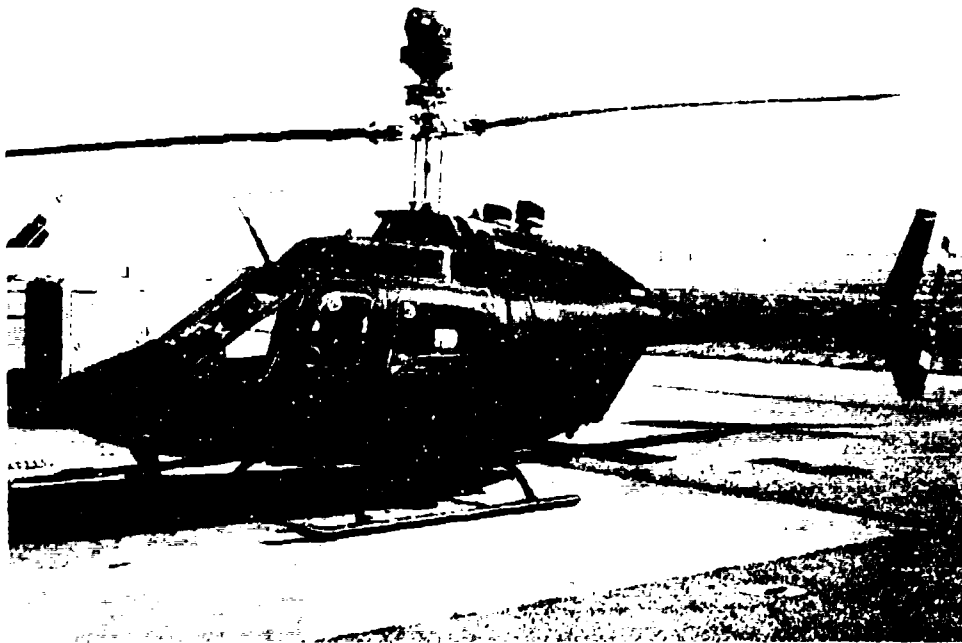
Photo 4. Rockwell International Mast Mounted Sight
