PROCEEDINGS OF THE THIRD SYMPOSIUM ON NONDESTRUCTIVE TESTING OF TIRES

Sponsored by
ARMY MATERIALS AND MECHANICS RESEARCH CENTER
Watertown, Massachusetts 02172

27-29 January 1976

The Holiday Inn Cascade, Akron, Ohio

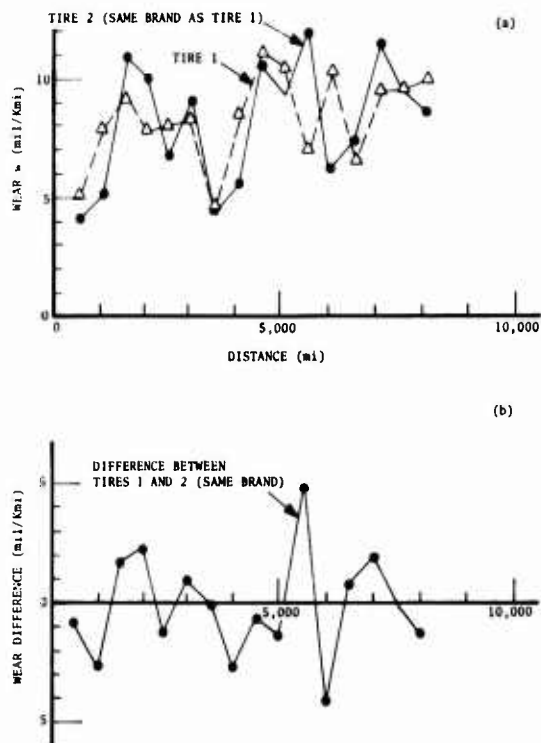
Figure 1. Results of road wear tests (from ref. 1).

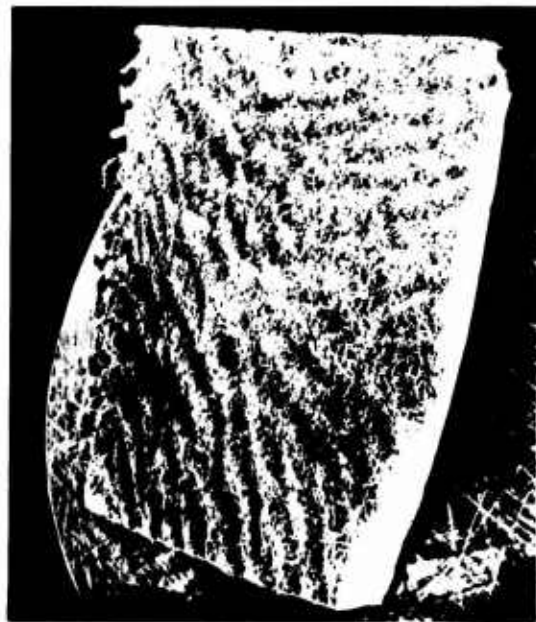
Figure 35. Scanning electron microscope photo (12X) of tread surface.

Test Condition: TIRF
 $\alpha = \pm 1^\circ$ (sinusoidal, 0.1 Hz)
 Tire Brand M

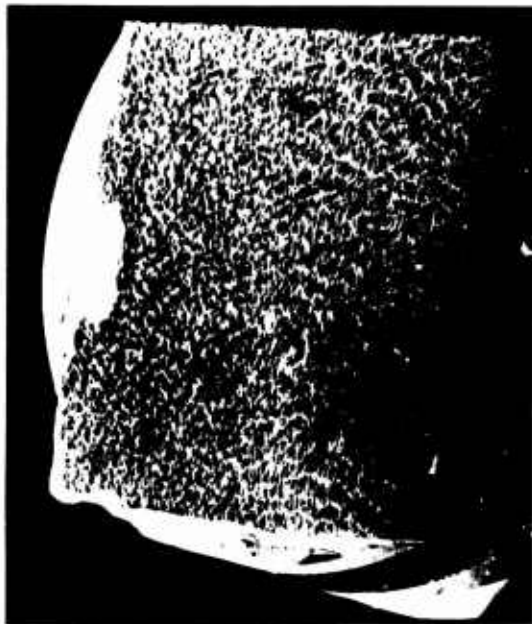
Figure 36. Scanning electron microscope photo (12X) of tread surface.

Test Condition: Tirt
Straight Braking (-100 ft/lb)
Tire Brand M

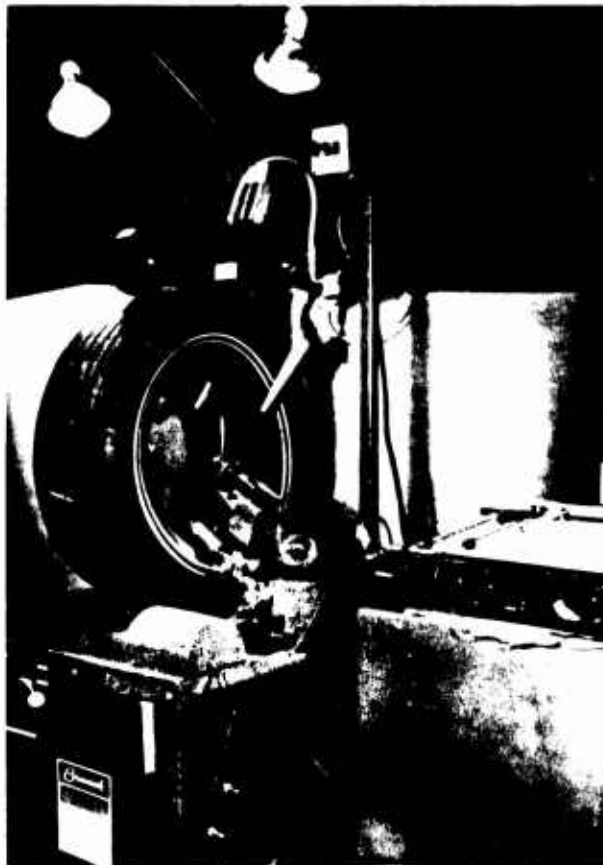
FIGURE 1
AN AUTOMATIC TIRE INSPECTION MACHINE WITH
A BEAD-INSPECTION ADAPTER (BIA) ATTACHED
TO THE SPREADER ARM

The basic feature of the BIA is a displacement transducer which is spring loaded against the spreader arm of the tire inspection machine. Tire beads are inspected as follows: A tire is placed in the machine and the spreader arms are positioned so that their rollers are in contact with the inside edge of the bead. The arms are then spread by means of a pneumatic cylinder and mechanical linkage assembly. Attached to the arm is a displacement transducer which converts the displacement of the spreader arm into an electrical signal. A photograph of this BIA is shown in Figure 2. As the tire is rotated by the motor-driven cylindrical drums of the tire inspection machine, a continuous record of the displacement is displayed on an x-y plotter. One axis of the recorded graph represents the relative displacement of the transducer, while the other represents the position around the circumference of the tire bead.

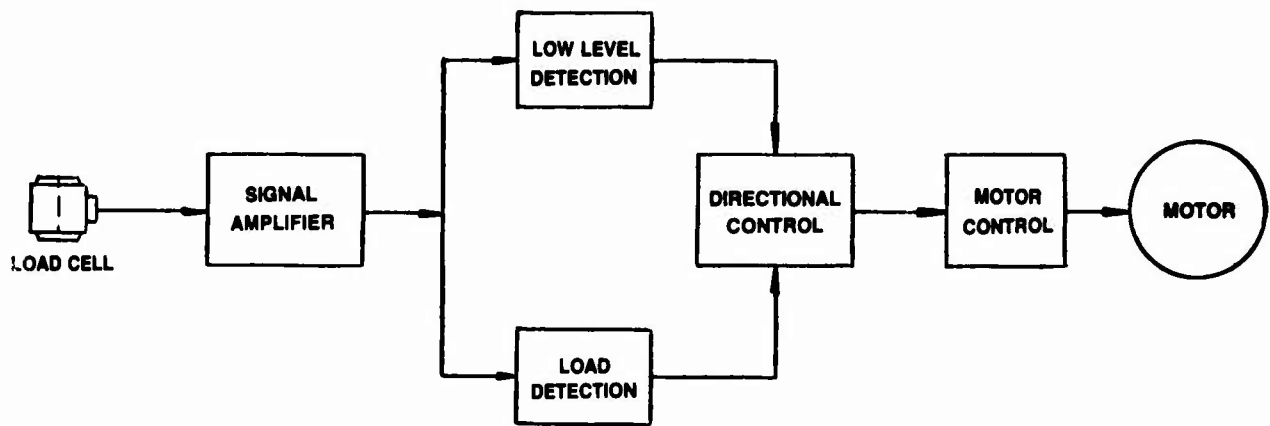
FIGURE 17
FUNCTIONAL BLOCK DIAGRAM

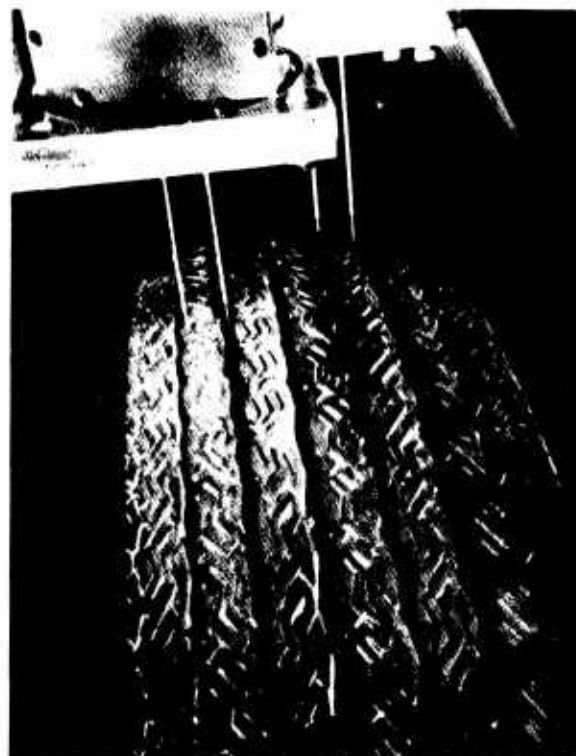
FIGURE 4
LVDT MECHANICAL PROBES
IN CONTACT WITH TIRE

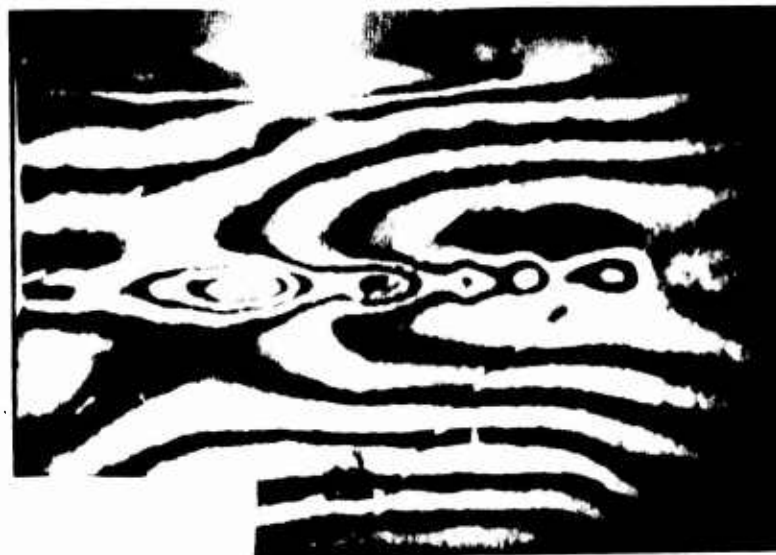
FIGURE 27
Porosity in Center Crown Region
