MML-TR-81-6c

THE DELAYED FRACTURE OF ALUMINUM ALLOYS

January 1981

4. TITLE (and Subtitle) THE DELAYED FRACTURE OF ALUMINUM ALLOYS, End of Year Report		5. TYPE OF REPORT & PERIOD COVERED End of year report (Jan. 1, 1980 to Dec. 31, 1980)

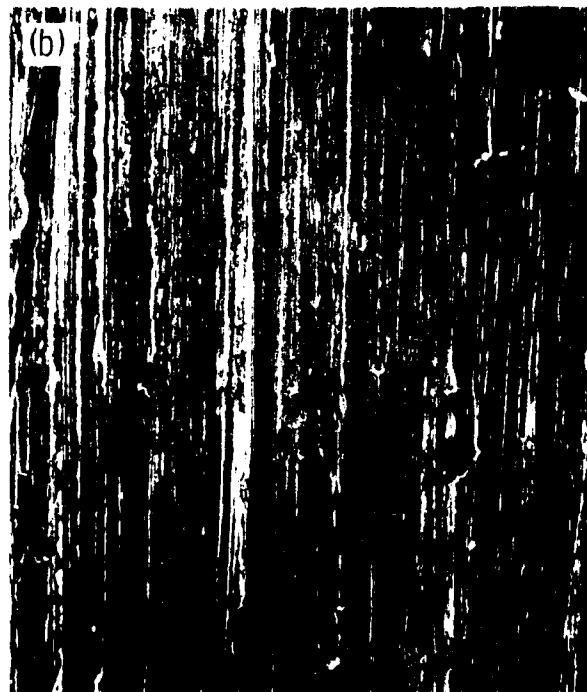
Figure 12. Scanning electron micrographs of (a) thermal oxide, and (b) TAA oxide. (Magnification 2,000x.)

The thermal film was quite porous (see Fig. 12a), having pores on the order of 2 μm in diameter, spaced about 10 μm apart. This porosity is probably caused by Mg evaporation that occurs during solution-heat treatment. In contrast, the TAA film was essentially pore free (Fig. 12b). At very high magnification, the TAA film appears to have fine porosity (see Fig. 13). However, a section including the profile of the TAA oxide reveals that pores are not present. The TAA film is wavy (Fig. 6), almost sinusoidal, and the downward undulations in the film look like pores when viewed normal to the surface. The thickness of the film is fairly constant.

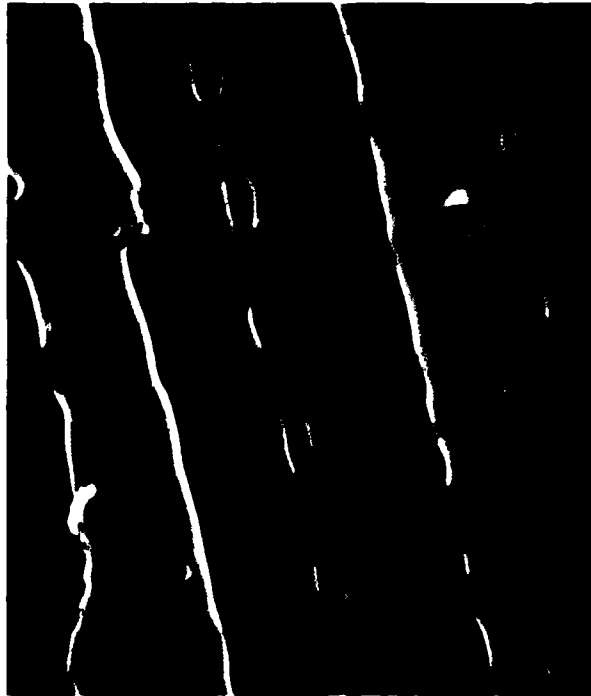
Figure 13. High magnification scanning electron micrograph of TAA oxide showing undulation in the film (compare with Fig. 6). (Magnification 50,000x.)

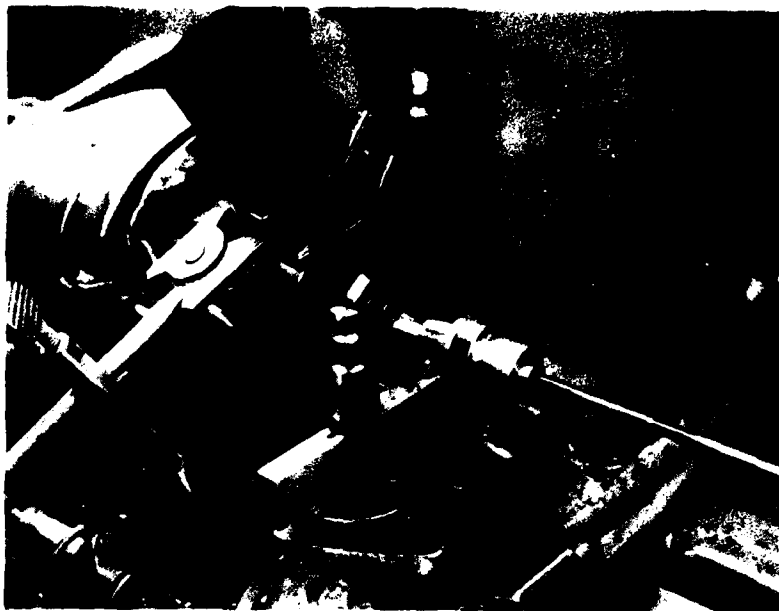
Figure 17. Mode III precracking apparatus.

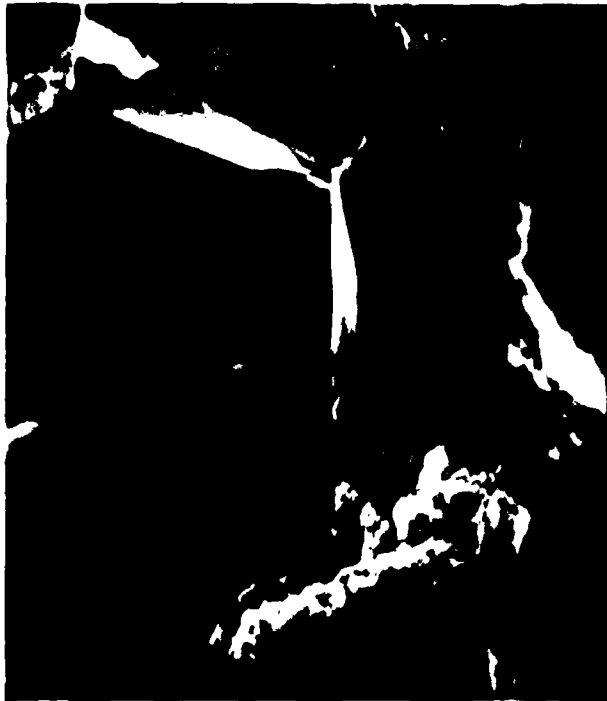
Figure 18. Scanning electron micrograph showing severe pitting that initiates intergranular cracking. (Magnification 300x.)
