Analysis of ice jams and their meteorological indicators for three winters on the Ottauquechee River, Vermont

CRREL Report 81-1

Roy E. Bates and Mary-Lynn Brown

February 1981

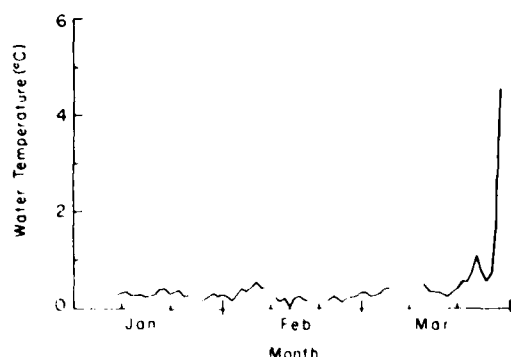
Figure 8. Average daily water temperature near the Woodstock Sewage Treatment Plant: winter 1977-78.

the ice. The associated gradual warming of the water, evident late in the winter (Fig. 8) and detailed for the last week of March in Figure 9, aided this process. Second, because of jamming and melting of the ice cover earlier in the winter, the ice thickness was less than expected. However, a completely open river channel was not reported until 25 March 1978 (later than the previous two winters), following two days of heavy rain.⁶

Continuous measurements demonstrated that the water temperature below the ice cover averaged approximately 0.03°C. With the arrival of higher air temperatures and increased solar radiation in early March, the ice cover deteriorated, open water areas appeared, and the water temperature became more responsive to air temperature fluctuations. During March the water temperatures gradually rose and greater daily temperature fluctuations were evident (Fig. 8 and 9).

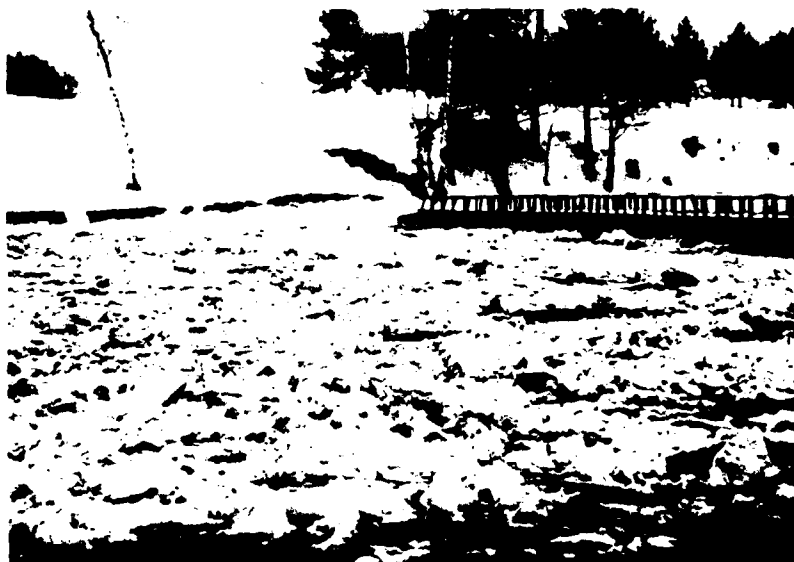
Figure B1. Ice jam at Quechee Golf Course bridge, 26-28 January 1976.

Coinciding with the rapid increase in temperature was heavy rainfall which accounted for over one-half of January's precipitation¹. The combination of temperatures above freezing and heavy precipitation on an already high water-equivalent snow cover² caused extensive flooding and jamming of ice on the Ottawa-Quebec River (Fig. B1).

<u>DATE</u>	<u>ICE THICKNESS (cm)</u>	<u>ICE CONDITIONS AND REMARKS</u>
	61-64	Woodstock Sewage Treatment Plant: Two holes drilled 6 m apart. Ice measures 61 to 64 cm. Water temperature 0.05°C. At outfall pipe opening in ice ≈61 cm downstream, water temperature 2.45°C. 8 m below pipe water temperature 0°C. (For last three weeks ice surface consists of small soft snow hillocks 1 to 4 cm deep below which is ice and soft slush.)
26-28 Jan -----		High air temperature coupled with heavy precipitation caused heavy flooding and severe ice jamming along the Ottauquechee River. High water caused by over 6 cm of rain in a three-day period. Air temperature rose as high as 8°C (Fig. B1).

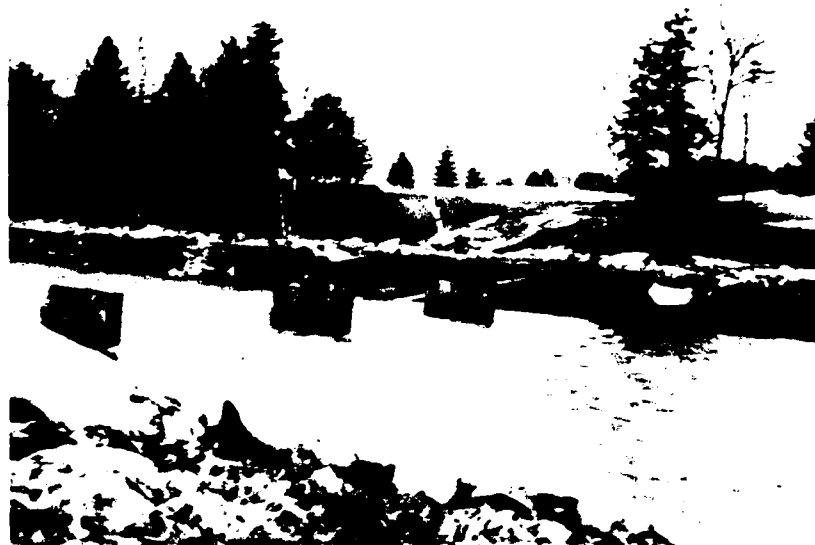
Figure B3. Quechee Golf Course Bridge destroyed by moving ice jam, 15 March 1977.

48.3	Ice measured above partial jam at Taftsville. 122 cm water under ice, 20 cm snow cover. Water temperature $0.1-0.3^{\circ}\text{C}$. Ice temperature -0.5°C . In general, considerable amounts of ice rafting, frozen frazil, and anchor ice as well as new ice formation in river.
12 Mar - 15 Mar	-----	Ice jams in river above Taftsville Pond and above Quechee Mill Pond Dam in addition to other areas. High water on river 12, 13, 14 March from snow melt induced by over 4 cm rain and warm weather. Ice jam formed upstream immediately above Taftsville Pond. Jam caused by remains old ice jam which formed in late Dec. 1976. Old ice jam, new ice formation and frazil flow caused ice jam in river. Many areas frozen to bottom. Ice flowed over river road. Huge ice jam also formed above Quechee Mill Pond Dam. Quechee Lakes: Quechee Golf Course Bridge taken out when ice moved in night of 13 March (Fig. B3). River so jammed with ice

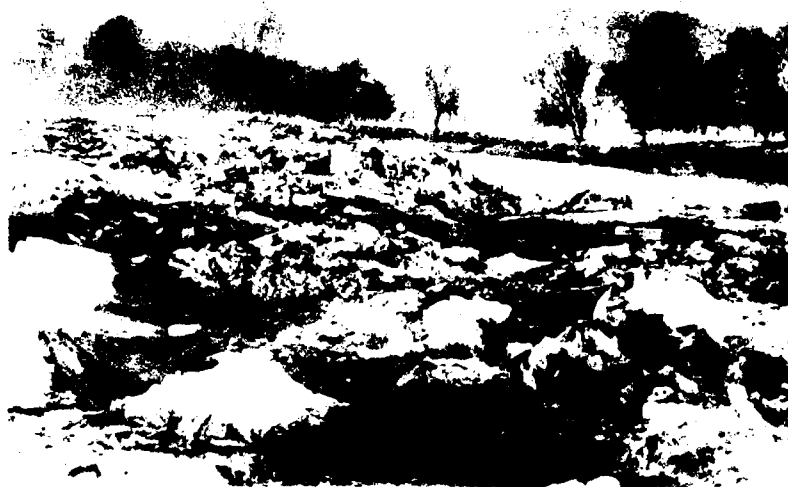
Figure B4. Ice rafted on Quechee Golf Course, 15 March 1977.

that water overflowed all low areas. Ice rafted and flowed over many areas of golf course (Fig. B4). Ice blocks 91-181 cm thick were (Fig. B5).

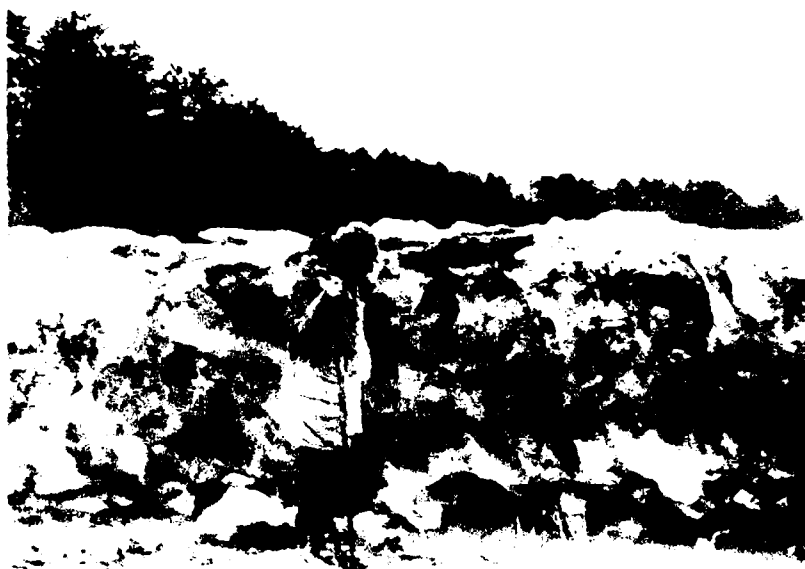
Figure B5. Ice blocks, 91-181 cm on shore of Ottawaquechee River, 15 March 1977.

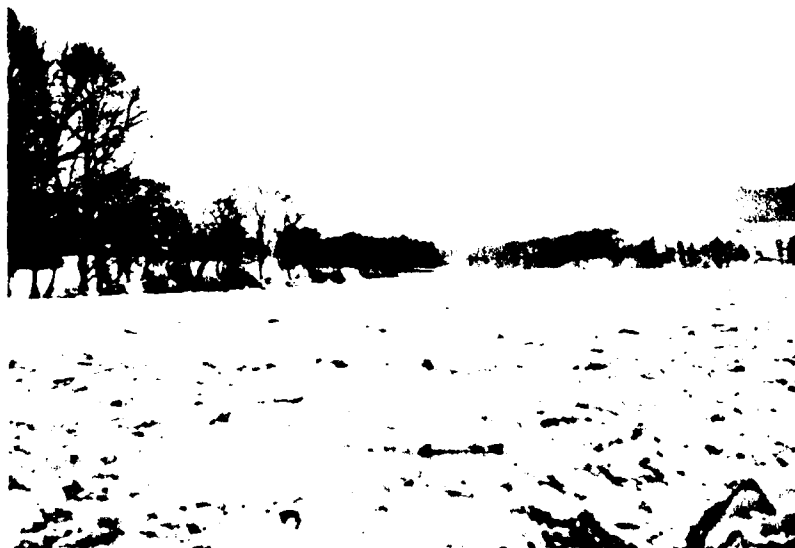
Figure B6. Ice jam at Woodstock, east of Sewage Treatment Plant, 26 January 1978.

Two minor thaws occurred in January 1978 (4-9 January, 24-26 January), causing slight jamming and rafting of the ice (App. B). The second thaw was the more serious one. According to the observational report "thaw and heavy rain caused flooding and a new ice jam at Woodstock" (Fig. B6).

<u>DATE</u>	<u>ICE THICKNESS (cm)</u>	<u>ICE CONDITIONS AND REMARKS</u>
25-26 Jan	-----	Thaw and heavy rain caused flooding and a new ice jam in Woodstock (Fig. B6). Solid ice remained in Quechee Lakes Mill Pond and Taftsville Pond. Ice jam extends from just below Woodstock Sewage Treatment Plant upstream to Woodstock Union High School.
9 Feb	25-38	New ice formation. Ice rafted and jammed at Woodstock and Quechee.
7 Mar	56	Water temperature at bridge near Yankee Musket Shop 0°C or slightly below. Water samples appear silty. Snow depth on ice 30 cm. Ice same thickness 3 m from shore and in center of river at shop. 51 cm water beneath ice in center of river; 66 cm water near sensor.
	71	Woodstock Sewage Treatment Plant: 3 m beyond temperature sensor, water samples nearly clear, 33 cm water beneath ice. Water temperature 0°C. (See Fig. B7 and B8.)
	74	6 m from shore: 3 m water beneath ice, water temperature 0°C.
