Flood Plain Information Connecticut River, West River
and Whetstone Brook BRATTLEBORO Vermont

FLOOD PLAIN INFORMATION
CONNECTICUT RIVER, WEST RIVER
AND
WHETSTONE BROOK

BRATTLEBORO
VERMONT

PREPARED FOR
THE TOWN OF BRATTLEBORO
BY
DEPARTMENT OF THE ARMY
NEW ENGLAND DIVISION CORPS OF ENGINEERS
WALTHAM, MASS.

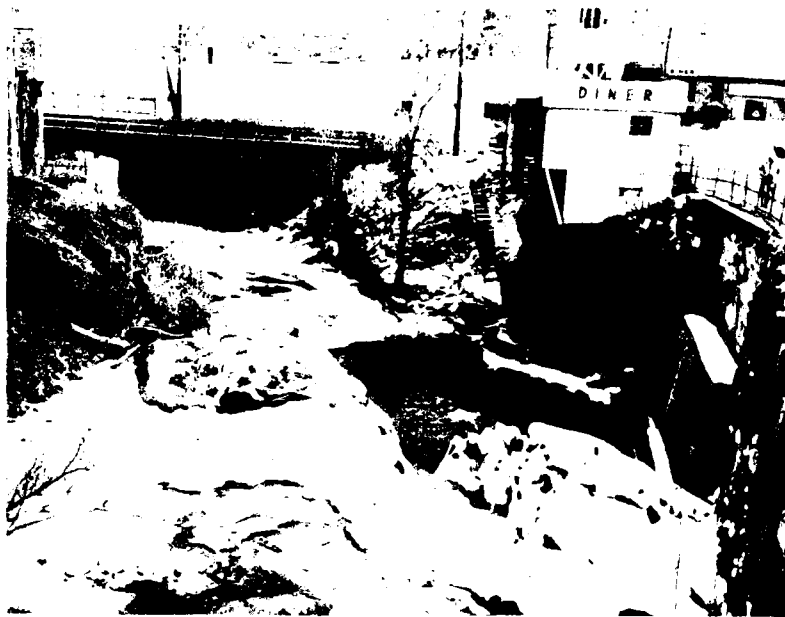
Whetstone Brook, looking downstream from Main Street (Route 5) bridge toward railroad bridge and Connecticut River.

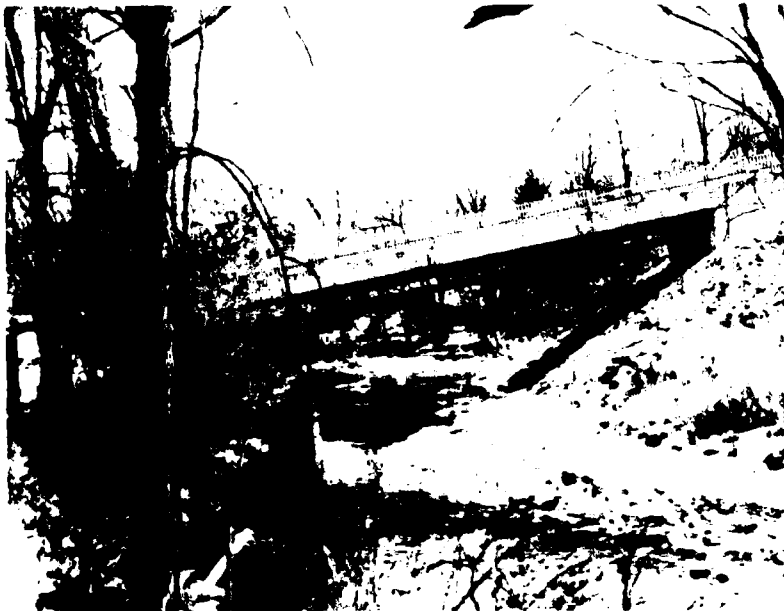
Figure 2

Whetstone Brook looking downstream through Elm Street bridge. A portion of the flood flow will bypass this bridge because of low left-bank approach.

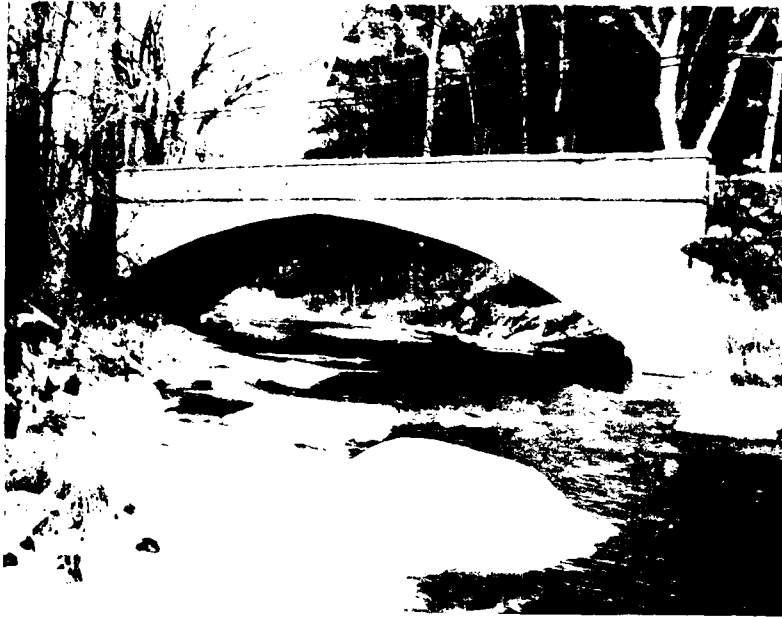
State Highway 9 bridge over Whetstone Brook. Standard Project Flood will overtop bridge deck by about three feet.

The one major bridge which is inadequate is that on State Highway 9 between Brattleboro and West Brattleboro. The deck of the concrete-arch bridge will be overtopped by both the Standard

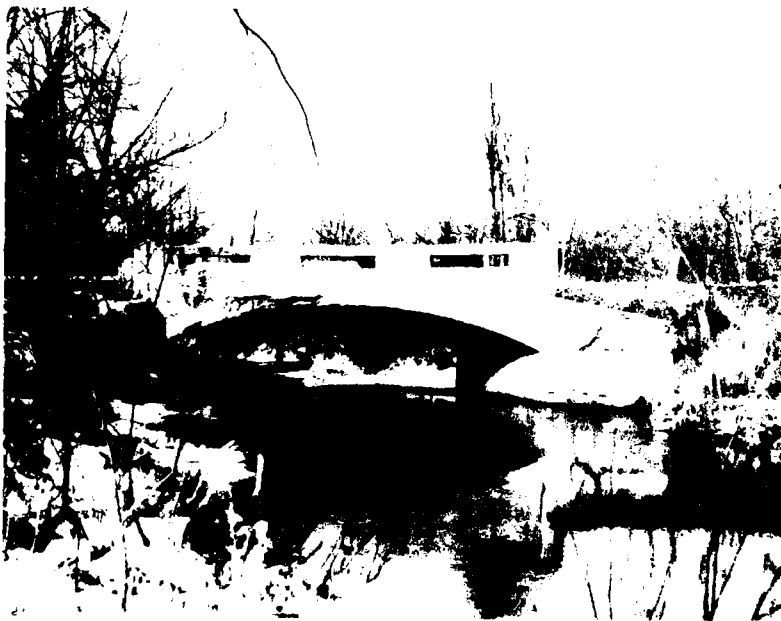
Figure 4

Meadowbrook Road bridge. Both Standard Project and Intermediate Regional Floods will overtop this bridge deck.

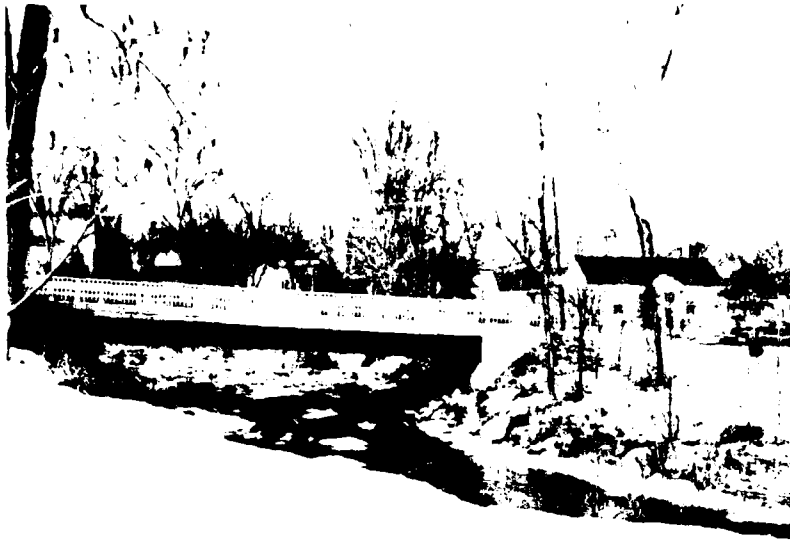
George F. Miller Drive bridge over Whetstone Brook. Entrance to Melrose Terrace housing development. Considerable flow will bypass this bridge through area in vicinity of cars.

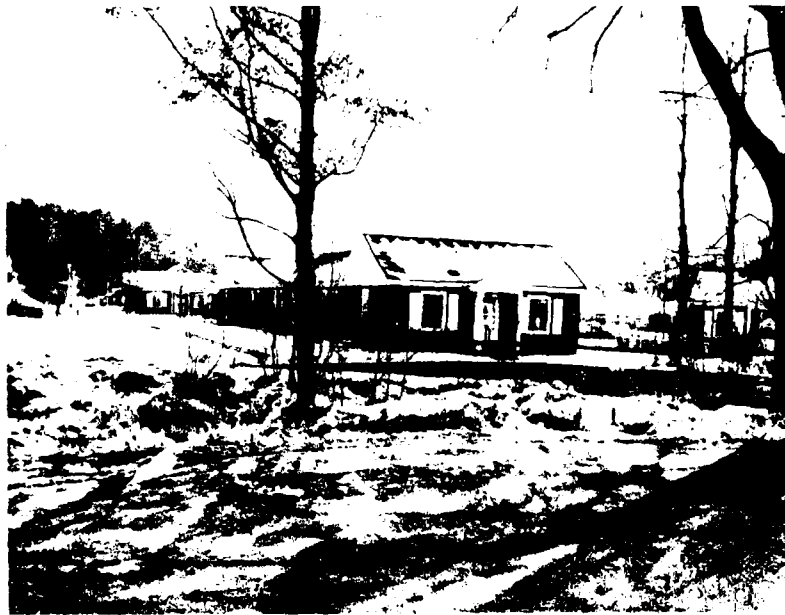
Melrose Terrace Housing Development for Elderly, looking downstream. Standard Project Flood will overtop bank in foreground to a depth of as much as five feet.

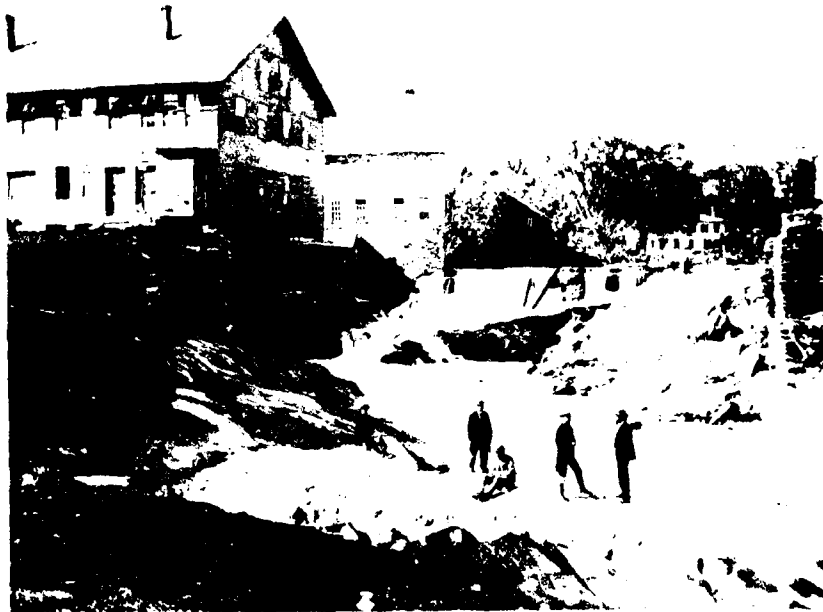
destruction resulting from flood of October 1869. View looking up Whetstone Brook from below Main Street (Route 5) bridge. Damaged abutments of old bridge in foreground. Note inadequate bridge structure and encroachment on flood plain at left. See also figure 1.

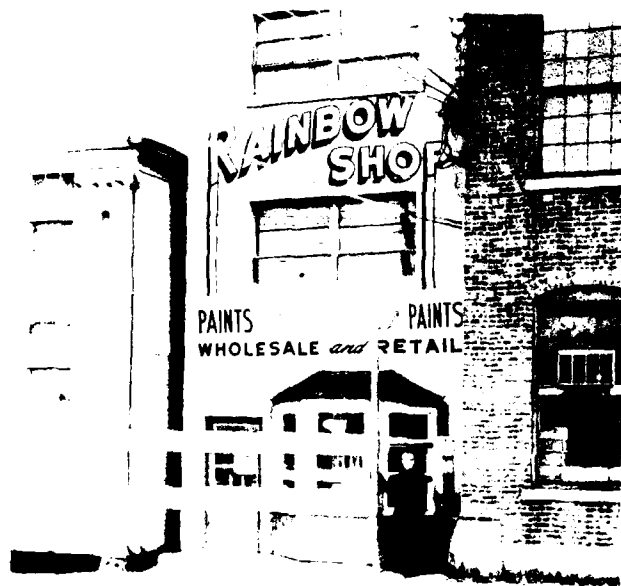
Flood Heights at Rainbow Shop, east side of Elm Street.

Part of the business district of West Brattleboro including several homes would be subject to possible damage during a flood equal to or greater than the Intermediate Regional Flood. More damage would result from a flood equal to or greater than the Standard Project Flood. (See Plates 11 and 12 and Figure 6).

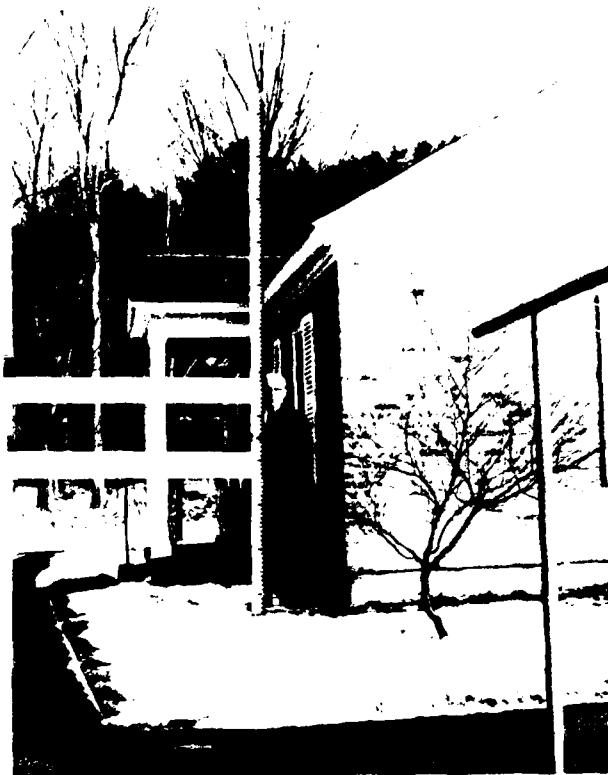
Flood Heights, upstream end of Melrose Terrace Housing Development for the Elderly, West Brattleboro.

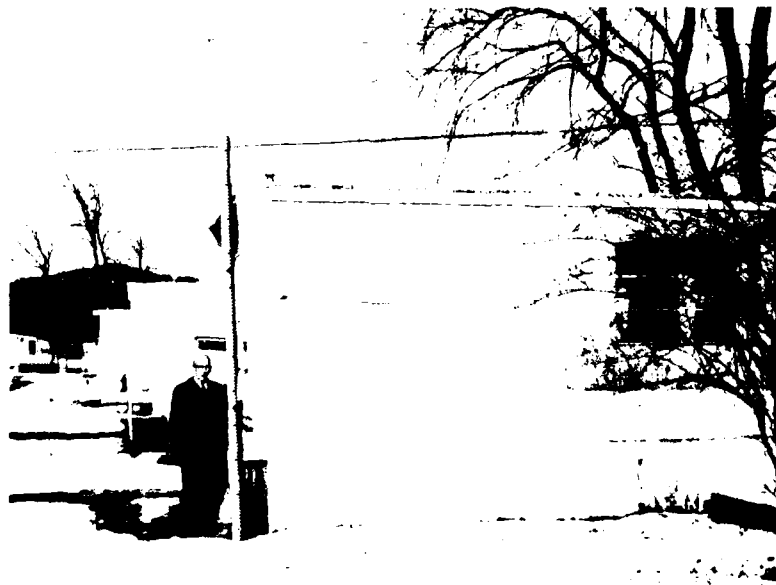
Flood Heights, mobile home in Glen Trailer Park, across Whetstone Brook from photograph above.

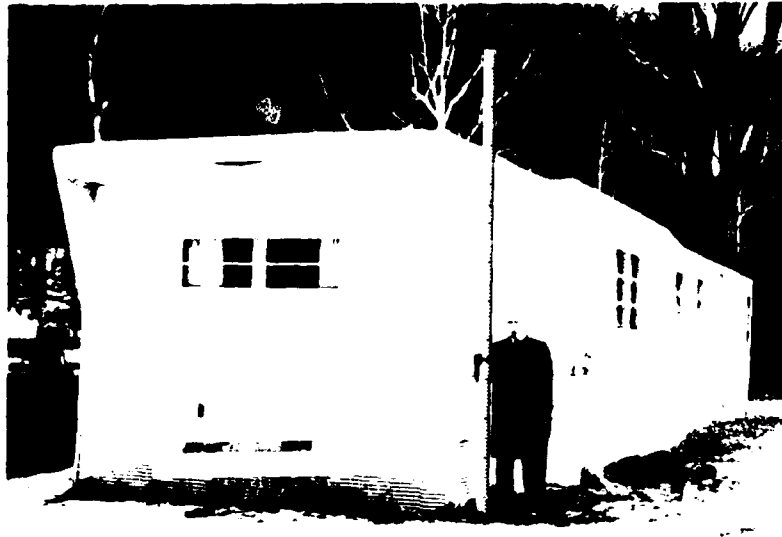
Flood Heights, mobile home in Mountain Home Trailer Park on left bank of Whetstone Brook opposite Country Kitchen, West Brattleboro.

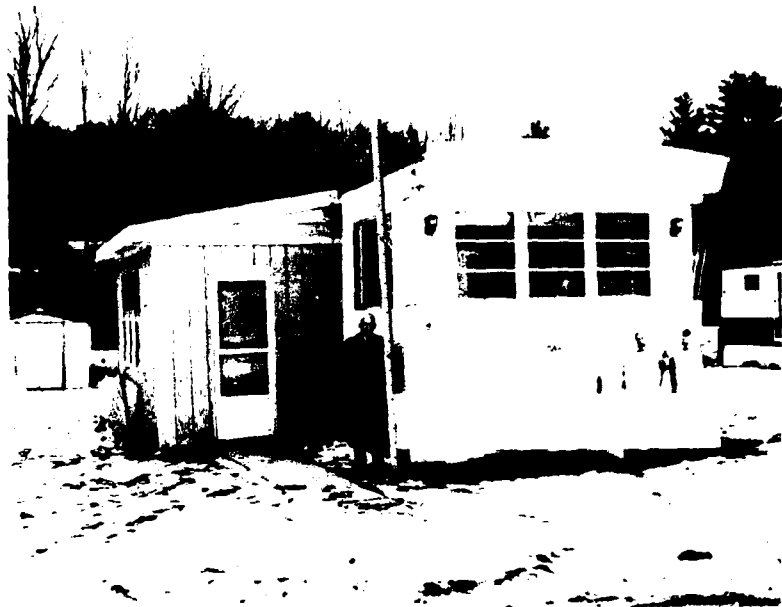
Flood Heights, mobile home, in Mountain home Trailer Park, right bank Whetstone Brook just downstream from Mountain Road, West Brattleboro.
