ARMY ENGINEER DISTRICT PHILADELPHIA PA
FLOOD PLAIN INFORMATION, LITTLE LEHIGH CREEK, CEDAR CREEK, LITT--ETC(U)

4. TITLE (and Subtitle) Flood plain information Allentown, Pa., Little Lehigh Creek, Cedar Creek, Little Cedar Creek <i>Allentown, Pa.</i>		5. TYPE OF REPORT & PERIOD COVERED Flood plain information

DEPARTMENT OF THE ARMY
 PHILADELPHIA DISTRICT, CORPS OF ENGINEERS
 PHILADELPHIA, PENNSYLVANIA
 FLOOD PLAIN INFORMATION

CITY OF ALLENTOWN
 PENNSYLVANIA
 INDEX MAP
 FLOODED AREAS
 OCTOBER 1972

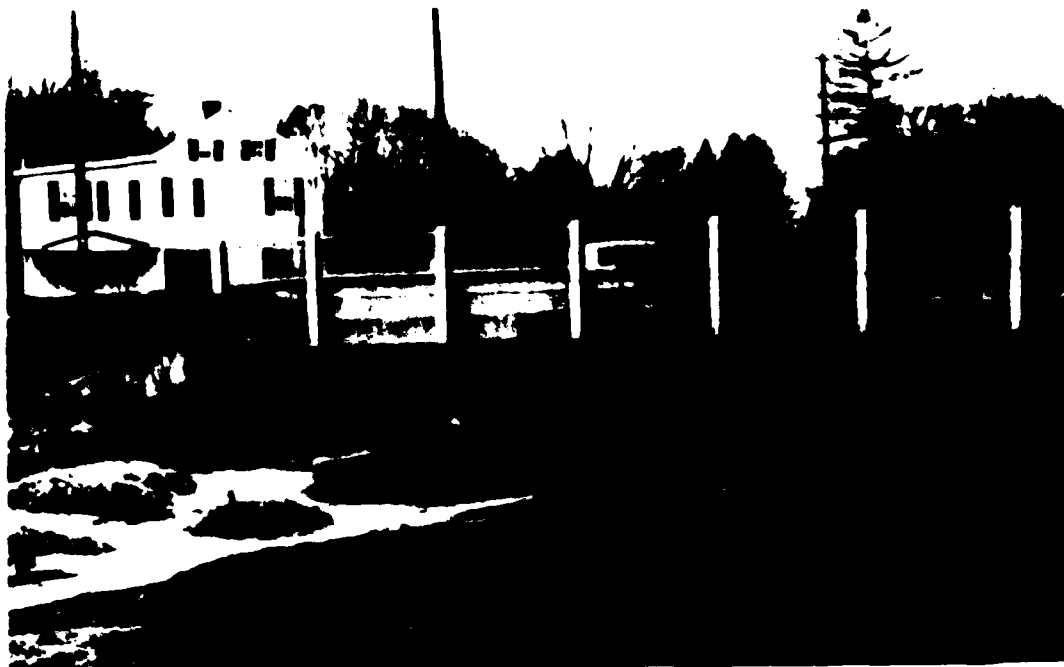
FIGURE 2- Shoaling and vegetation impede the flow of water in Cedar Creek under this bridge at the intersection of Cedar Crest Boulevard and Parkway Boulevard. The low underclearance of this bridge may also be restrictive to floodflows.

Obstructions to floodflows - Obstructions to floodflows can be either natural or man-made. Natural obstructions that impede floodflows may be sharp bends in stream alignment, channel constrictions due to topography of adjacent terrain, shoaling, rock outcrops in the stream or on the flood plain, and vegetation such as grass, brush or trees. Photographs of representative natural obstructions may be found in Figures 1 and 2. As floodflow is impeded, the velocity of the water decreases and the depth of flow increases; this results in flooding along streams. Man-made obstructions include bridges, culverts, dams, docks, levees, and earthfills. These man-made obstructions may severely hamper flow and cause a backwater condition, which creates more flooding than normally would occur with only natural obstructions present.

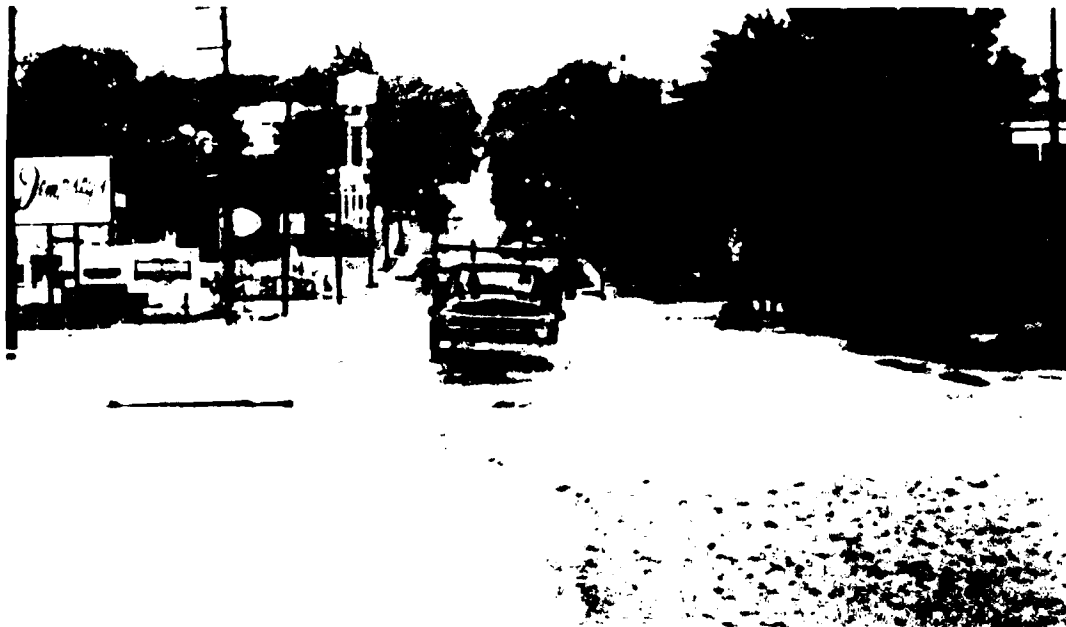
FIGURE 12 - Tropical Storm Agnes caused Cedar Creek to overflow its banks along Hamilton Street. This flooding was approximately equal to an Intermediate Regional Flood (IRF) at the bridge. (Note the flood profile on Plate No. 10.)

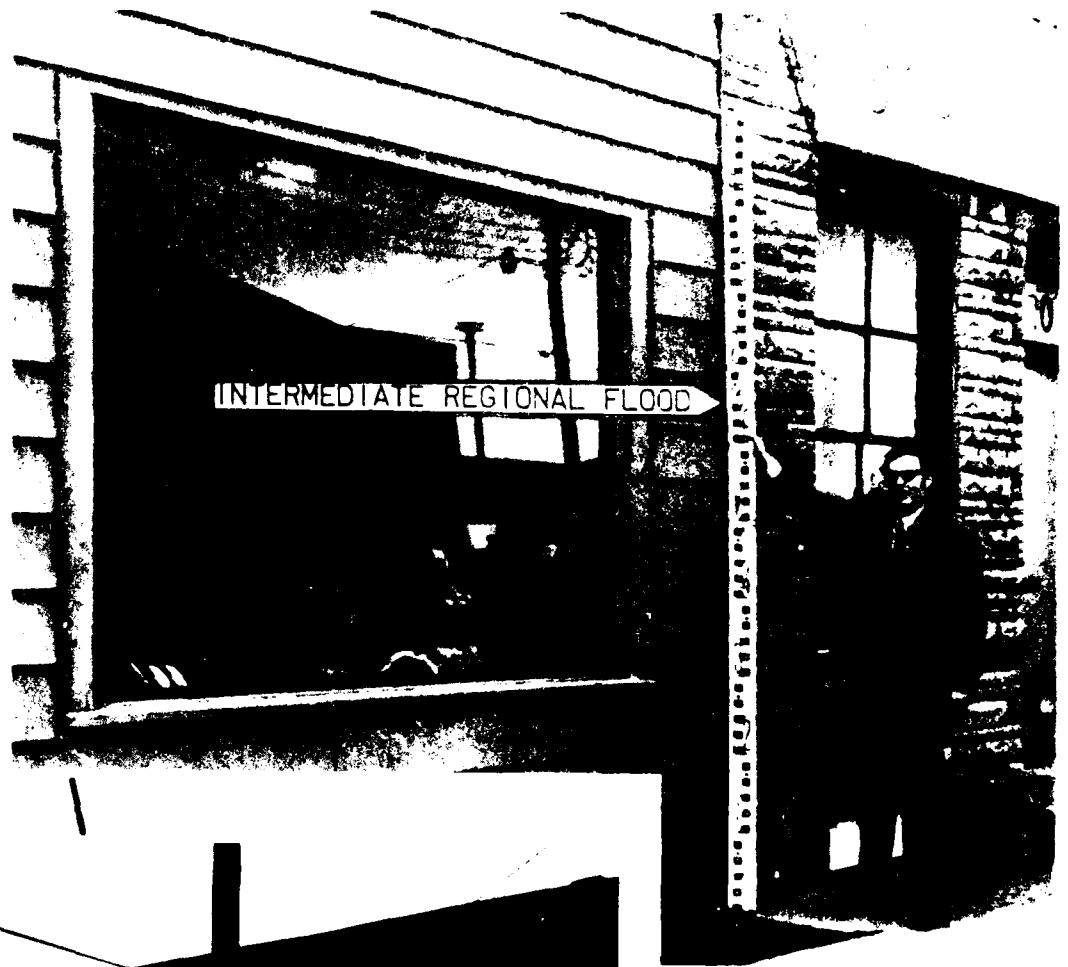
FIGURE 13 -
Picture of signs on this
at 14 High Street. The
Standard Project 111
would be 100 feet
above top of roof.

Photographs, future flood heights - The levels that the Intermediate Regional and Standard Project Floods are expected to reach at various locations along Little Lehigh Creek, Cedar Creek, and Little Cedar Creek are indicated on the following photographs.
