**BRANDYWINE CREEK**  
**NEW CASTLE COUNTY, DELAWARE**

PREPARED FOR THE NEW CASTLE COUNTY DEPARTMENT OF PLANNING  
BY CORPS OF ENGINEERS, U.S. ARMY PHILADELPHIA DISTRICT

JULY 1973

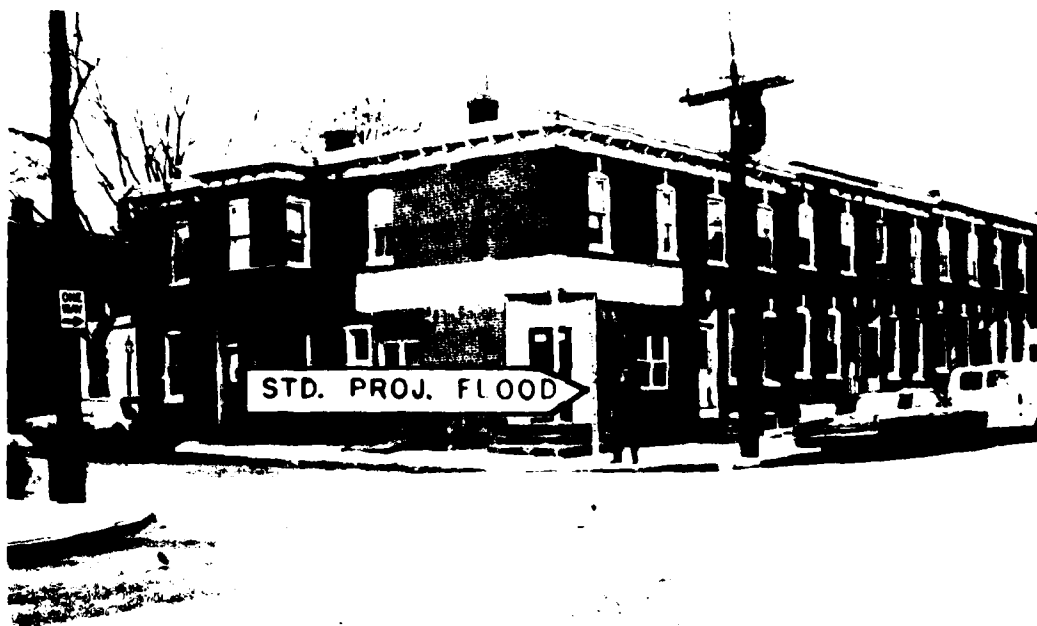
FIGURE 4 - Future flood height at the intersection of Bennett and 11th Streets.

**Photographs, future flood heights** - The levels that the Intermediate Regional and Standard Project Floods are expected to reach at various locations along Brandywine Creek are indicated on the following photographs.

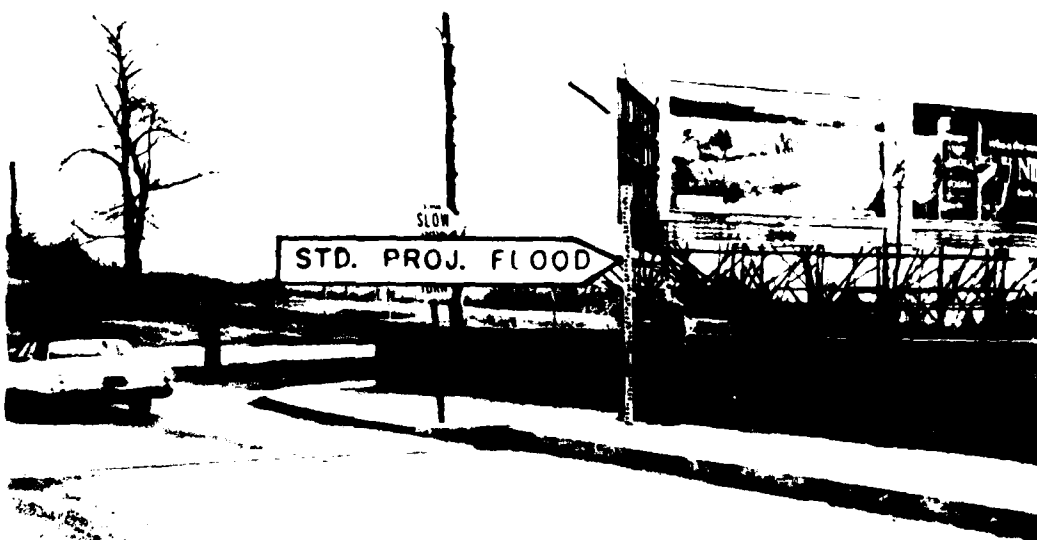
FIGURE 5 - Future flood height at Jessup Street bridge.

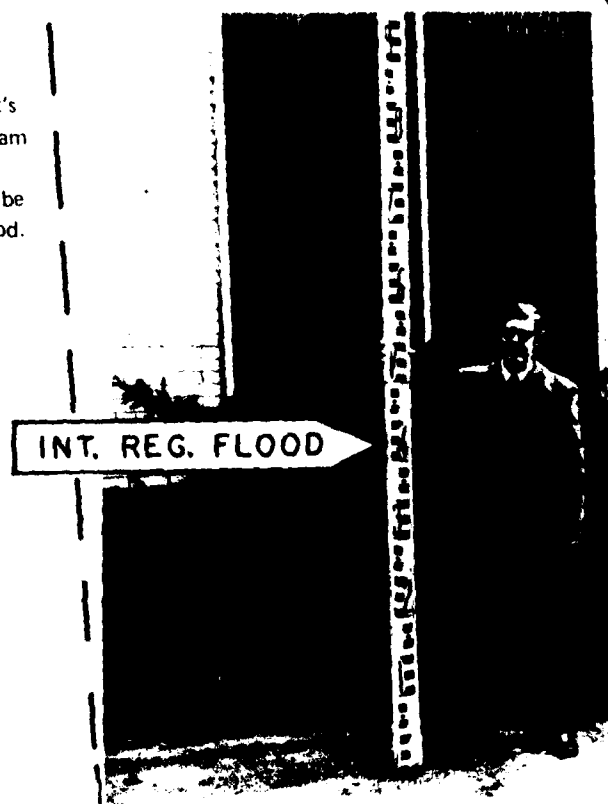
**FIGURE 7** - Future flood heights at Hagley Museum. The Standard Project Flood would be 5.8 feet above the top of the rod.

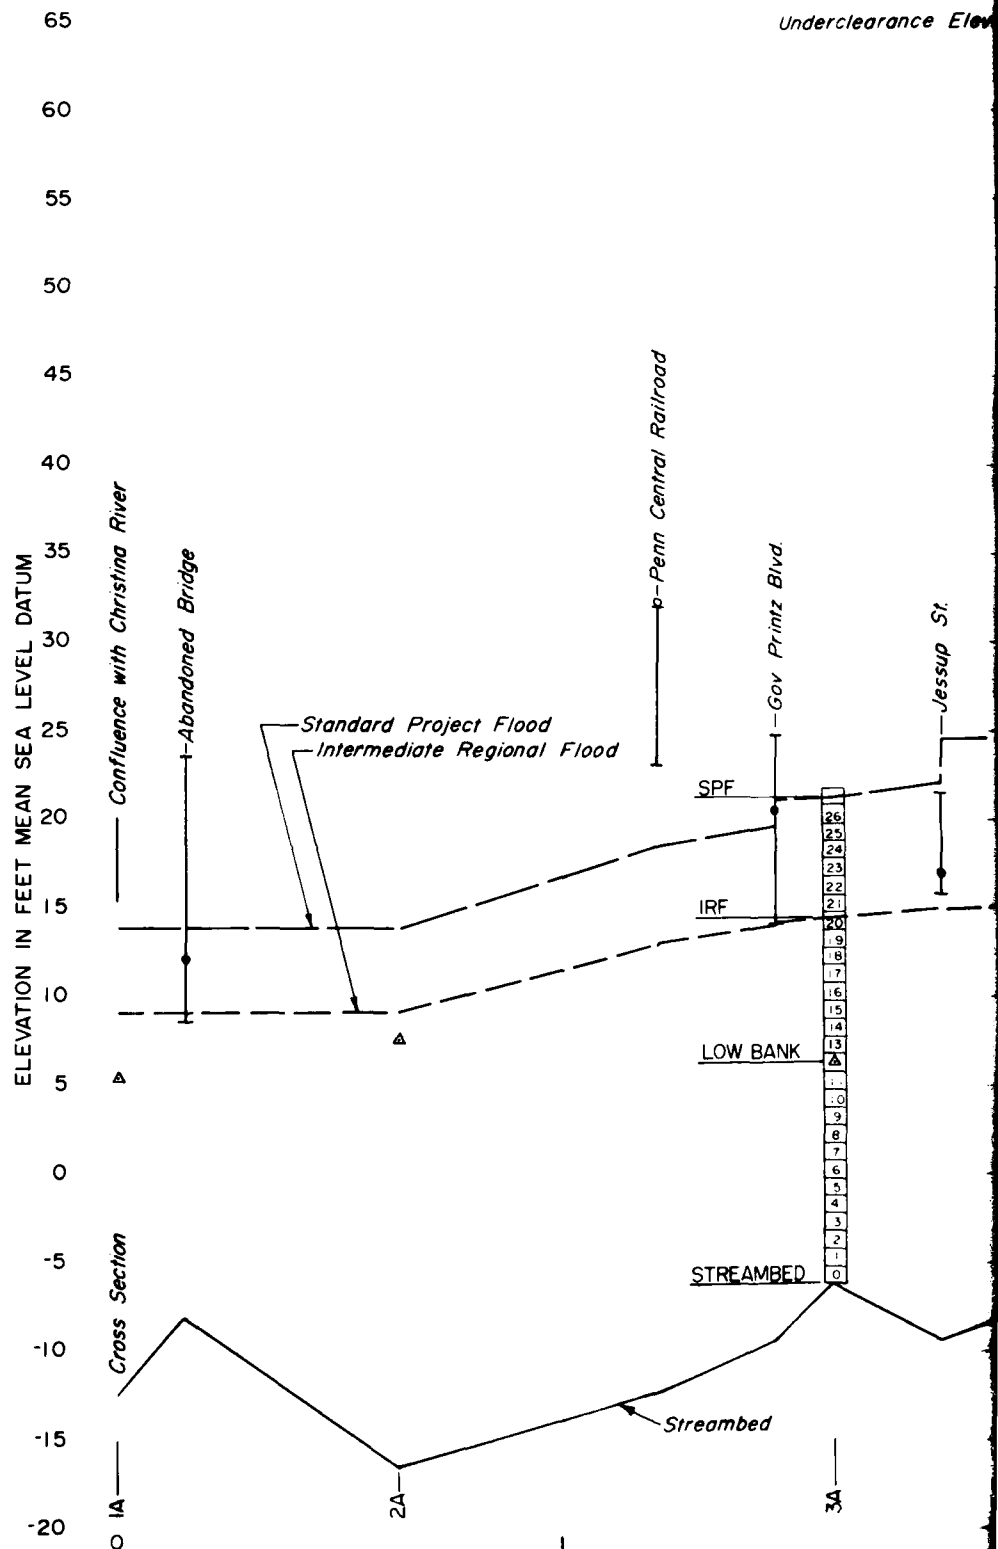
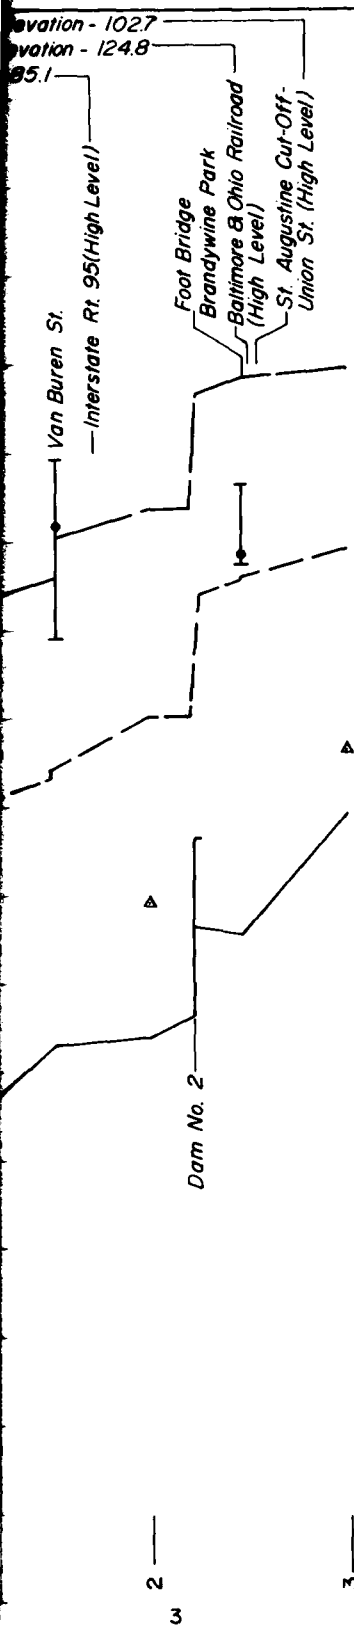
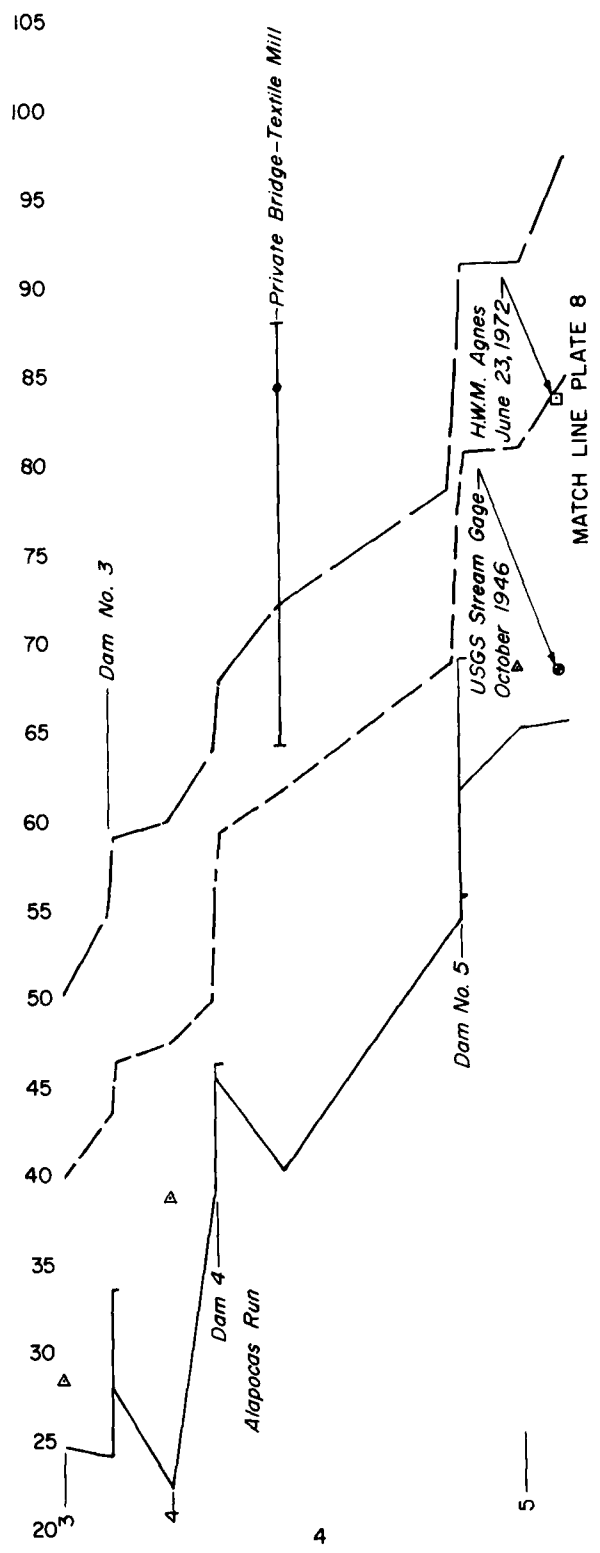
DEPARTMENT OF THE ARMY  
 PHILADELPHIA DISTRICT, CORPS OF ENGINEERS  
 PHILADELPHIA, PENNSYLVANIA  
 FLOOD PLAIN INFORMATION  
 BRANDYWINE CREEK  
 NEW CASTLE COUNTY  
DELAWARE  
 HIGH WATER PROFILES  
 JULY 1973

Stationing of natural streambed for Brandywine Creek begins along the projection of the left bank of Christina River at the confluence with Brandywine Creek

**Flooded areas and flood damages** - The areas along the study reach of Brandywine Creek that would be flooded by the Standard Project Flood are shown on Plate 2, which is also an index map to Plates 3 through 6. Areas that would be flooded by the Intermediate Regional Flood and the Standard Project Flood are shown in detail on Plates 3 through 6. The actual limits of these overflow areas may vary somewhat from those shown on the maps because the 10-foot contour interval and scale of the maps do not permit precise plotting of the flooded area boundaries. As may be seen from these plates, floodflows from the main stem of Brandywine Creek inundate Wilmington and other small communities adjacent to the stream. The areas that would be flooded by the Intermediate Regional and Standard Project Floods include commercial and residential properties, along with associated streets and roads. Considerable damage to the facilities would occur during an Intermediate Regional Flood. However, due to the wider extent, greater depths of flooding, higher velocity flow and longer duration of flooding during a Standard Project Flood, damage would be more severe than during an Intermediate Regional Flood. Plates 7 and 8 show the water surface profile for the Intermediate Regional and Standard Project Floods. Plates 9 and 10 show the water surface profile for the same floods as modified by the proposed Soil Conservation Service Dams. Depth of flow in the channel can be estimated from these illustrations. Cross sections of the flood plain at selected locations, together with the water surface elevation and lateral extent of the Intermediate Regional and the Standard Project Floods are shown on Plate 11.
