THE EFFECT OF ENVIRONMENT ON THE MECHANICAL BEHAVIOR OF AS/3501-6 GRAPHITE/EPOXY MATERIAL PHASE II

T. HO

Vought Corporation Advanced Technology Center
Dallas, Texas 75266

10 January 1980

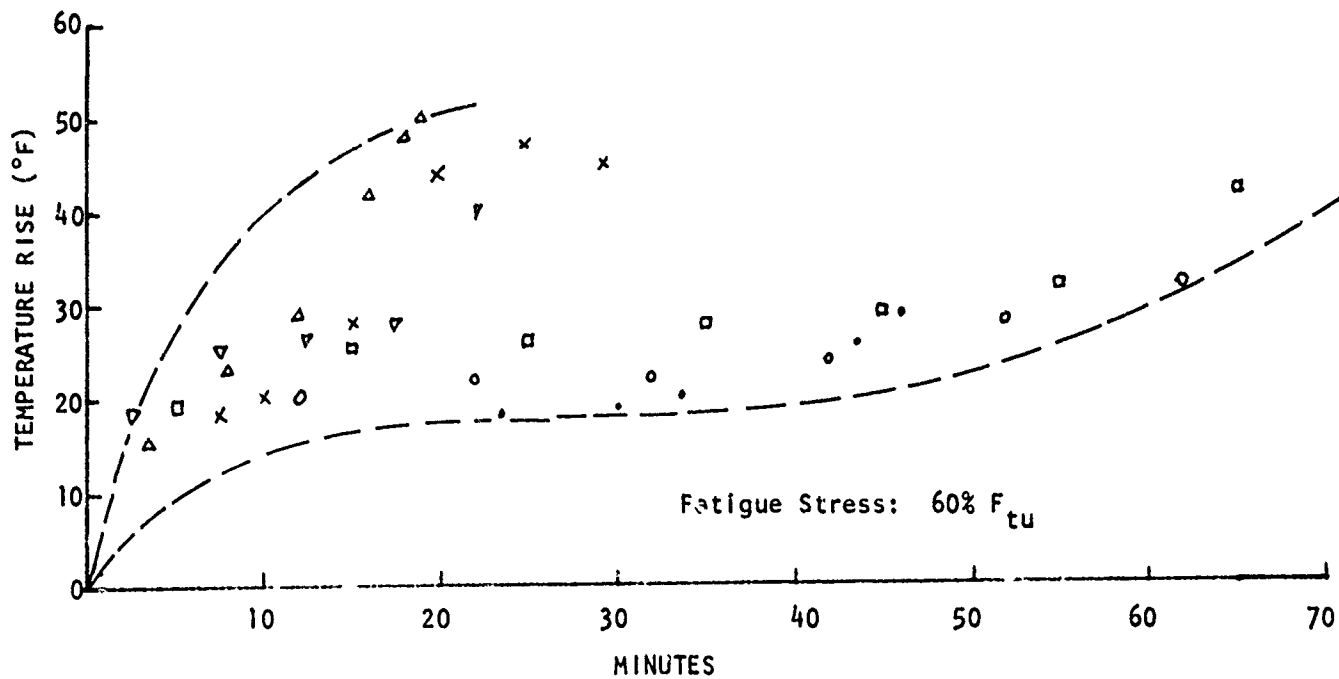
FIGURE 32. TEMPERATURE RISE ON $\pm 45^\circ$ -SPECIMEN SURFACES WHEN FATIGUE TESTED IN AN $75^\circ\text{F}/50\%$ R.H. ENVIRONMENT.

FIGURE 32 (Continued). TEMPERATURE RISE ON $\pm 45^\circ$ -SPECIMEN SURFACES WHEN FATIGUE TESTED IN AN $75^\circ\text{F}/50\%$ R.H. ENVIRONMENT.

The specimen's surface temperature was monitored continuously by temperature sensors and the results for $\pm 45^\circ$ specimens at various environments and approximate stress levels are shown in Figures 32 through 36. Steady state temperature was reached in only a few cases. Temperature data scatter from specimen to specimen at each environment is typical. Several factors contributed to the scatter.

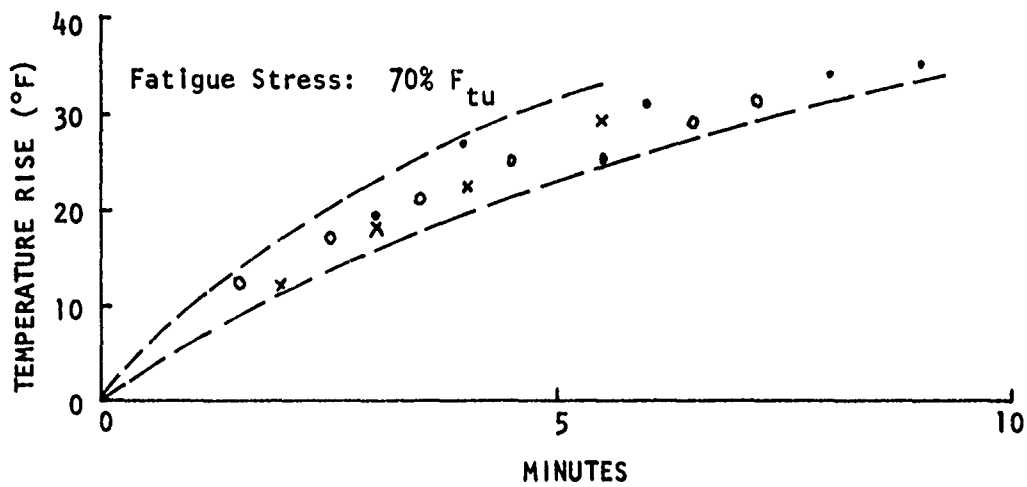
FIGURE 35. TEMPERATURE RISE ON $\pm 45^\circ$ SPECIMEN SURFACES WHEN FATIGUE TESTED IN AN $170^\circ\text{F}/50\%$ R.R. ENVIRONMENT.
