RECONNAISSANCE STUDY
FOR
CAPE VINCENT HARBOR, NEW YORK

U.S. Army Engineer District, Buffalo
1776 Niagara Street
Buffalo, NY 14207

1 April 1981

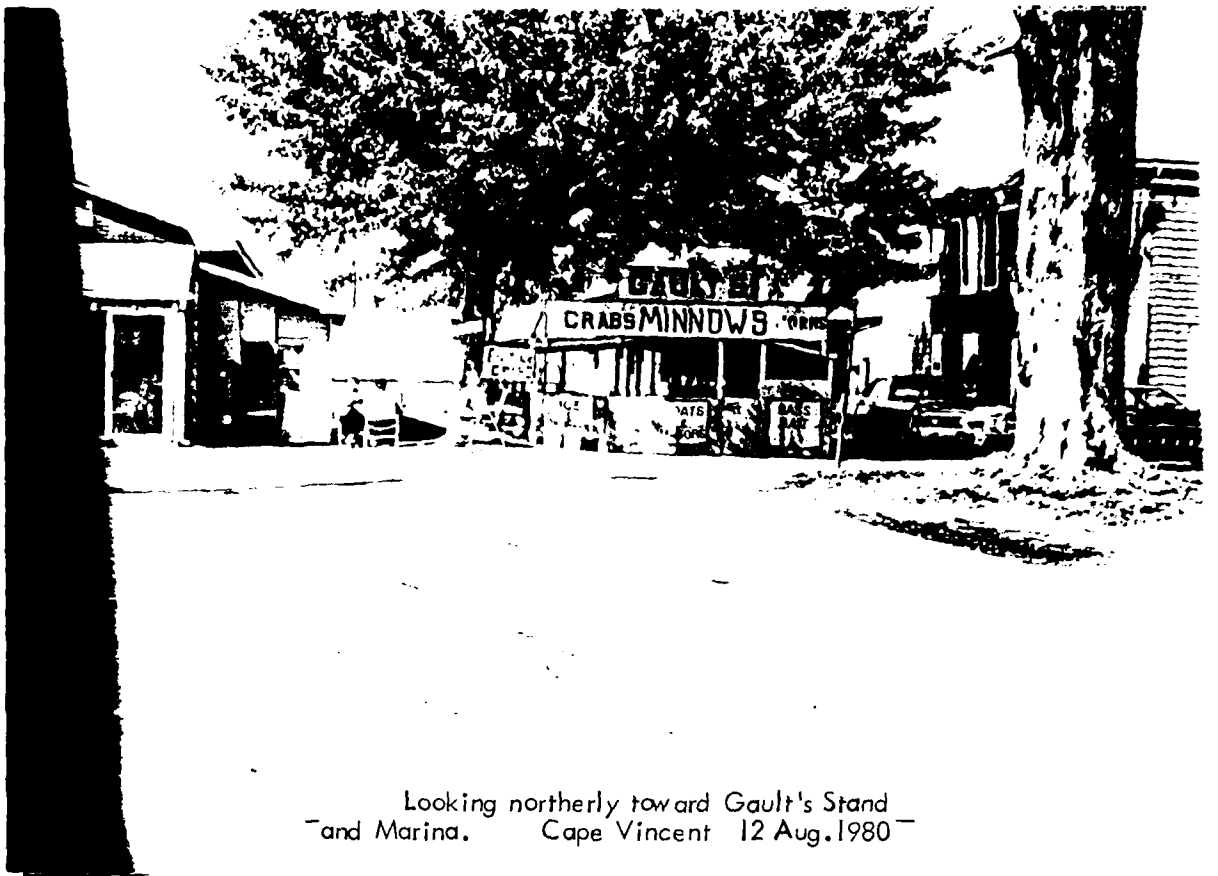
Illustration No. 5

Looking northerly toward Gault's Stand
and Marina. Cape Vincent 12 Aug. 1980

e. Gault's Marina, next to the U.S. Customs area, consists of a number of old wooden structures. There is a small bait shop providing crabs and minnows and other bait items to fishermen; the small buildings are in fair condition. The marina is to the rear of the small buildings and extends into the protected area of the river. The structures are protected by the breakwater from storm and ice (movement) damage. The marina has six berths which are fully occupied. A breakdown of the number of type of craft, as well as their depreciated value appear in Table 13.

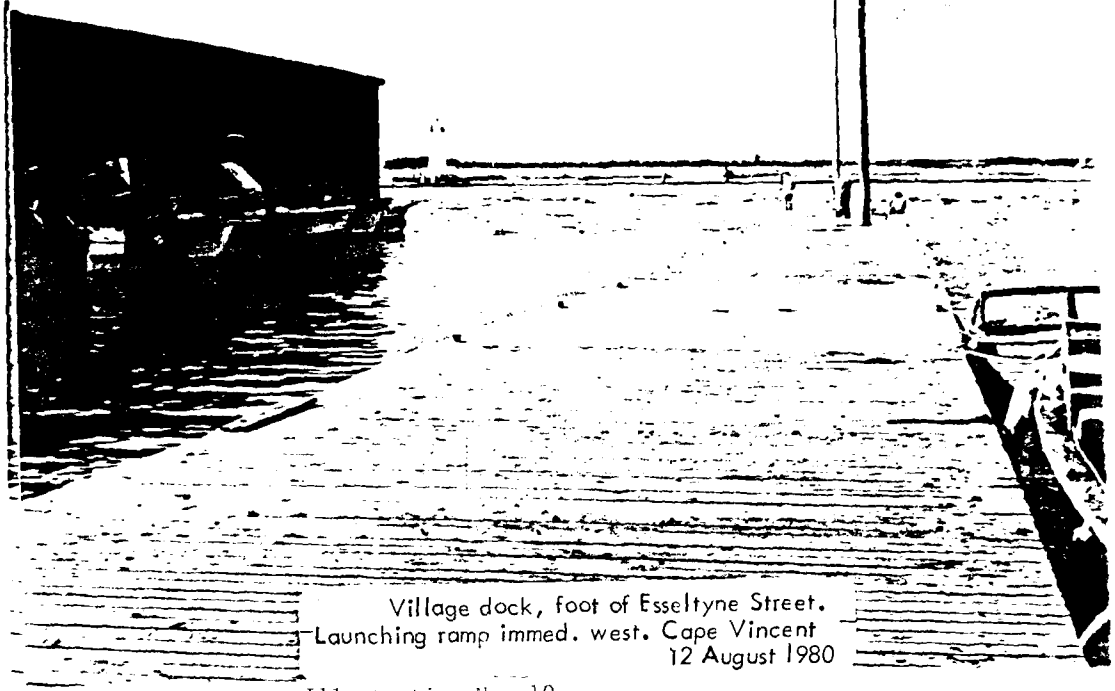
Illustration No. 10

Village dock, foot of Esseltyne Street.
Launching ramp immed. west. Cape Vincent
12 August 1980

*h. The Village Dock is in good repair. There is a launching ramp, also is in good condition, between the dock and Aubrey's Boating Center. The dock is the usual wood frame on piles with creosoted wood boardwalk. The general condition of the dock is fair to good.
