FLOOD PLAIN INFORMATION
ELLICOTT CREEK
 IN THE CITY OF
TONAWANDA
 AND IN THE TOWNS OF
TONAWANDA, AMHERST,
CHEEKTOWAGA & LANCASTER
ERIE COUNTY, NEW YORK

PREPARED FOR
ERIE-NIAGARA BASIN REGIONAL WATER RESOURCES
PLANNING AND DEVELOPMENT BOARD
 By
CORPS OF ENGINEERS, U.S. ARMY
BUFFALO DISTRICT
JANUARY 1968 (REPRINTED JUNE 1971)

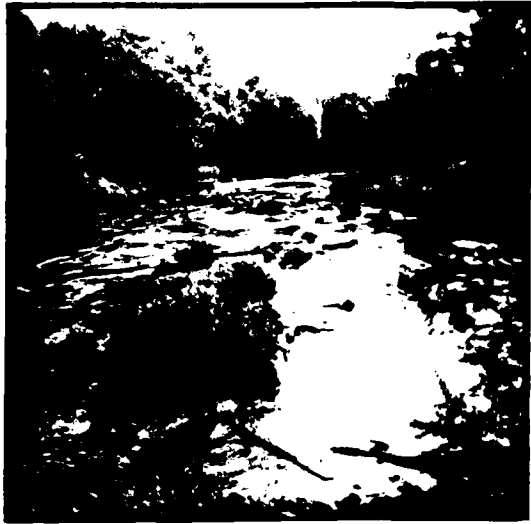
Figure 10- Photo taken looking up-stream of Millersport Highway bridge.

Figures 10-13 all show that floodway capacity is greatly reduced by debris, weeds, brush and trees.

The existing channel in this reach is covered in many locations with brush, large trees, debris and various obstructions as shown in figures 10 through 13.

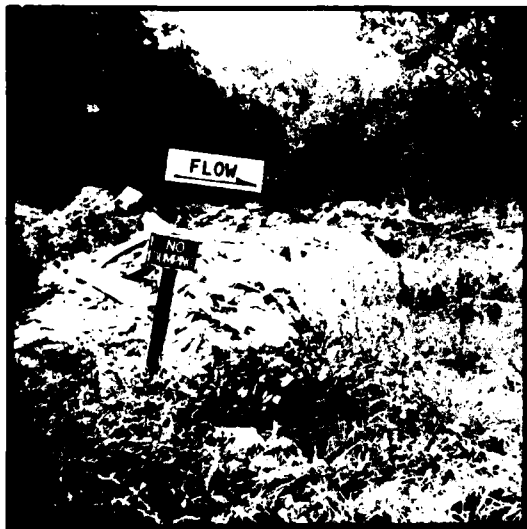
Figure 12- Photo of trash being dumped in area on right bank of Ellicott Creek near Heim Road, near creek mile 7.9.

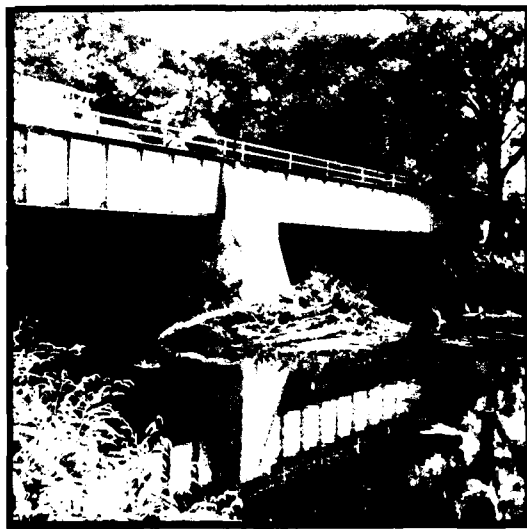
Figure 13- Photo of upstream side of Maple Road bridge. Note amount of debris collecting at center pier.

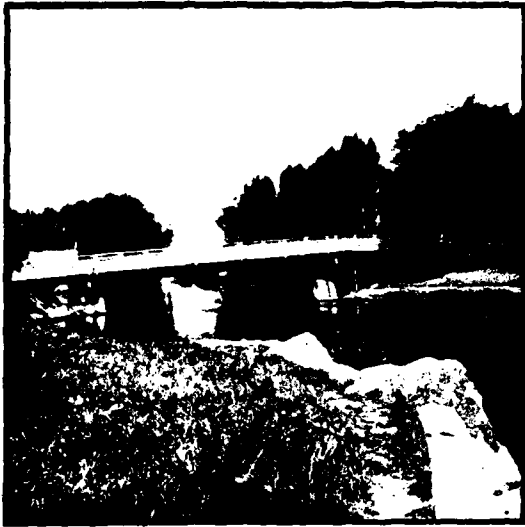
Figure 22- Looking downstream toward the Fremont Street bridge at creek mile 0.44 in the city of Tonawanda.

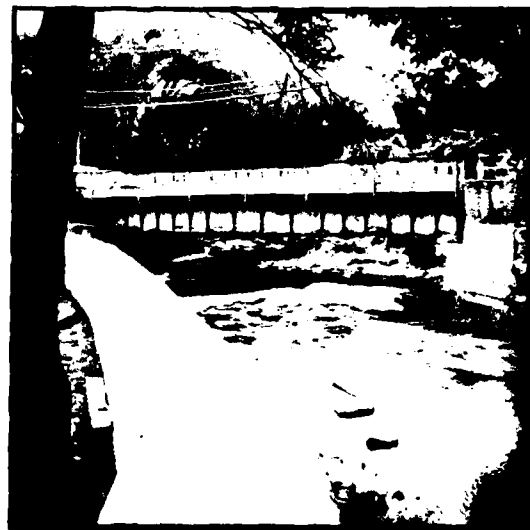
Figure 25- Looking downstream at the Glen Avenue bridge at creek mile 12.9 in the village of Williamsville. This bridge constructed in 1937 after the 1936 flood washed out the existing structure.

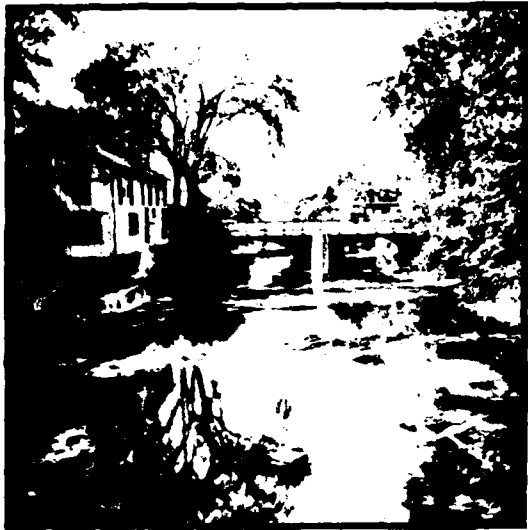
Figure 26- Looking downstream toward Main Street bridge at creek mile 13.1 in the village of Williamsville.

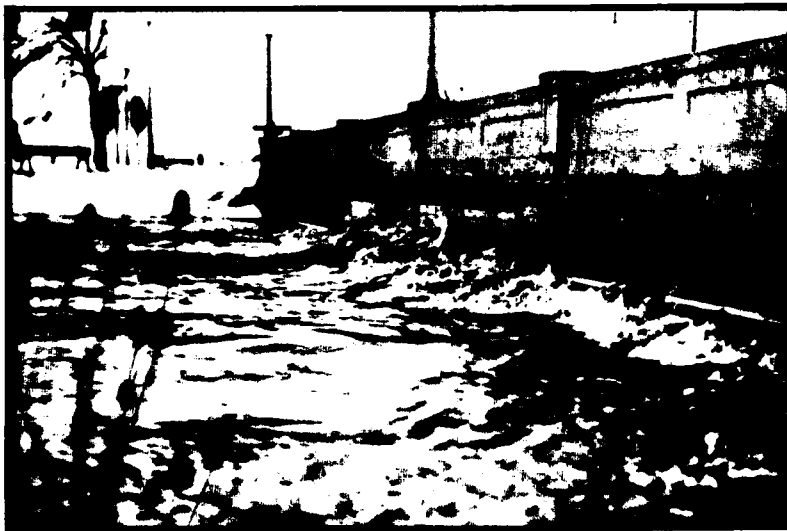
Figure D- Photo showing the water surface upstream side of Wehrle Drive bridge in the village of Williamsville, at creek mile 14.1 during the March 1936 flood.

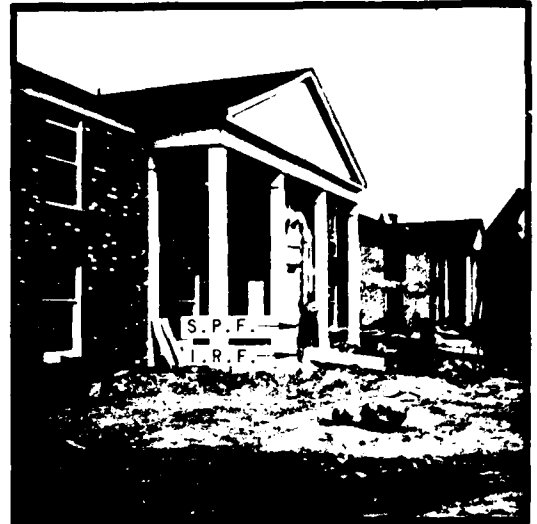
Figure 44- The heights of the Standard Project and Intermediate Regional Floods are indicated by arrows at the Sturbridge Village Apts. under construction at approximate creek mile 9.3 in the town of Amherst.

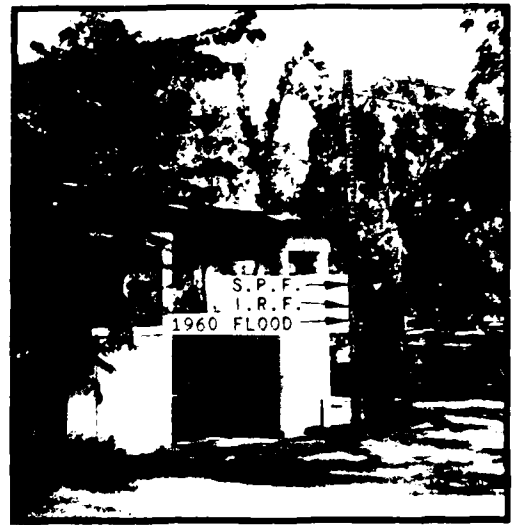
Figure 46- The Standard Project, Intermediate Regional and the 1960 flood heights are indicated by arrows at Walker's Grove just downstream of Wehrle Drive near creek mile 14.0 in the town of Amherst. Although depth of flooding is great, damages would be minor.

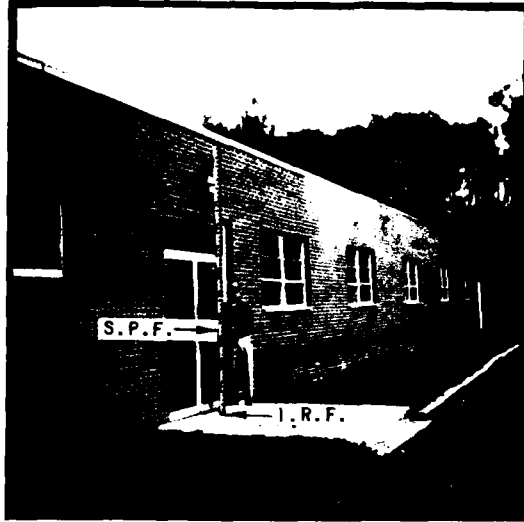
Figure 47- The Standard Project and Intermediate Regional Flood heights are indicated by the arrows at the Bowmansville Volunteer Fire Company House, near creek mile 17.8 in the town of Lancaster.
