LEVEL II
FLOOD PLAIN
INFORMATION

LITTLE NESHAMINY CREEK
BUCKS COUNTY, PENNSYLVANIA

PREPARED FOR THE BUCKS COUNTY PLANNING COMMISSION
BY CORPS OF ENGINEERS, U.S. ARMY PHILADELPHIA DISTRICT

NOVEMBER 1973

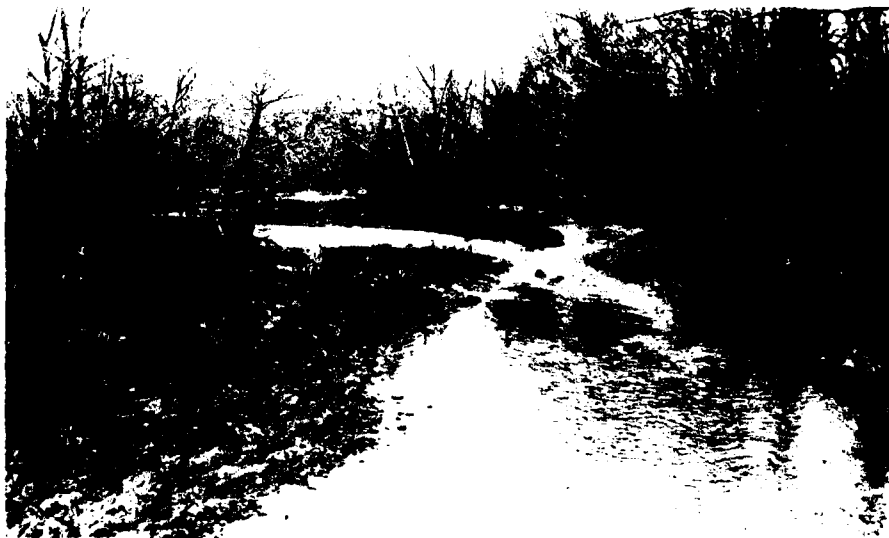
FIGURE 2 - Island upstream of Almshouse Road could be restrictive during times of high flow on Little Neshaminy Creek.

In general, obstructions restrict floodflows and result in overbank flows and unpredictable areas of flooding; destruction of or damage to bridges and culverts; and, an increased velocity of flow immediately downstream. It is impossible to predict the degree or location of the accumulation of debris; therefore, for the purposes of this report, it was necessary to assume that there would be no accumulation of debris to clog any of the bridge or culvert openings in the development of the flood profiles. Representative photographs of obstructions to floodflows may be seen in Figures 1 and 2.

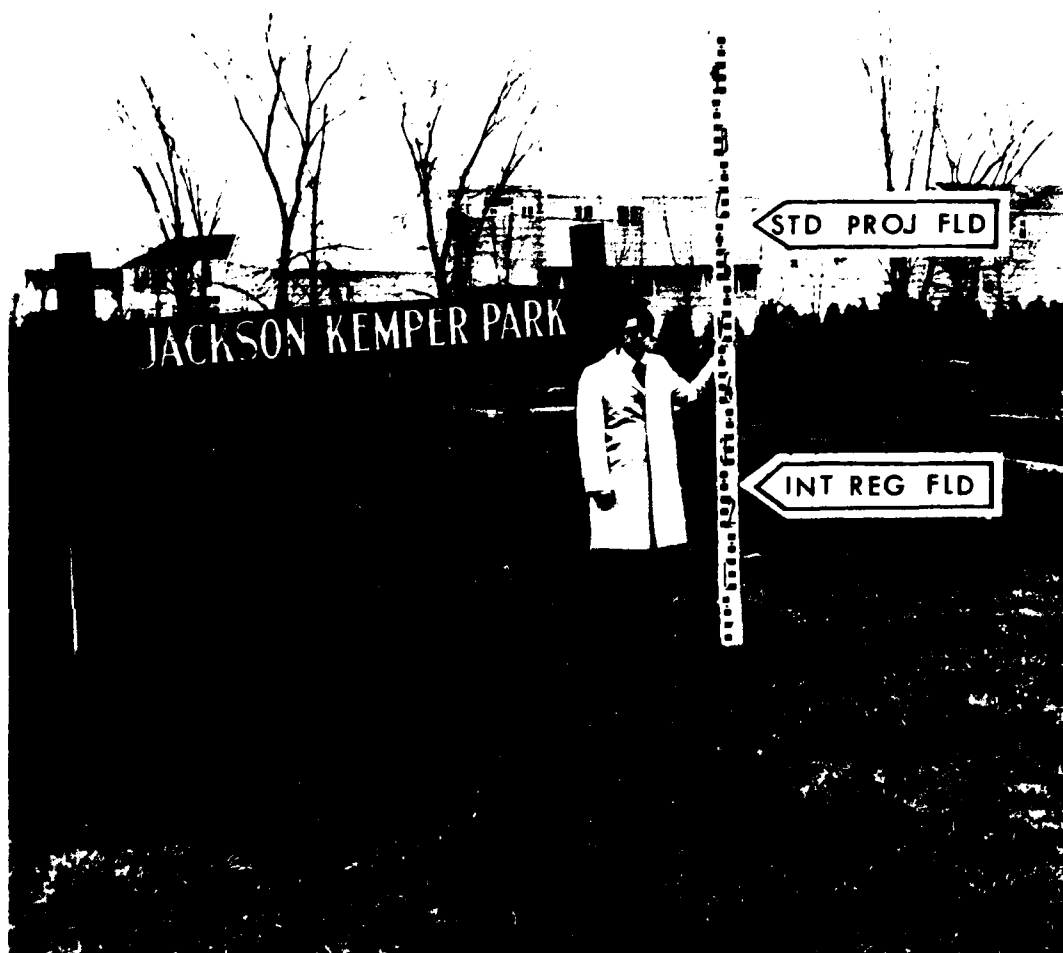
FIGURE 3 - Future flood heights at Jackson Kemper Park near Valley Road Bridge.

Photographs, future flood heights - The levels that the Intermediate Regional and Standard Project Floods are expected to reach at various locations along Little Neshaminy Creek are indicated on the following photographs.

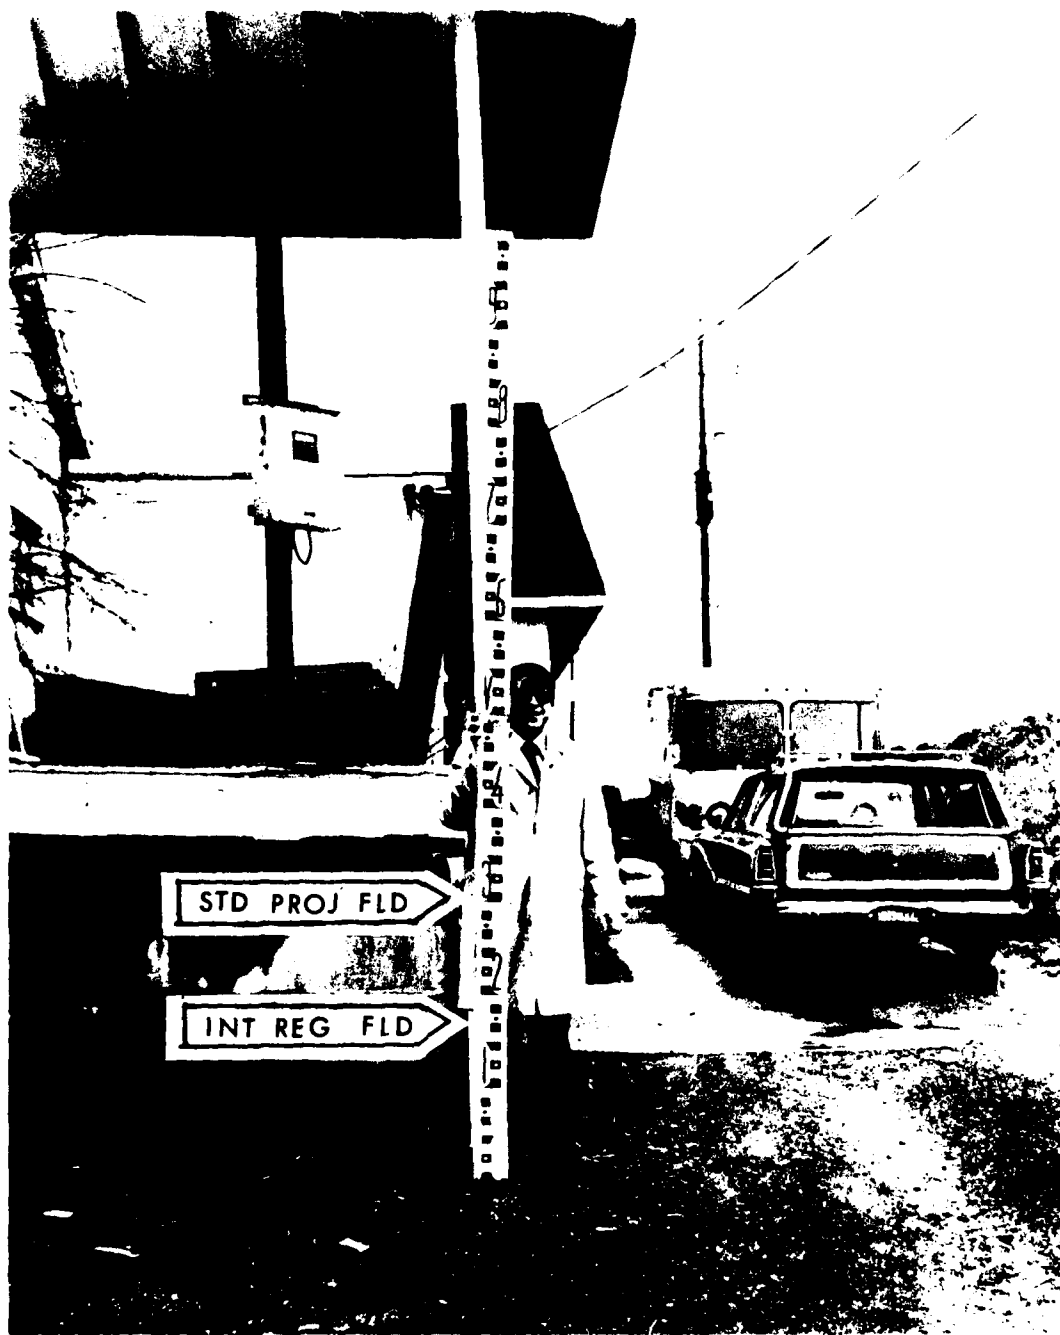
FIGURE 4 - Future flood heights on Little Neshaminy Creek near U.S. Route 611 Bridge.

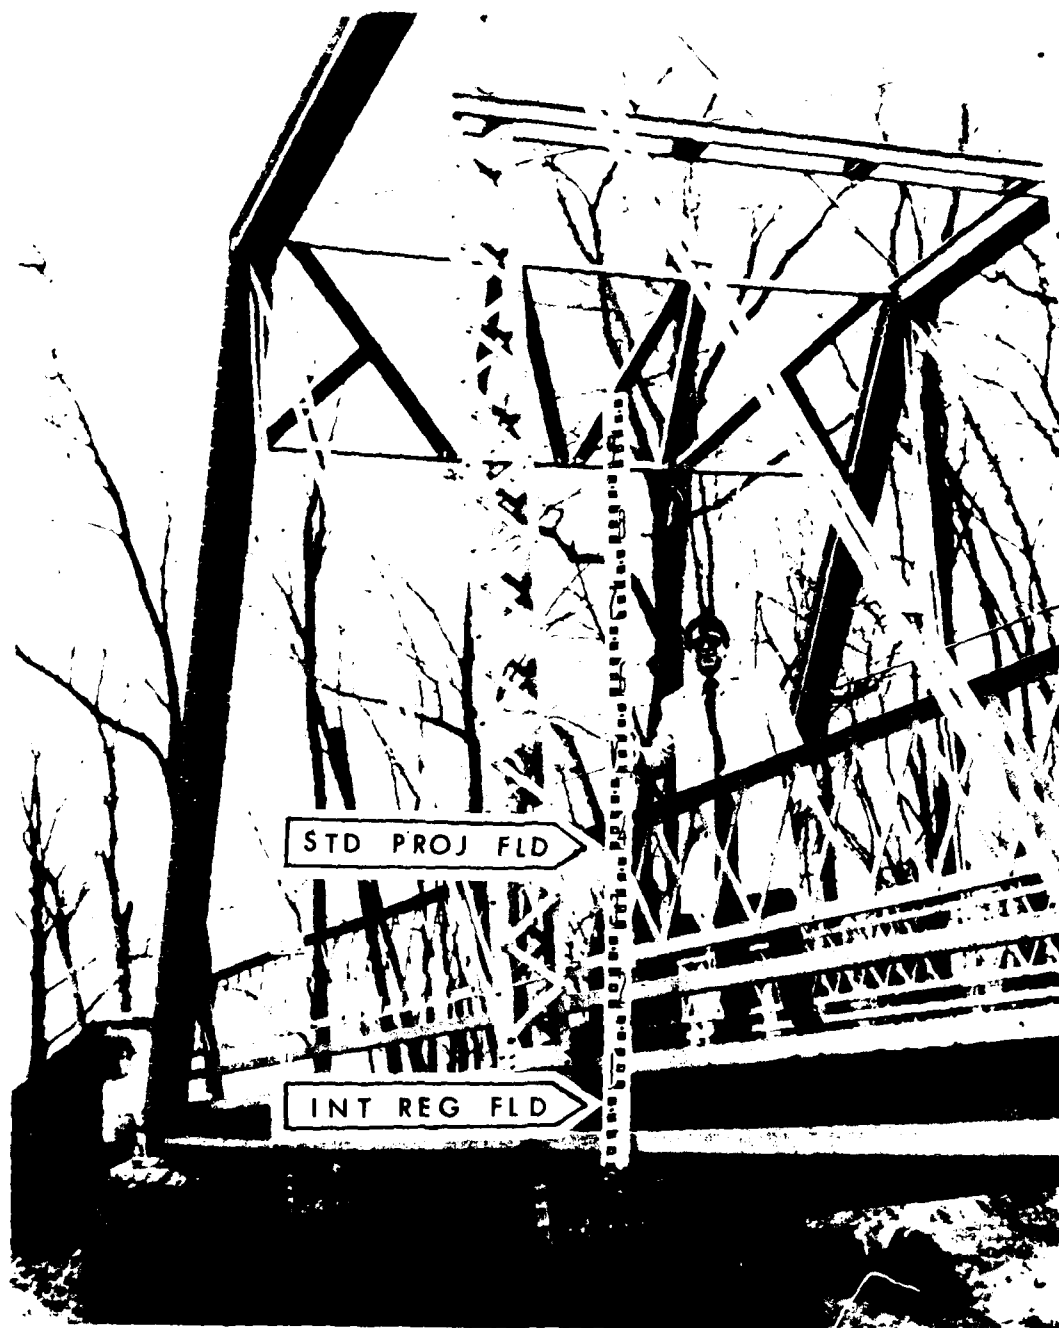
FIGURE 5 - Future flood height on Little Neshaminy Creek at Kansas Road Bridge.
