FLOOD PLAIN INFORMATION; MANTUA CREEK, GLOUCESTER COUNTY, NEW J--ETC(U)

# FLOOD PLAIN INFORMATION

MANTUA CREEK  
GLOUCESTER COUNTY, NEW JERSEY

REPT. NO. DAEN/NAP - 82040/FPI 23-72/11

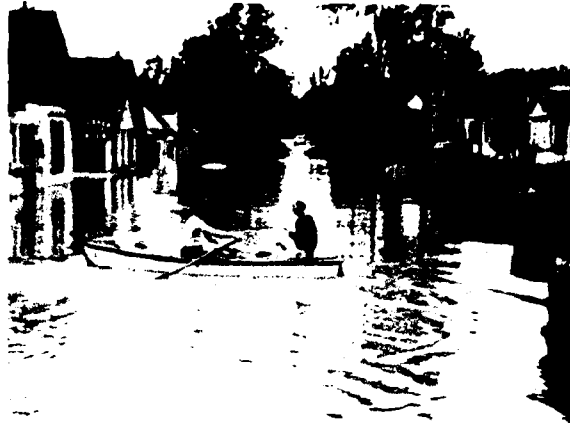
*First Avenue, Mantua Terrace, with flood waters of Mantua Creek; September, 1940*

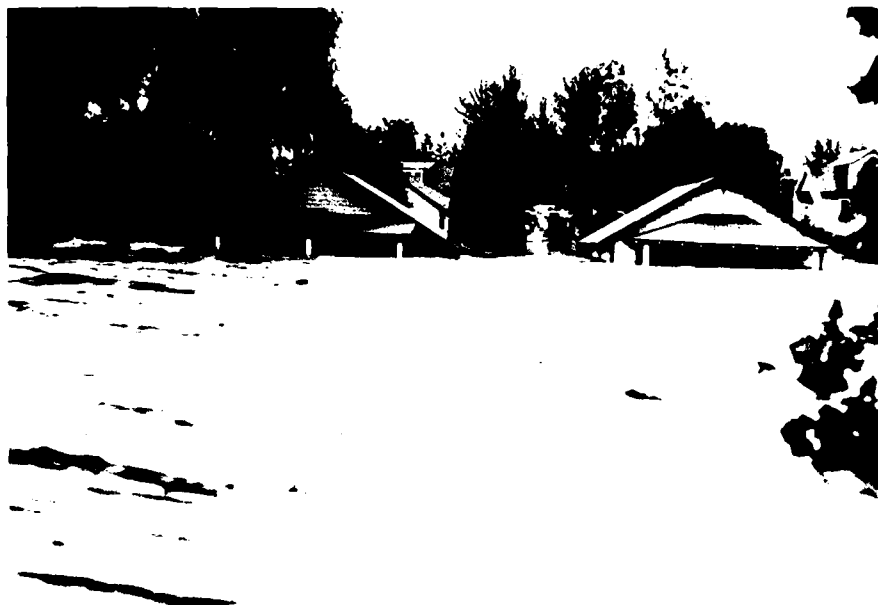
**FIGURE 3 -** Floodwaters of Mantua Creek approach the rooftops of these homes in Mantua Terrace as flooding nears its crest during the September 1, 1940, storm.

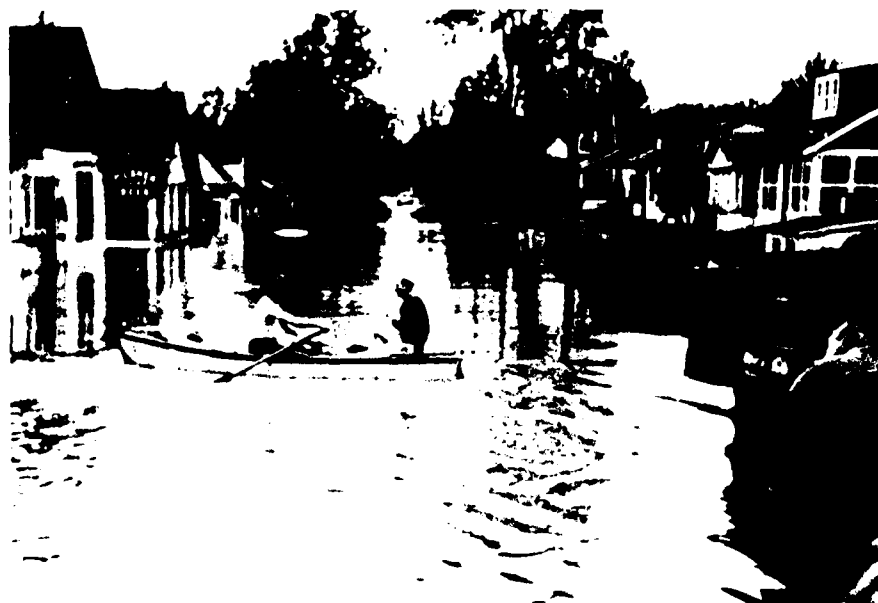
**FIGURE 4 -** Floodwaters on First Avenue, Mantua Terrace, limit transportation to boats.

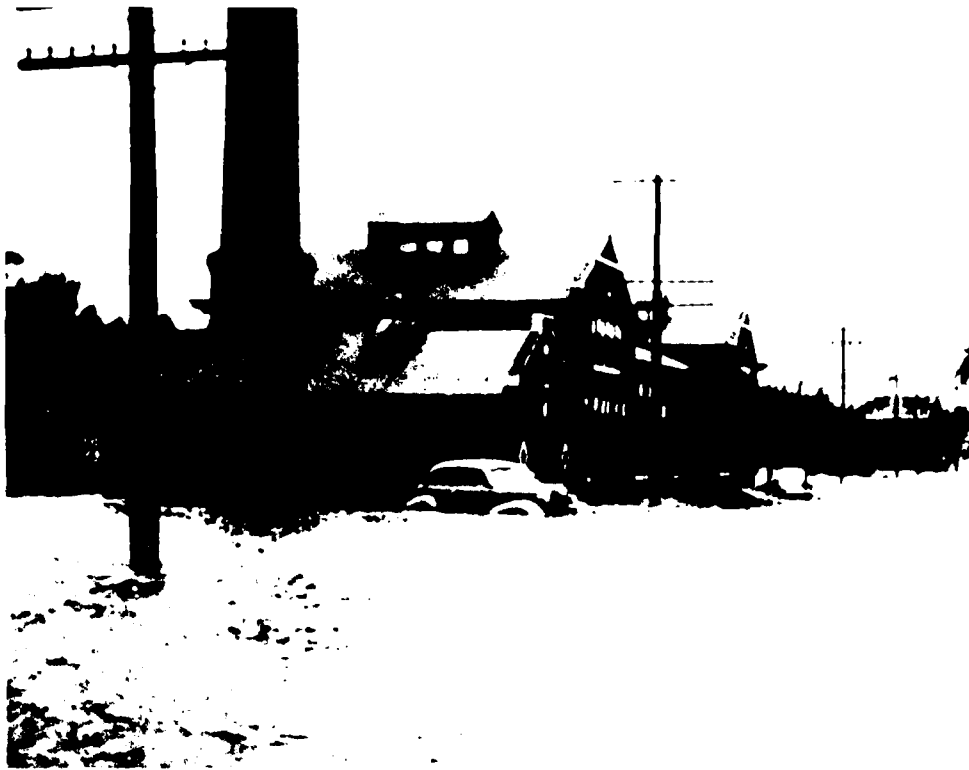
**FIGURE 5 -** This photo of the old Woodbury Water Works on Glassboro Road at Sewell was made September 1, 1940, after floodwaters had receded several feet. Car shown in center was completely submerged at the crest of flooding.

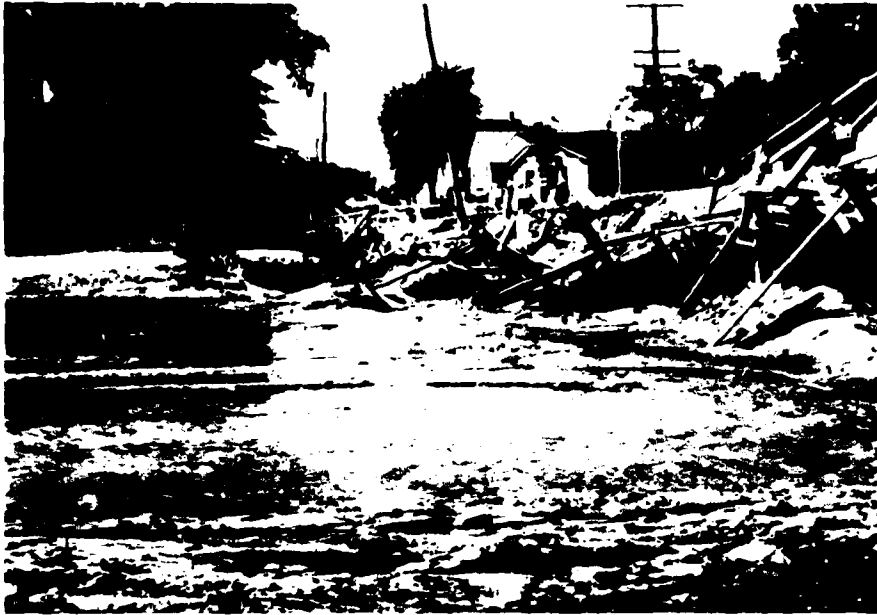
**FIGURE 7** - Floodwaters from the storm of September 1, 1940, caused this damage at Alcyon Lake, Pitman. Fifty feet of embankment was washed out, allowing the water to flow under the roadbed and drain the lake. Photo was taken from a spot in the lakebed which is normally under fifteen feet of water.

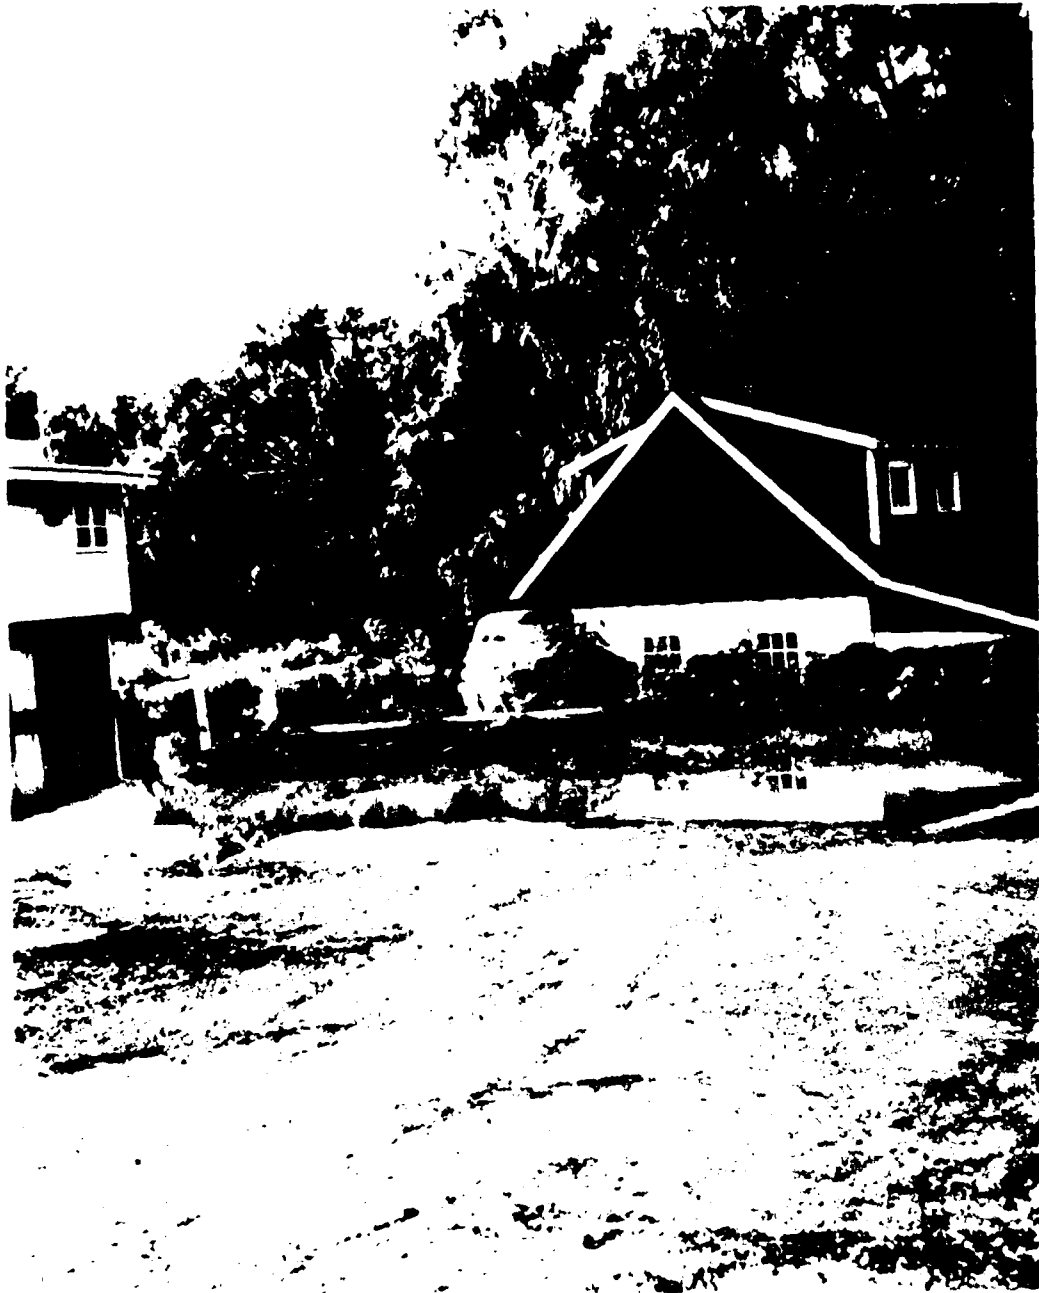
**FIGURE 10** - Floodwaters recede from these properties along Mantua Creek upstream of New Jersey Route 45 following the August 10, 1967, storm. Note the high water mark on both buildings.

(Photographs of flooding that occurred as a result of the August 1967 storm may be found in Figures 9 and 10 on Pages 18 and 19.)

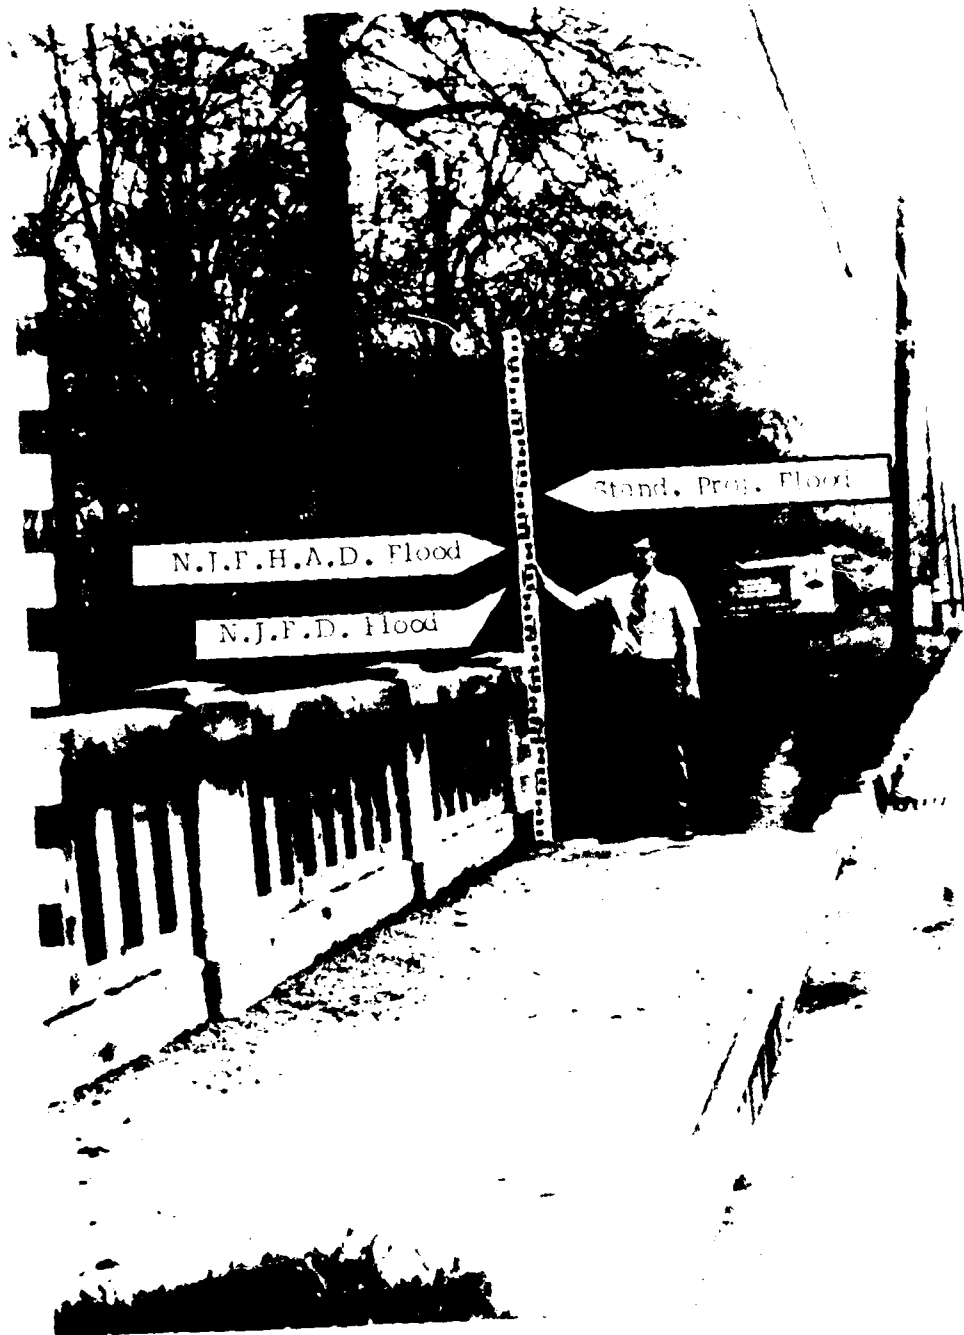
FIGURE 11 - Future flood heights at Delsea Drive (N.J. Rt. 471) bridge on Mantua Creek

**Photographs, future flood heights** - The levels that the Floodway Design, Flood Hazard Area Design, and Standard Project Floods are expected to reach at various locations along Mantua Creek and Chestnut Branch are indicated on the following photographs.
