ARMY ENGINEER DISTRICT PHILADELPHIA PA
FLOOD PLAIN INFORMATION, MILL CREEK, NEW CASTLE COUNTY, DELAWARE--ETC(U)
MAY 73

FLOOD PLAIN INFORMATION

MILL CREEK
NEW CASTLE COUNTY
DELAWARE

PREPARED FOR NEW CASTLE COUNTY DEPARTMENT OF PLANNING
BY CORPS OF ENGINEERS, U.S. ARMY PHILADELPHIA DISTRICT

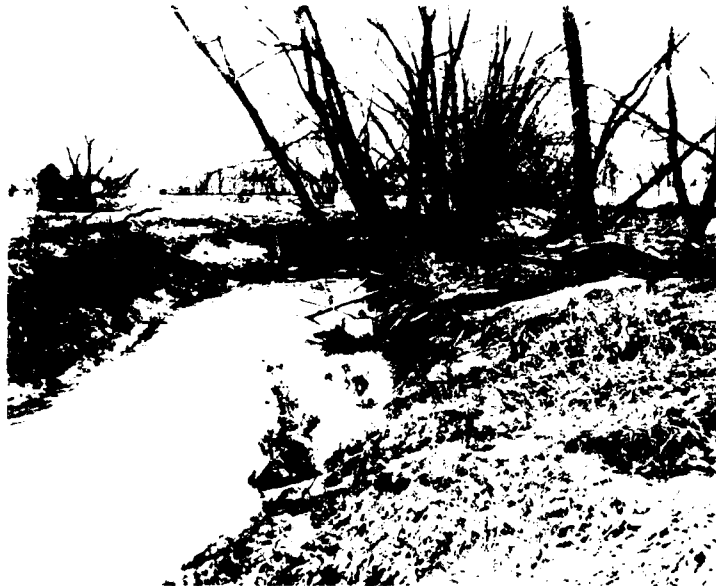
FIGURE 1 - Debris deposited by a recent flood would be obstructive to floodflows.

be washed away and carried downstream to collect on bridges and other obstructions to flow. As floodflow increases, masses of debris break loose and a wall of water and debris surges downstream until another obstruction is encountered. Debris may collect against a bridge until the hydraulic load exceeds the structural capacity and the bridge is destroyed. The limited flow capacity of obstructive bridges or culverts, debris plugs at the culvert mouth or a combination of these factors retard floodflows resulting in flooding upstream, erosion around the culvert entrance and bridge approach embankments and possible damage to the overlying road bed.

Obstructions - During floods, debris collecting on bridges and culverts could decrease their carrying capacity and cause greater water depths (backwater effect) upstream of these structures. Since the occurrence and amount of debris are indeterminate factors, only the physical characteristics of the structures were considered in preparing profiles of the Intermediate Regional and Standard Project Floods. Similarly, the maps of flooded areas

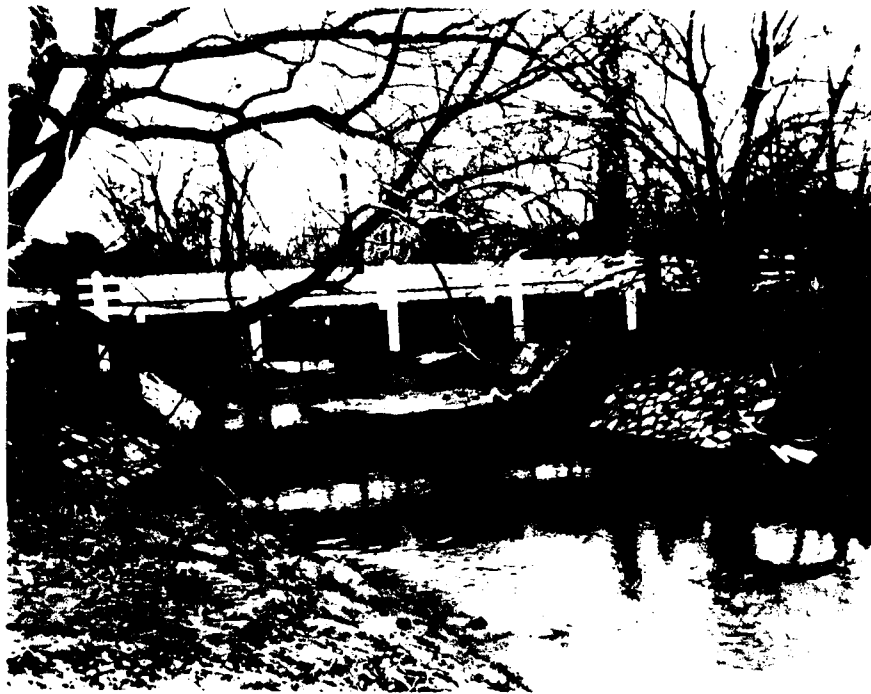
FIGURE 3 - Silt deposit beginning to form and clog right bridge opening.

show the backwater effect of obstructive bridges and culverts, but do not reflect increased water surface elevation that could be caused by debris collecting against the structures, or by deposition of silt in the stream channel under structures. As previously indicated, there are two dams within the study area which have no flood control capacities nor will they seriously alter flow characteristics of floodwaters. Of the twenty-seven bridges crossing the stream in the study area, most of them are obstructive to the Intermediate Regional Flood and all of them are obstructive to the Standard Project Flood as illustrated by the high water profiles on Plates 7 through 9. Table 6 shows water surface elevations at these bridges.

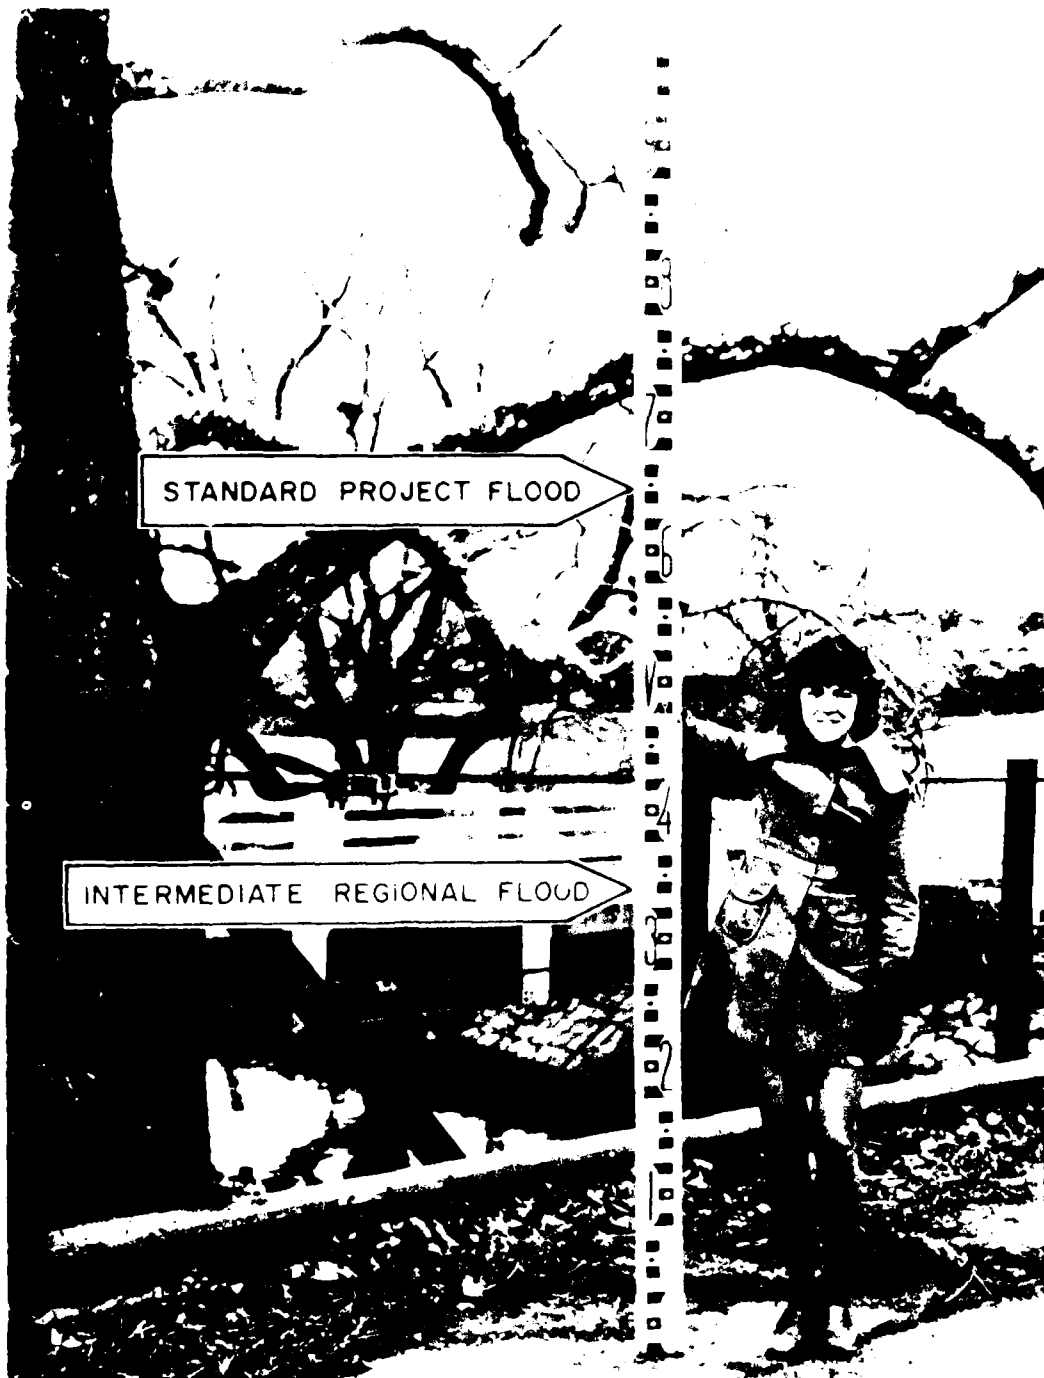
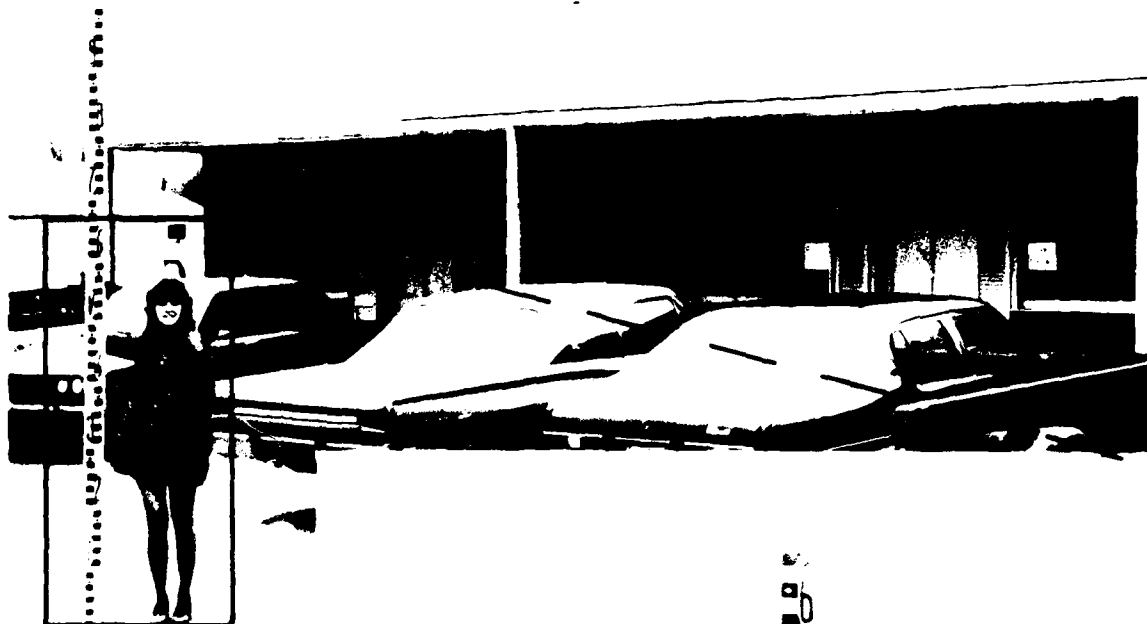
FIGURE 5 - Future flood heights at entrance road to Delaware Park Race Track

STANDARD PROJECT FLOOD
INTERMEDIATE REGIONAL FLOOD

Photographs, future flood heights - The levels that the Intermediate Regional and Standard Project Floods are expected to reach at various locations along Mill Creek are indicated on the following photographs.

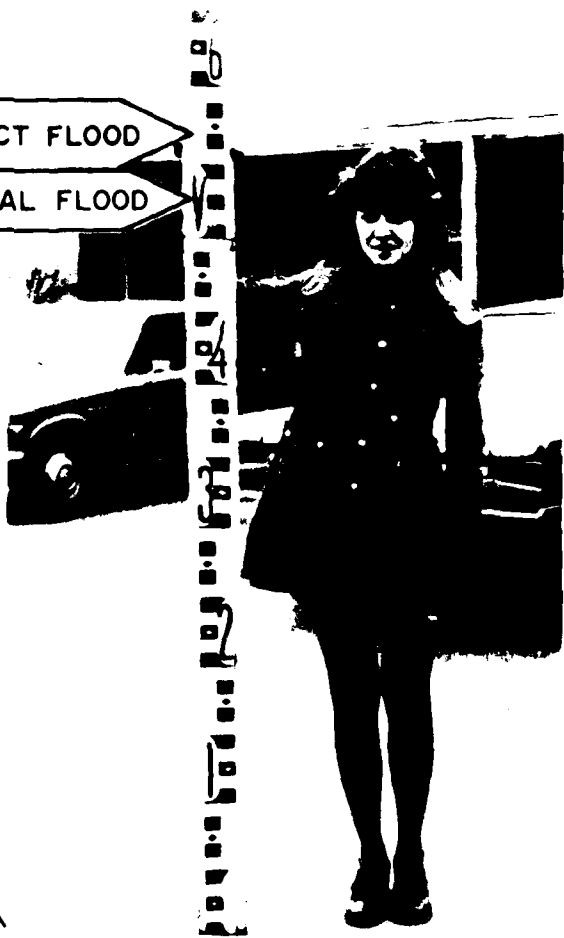
FIGURE 6 - Future flood heights at Presley's Barber Shop near Old Capitol Trail bridge.

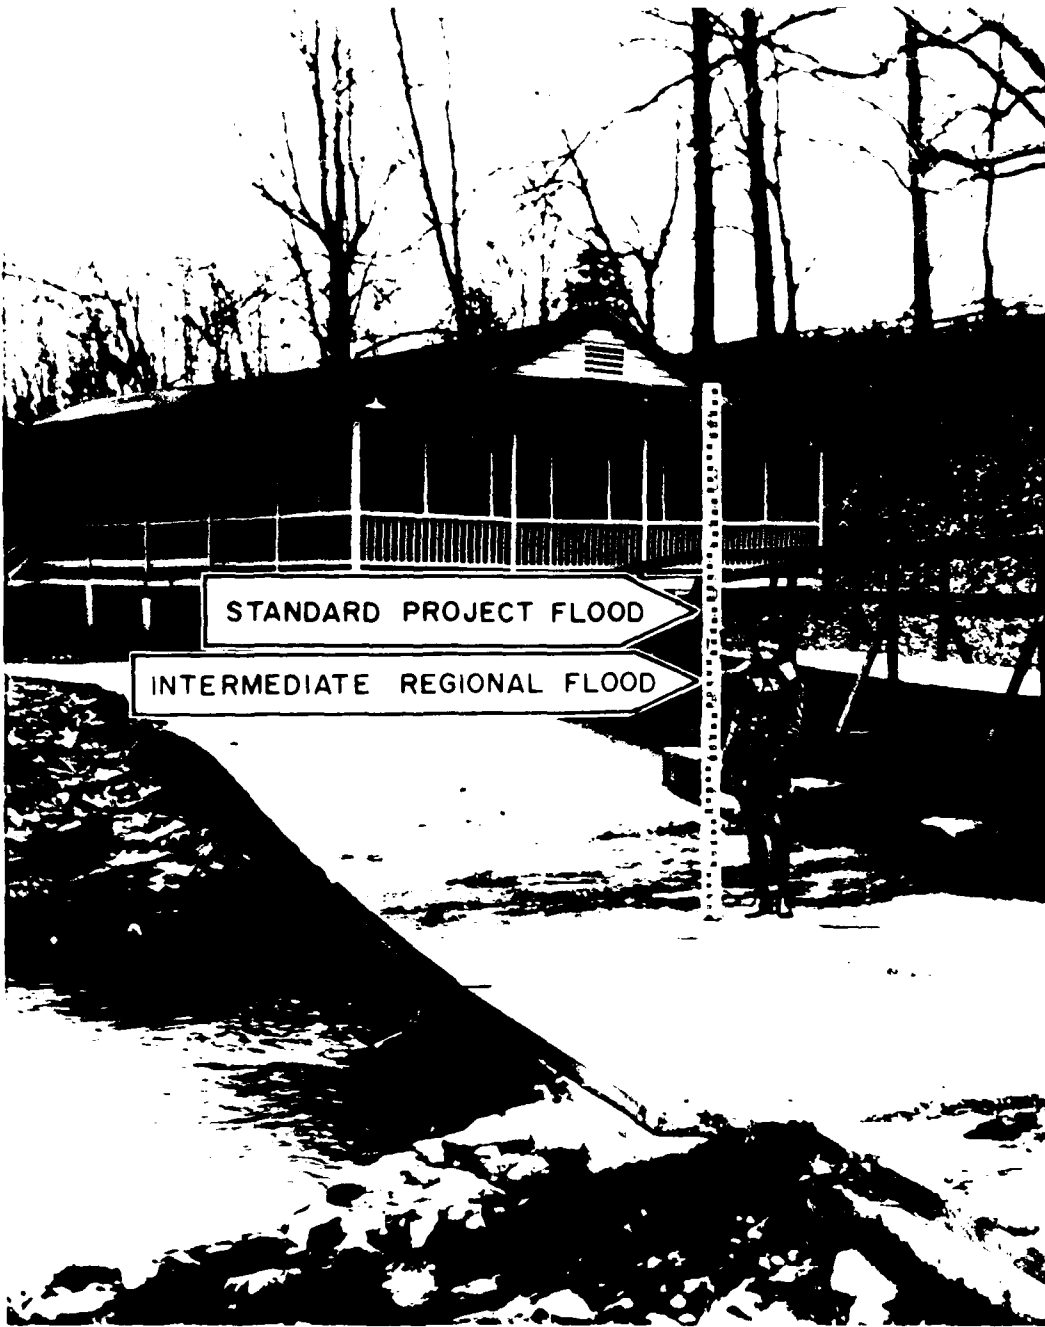
FIGURE 7 - Future flood heights at West End Neighborhood Center Camp.

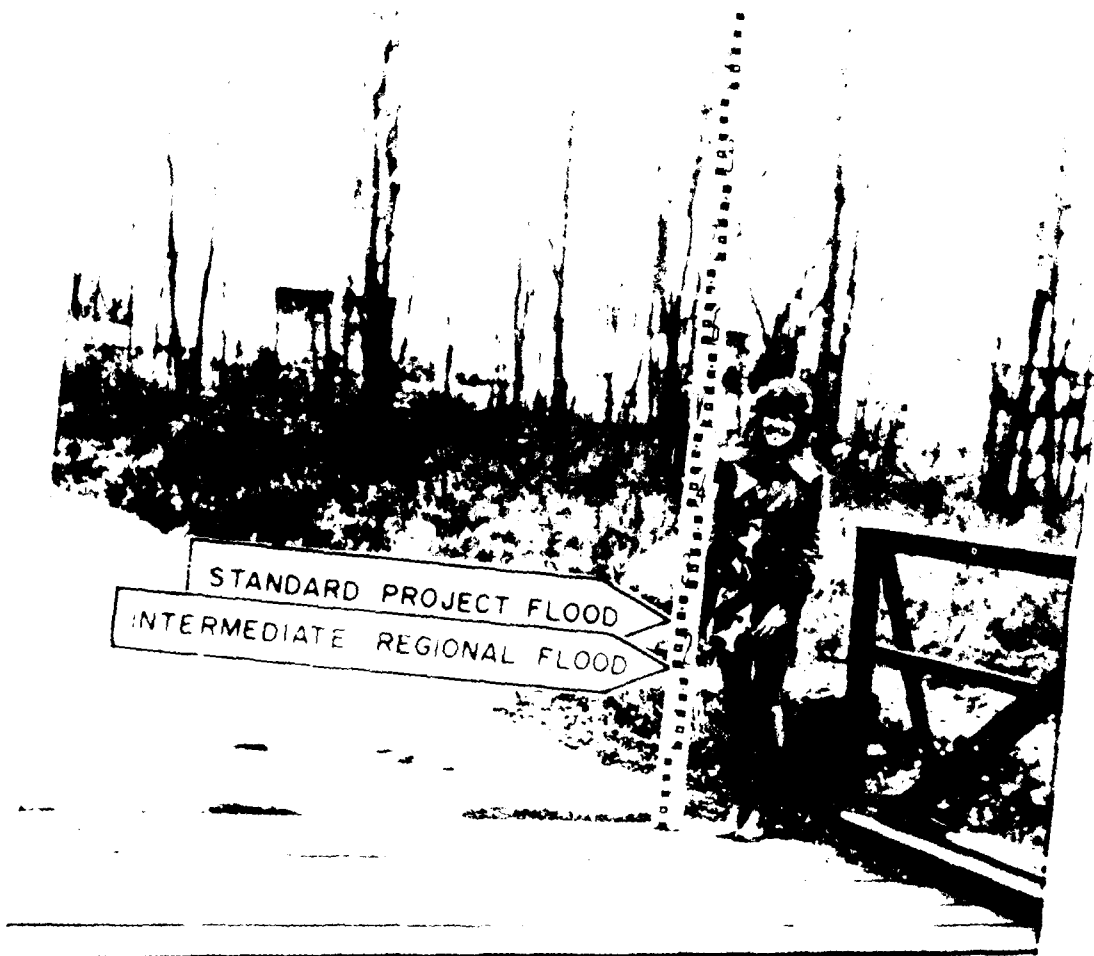
FIGURE 9 - Future flood heights at Mill Creek Road bridge

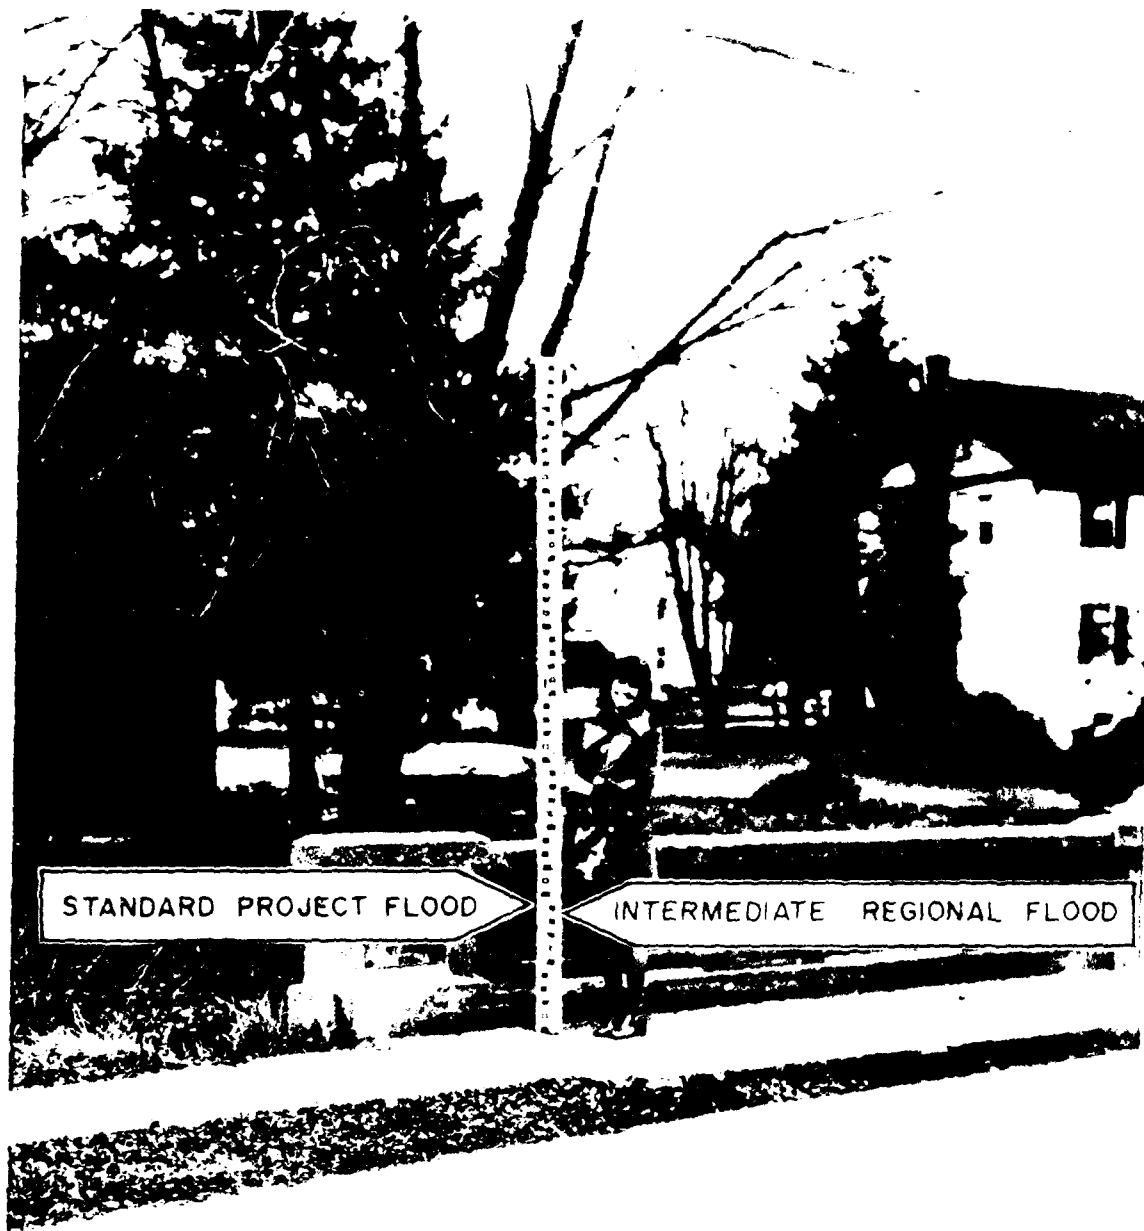
FIGURE 10 Future flood heights at Old Lancaster Pike bridge

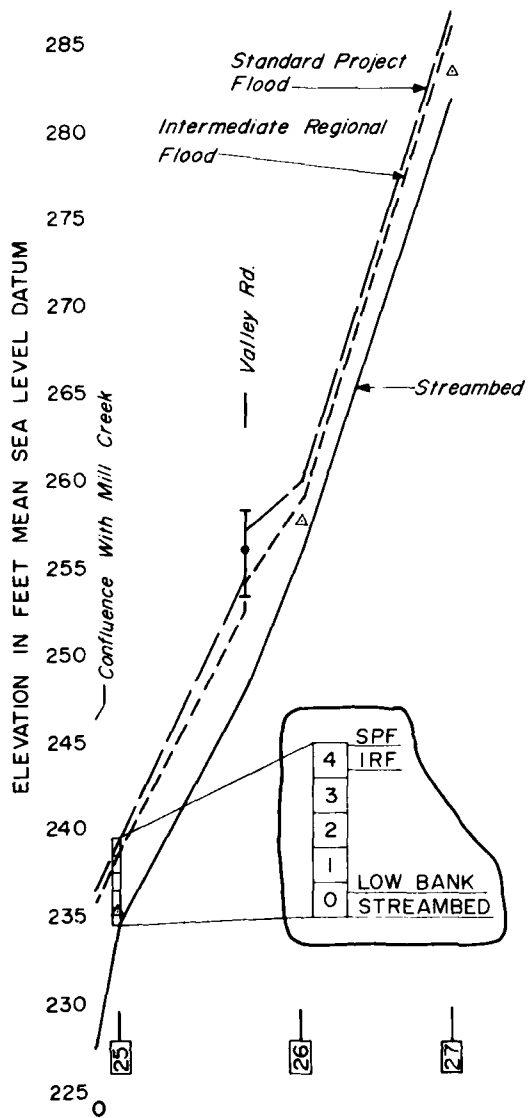
DEPARTMENT OF THE ARMY
 PHILADELPHIA DISTRICT, CORPS OF ENGINEERS
 PHILADELPHIA, PENNSYLVANIA
 FLOOD PLAIN INFORMATION
 MILL CREEK
 NEW CASTLE COUNTY, DEL
 HIGH WATER PROFILES
 WEST BRANCH MILL CREEK
 MAY 1973

The Standard Project Flood is defined as a major flood that can be expected to occur from a severe combination of meteorological and hydrological conditions that is considered reasonably characteristic of the geographical area in which the study area is located, excluding extremely rare combinations. The Corps of Engineers, in cooperation with the NOAA Weather Service, has made comprehensive studies and investigations based on the past records of experienced storms and floods and has developed generalized procedures for estimating the flood potential of streams. Peak discharges for the Standard Project Flood at selected locations in the study area are shown in Table 4. Discharge hydrographs for the Standard Project Flood at the mouth of Mill Creek and at the U.S. Geological Survey Gage near Hockessin are shown on Plate 11. The relative water surface elevations for the Intermediate Regional Flood and the Standard Project Flood are shown on Plates 7 through 9.

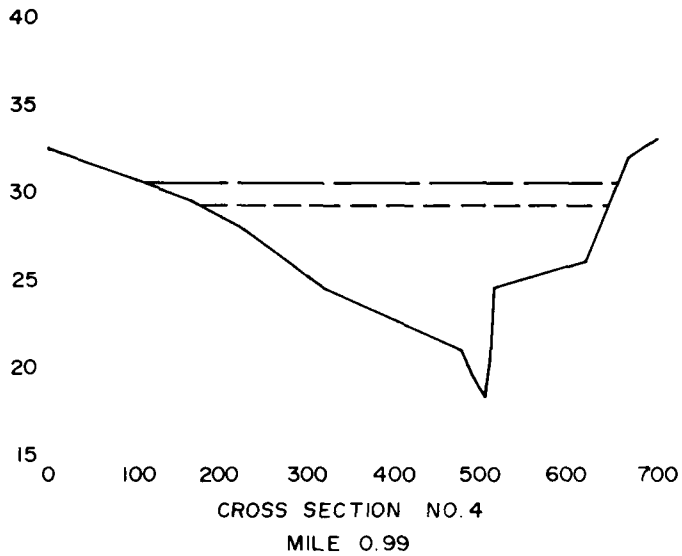
THE 18 SECTIONS ON MILL CREEK AND ITS WEST BRANCH NOT SHOWN IN THIS REPORT ARE ON FILE AT THE PHILADELPHIA DISTRICT, CORPS OF ENGINEERS AND ARE AVAILABLE FOR INSPECTION UPON REQUEST
CROSS SECTIONS TAKEN LOOKING DOWNSTREAM

DEPARTMENT OF THE ARMY
PHILADELPHIA DISTRICT, CORPS OF ENGINEERS
PHILADELPHIA, PENNSYLVANIA
FLOOD PLAIN INFORMATION
MILL CREEK
NEW CASTLE COUNTY, DEL.
SELECTED CROSS SECTIONS

Flooded areas and flood damages - The areas along Mill Creek that would be flooded by the Standard Project Flood are shown on Plate 2 which is also an index map to Plates 3 through 6. Areas that would be flooded by the Intermediate Regional Flood and the Standard Project Flood are shown in detail on Plates 3 through 6. The actual limits of these overflow areas may vary somewhat from those shown on the maps because the 10-foot contour interval and scale of the maps do not permit precise plotting of the flooded area boundaries. The areas that would be flooded by the Intermediate Regional and Standard Project floods include commercial and residential properties, along with associated streets and roads. Considerable damage to the facilities would occur during an Intermediate Regional Flood. However, due to the wider extent, greater depths of flooding, higher velocity flow and longer duration of flooding during a Standard Project Flood, damage would be more severe than during an Intermediate Regional Flood. Plates 7 through 9 show the water surface profiles for the Intermediate Regional and Standard Project Floods. Depth of flow in the channel can be estimated from these illustrations. Cross sections of the flood plain at selected locations, together with the water surface elevation and lateral extent of the Intermediate Regional and the Standard Project Floods are shown on Plate 10.

Velocities of flow - Water velocities during floods depend largely on the size and shape of the cross sections, conditions of the stream, and the bed slope, all of which vary on different streams and at different locations on the same stream. During an Intermediate Regional Flood, velocities of main channel flow in the study area would typically average 8 to 9 feet per second. Water flowing at this rate is capable of causing severe erosion to stream banks and fill around bridge abutments and capable of transporting large objects. It is expected that velocity of main channel flow during a Standard Project Flood would be slightly higher than during an Intermediate Regional Flood. During these floods, the velocity of overbank flow in the study area would average 1 to 2 feet per second. Water flowing at 2 feet per second or less would deposit debris and silt. Table 7 lists the maximum velocities that would occur in the main channel and overbank areas of Mill Creek for selected cross sections during the Intermediate Regional and the Standard Project Floods.
