FLOOD PLAIN INFORMATION

**EAST BRANCH
PERKIOMEN CREEK**

**BUCKS COUNTY
PENNSYLVANIA**

PREPARED FOR
BUCKS COUNTY PLANNING COMMISSION
AND
PENNSYLVANIA DEPARTMENT OF FORESTS AND WATERS
BY
CORPS OF ENGINEERS, U. S. ARMY
PHILADELPHIA DISTRICT
JANUARY 1971

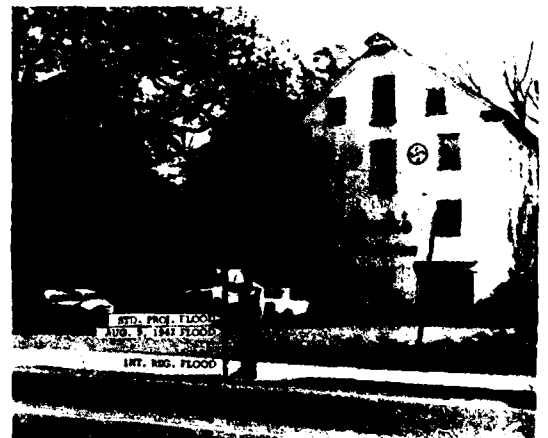
Photograph 2 - Past and future flood heights in the vicinity of U. S. Rt. 309 bridge at Sellersville.

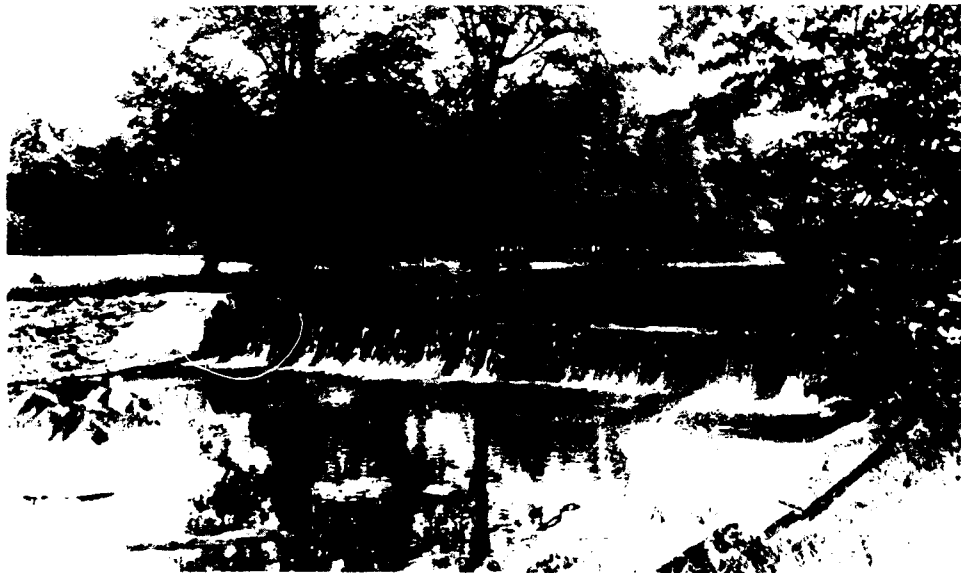
Figure 1. --DAMS ACROSS EAST BRANCH PERKIOMEN CREEK

Top view is Dam No. 2 located below the Montgomery - Bucks County Line. Bottom view is Dam No. 4 located in Lenape Park at Sellersville, Pa.

Dam No. 2 is also located in Montgomery County about 0.28 mile above Dam No. 1 and 0.46 mile below the Montgomery - Bucks County Line. It is also an old dam of rock construction with some concrete mortar and is in poor condition. The dam has a width of about 200 feet and varies from 3.5 to 4 feet in height. A shallow ponded area extends about 500 feet above the dam and has an average width of about 100 feet. The center and left bank sections of the dam have been ruptured to a considerable extent. The dam was built in the late 1920's to serve a YMCA summer camp for recreational purposes. It is now privately owned.

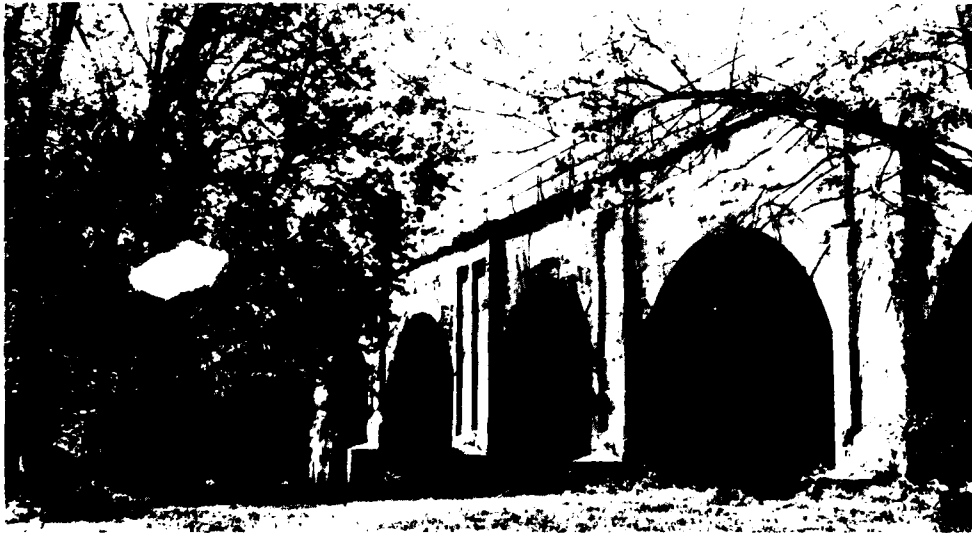
Figure 2. --BRIDGES ACROSS EAST BRANCH PERKIOMEN CREEK

Top view is the downstream side of Cowpath Road bridge at Mile 0.47. Bottom view is the downstream side of the multi-arch Reading Railroad bridge at Mile 3.83.

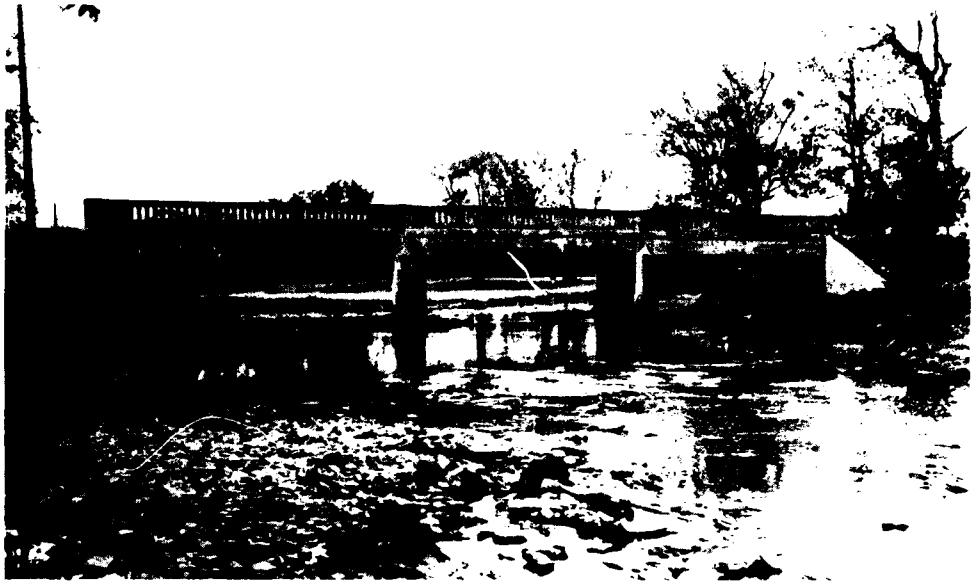
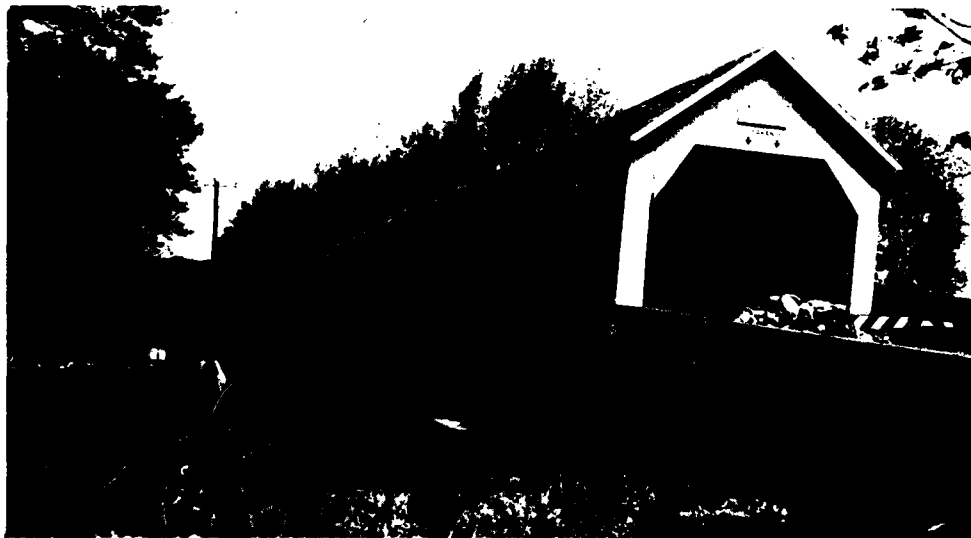
Figure 3.--BRIDGES ACROSS EAST BRANCH PERKIOMEN CREEK
Top view is the upstream side of Main Street bridge in Sellersville.
Bottom view is Moods covered bridge at Mile 6.89.

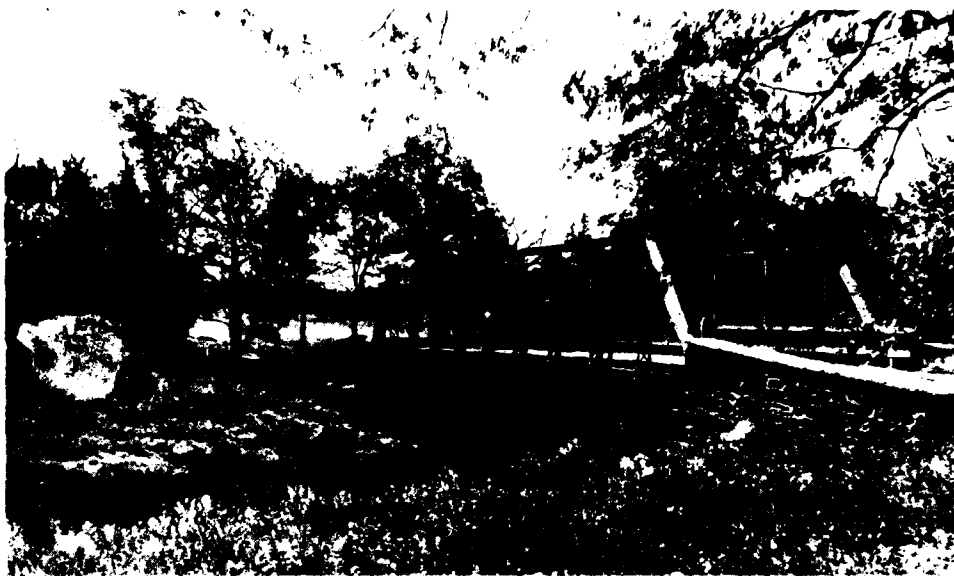
Figure 4. --BRIDGES ACROSS EAST BRANCH PERKIOMEN CREEK

Top view is the downstream side of the Schwenk Mill Road bridge at Mile 7.94. Bottom view is the upstream side of Doylestown Road (Pa. Rt. 313) bridge at Mile 8.94.

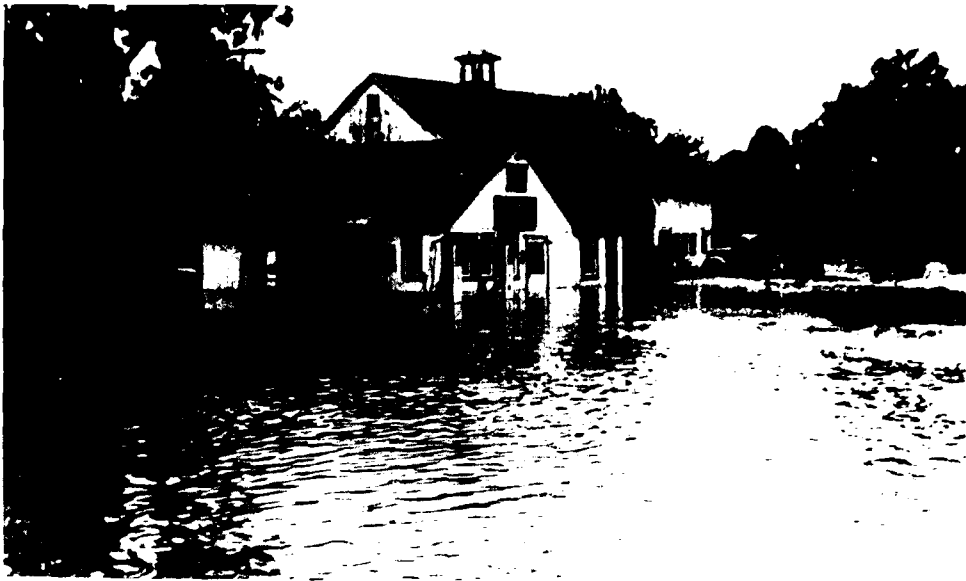
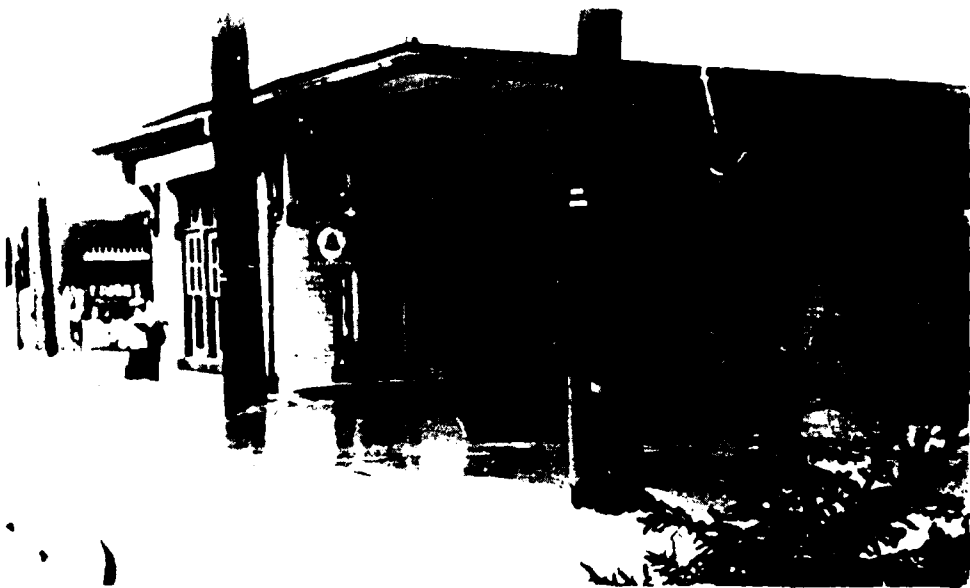
Figure 5.--FLOOD PHOTOGRAPHS IN SELLERSVILLE, PENNSYLVANIA
Photographs show the August 9, 1942 flood in the Sellersville area .

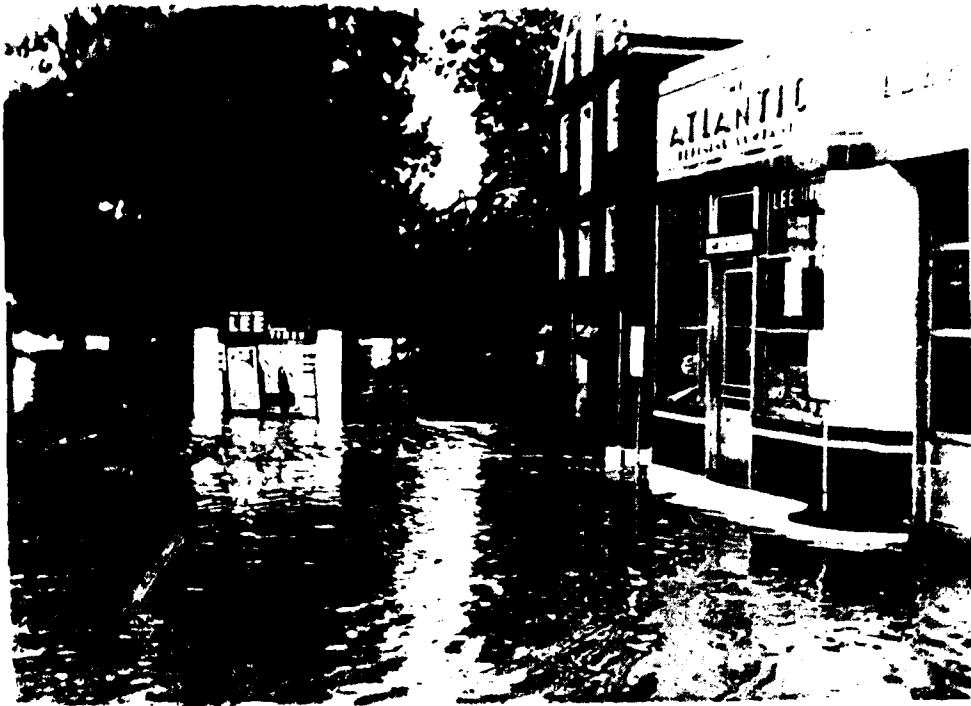
Figure 6.--FLOOD PHOTOGRAPH IN SELLERSVILLE, PENNSYLVANIA
Photograph shows the August 9, 1942 flood in the Sellersville area.

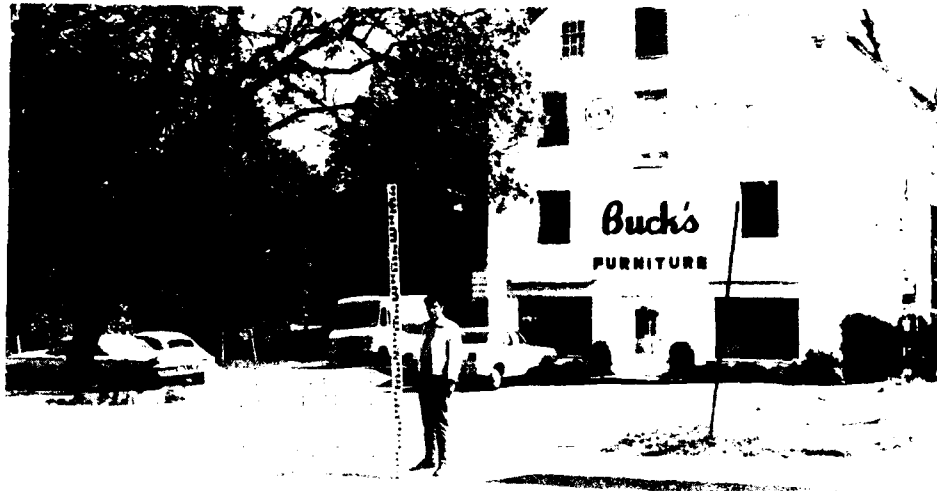
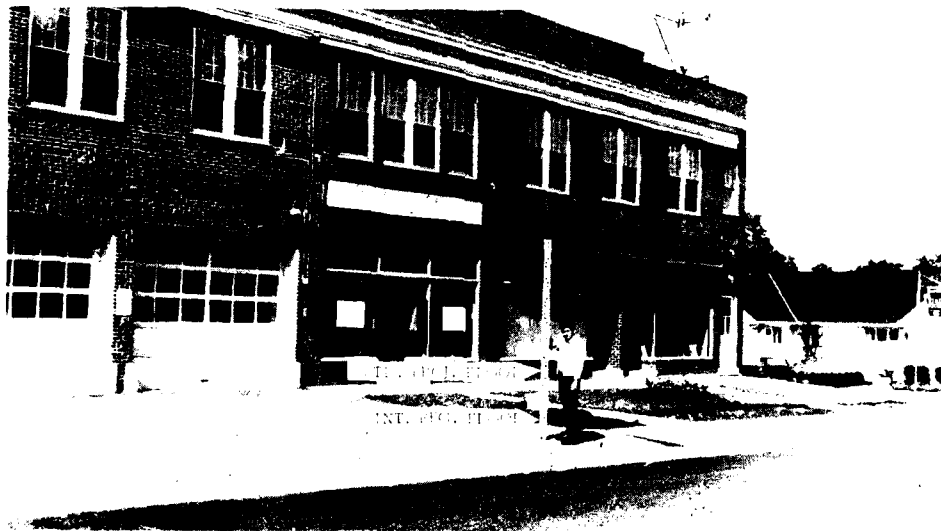
Figure 7.--FLOOD HEIGHTS ALONG EAST BRANCH PERKIOMEN CREEK

Top view is in front of Bucks Furniture Store; the arrows indicate the heights the Standard Project and the Intermediate Regional Floods could reach and the height of the 1942 flood. Bottom view was taken at the Sellersville Fire Co.; the arrows indicate the heights the Standard Project and Intermediate Regional Floods would reach.

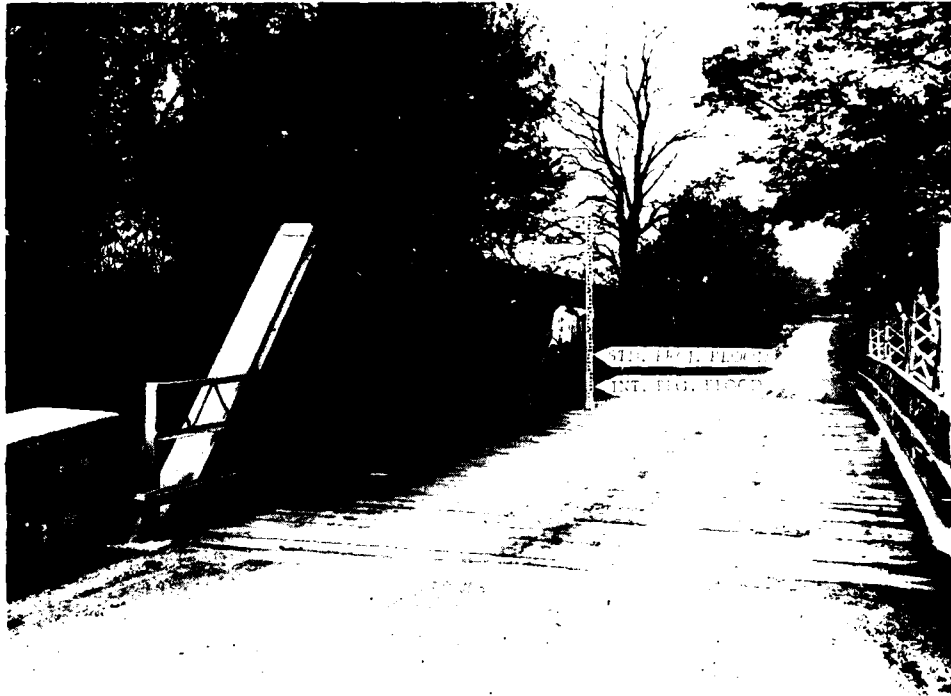
FIGURE 8.--FLOOD HEIGHTS ALONG EAST BRANCH PERKIOMEN CREEK

The arrows indicate the heights that the Standard Project and Intermediate Regional Floods could reach at Bucks Road Bridge.
