FLOOD PLAIN INFORMATION

MILL CREEK AND IRONWORKS CREEK BUCKS COUNTY, PENNSYLVANIA

PREPARED FOR THE BUCKS COUNTY PLANNING COMMISSION BY THE DEPT. OF THE ARMY,
PHILADELPHIA DISTRICT, CORPS OF ENGINEERS, PHILADELPHIA, PA.

REPT. NO: DAEN/MAR-82040 | MAY 1974 | FPI 27-74/05

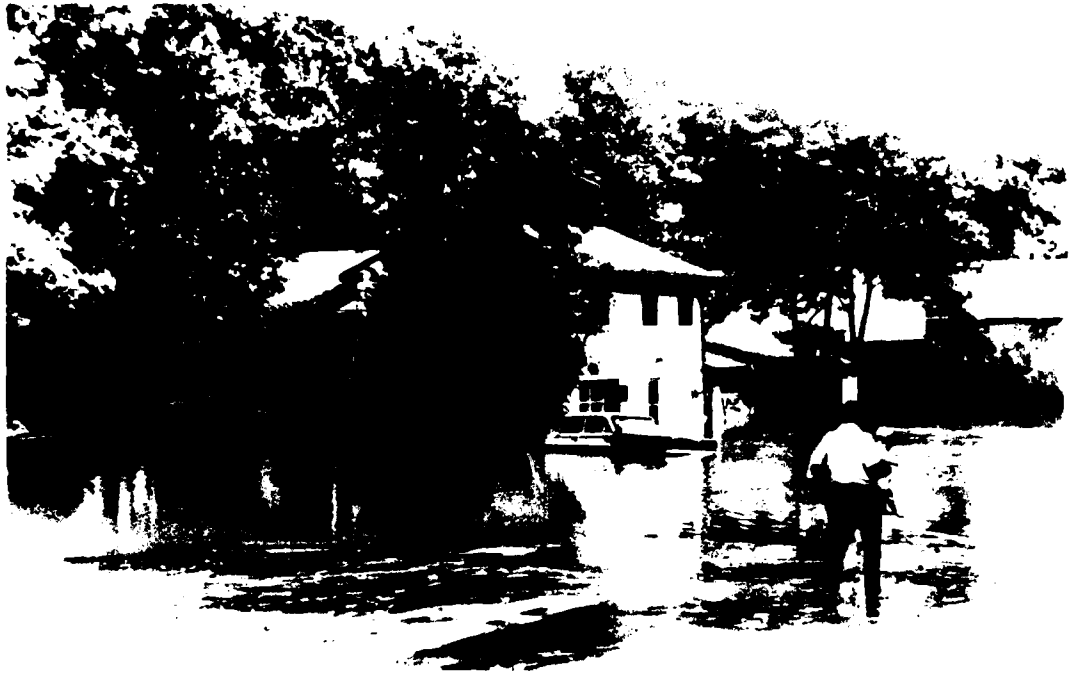
FIGURE 3 - Floodwaters from the August 28, 1971, flood surround the Valley Stream Bar and Restaurant located on Bridgetown Pike. (Photo from September 2, 1971, issue of *Delaware Valley Advance*).

August 28, 1971 - A fairly uniform rainfall distribution resulting from the passage of Tropical Storm Doria through Bucks County produced the sixth highest flood of record in the Neshaminy Basin. Personal interviews with residents along Mill Creek indicate that flooding caused major damage. Although the flood level was known by one resident to be less than that of August 19, 1955, the Mill Race Restaurant at Buck Road had nearly 18 inches of floodwater in its lower dining room. The Valley Stream Restaurant at Bridgetown Pike also sustained considerable damage as seen in Figure 3 on Page 13.

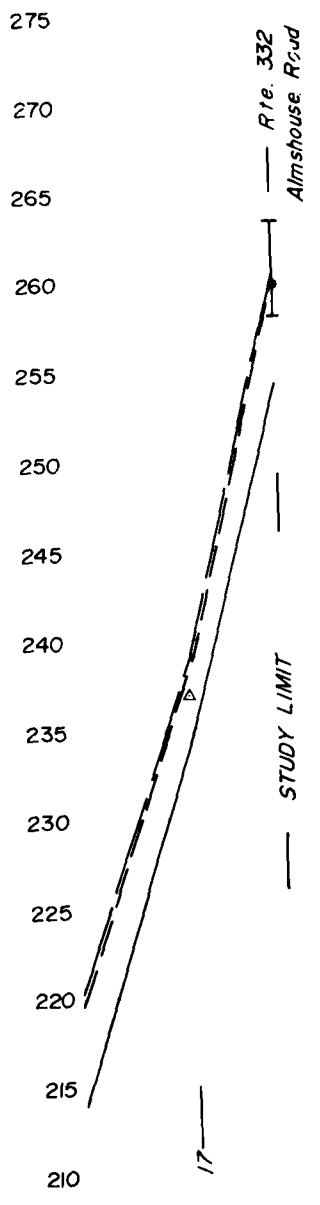
DEPARTMENT OF THE ARMY
PHILADELPHIA DISTRICT, CORPS OF ENGINEERS
PHILADELPHIA, PENNSYLVANIA
FLOOD PLAIN INFORMATION
MILL CREEK & IRONWORKS CREEK
BUCKS COUNTY, PA.
HIGH WATER PROFILE
IRONWORKS CREEK

The Standard Project Flood is defined as a major flood that may be expected to occur from a severe combination of meteorological and hydrological conditions that is considered reasonably characteristic of the geographical area in which the study area is located, excluding extremely rare combinations. The Corps of Engineers, in cooperation with the NOAA Weather Service, has made comprehensive studies and investigations based on the past records of experienced storms and floods and has developed generalized procedures for estimating the flood potential of streams. Peak discharges for the Standard Project Flood at selected locations in the study area are shown in Table 3. Discharge hydrographs for the Standard Project Flood at the mouths of Mill Creek and Ironworks Creek are shown on Plate 10. The relative water surface elevations for the Intermediate Regional Flood and the Standard Project Flood are shown on Plates 7 and 8.

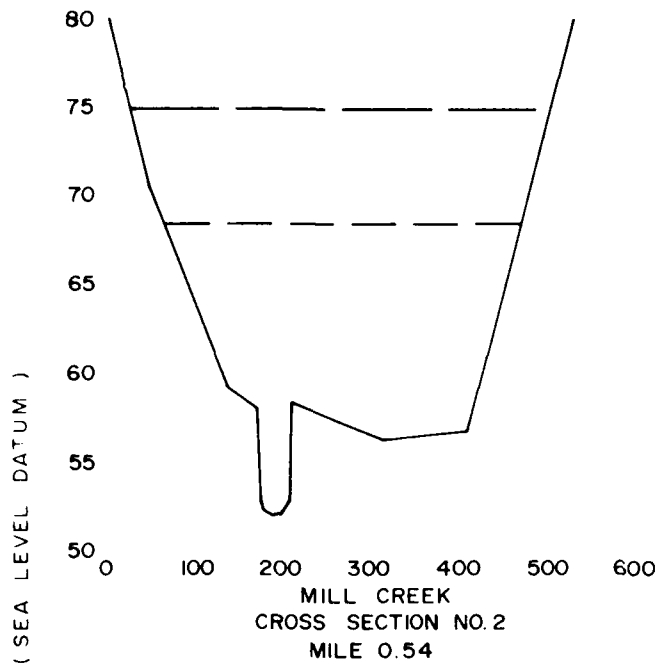
NOTES:
1. The 11 sections on Mill Creek and Ironworks Creek not shown in this report are on file at the Philadelphia District, Corps of Engineers and are available for inspection upon request.
2. Cross sections taken looking downstream.

DEPARTMENT OF THE ARMY
PHILADELPHIA DISTRICT, CORPS OF ENGINEERS
PHILADELPHIA, PENNSYLVANIA
FLOOD PLAIN INFORMATION
MILL CREEK AND IRONWORKS CREEK
BUCKS COUNTY, PA.
SELECTED CROSS SECTIONS
MILL CREEK AND IRONWORKS CREEK
