AMMRC TR 81-14

BRITTLE MATERIALS DESIGN, HIGH TEMPERATURE GAS TURBINE

Technical Report By:

Final Report, July 1, 1971 to August 31, 1979

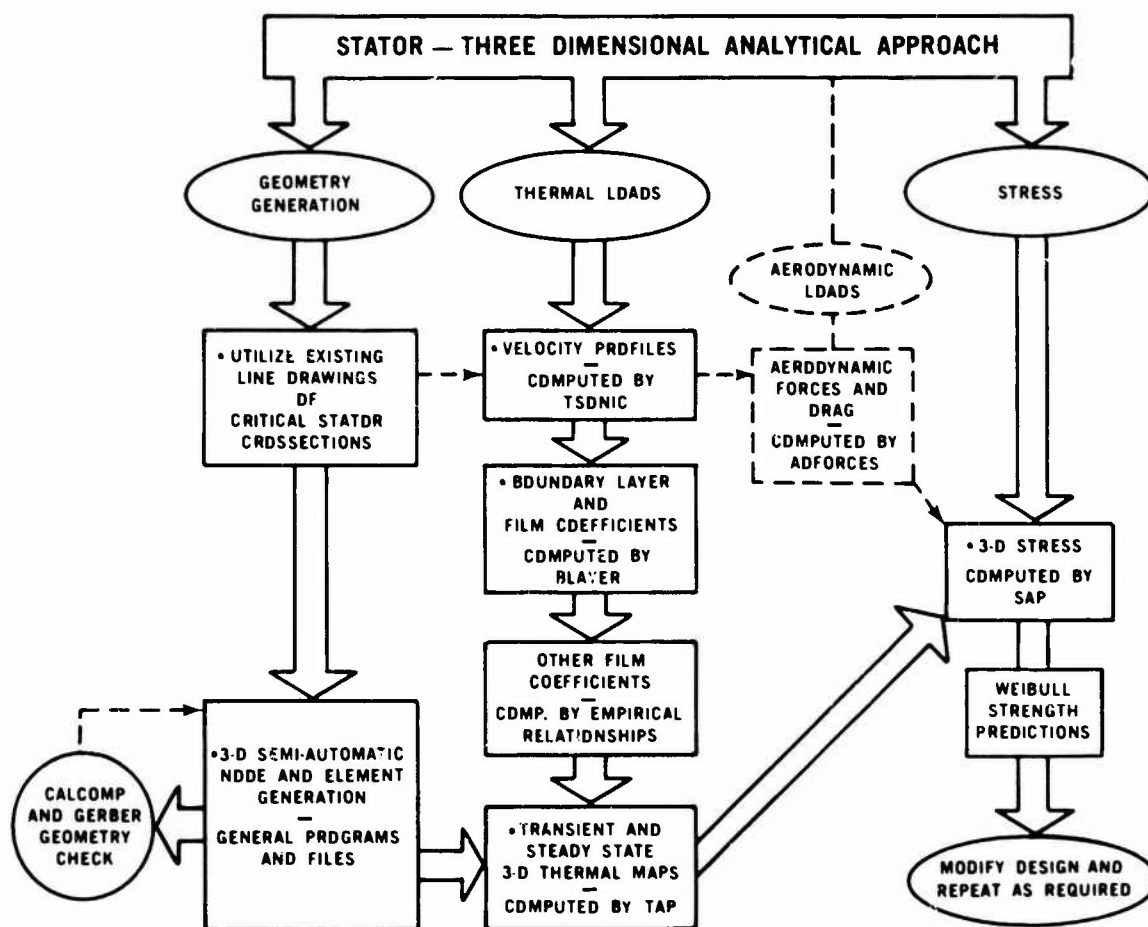
Figure 3.1.2-9 — Schematic Diagram of Three Dimensional Analytical Process as Applied to Ceramic Stator

All five programs (TAP, SAP III, TSONIC, BLAYER and ADFORCE) compose the basic units of an analytical process devised for the three-dimensional analysis of turbine flowpath components. A schematic diagram of the process developed for the stator study is displayed in Figure 3.1.2-9. The three-dimensional finite element models generated and used in the analysis of the first stage rotor and stator are displayed in Figures 3.1.2-5 and 3.1.2-10. The stator model, as shown, was generated by the Lawrence Livermore Laboratories under a separate ARPA contract.

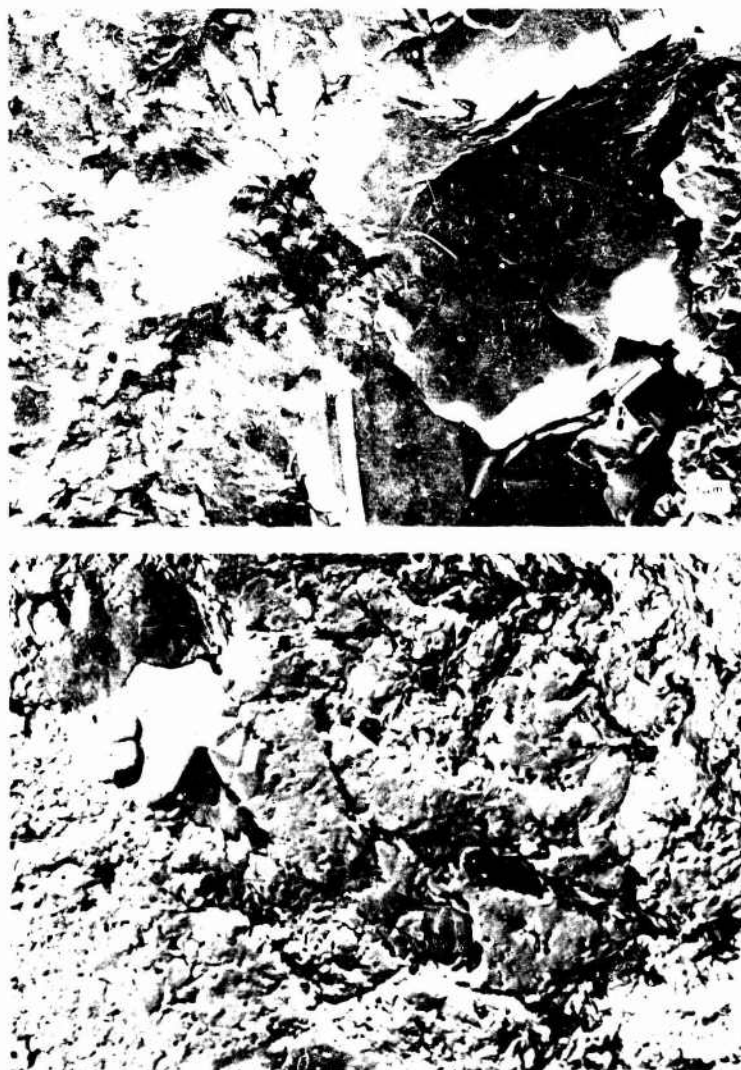
Figure 3.2.1-14 — Microstructure of RBSN Showing Effect of Changes in the Two Stage Nitriding Cycle

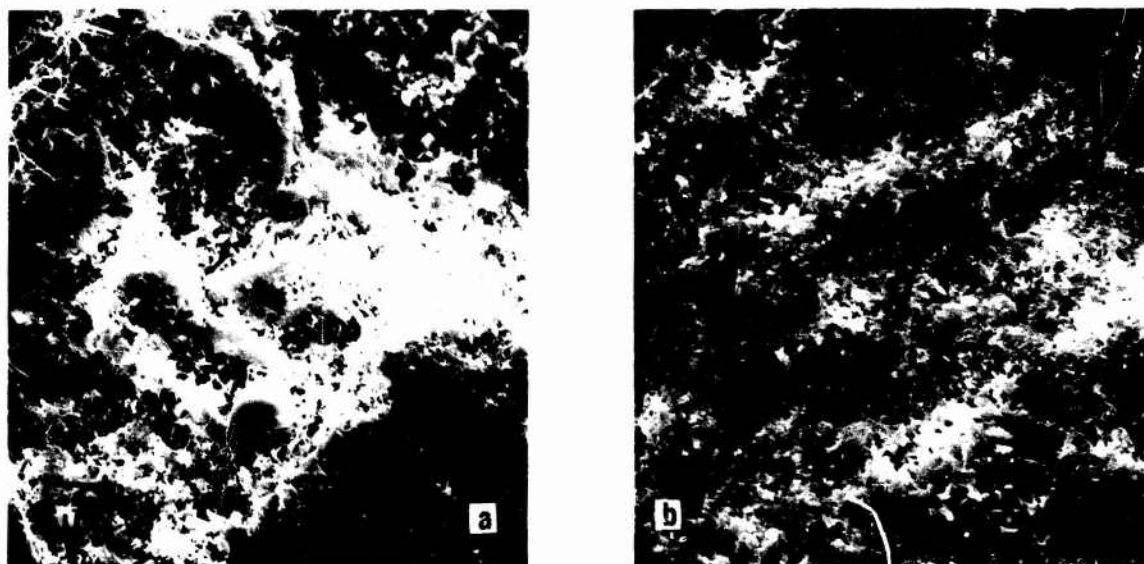
Figure 3.2.1-15 — Microstructure of RBSN, Nitrided Using the Constant Rate Cycle, Showing Effect of an Atmosphere of 100% Nitrogen (Left) and an Atmosphere of 96% Nitrogen, 4% Hydrogen (Right)

The third type of cycle, the constant rate cycle, increases the temperature at about 3°C/hour.(8,9,10,32) It has been shown to change the nitriding kinetics.(11,33) Material showed no immediate improvement when nitrided in a 100% nitrogen (N₂) atmosphere. However, when a hydrogen/nitrogen (H₂/N₂) atmosphere was present, strength increased by 50%, again due to an improved microstructure, as shown in Figure 3.2.1-15.

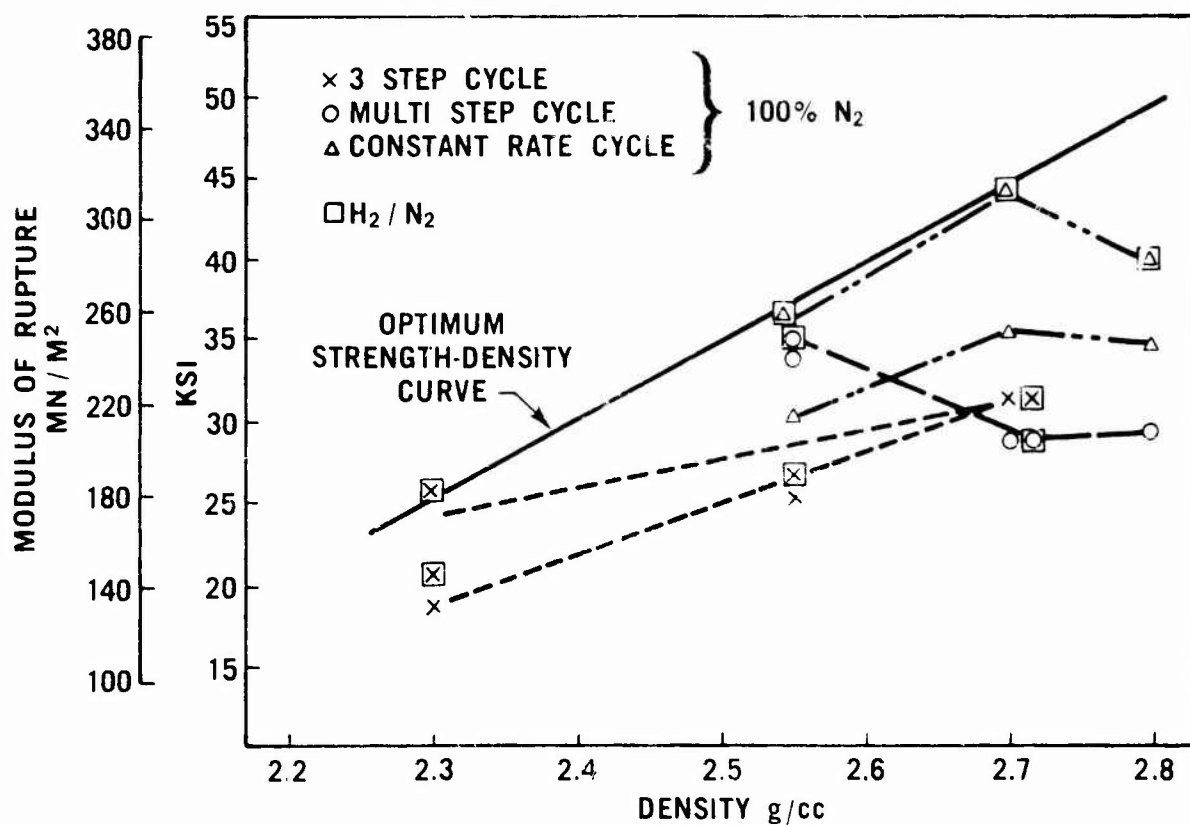
Figure 3.2.1-17 — Effect of Various Nitriding Cycles and Atmospheres Upon Strength of RBSN as a Function of Nitrided Density

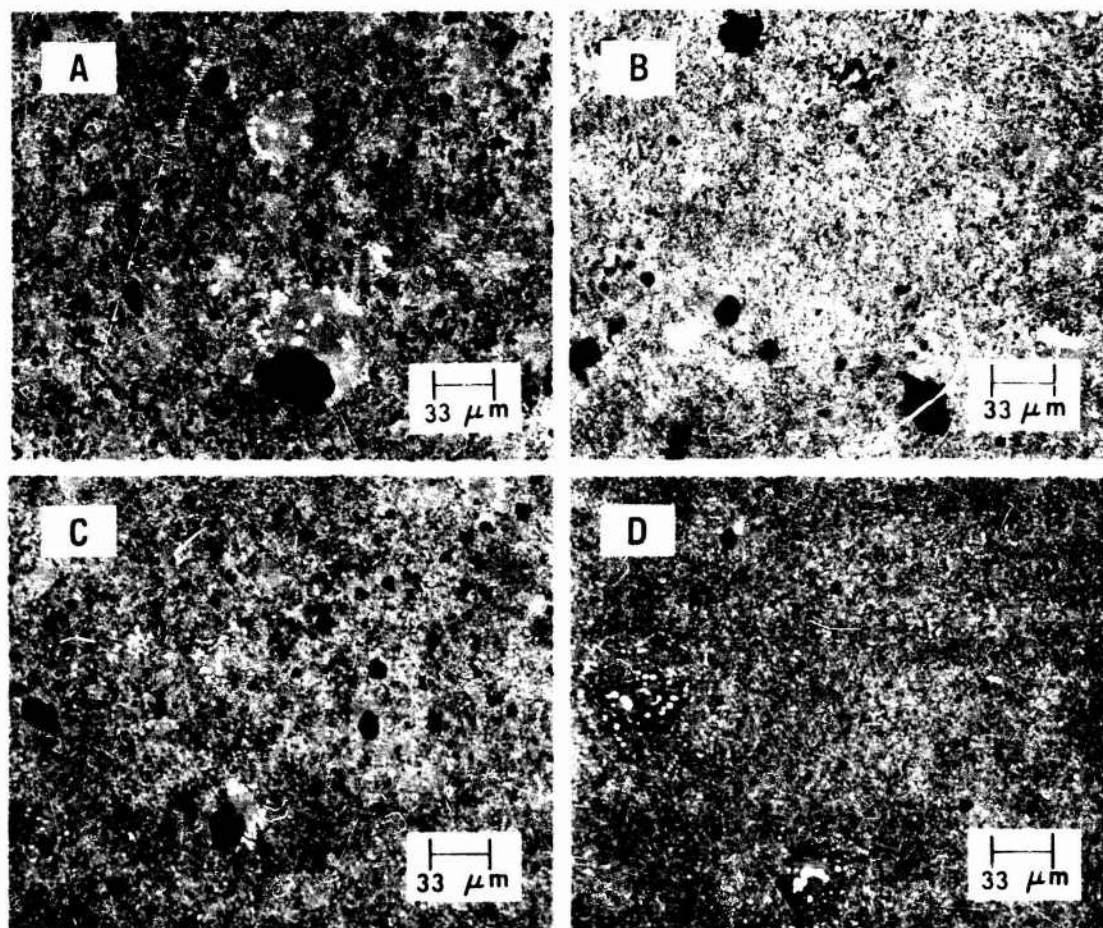
Figure 3.2.1-19 — Optical Micrographs of 2.7 g/cc Density RBSN

The micrographs shown in Figures 3.2.1-19 (A-D), show some degree of silicon melting due to the exotherm. Figure 3.2.1-19D shows the improvement observed by using a H_2/N_2 atmosphere.

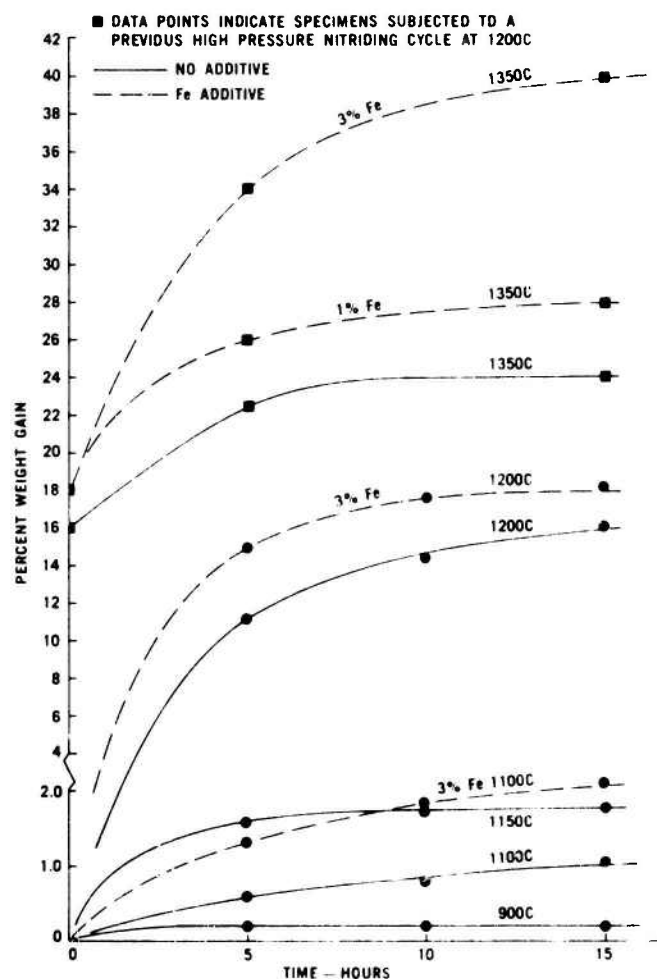
Figure 3.2.1-26 — Nitriding Weight Gain Vs. Nitriding Time for Various High Pressure Nitriding Runs

Several runs were made at nitrogen pressures between 10,000 psi and 20,000 psi with temperatures ranging from 900°C to 1350°C^(7,8). As shown in Figure 3.2.1-26, using Fe₂O₃ aids and higher temperatures yielded the most encouraging results although the microstructure still consisted of a core of silicon surrounded by a case of high density Si₃N₄. (Figure 3.2.1-27). This did demonstrate, however, that 90% dense Si₃N₄ could be completely nitrated. High costs (over \$5,000 per run) and the extreme difficulties encountered in performing and controlling the runs resulted in abandoning this approach.

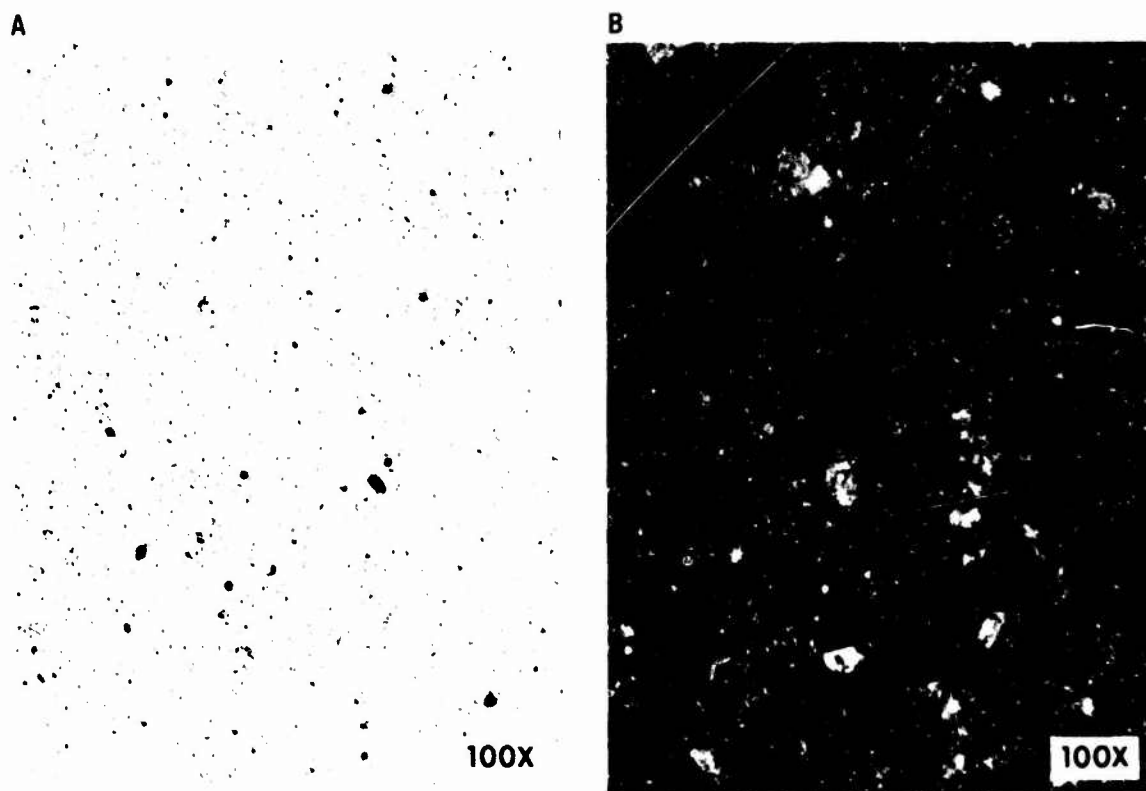
Figure 3.2.1-29 — Optical Micrographs of 2.7 g/cc Density RBSN (100x)
A. Normal Light
B. Polarized Light

Optical microscopy was a powerful tool in the study of RBSN. It permitted examination of large areas of pore distribution, general microstructural uniformity, and detection of gross differences in grain size, such as the presence of large β Si_3N_4 grain clusters. Typical microstructure of the Ford 2.7 g/cm³ density IMRBSN is shown in Figure 3.2.1-29.

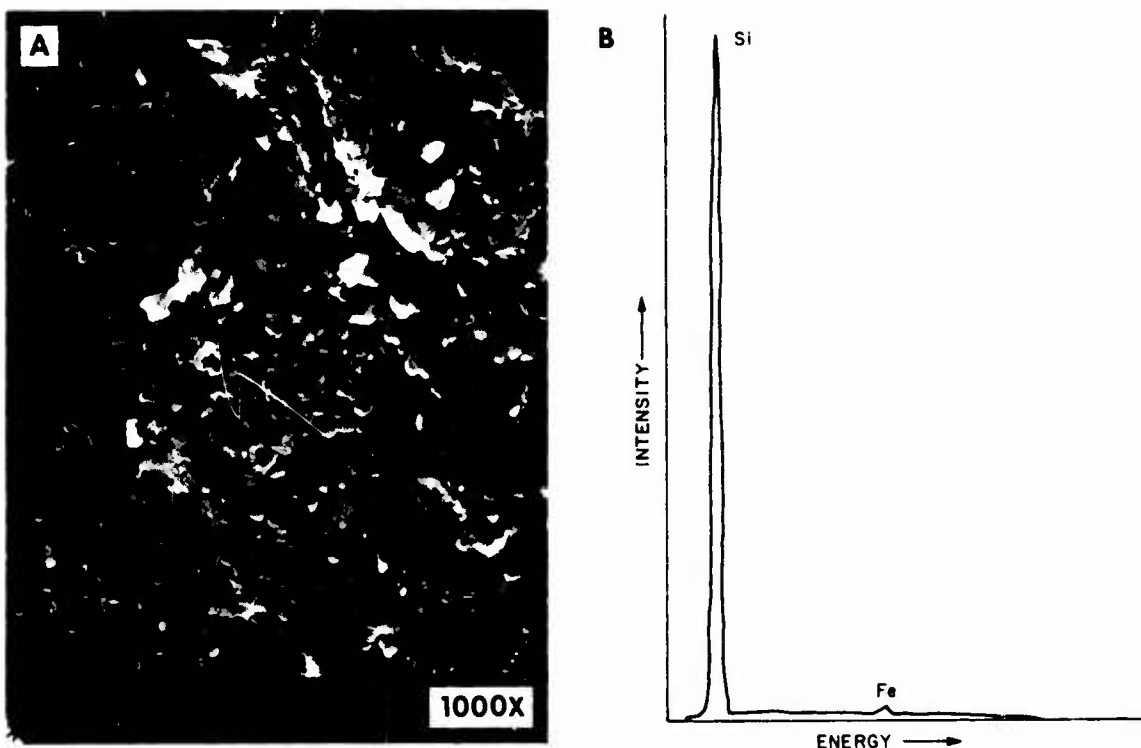
Figure 3.2.1-30 — A. Scanning Electron Micrograph of 2.7 g/cc Density RBSN Fracture Surface, HF Etch (1000x)
B. Non-Dispersive X-Ray Spectrum of Thin Surface

The Scanning Electron Microscope (SEM) was not too useful for studying the general microstructure of RBSN because fractures produced a featureless surface with little grain structure. Since RBSN contained very little alkali and alkaline earths, grain boundaries were chemically inert. Figure 3.2.1-30A shows a typical fracture surface of IMRBSN etched in HF for four hours. Some porosity can be noted, but little of the grain morphology can be seen.

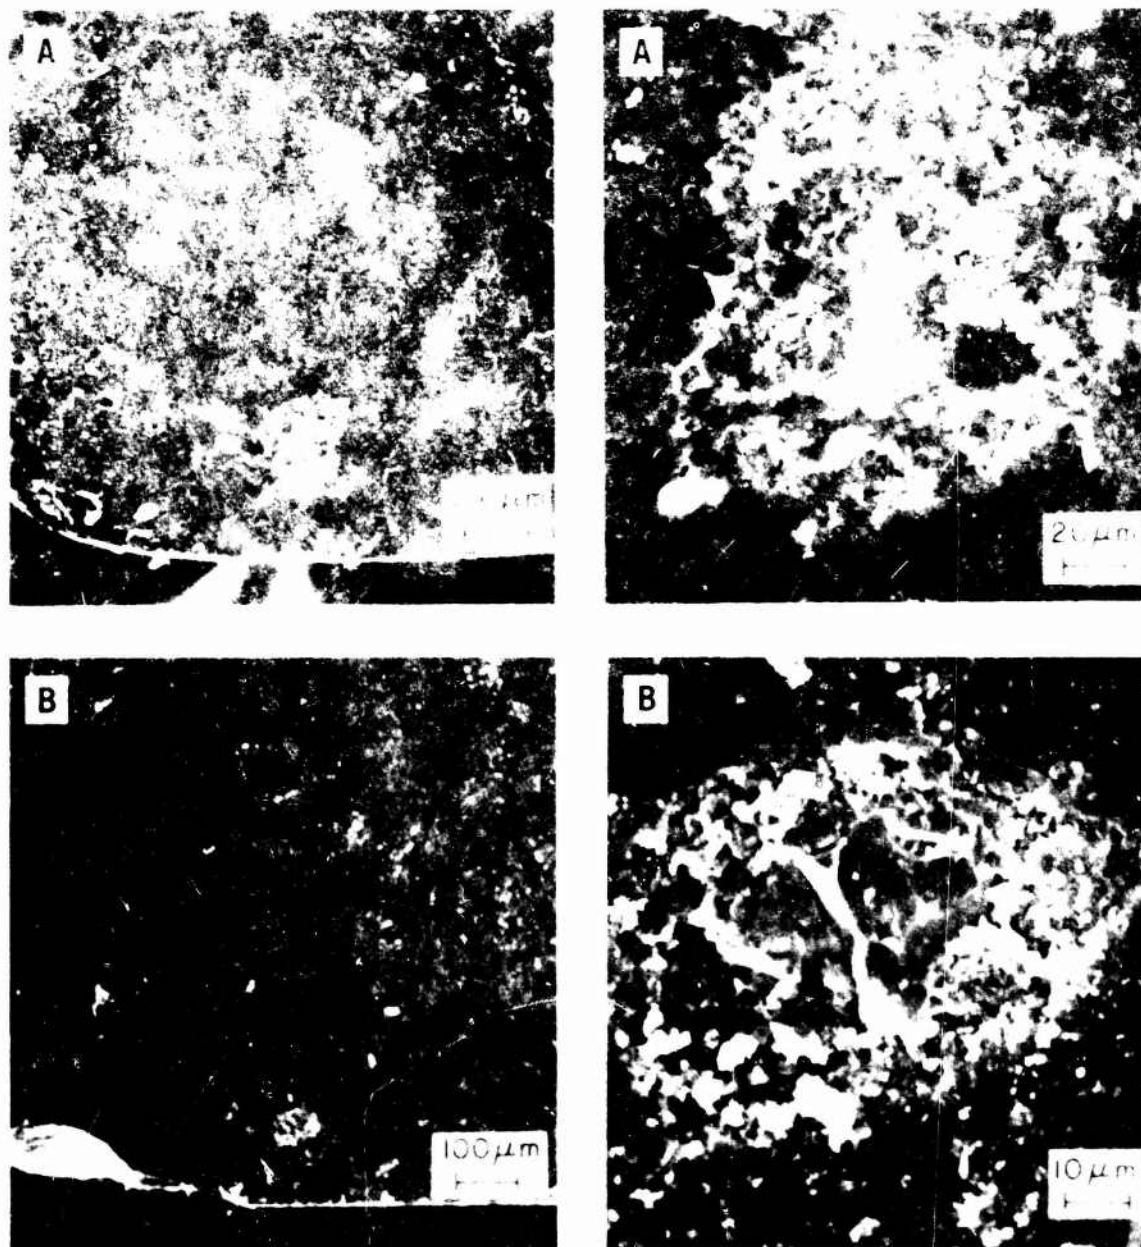
Figure 3.2.1-31 — Scanning Electron Micrographs of Fracture Origins in 2.7 g/cc Density RBSN

Room temperature strength of 2.7 g/cc density IMRBSN was studied using four-point bending. The fixture had a 3.3" top span and a 3.4" bottom span. A loading rate of 0.02 in./min. was used. The test specimen size was 1.8" x 1.4" x 1-1/8". The specimens were representative of a large number of batches and nitriding runs. The data, therefore, represents batch-to-batch variations. The specimens were inspected prior to nitriding, using X-ray radiography to remove any samples with molding defects similar to the method used to evaluate engine components. Table 3.2.1-9 displays the room temperature strength of 2.7 g/cc density IMRBSN and Figure 3.2.1-33 shows the room temperature strength as a function of flaw size.

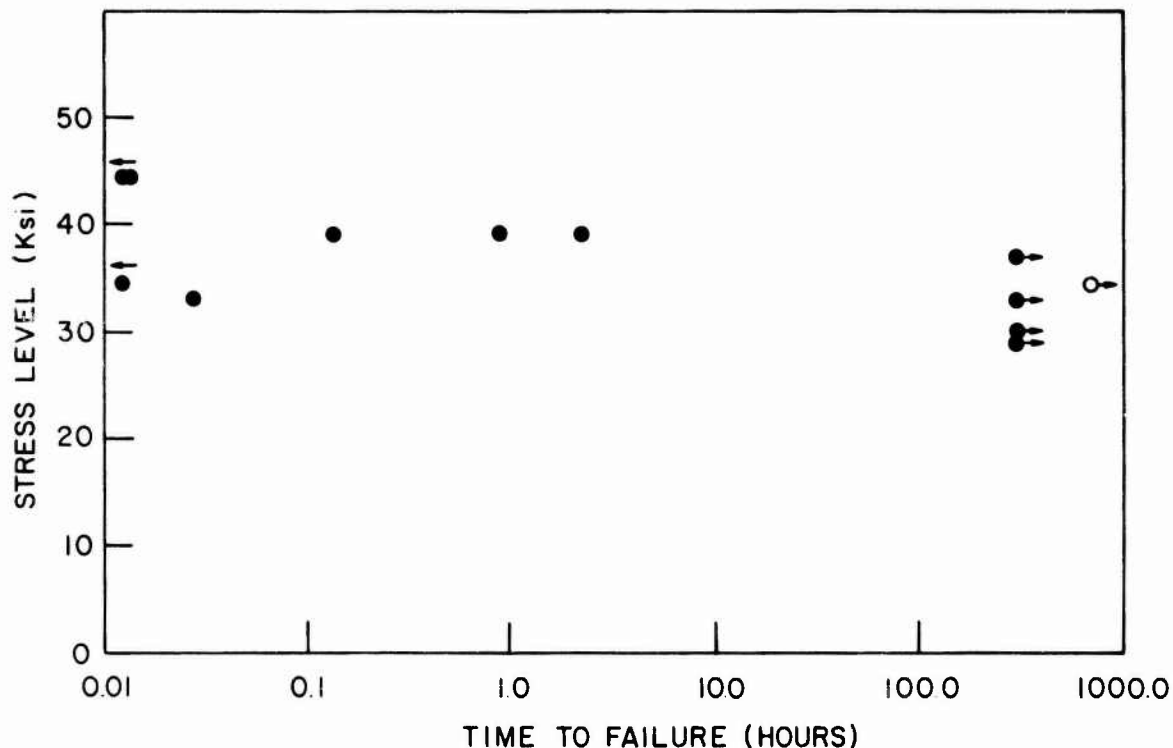
Figure 3.2.1-35 — Isothermal 1200°C Stress Rupture Test Results, 2.7 g/cc Density RBSN Tests Performed by AMMRC

A summary of all the stress rupture data shows that the 2.7 g/cm^3 IMRBSN does not exhibit time-dependent failure at stress levels of 33 Ksi at temperatures up to 1400°C and times of at least 200 hours. These results were expected because this material does not exhibit slow crack growth up to 1400°C , the maximum temperature investigated. Time-dependent failures at the higher stress levels and lower temperatures were attributed to oxidation rather than slow crack growth.

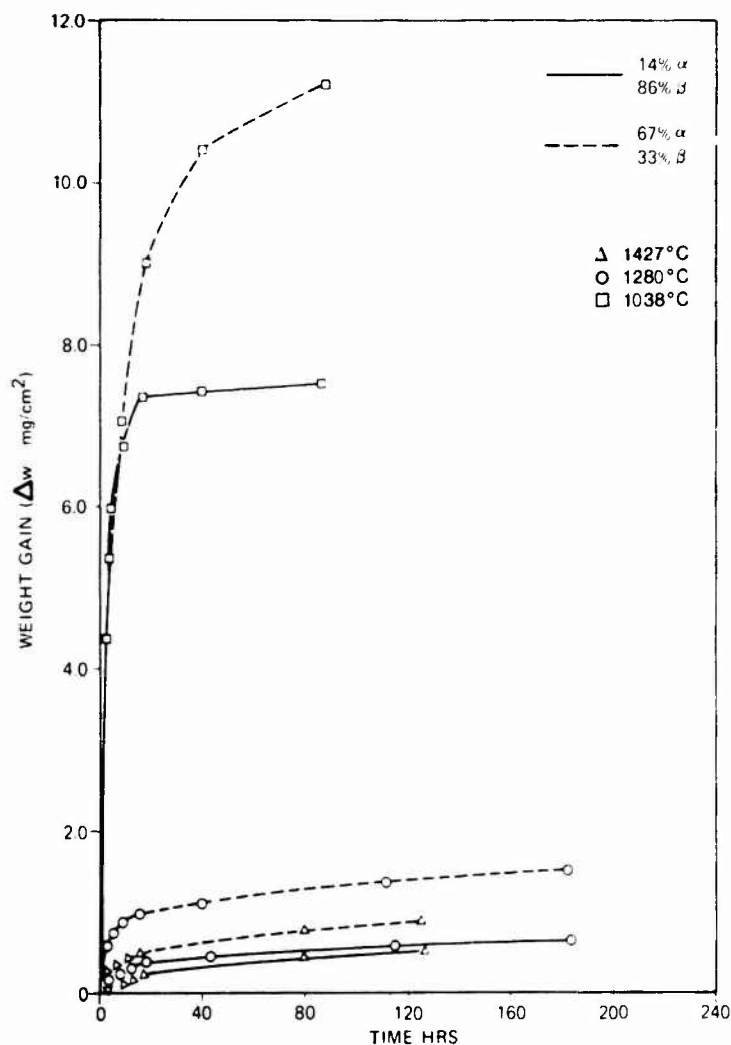
Figure 3.2.1-38 — Weight Gain Due to Oxidation of 2.3 g/cc RBSN of Two Different Phase Compositions as Measured at Various Temperatures.

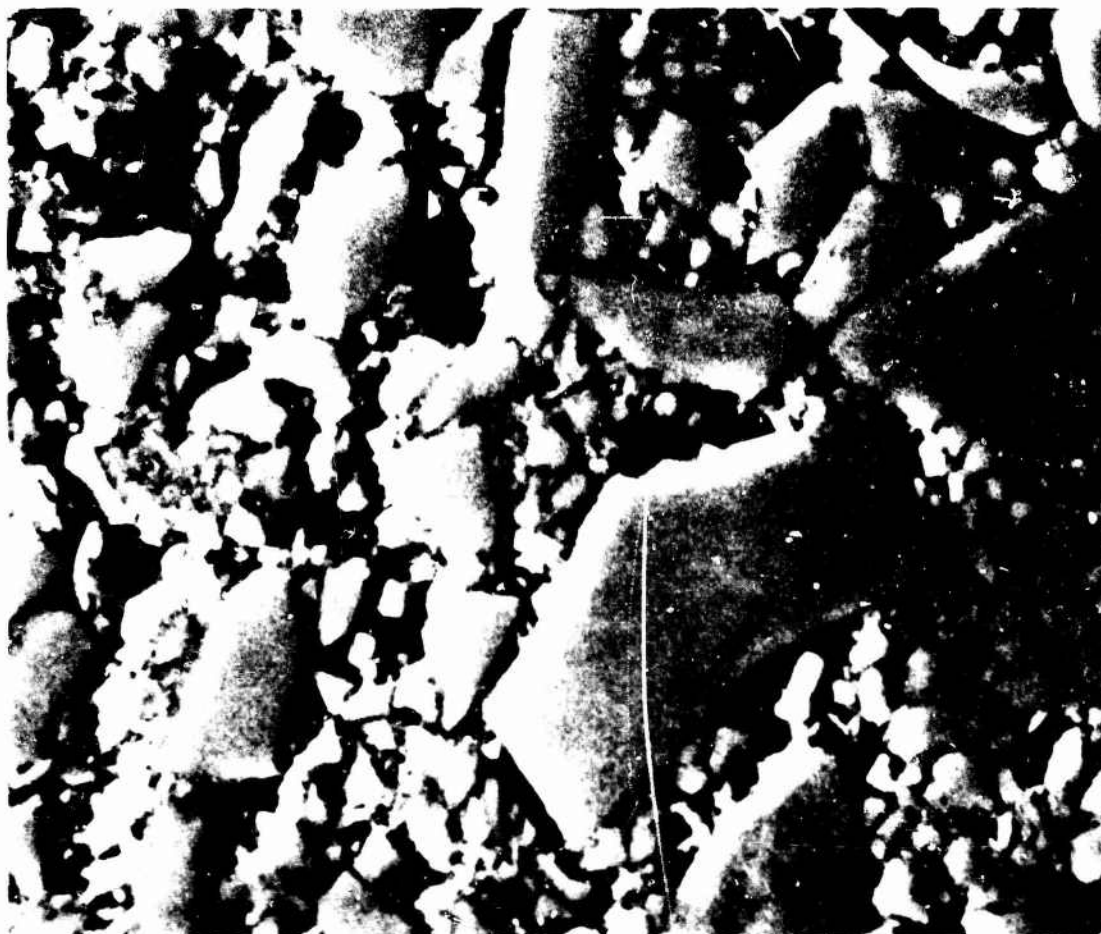
Figure 3.2.2-3 — Microstructure of Cast Silicon Structure (800x)

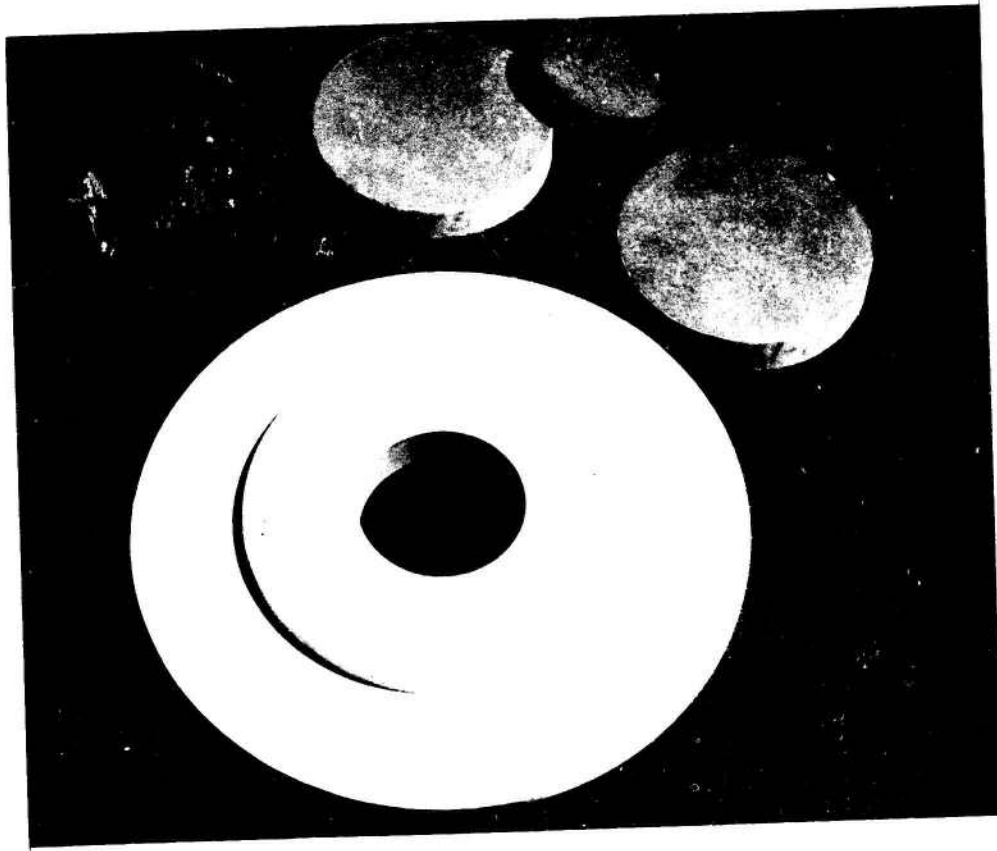
Figure 3.2.3-1 — Press Bonded Duo Density Shape

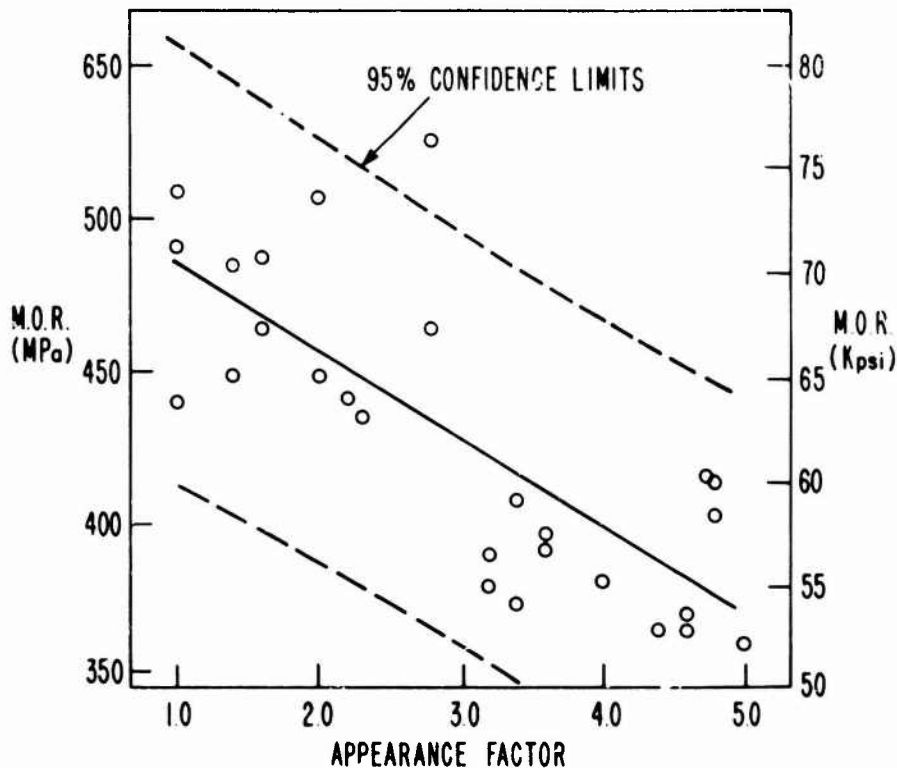
Figure 3.2.3-9 — Relationship Between Appearance Factor and 2200°F Strength of HPSN

Quantitative values were given to this effect by asking several people to assign test sections of each billet, based on its degree of mottling, to one of five groups. Group 1 was not mottled and Group 5 was badly mottled. The average group number resulting from five trials was termed the "appearance factor" for each pressing. This factor correlated well to the 2200°F strength tests but did not correlate to the room temperature tests (Figures 3.2.3-9 and 3.2.3-10). Figures 3.2.3-11 and 3.2.3-12 display the dependence of the 2200°F strength on hold time and pressure during hot pressing. Further work is required to better understand the causes of this mottling even though this study gave insight into the processing requirements for producing high strength hot pressed silicon nitride.

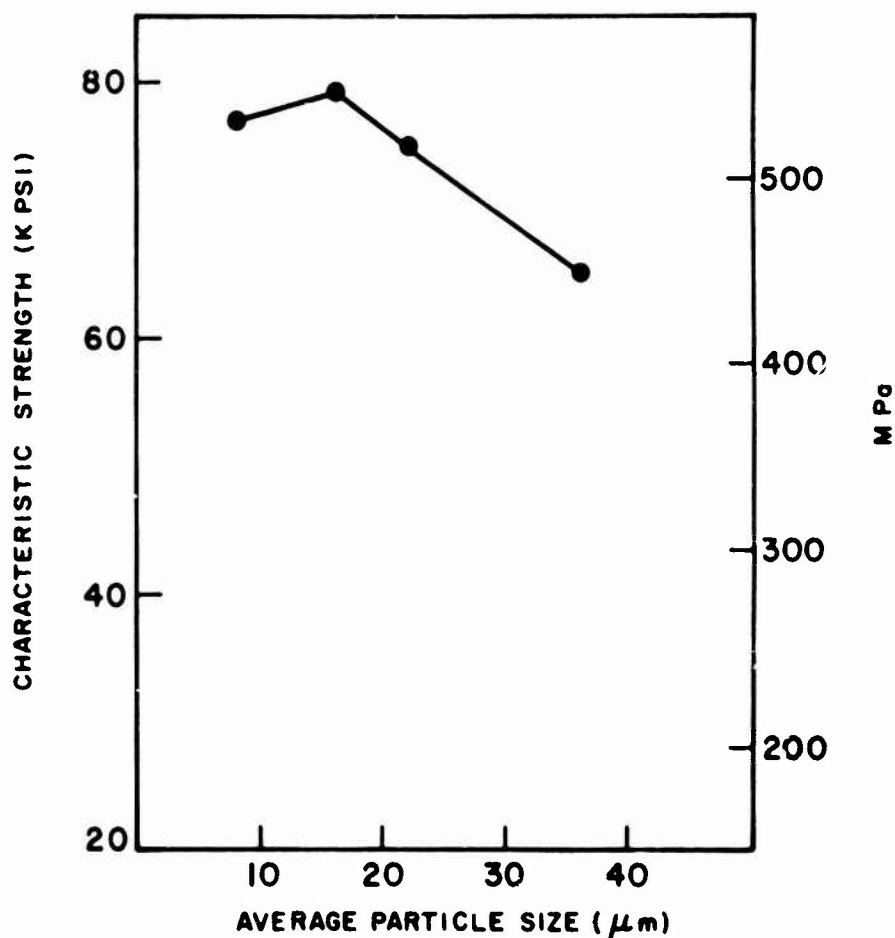
Figure 3.2.4-2 — Flexural Strength of Reaction Bended Silicon Carbide as a Function of Initial α SiC Particle Size

Individual strengths as high as 100 Kpsi (689 MPa) have been measured. As seen in Table 3.2.4-1, the strength is influenced by surface preparation. Research has been aimed at improving the strength of both as-silicided and ground materials since practical applications favor as-silicided surfaces for economic considerations. Strength has also been found to be a function of α -SiC particle size, as seen in Figure 3.2.4-2.

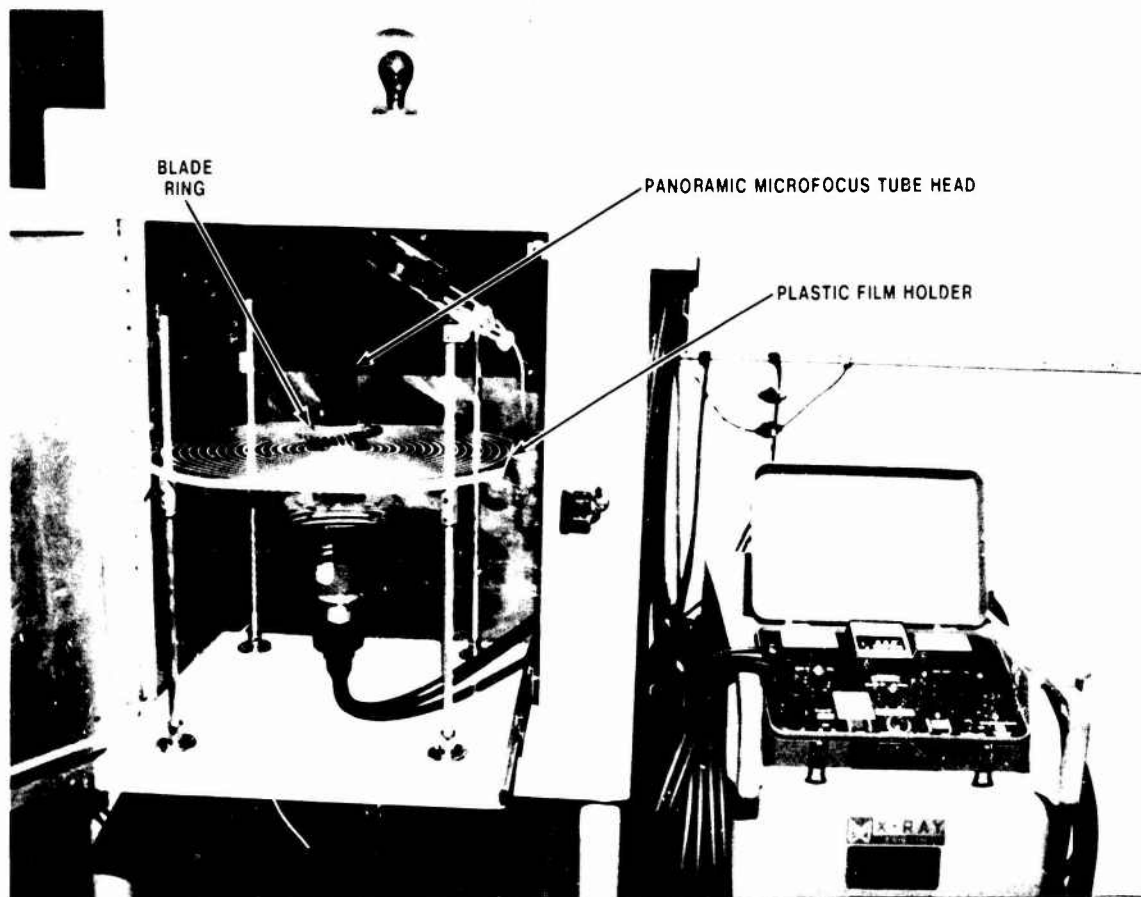
Figure 3.3.1-6 — Panoramic Microfocus Equipment and Fixture for Radial X-Ray

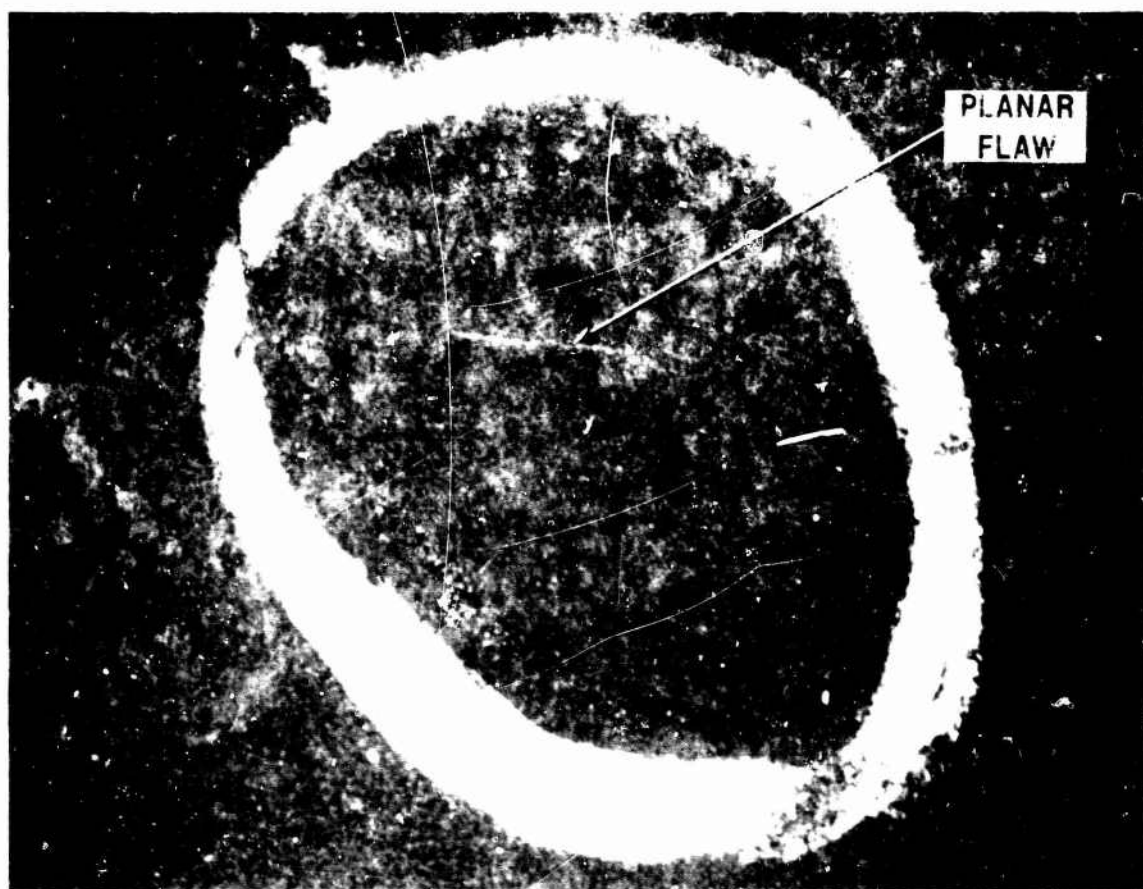
Figure 3.3.1-7 — Planar Type Defect Detected by Visual Inspection (37X)

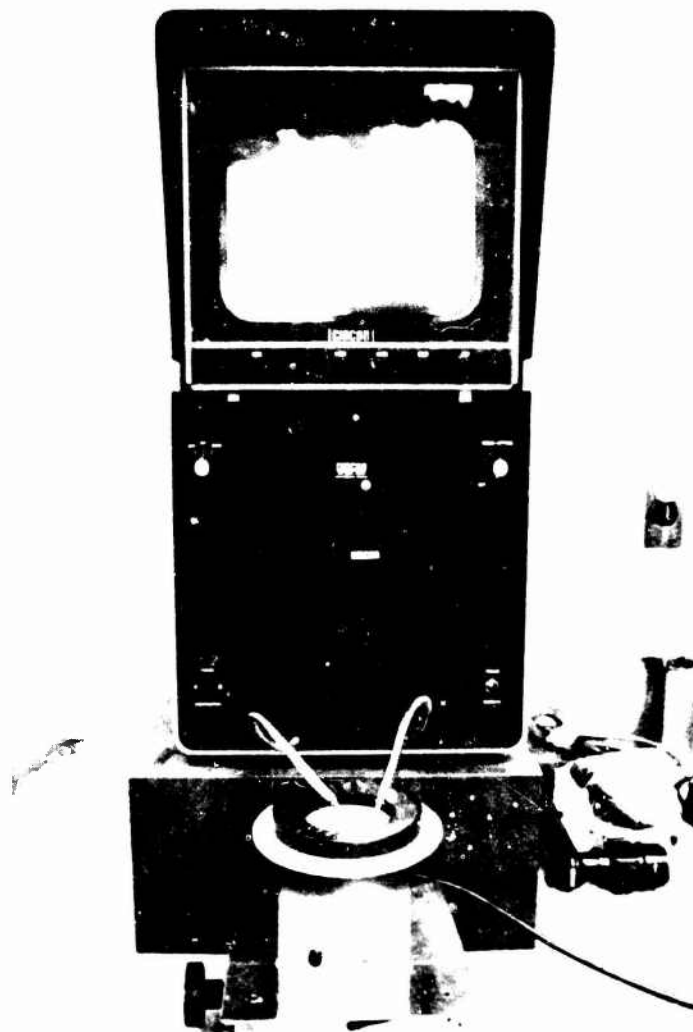
Figure 3.3.1-8 — Circon Video Visual Inspection Equipment

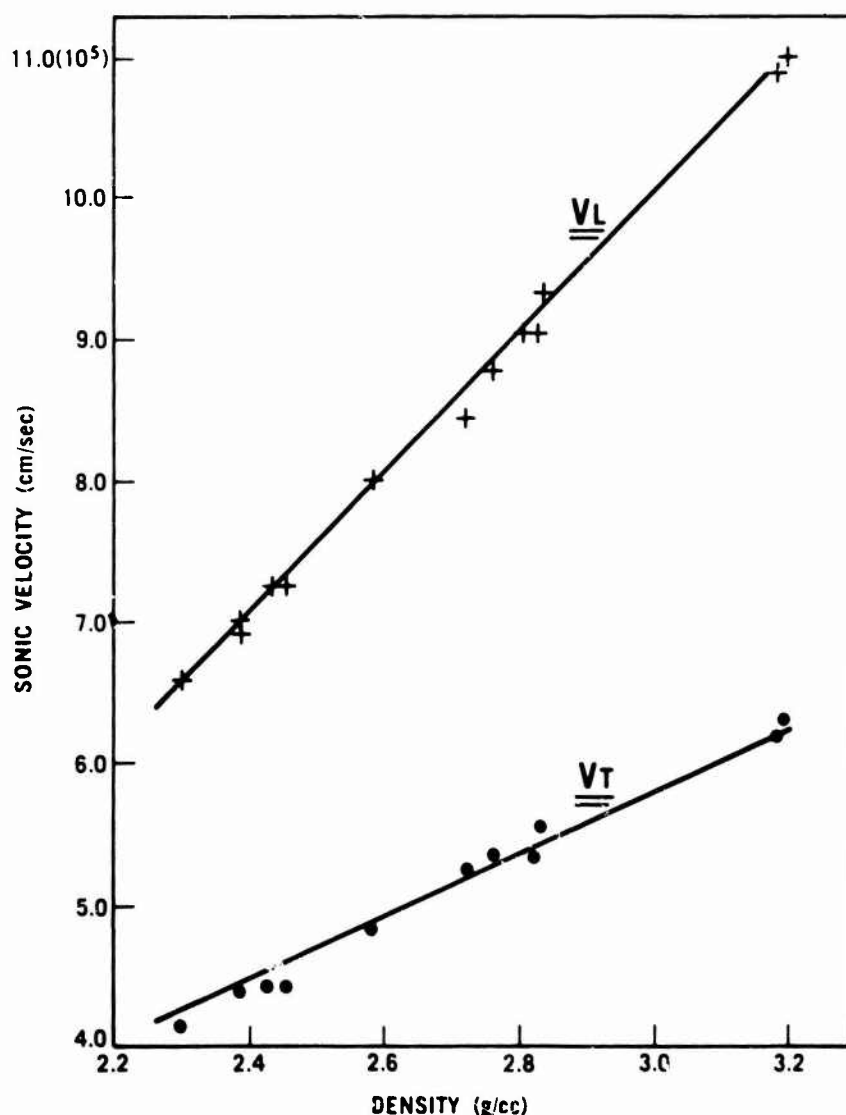
Figure 3.3.1-10 — Longitudinal (V_L) and Transverse (V_T) Sonic Velocity Vs. Density for Silicon Nitride

Relationships between sonic velocity of RBSN and density were established⁽⁷⁾ (Figure 3.3.1-10). Density gradients were detected in LAS samples,⁽²⁾ and material inhomogeneity was observed through sonic velocity gradients. It appeared that longitudinal velocity data, rather than dynamic modulus of elasticity data, was more useful in determining the level of material inhomogeneity.

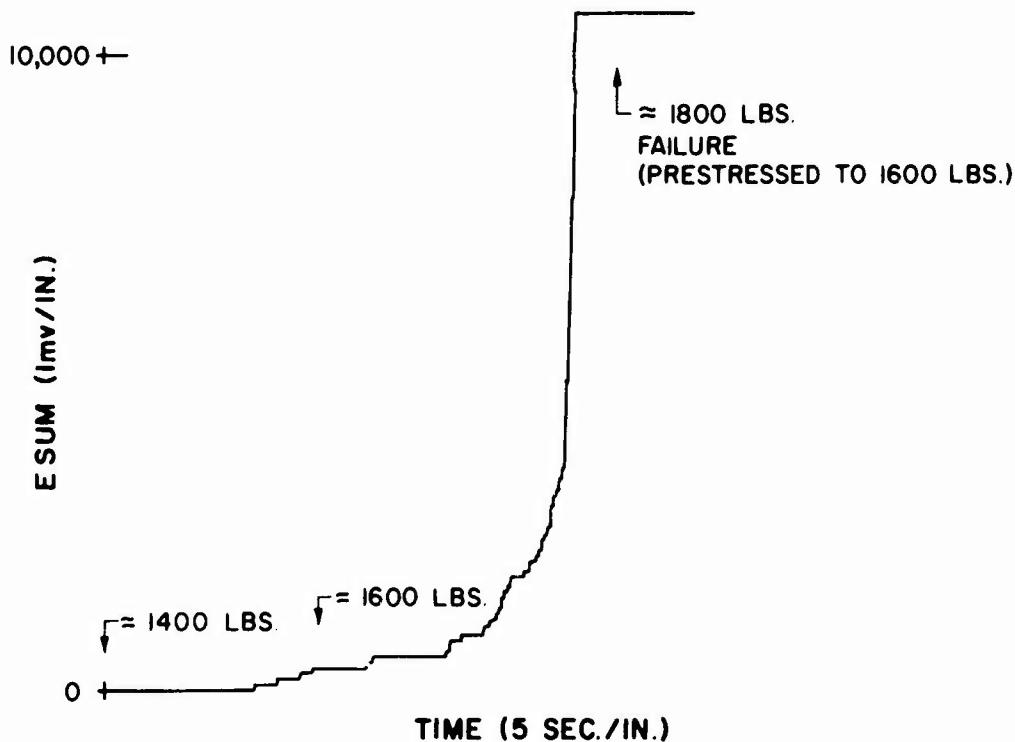
Figure 3.3.1-11 — Acoustic Emission Summation Vs. Time for Prestressed (to 1600 Pounds) Corning 9453 Lithium Aluminum Silicate

Figure 3.3.1-11 shows the AE versus time response of prestressed LAS. This curve demonstrates the well-known Kaiser effect (defined as a lack of AE until a previous stress level is exceeded). Figure 3.3.1-11 also shows the AE response-to-stress signature as a precursor to failure. This suggests the use of AE as a proof testing technique to determine subcritical and critical crack growth.

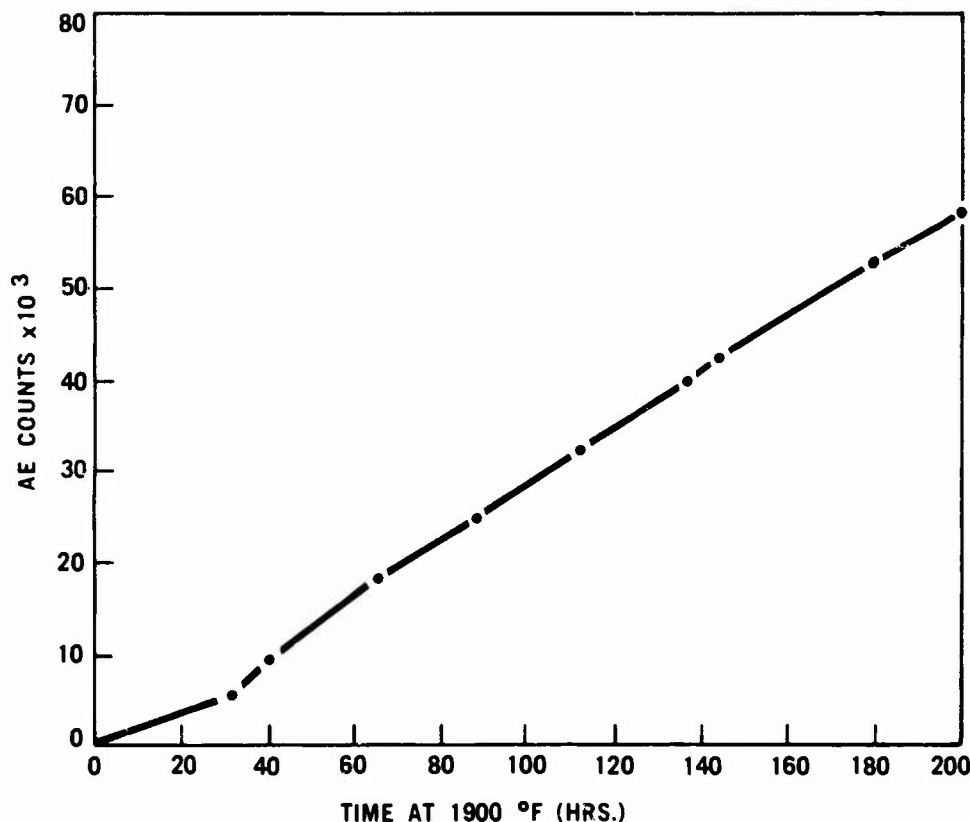
Figure 3.3.1-12 — Acoustic Emission Vs. Time for Severely Oxidized RBSN Stator (No Load)

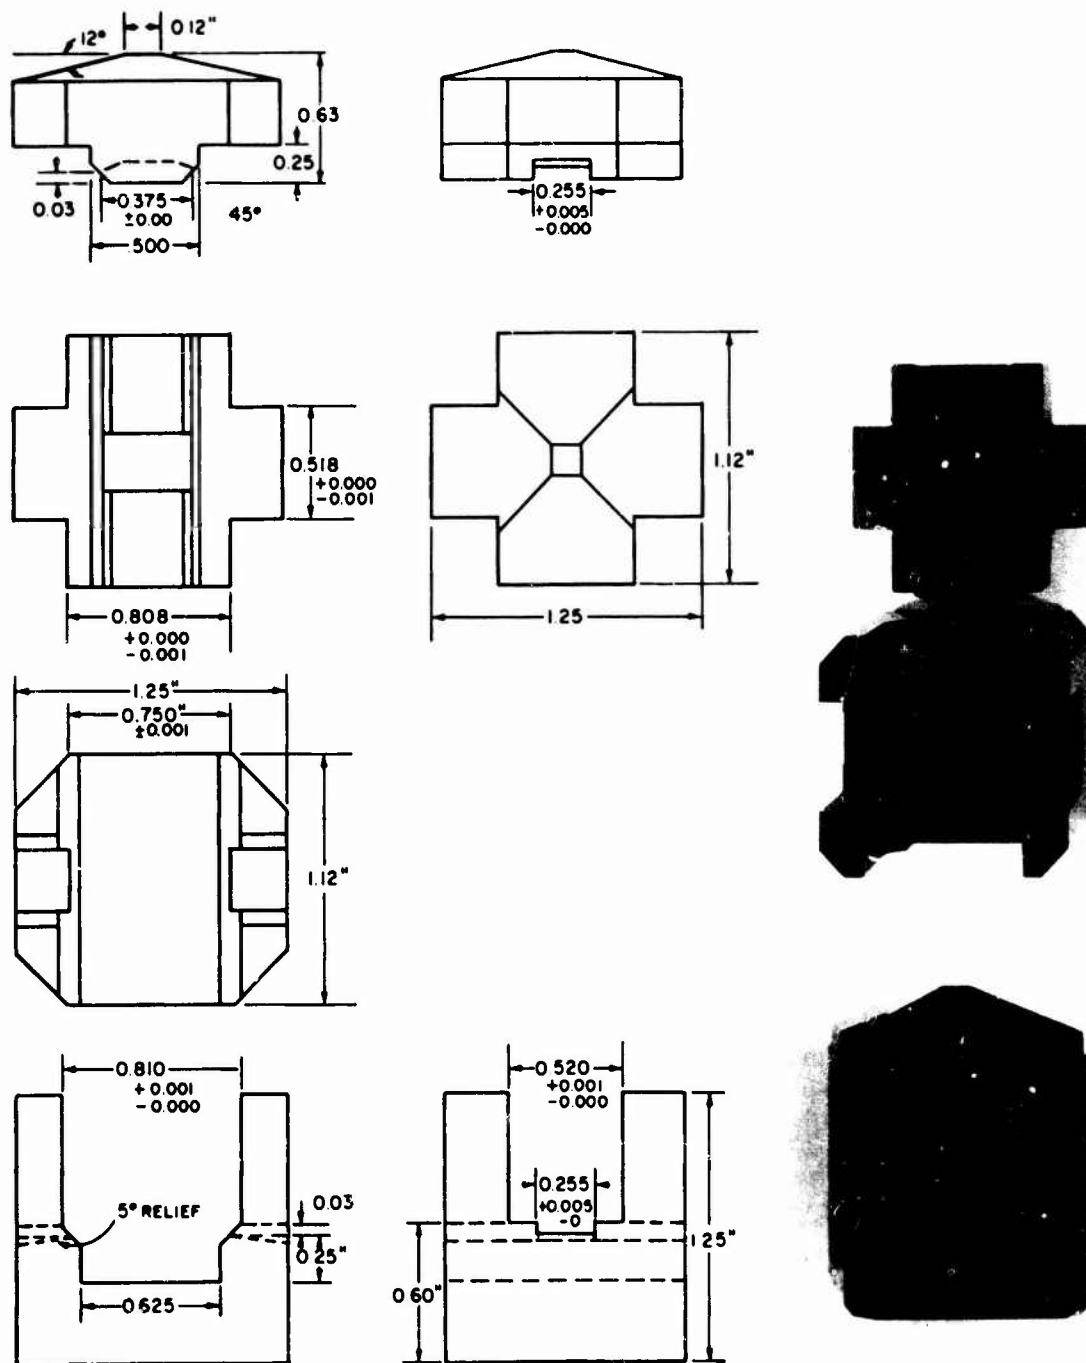
Figure 3.3.2-1 — Details of Self-Aligning Ceramic Fixture Used for MOR Testing
