AMMRC TR 81-14

BRITTLE MATERIALS DESIGN, HIGH TEMPERATURE GAS TURBINE

Technical Report By:

Final Report, July 1, 1971 to August 31, 1979

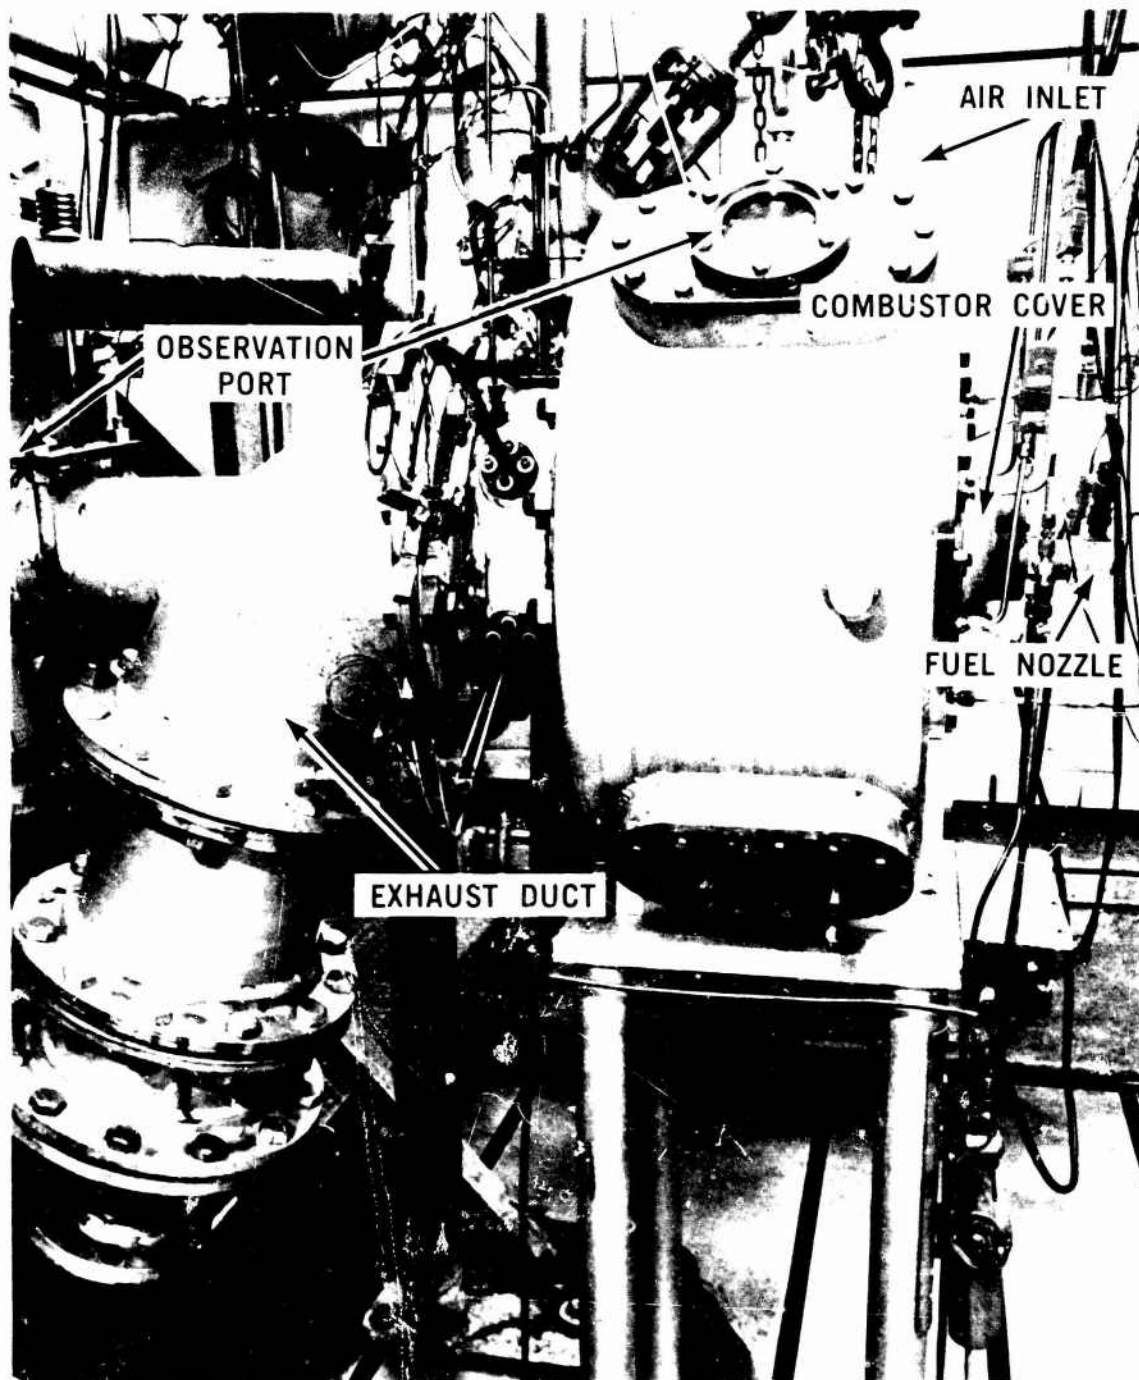
Figure 3.3.2-8 — Combustor Test Rig

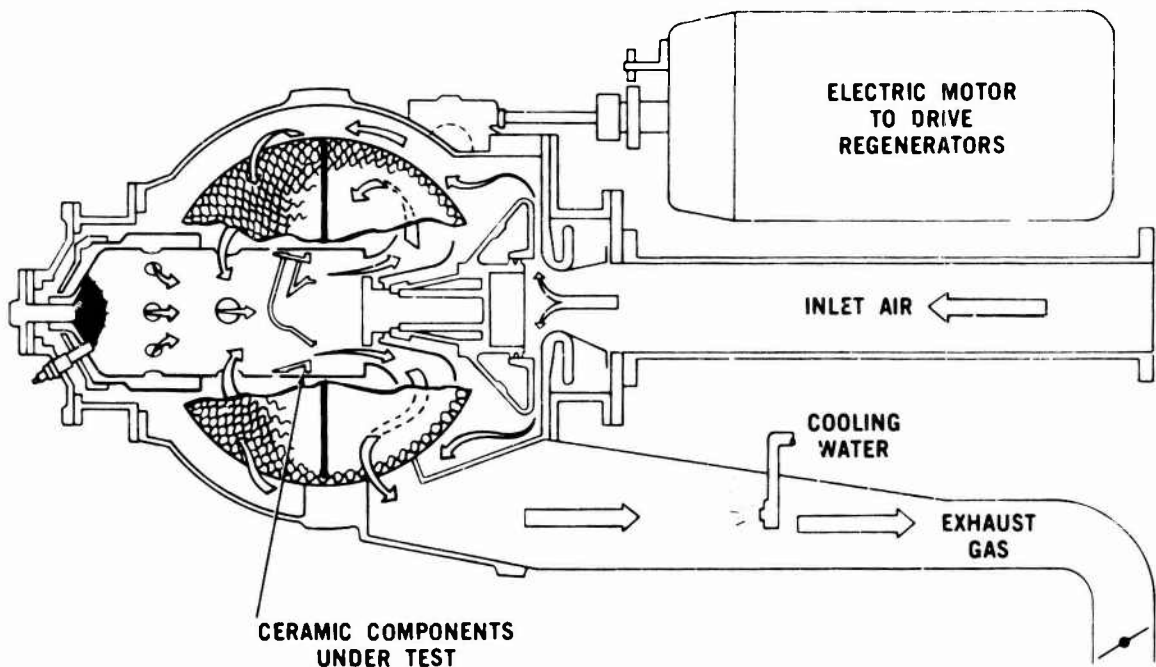
Figure 3.3.2-11 — Schematic Cross-Section View of Ceramic Structures Test Rig

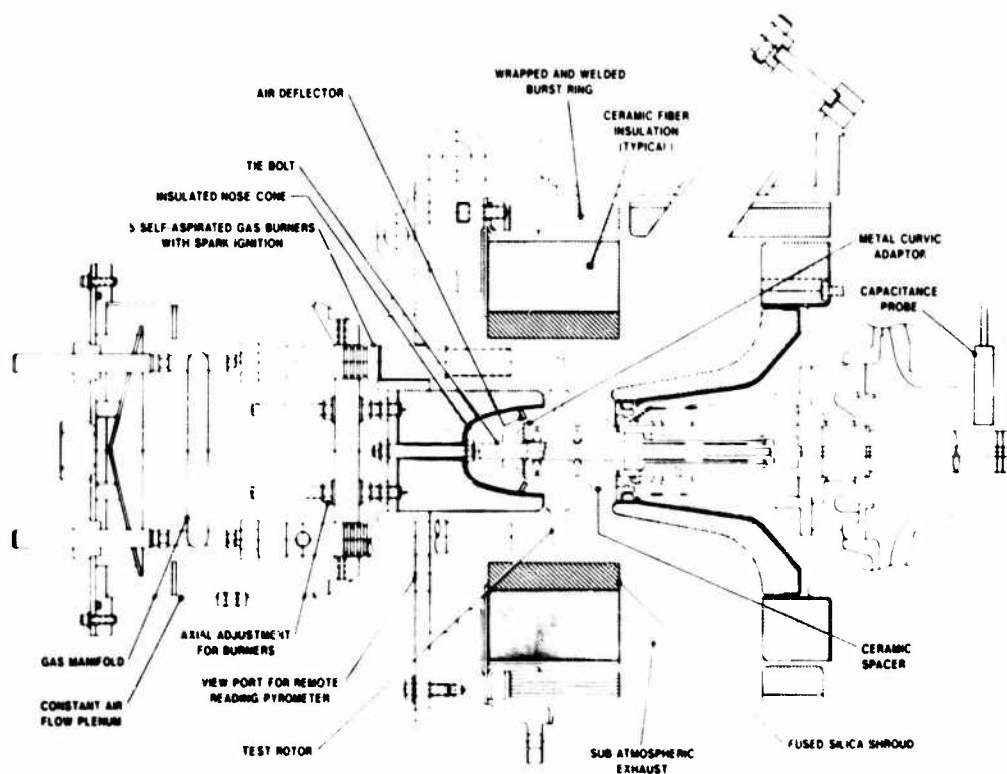
Figure 3.3.2-13 — Schematic Cross-Section View of Hot Spin Test Rig

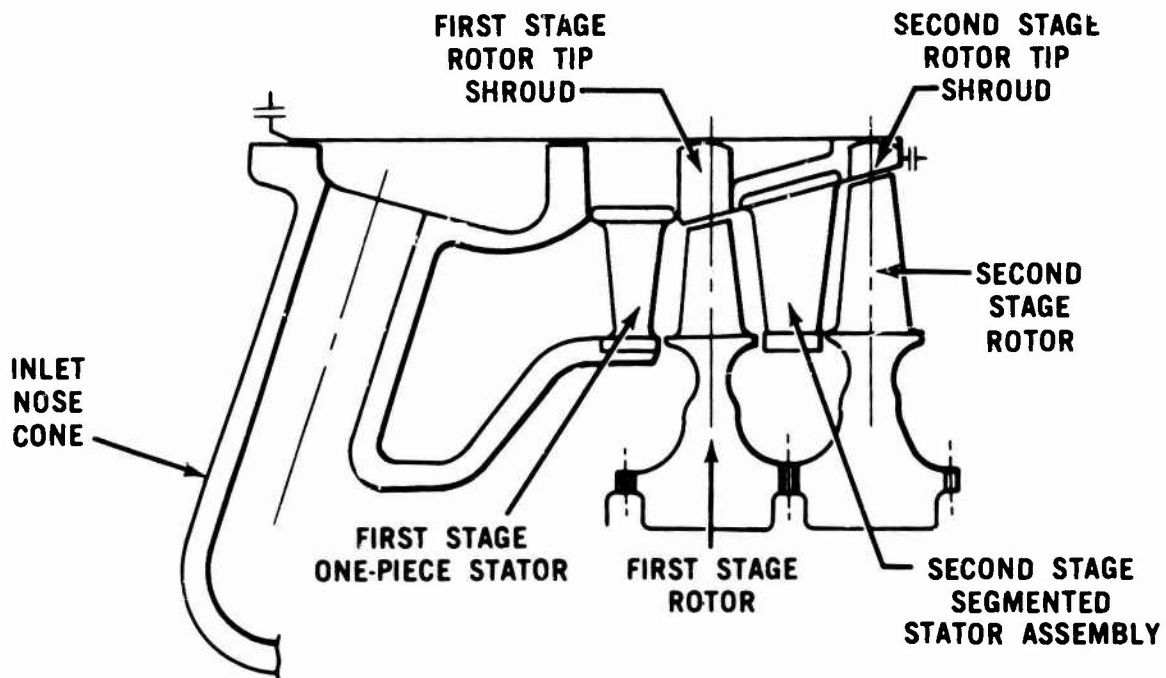
Figure 4.2.3-1 — Schematic Cross-Section View of Design C Flowpath

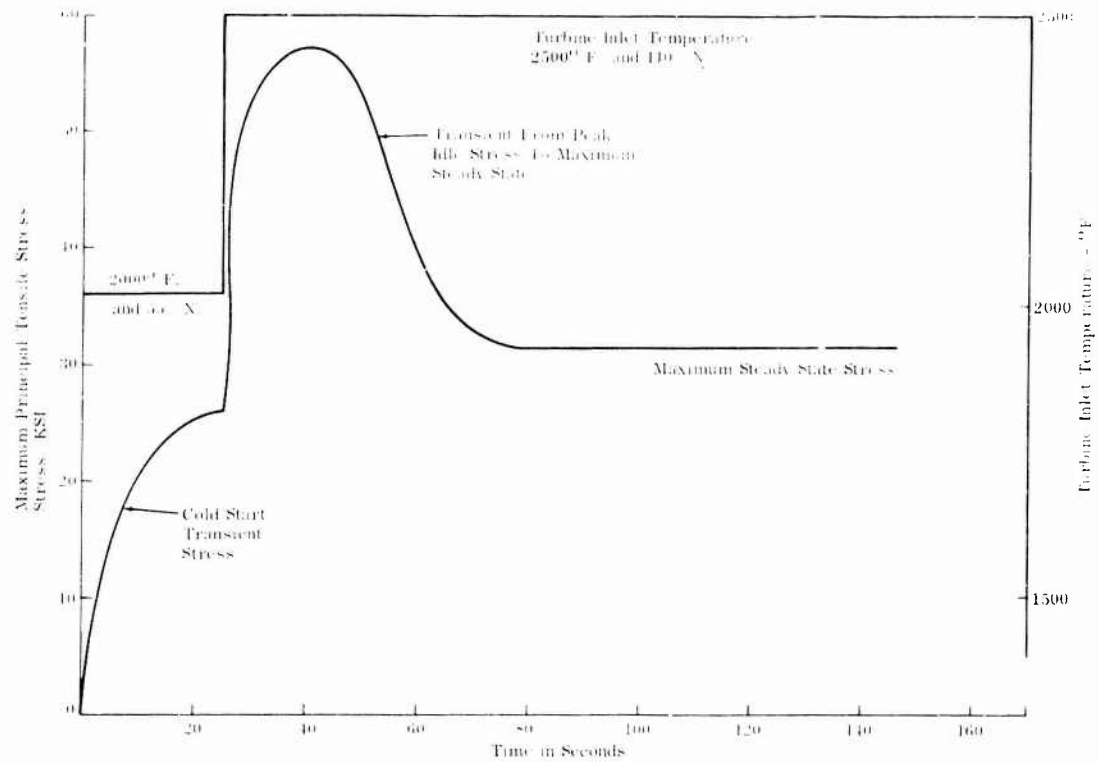
Figure 4.3.1-2 — Effect of Assumed Engine Operating Conditions Upon Dense Silicon Carbide Rotor Disk Stresses

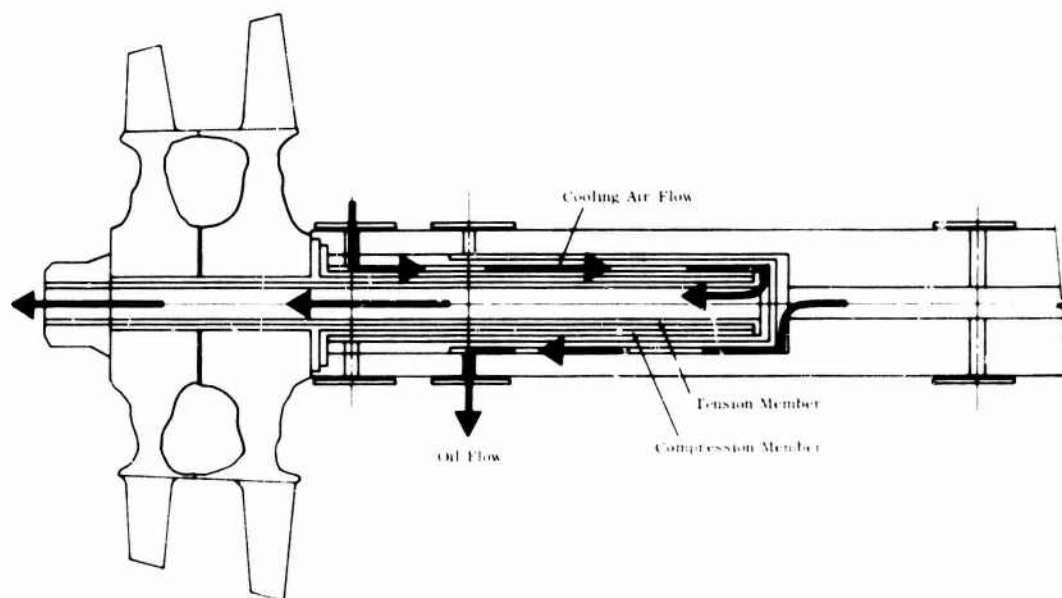
Figure 4.3.1-3 — Schematic View of Hollow Folded Bolt

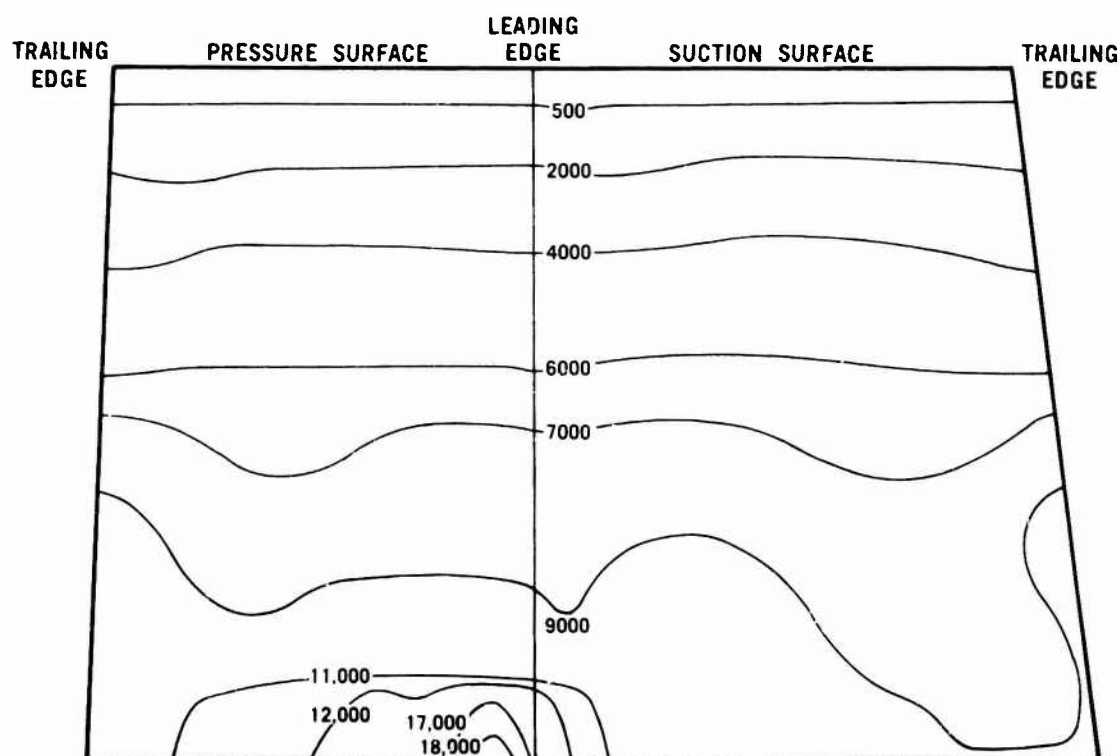
Figure 4.3.1-8 — Contour Map of Principal Tensile Surface Stresses (psi) of Rotor Blade at 2500°F T.I.T. and 100% Speed

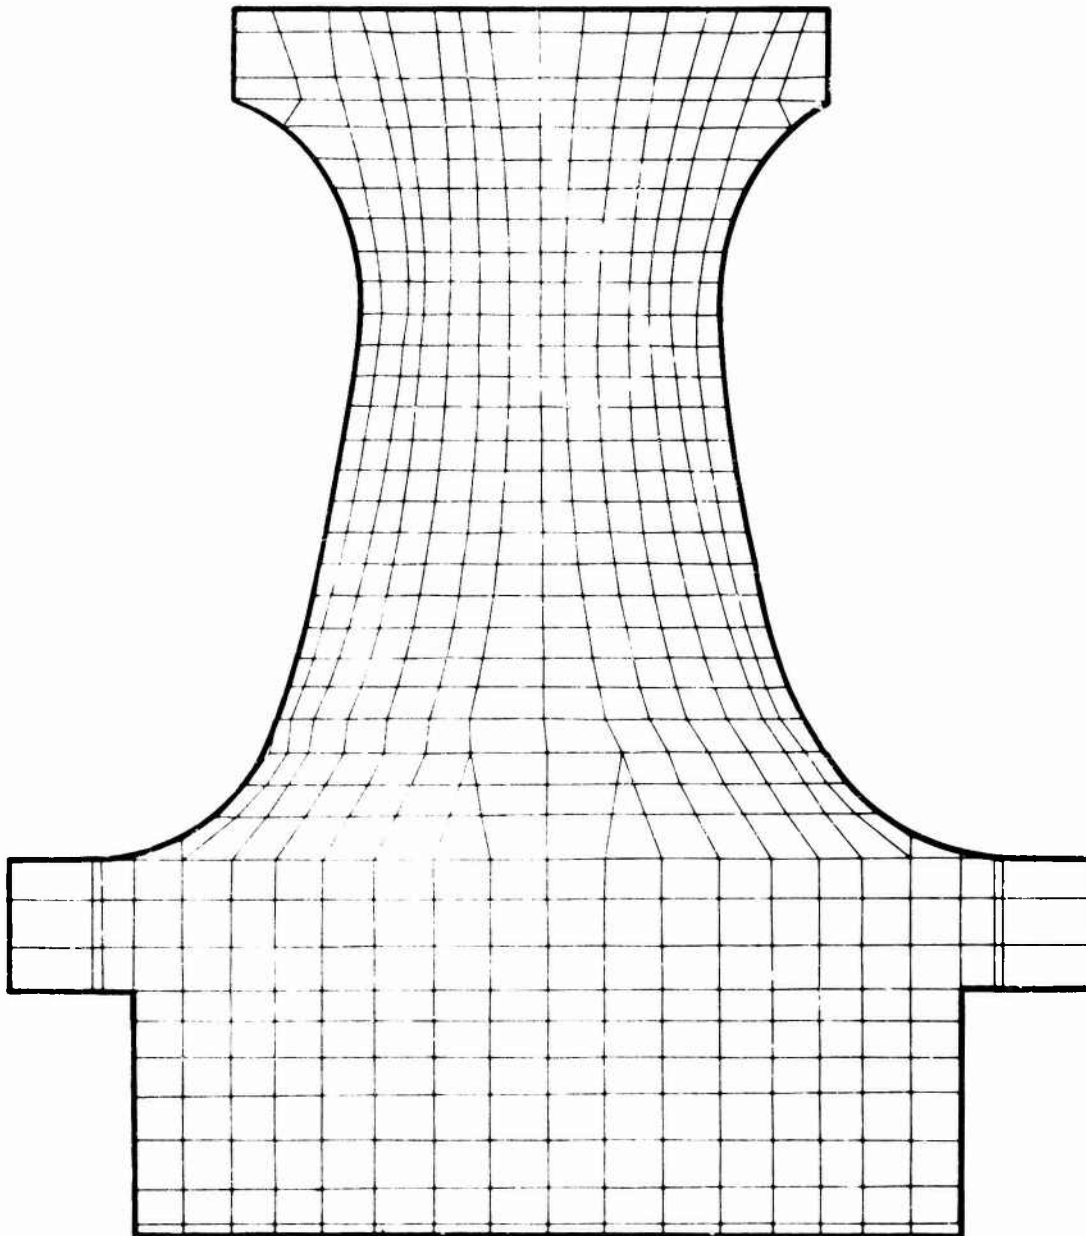
Figure 4.3.1-9 — Rotor Disk Model, 0.400 Inch Throat

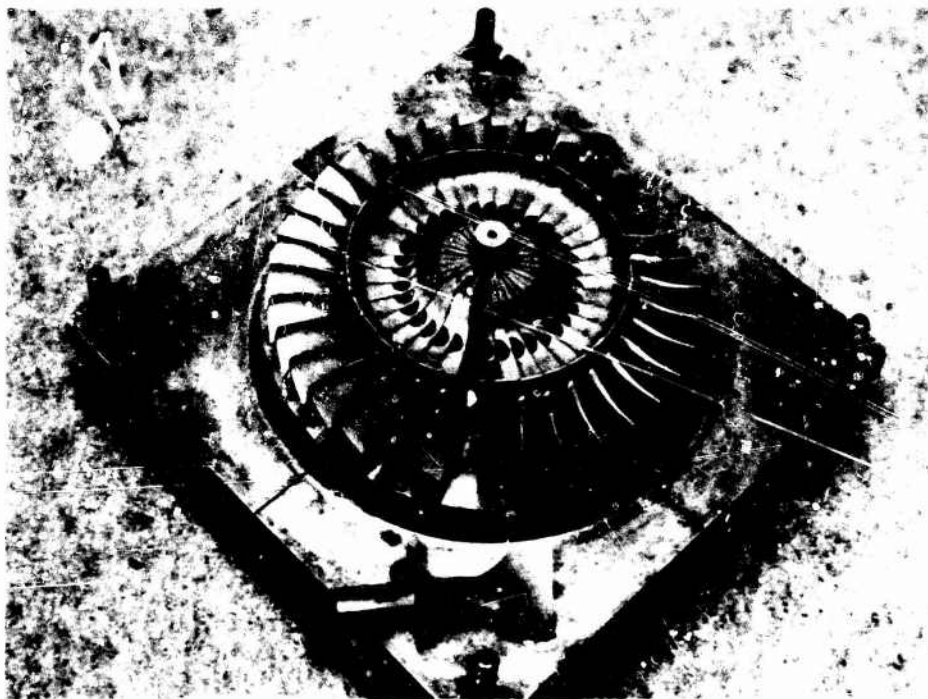
Figure 4.3.2-4 — Assembly of Molded Rotor Blades

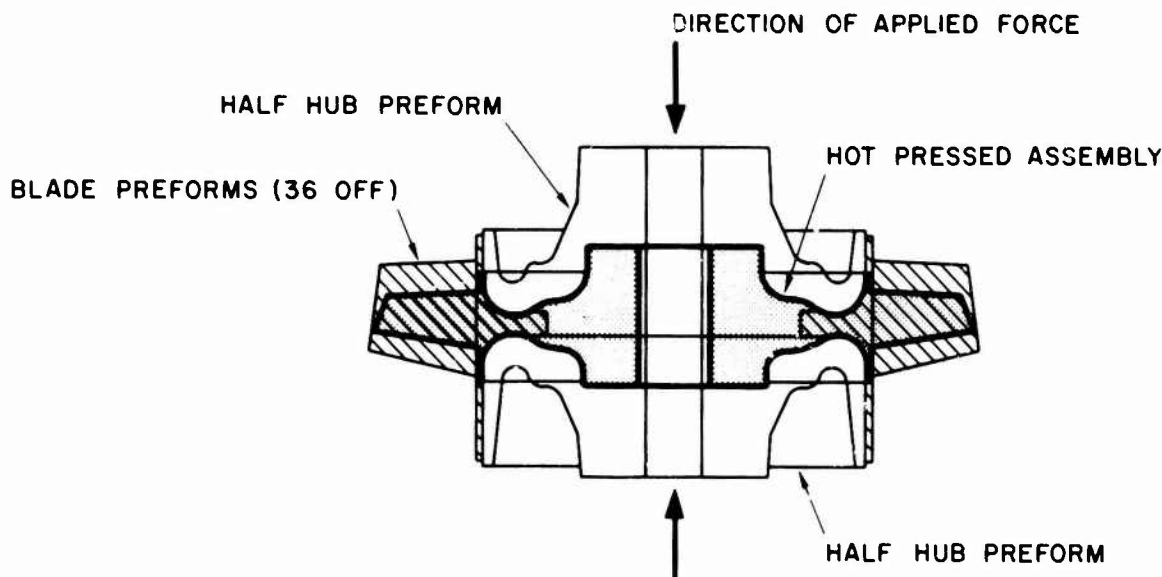
Figure 4.3.2-5 — 'Conformable Tooling' Rotor Assembly Concept

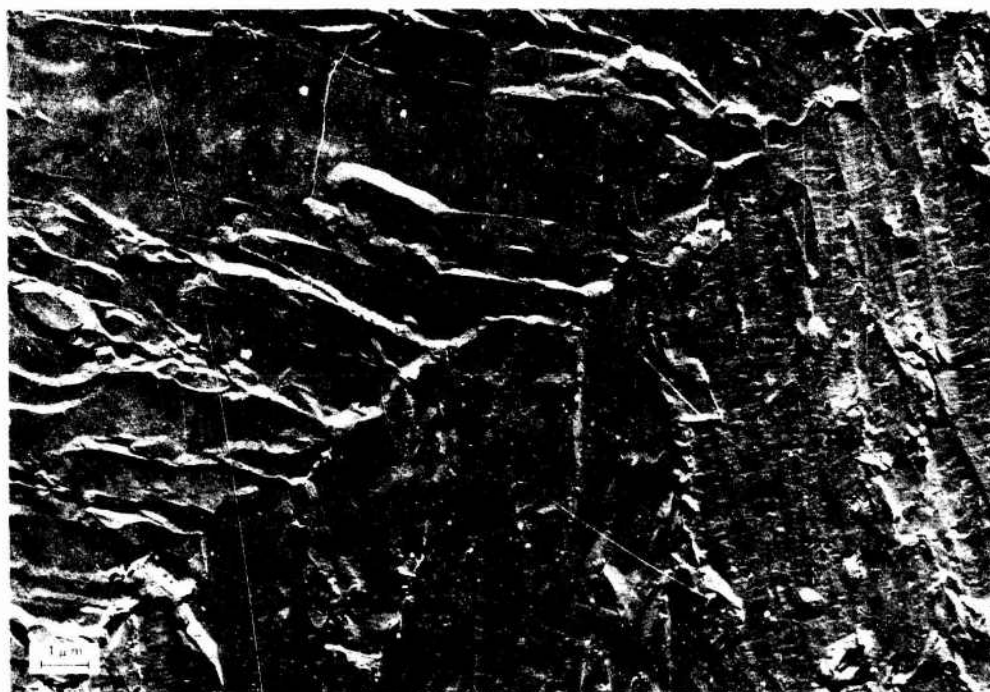
Figure 4.3.2-9 — Microstructure of CVD Silicon Carbide at Joint of Two Adjacent Areas (7100X)

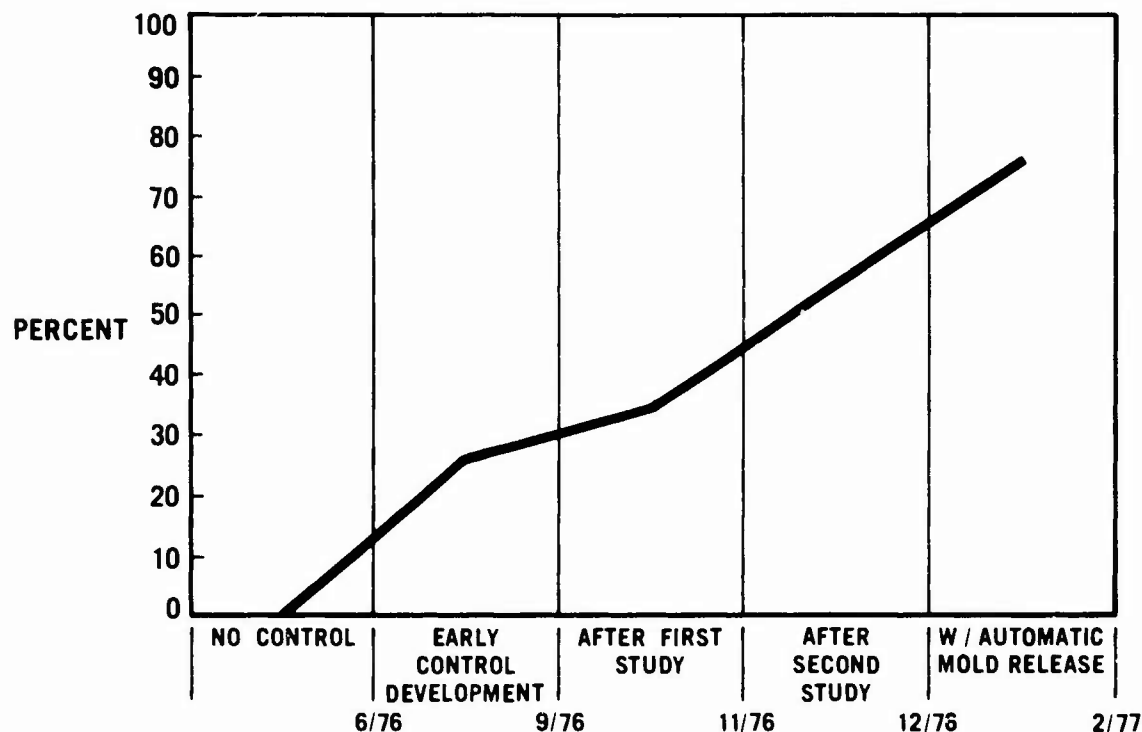
Figure 4.3.2-16 — Improvement in Quality of Rotor Blade Rings Vs. Time

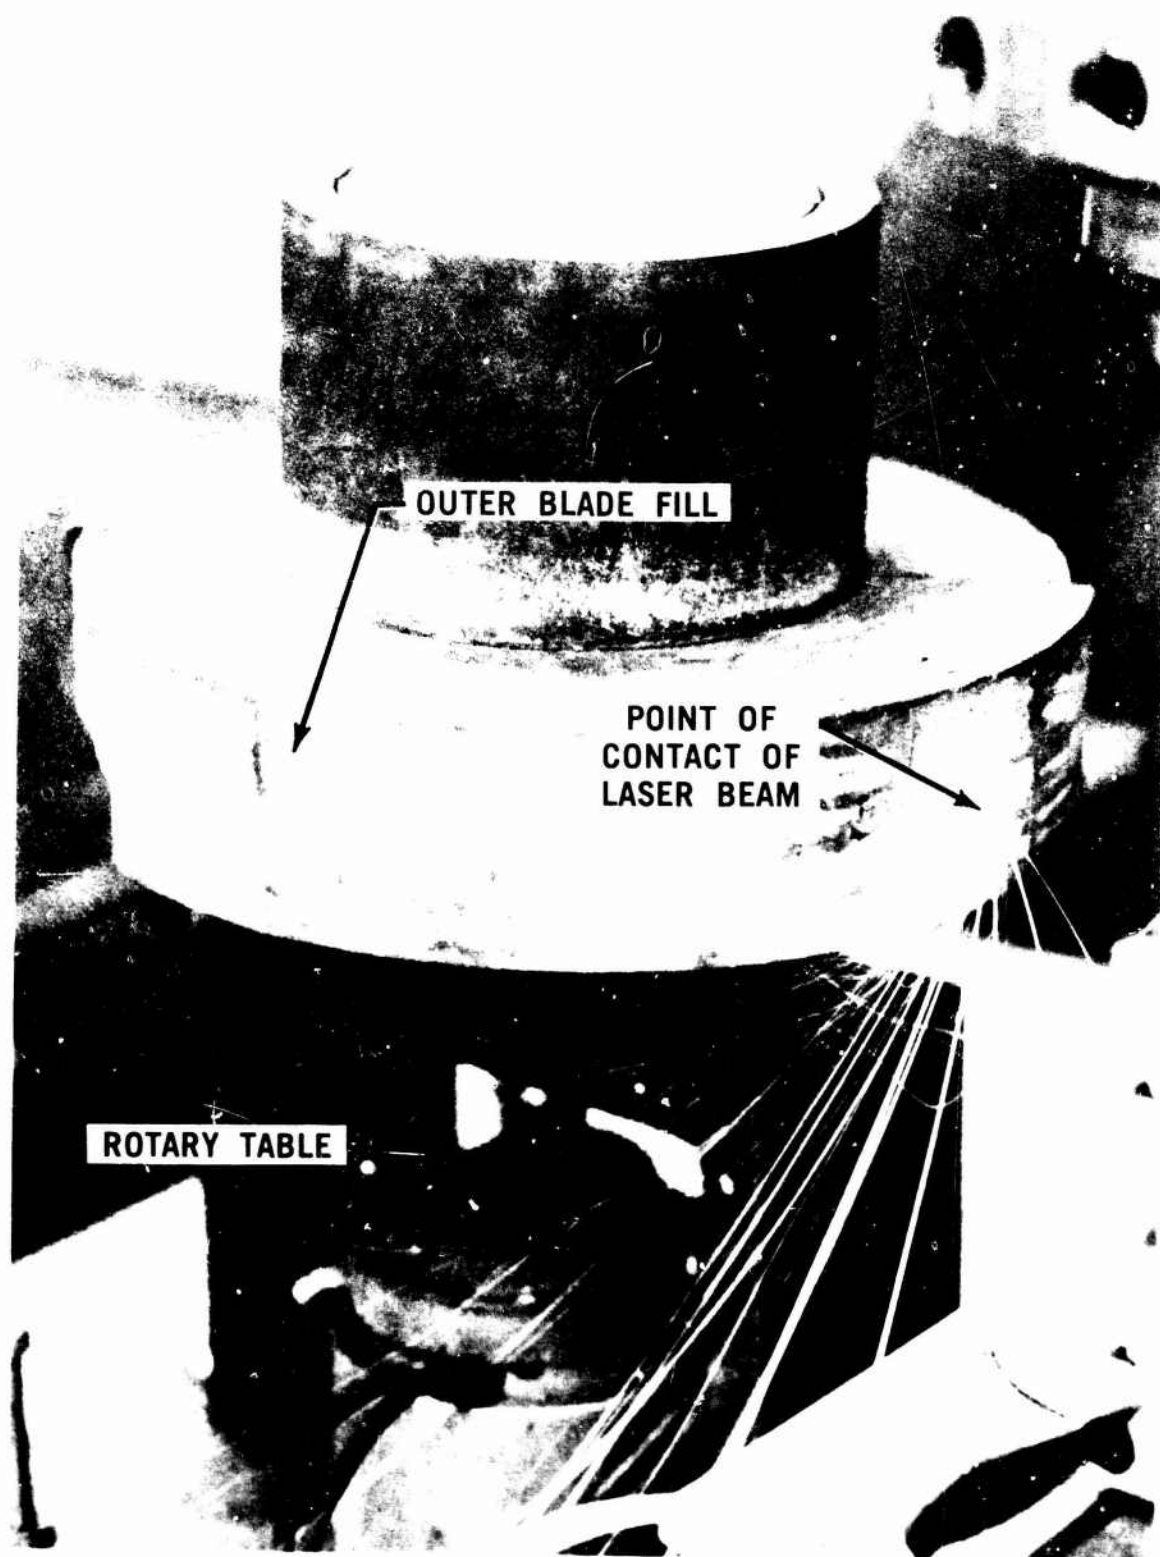
Figure 4.3.2-20 — Circumferential Cutting of Outer Blade Fill with CO₂ Laser

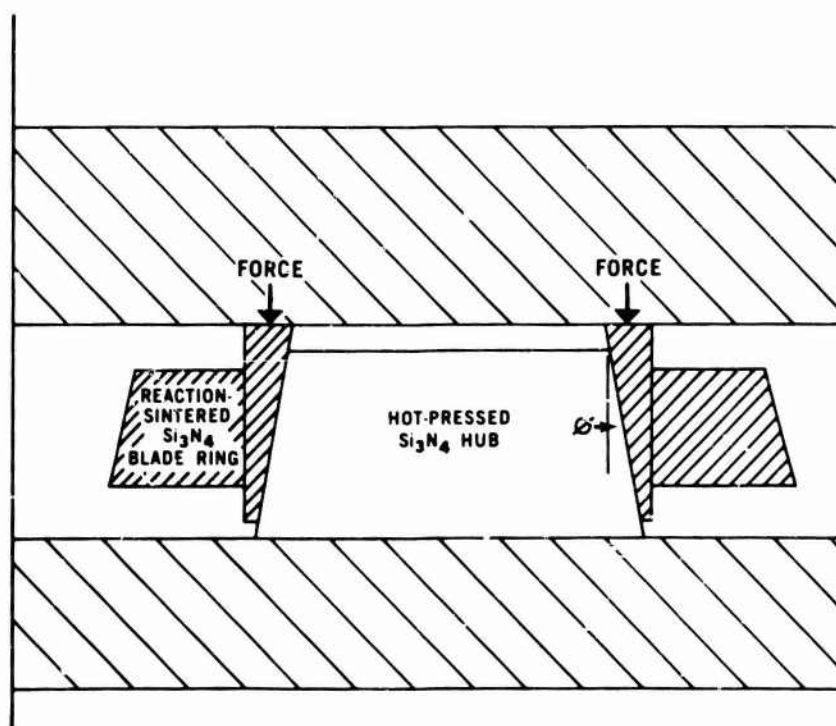
Figure 4.3.2-23 — Schematic View of Duo Density Rotor Fabrication Concept Using Tapered HPSN Hub

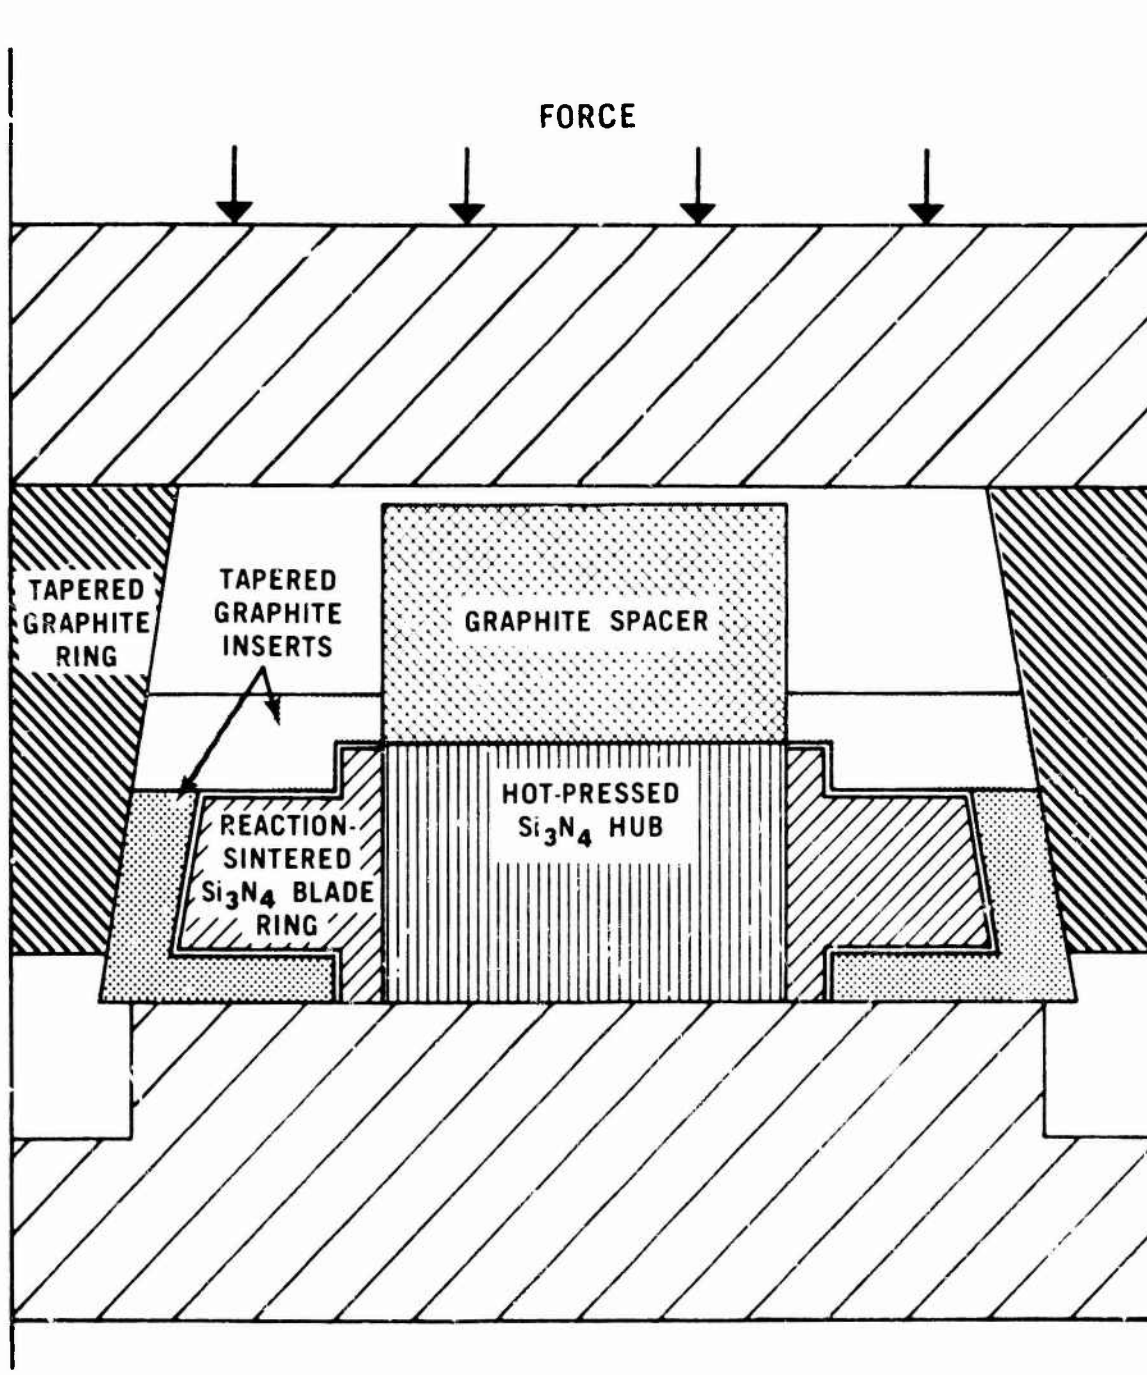
Figure 4.3.2-24 — Schematic View of Duo Density Rotor Fabrication Concept Using Graphite Blade Support and Graphite Wedges

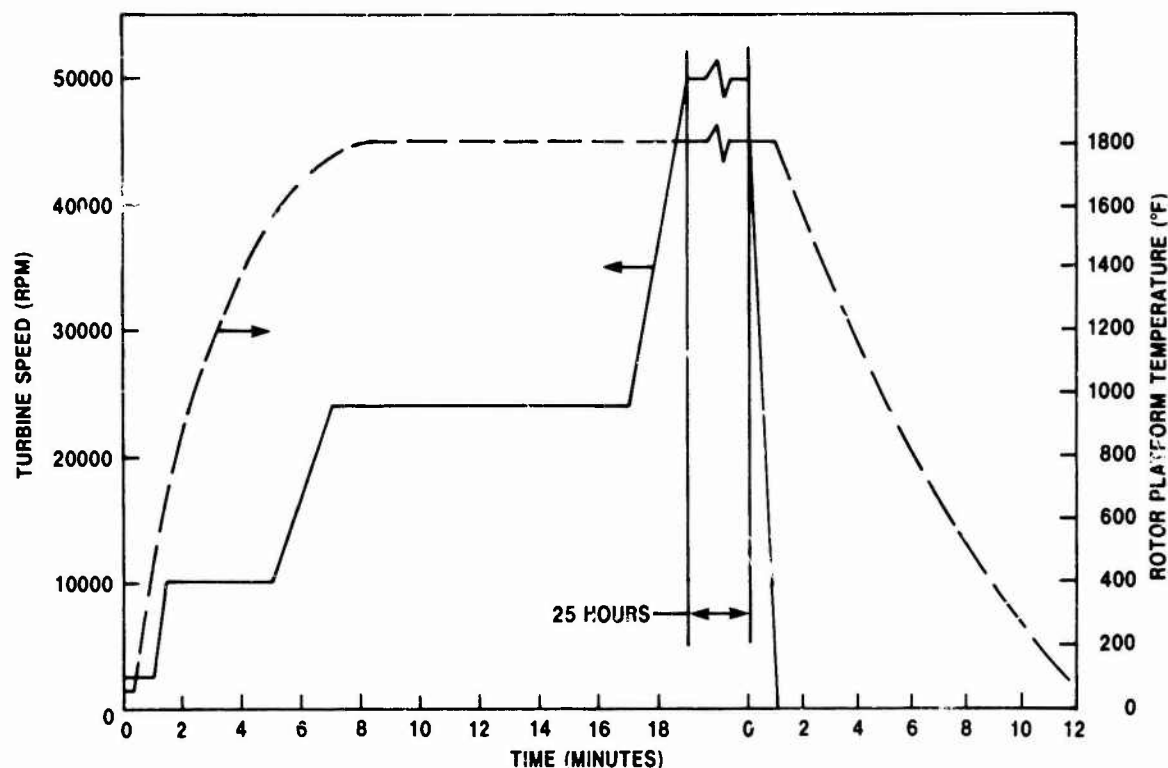
Figure 4.3.3-1 — Twenty-Five Hour Durability Test Schedule

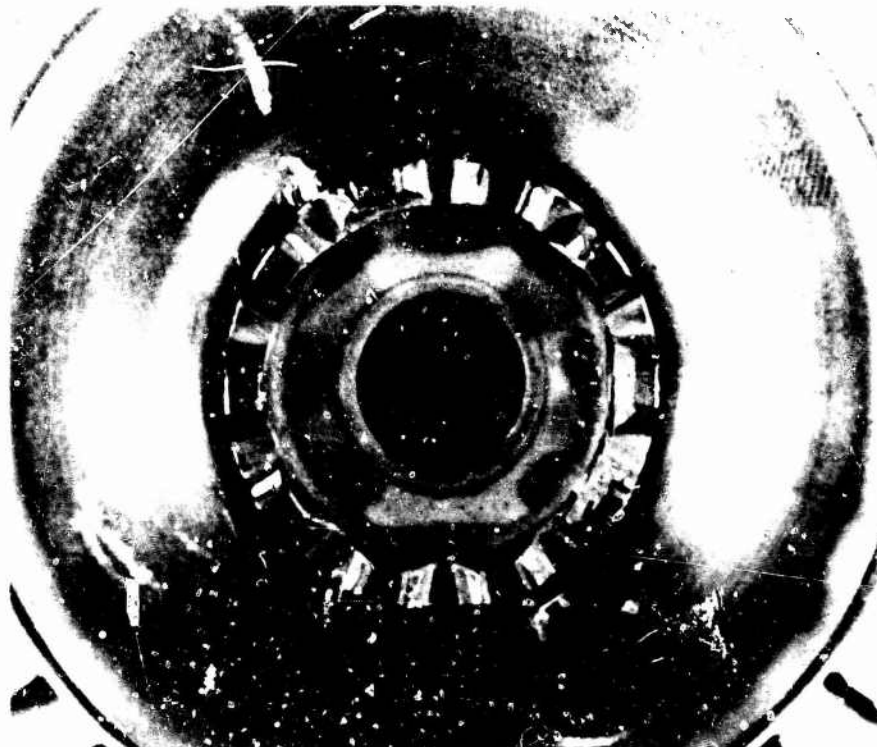
Figure 4.3.3-3 — Cracked Curvic Region of Rotor 1306 After Testing

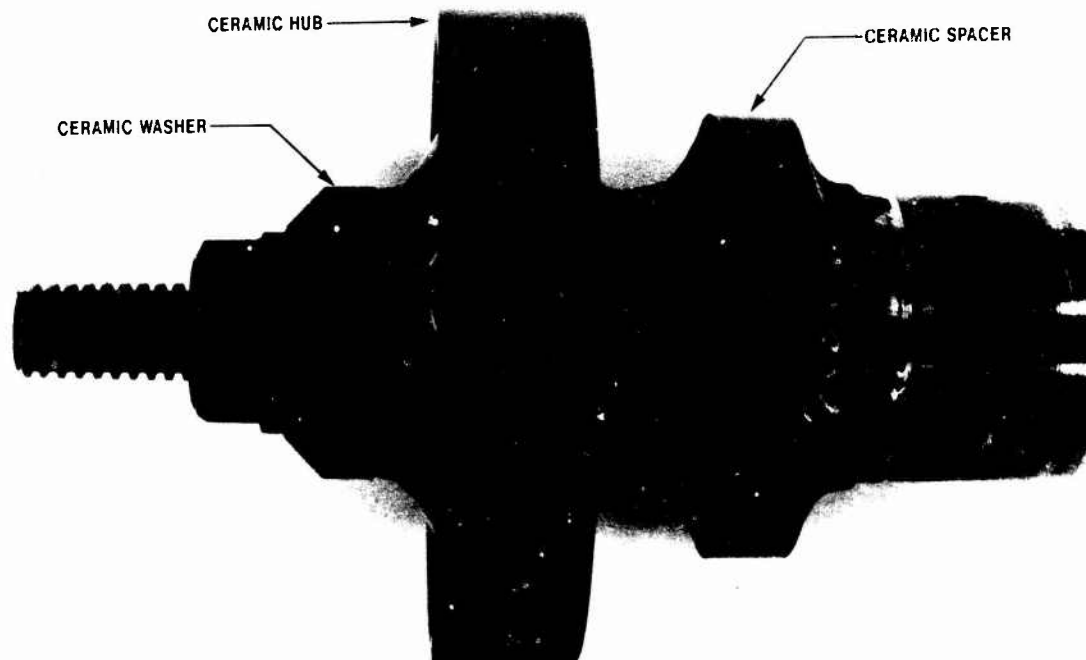
Figure 4.3.3-4 — Assembly Showing Ceramic Washer

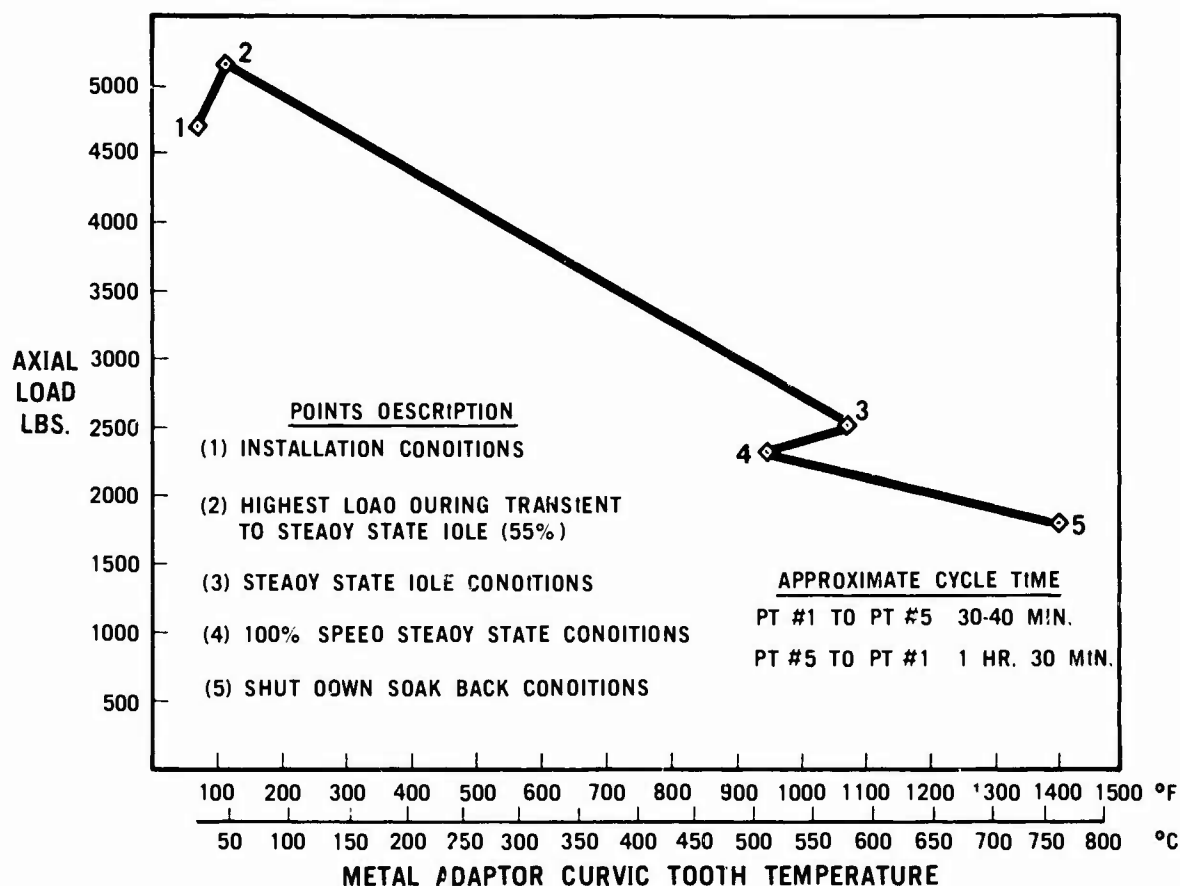
Figure 4.3.3-11 — Thermal-Load Cycle Schedule for Curvic Tooth Lubrication Tests

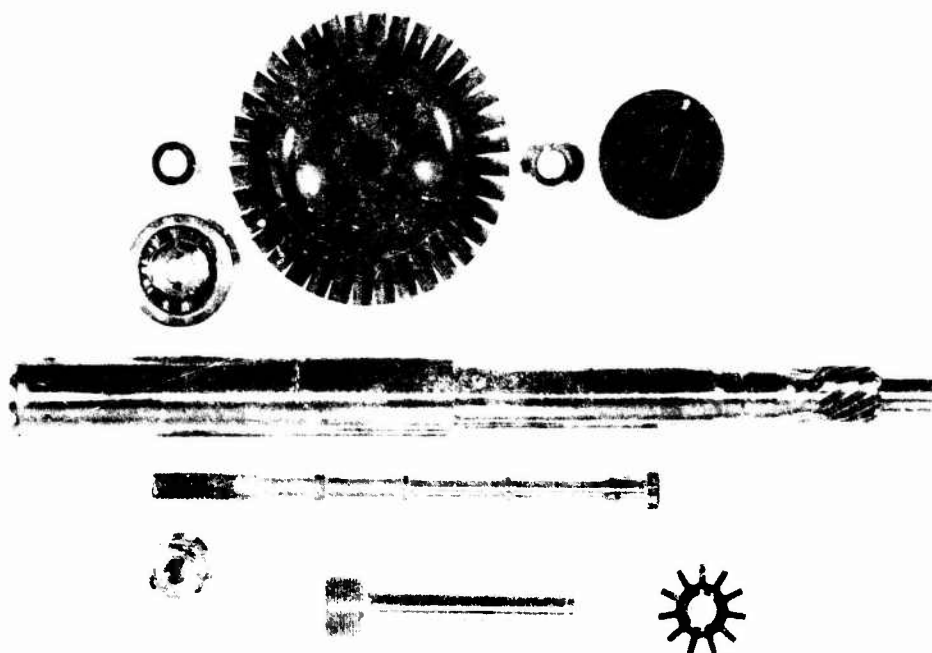
Figure 4.3.3-13 — Ceramic Rotor Number 1195, Attachment Hardware, and Main Shaft
(Defective Blades Were Removed Before Assembly and Test)

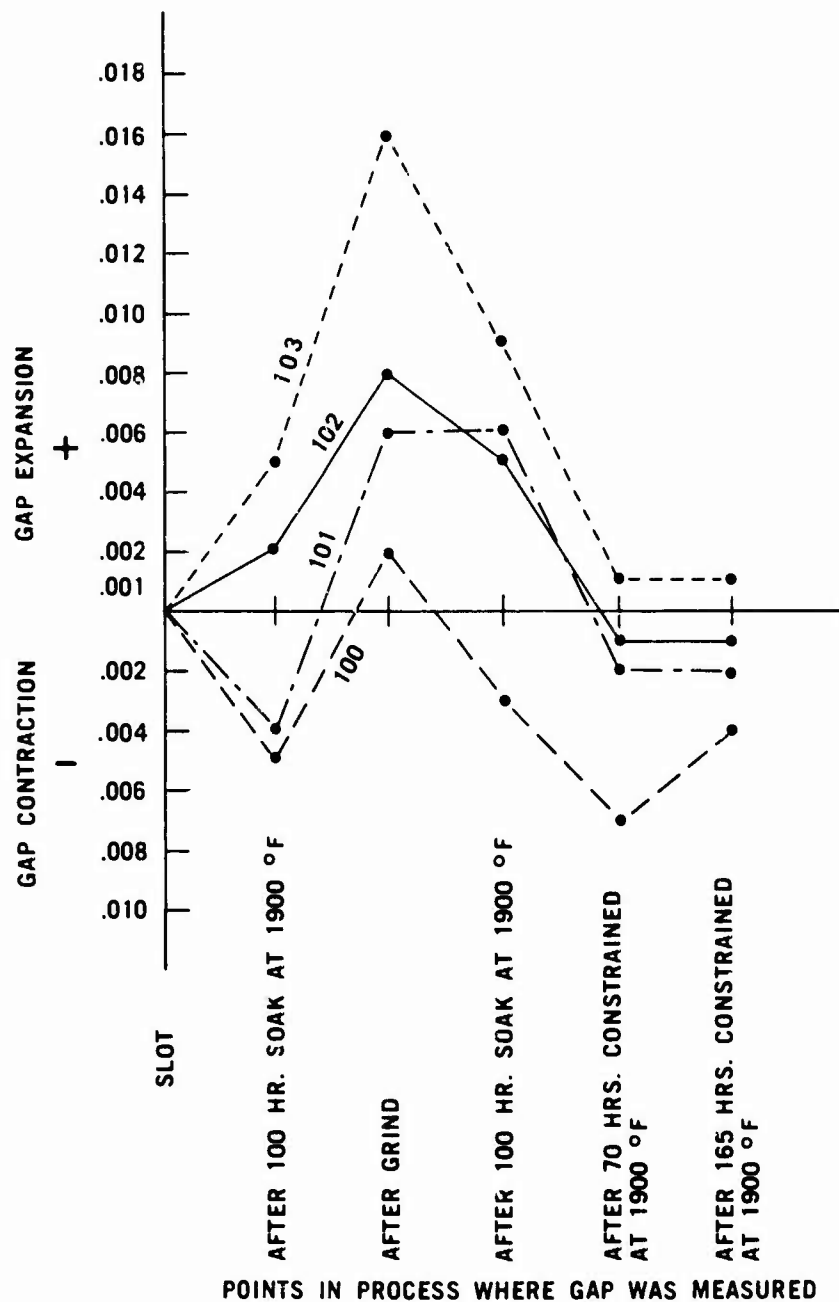
Figure 4.4.2-2 — Gap Changes in Slip Cast RBSN Shroud Rings at Various Stages of Heat Treatment

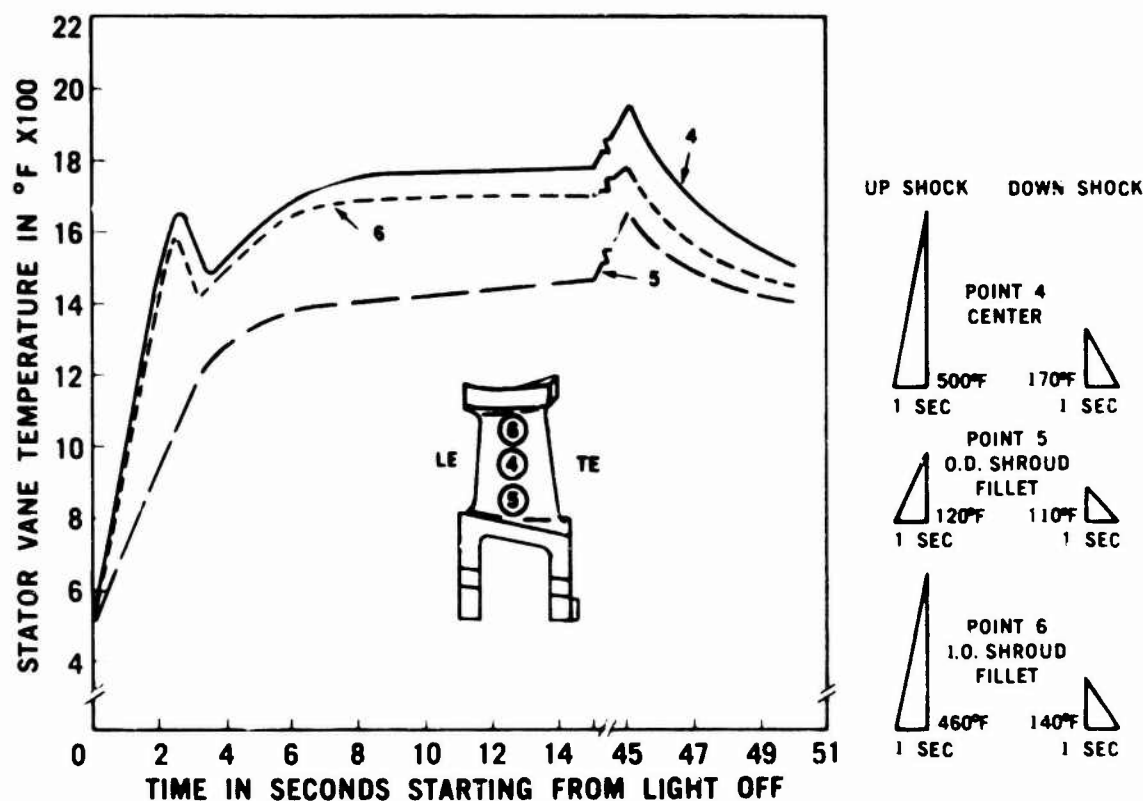
Figure 4.4.3-2 — Heating and Cooling Behavior of First Stage RBSN Design B Stator Vanes in Light-Off Qualification Testing From 500°F Start

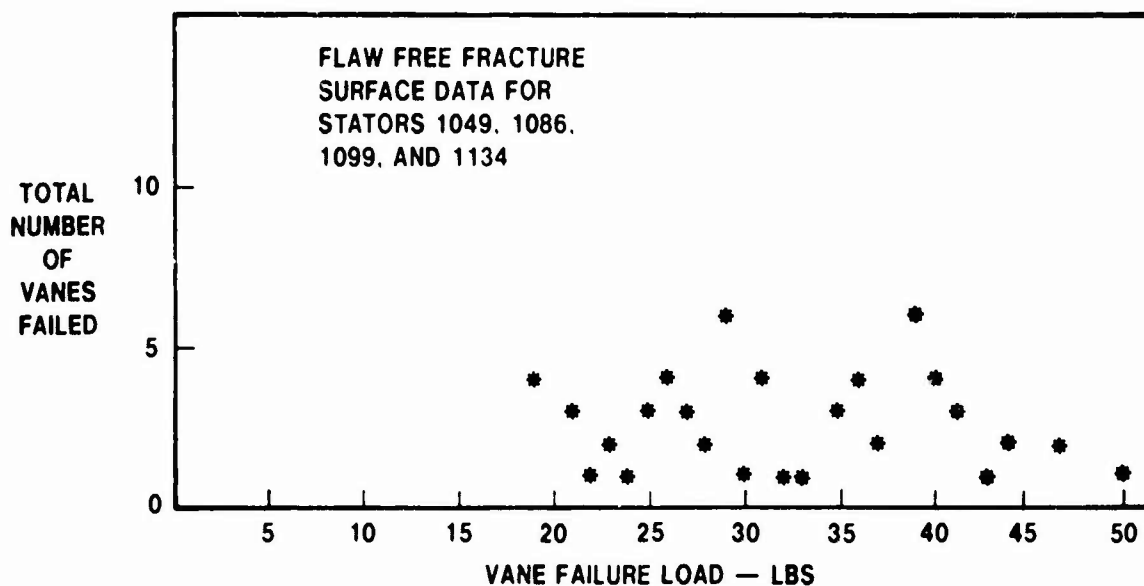
Figure 4.4.3-7 — Distribution of Vane Failure Loads for Unflawed Vanes, One Piece Design D Stators

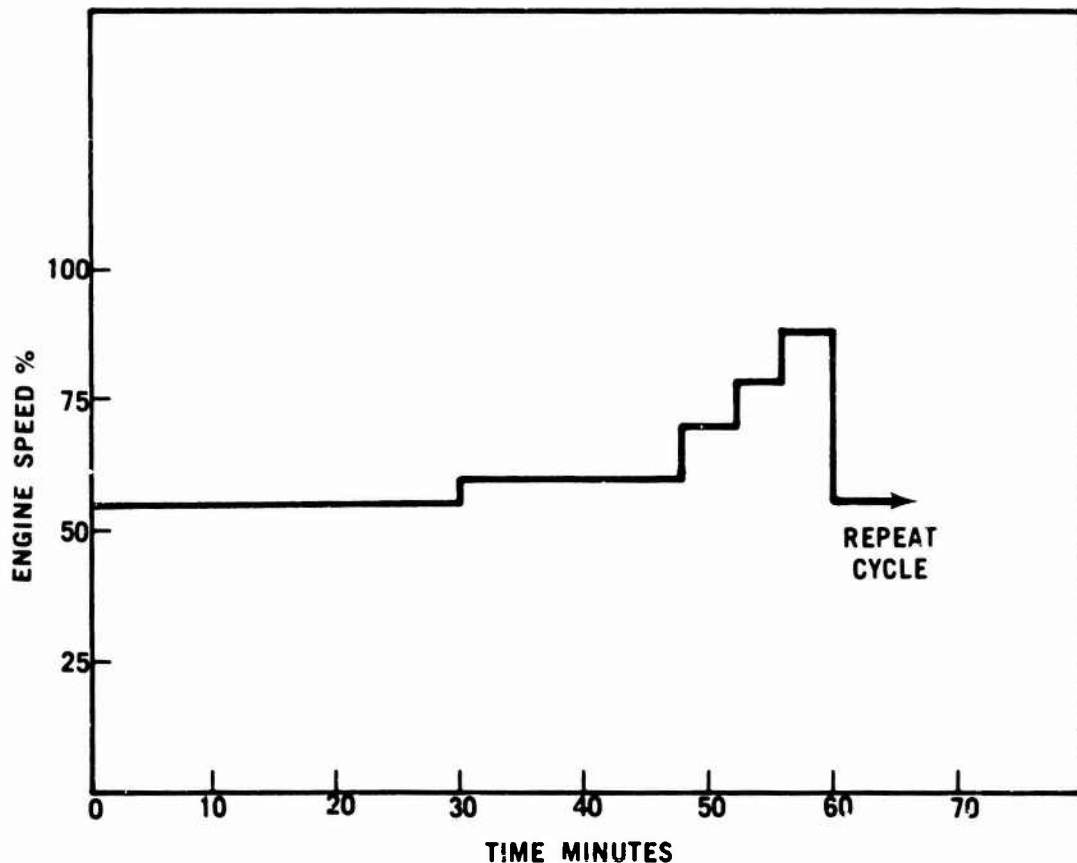
Figure 4.4.4-11 — Durability Duty Cycle For Ceramic Components Tested With Metal Turbine Rotors
