TECHNICAL REPORT M-301
October 1981
Field Welding of Aluminum Alloys

IDENTIFICATION OF PROBLEMS ENCOUNTERED
IN THE FIELD WELDING OF ALUMINUM

by
R. A. Weber

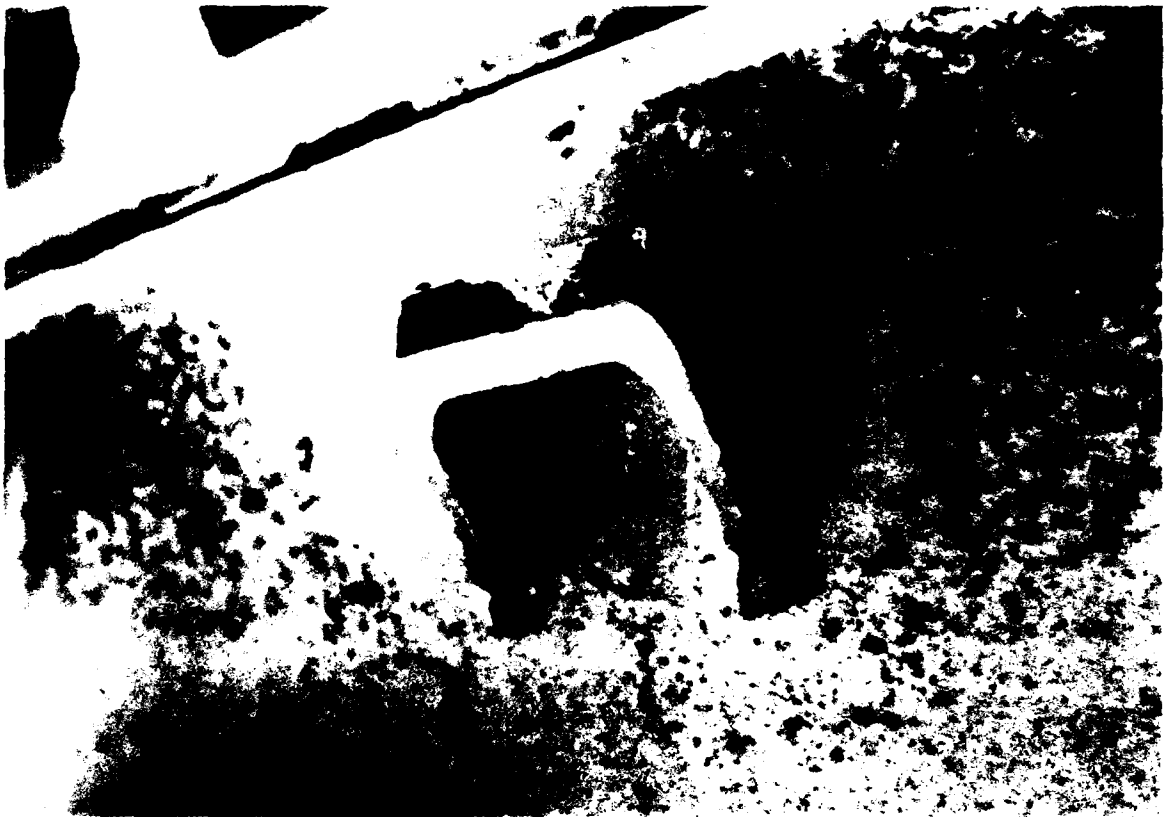
The MGB is a new bridge system in the U.S. Army, and has not been erected very often in the United States except by USAES. Therefore, the information obtained on the MGB comes primarily from USAES personnel. The primary failure of the MGB system is in the carrying brackets (Figure 14). Pry bars are inserted

into the brackets to lift and place the various pieces of the MGB together. As the pieces are manipulated into place, the carrying brackets take all the stress and are subject to tearing. The technical manual supplied with the bridge by the manufacturer notes which areas of the piece may be welded and the welding procedure that should be used. If failures occur in an unweldable area, then that section must be replaced. The MGB is a unique system in that it uses a weldable, age-hardening aluminum alloy. The 7005 alloy used is a natural-aged alloy; therefore, it loses its strength in the area of the weld because of the heat and requires an aging period of 30 days to regain 90 percent of its strength. As a result, these bridge sections cannot be used immediately after welding; therefore, these parts need not be field-welded.

Figure 14. Lifting cleat on medium girder bridge.
