USAAEFA PROJECT NO. 89-06

**PRELIMINARY AIRWORTHINESS EVALUATION OF  
THE UH-1H WITH HOT METAL PLUS PLUME INFRARED  
SUPPRESSOR AND INFRARED JAMMER**

FINAL REPORT

UNITED STATES ARMY AVIATION ENGINEERING FLIGHT ACTIVITY  
EDWARDS AIR FORCE BASE, CALIFORNIA 93523

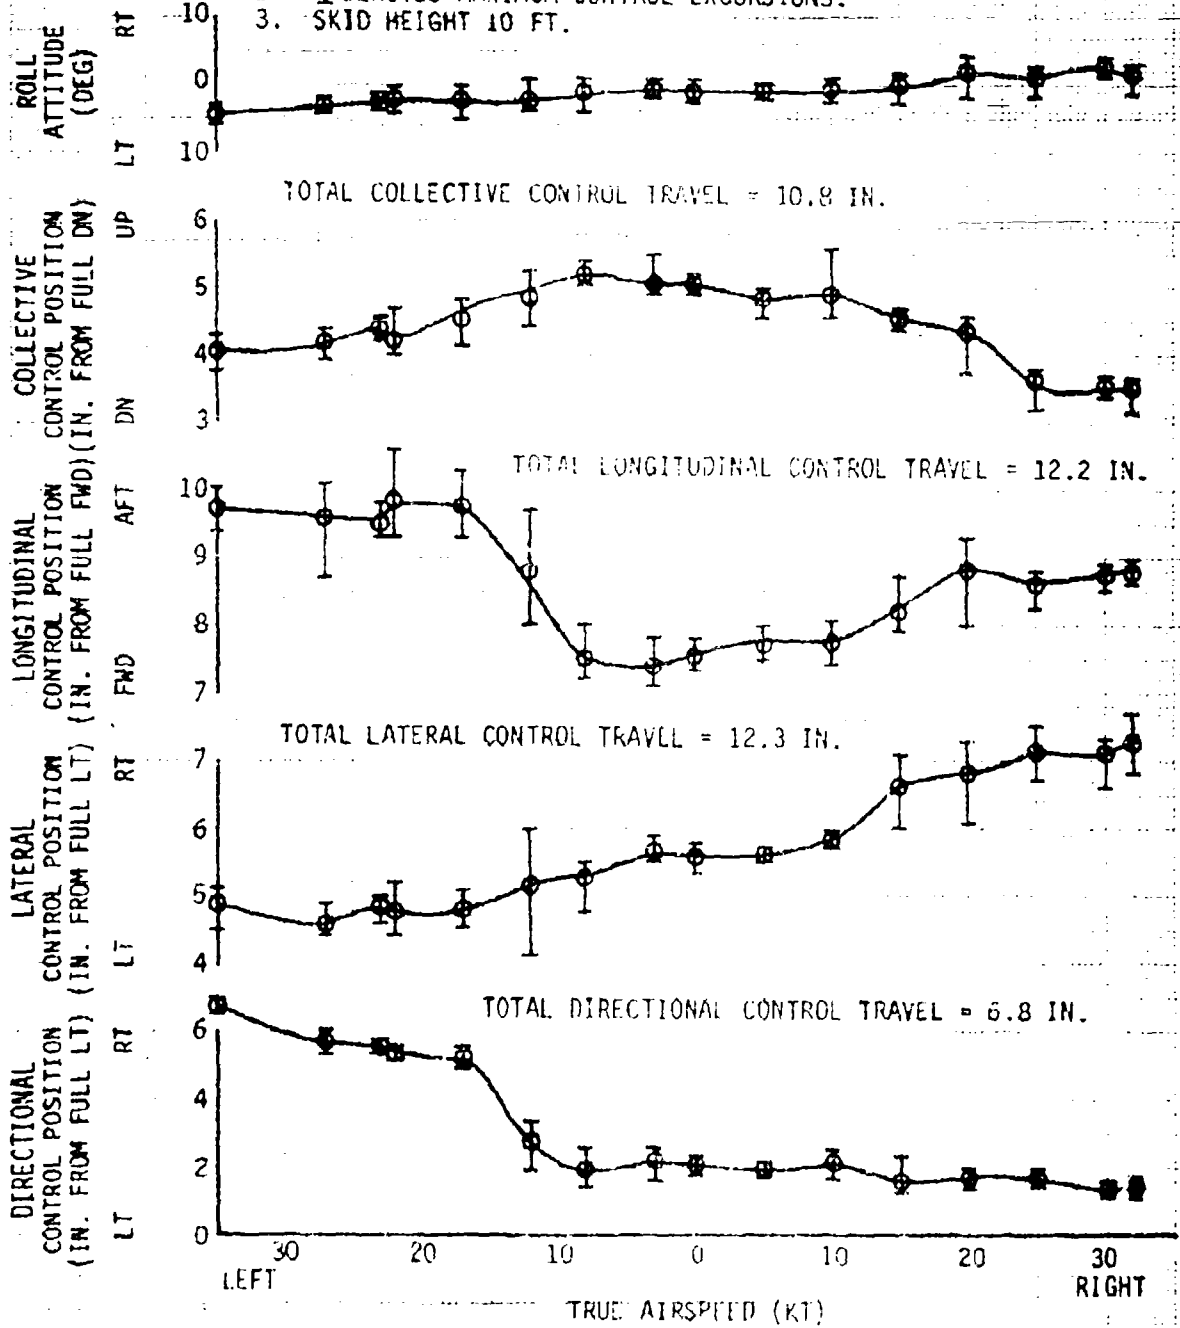
FIGURE 82  
SIDWARD FLIGHT  
UH-1H USA S/N 69-16532

AVG GROSS WEIGHT (LB)	AVG CG LOCATION		AVG DENSITY ALTITUDE (FT)	AVG OAT (°C)	AVG ROTOR SPEED (RPM)
	LONG (FS)	LAT (BL)			
8840	141.0(AFT)	0.1(LT)	2520	16.0	324

- NOTES: 1. INFRARED SUPPRESSOR AND INFRARED JAMMER INSTALLED.  
2. I DENOTES MAXIMUM CONTROL EXCURSIONS.  
3. SKID HEIGHT 10 FT.

18. The results of the left and right sideward flight tests are presented as figures 31 and 32, appendix F. The longitudinal trim shift of approximately 2.5 inches during left sideward flight between 8 and 15 KTAS is characteristic of the standard UH-1H (ref 8, app A) and contributed to high pilot work load (HQRS 5). Figure 32, shows that at the left sideward flight limit of 35 KTAS the right directional control pedal stop was contacted. Inadequate directional control margin was previously reported as a deficiency for the standard UH-1H (ref 7) and was not a result of the IR suppressor and jammer installation.
