FACTORS INFLUENCING
THERMOMECHANICAL FAILURE OF FACE SEALS

Interim Report
submitted to

Office of Naval Research
Contract No. N00014-81-K-0090
Period Covered: December 1, 1980 to November 30, 1981

THAYER
SCHOOL
OF
ENGINEERING

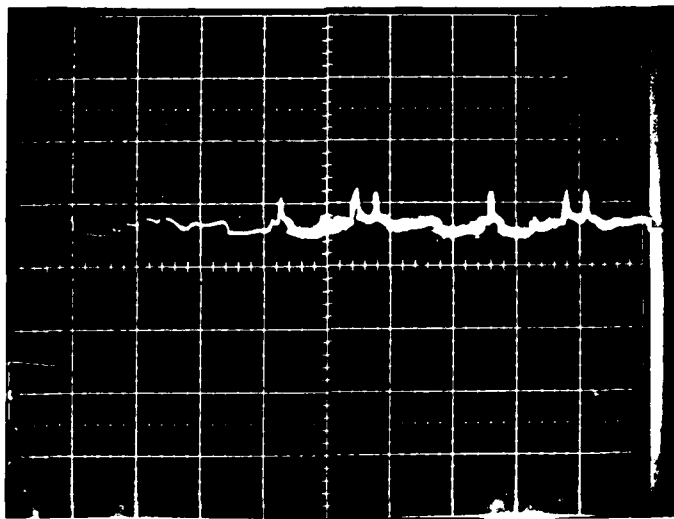
FIGURE 22. Contact probe output at 30 rev/sec, (horizontal scale: 10 msec/div, vertical scale: 2 V/div).

The influence of velocity on thermoelastic instabilities is shown in Figure 22. That trace was taken from a test run at 30 rev/sec (33 sec/rev), with all other conditions being the same as in test of Figures 20 and 21. It can be seen that there are still three contact patches on the mating ring surface and rotating with that ring. The patches appear to be sharper (smaller) than those in the slower tests.
