FRACTURE AND FATIGUE OF BI-MATERIALS

TECHNOLOGY LABORATORY FOR ADVANCED COMPOSITES  
MASSACHUSETTS INSTITUTE OF TECHNOLOGY  
CAMBRIDGE, MASSACHUSETTS 02139

FINAL REPORT FOR PERIOD OCTOBER 1979-SEPTEMBER 1980

DAMAGE INITIATION AND PROPAGATION DURING COMPRESSIVE  
FATIGUE OF FLAWED GRAPHITE/EPOXY COMPOSITES

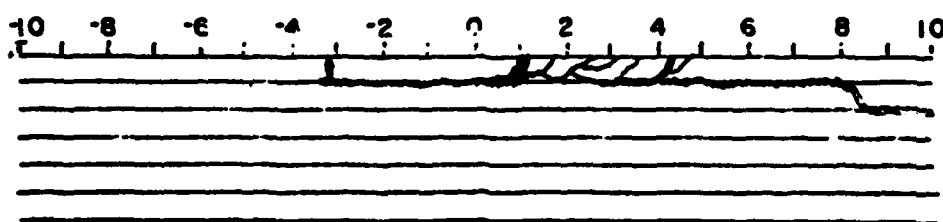
( $\pm 45/0$ )<sub>s</sub> Cross Section at 1.5

Longitudinal Cut 0.5 mm. from Right Edge of Hole

Longitudinal Cut 0.5 cm. from Right Edge of Hole

FIGURE 21 FATIGUE DAMAGE IN  
CROSS SECTIONS FROM TEST 63B
