USAAEFA PROJECT NO. 80-13

HISS CALIBRATION, ICE PHOBICS AND FAA R&D EVALUATIONS

FINAL REPORT

UNITED STATES ARMY AVIATION ENGINEERING FLIGHT ACTIVITY
EDWARDS AIR FORCE BASE, CALIFORNIA 93523

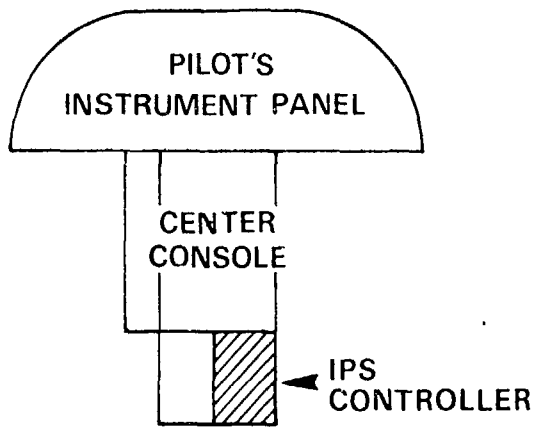
FIGURE 4. IPS CONTROLLER

INDEX	SWITCH OR INDICATOR	FUNCTION
1	MAIN ROTOR ZONE POWER	Provides indications when power is being applied to each of the six main rotor heated areas. As power is programmed to the main rotor heated areas, indicators come on and go off in sequence
2	MAIN ROTOR HEATER FAILURE BITE	Provides indication of failure of one of the six main rotor Heater elements
3	MAIN ROTOR TIME ADJUST	Provides for individual adjustment of the heater-on time for each of the six main rotor heater elements. Locking nuts are provided to secure the settings
4	LWC TIME ADJUST	Provides for the simultaneous adjustments of the time periods that all <u>main and tail rotor</u> heaters are off for light, moderate and heavy voltage settings
5	MASTER POWER	Provides master power control for the ice protection system. Detented to prevent inadvertent operations. Must be cycled OFF, then ON to unlatch any failure lamps. Master power switch is used to activate the blade deice cycle when in the semi-automatic mode

6	PANEL INPUT BREAKER	Controls 28 vdc power to the system. Provides protection against excessive current
7	TEST OVERLOAD	Provides simulation of overload condition for preflight checkout of fault protection circuit
8	TEST LAMPS	Provides test of all lamps on ice protection system control panel only
9	TAIL ROTOR TIME ADJUST	Provides for adjustment of the heater-on time for the tail rotor heater elements
10	TAIL ROTOR HTR FAIL BITE	Provides indication of a failure in the tail rotor deicing system
11	TAIL ROTOR POWER	Provides indication that power is being applied to tail rotor heaters
12	TAIL ROTOR OFF-TIME	Provides selection of tail rotor heater element off-time as 4, 8 or 12 times the heater element on-time

5. The IPS controller was an automatic processor which accepted automatic data from the MK 10 ice detector and Lewis OAT probe, or manual data inputs

from the IPS control unit. It provided the means for adjusting the heat ON/OFF time of the main rotor and provided system fail indications for main and tail rotor blade heater failure.
