NAVAL POSTGRADUATE SCHOOL

THESIS

CHARACTERIZATION OF AN HY-130 STEEL WELDMENT
BY TRANSMISSION ELECTRON MICROSCOPY

December 1981

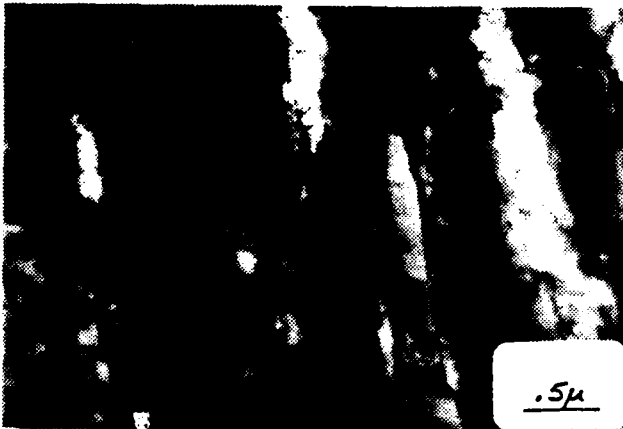
Figure 11

BASE METAL
MICROSTRUCTURES,
DESCRIBED IN TEXT,
ALL PHOTOGRAPHS
AT 22,000X WITH TEM

The base metal was examined in the transmission electron microscope to provide a known baseline microstructure. The microstructures presented in figure (11) show several prior austenite grain boundaries, and large spheroidal carbides are seen at those prior austenite grain boundaries and at lath boundaries. The microstructure is indicative of a tempered martensite with large spheroidal carbides. The martensite laths contain a moderately high dislocation density. Lath spacings have been calculated for these specimens and the other specimens and are presented in table (5).

The base metal microstructures, figure (11), exhibited a tempered martensitic appearance, where the heavy tempering of the base metal prior to welding allowed large spheroidal carbides to be formed. The tempering temperature was held at 620°C for three hours, followed by a water quench. Speich (Ref. 14] showed that a tempering temperature of 400°C for three hours was sufficient for the formation of spheroidal carbides of Fe₃C to form in a low carbon martensite (0.1%C) and this effect is seen in the microstructure of the HY-130 base metal region.

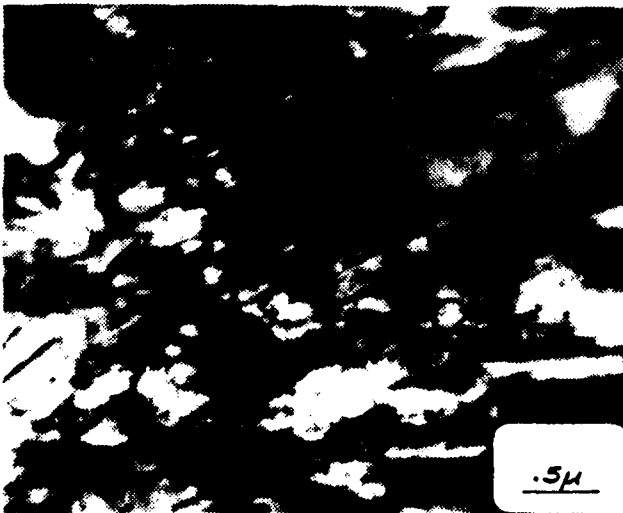
Figure 12

MICROSTRUCTURES AT
3.25mm. DISTANCE FROM
FUSION LINE, ALL
PHOTOGRAPHS AT 22,000X
WITH TEM

heavily dislocated martensitic microstructure, but the large carbides are still visible, the hardness of all the regions show that they represent the HAZ region nearest the base metal.

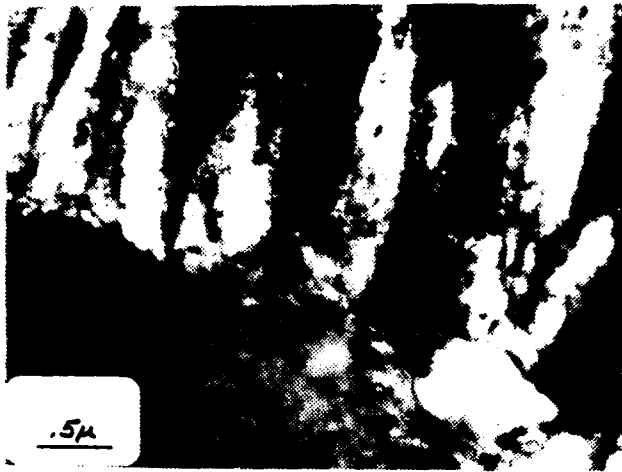
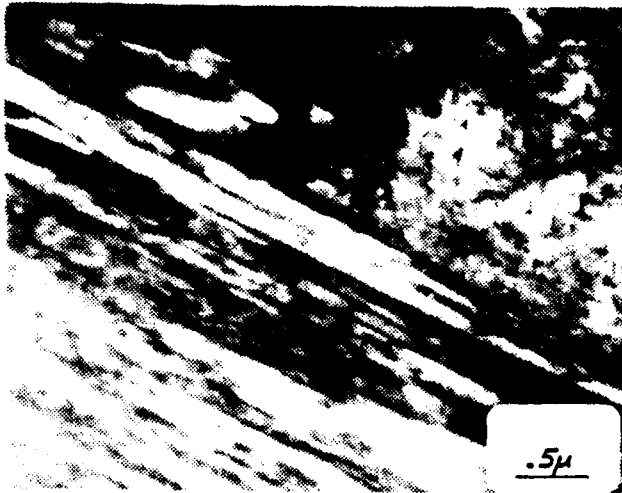
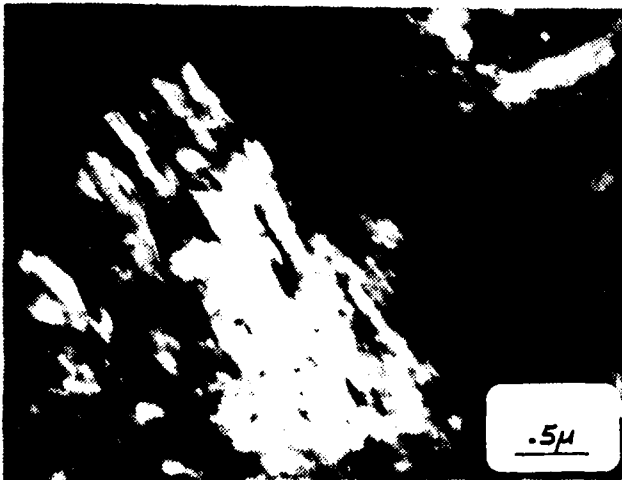
Figure 13
MICROSTRUCTURES AT 2.5mm.
DISTANCE FROM FUSION
LINE ALL
PHOTOGRAPHS AT 22,000X
WITH TEM

Changes begin to appear in the next region which represents the HAZ at a distance of 2.5mm. away from the fusion line, figure (13). Although the predominant microstructure is still martensite, very few large carbides are visible, and region 3 shows bainite I (upper bainite) with Widmanstatten carbide in a wide bainitic lath as sharply contrasted to the narrow lath spacing of the martensitic microstructure. Region 4 shows some granular bainitic microstructure within a predominantly martensite and bainite I field. Region 2 shows martensite with an occasional ferrite region bordering the martensite-bainite interface. Large carbides encircle the ferrite, and retained austenite is also suspected in this region. Figure (14) shows a ferrite, and typical microstructure of region 3 with the wide bainite I laths shown in contrast to the martensitic microstructure. Within the bainite, large regions of rod-shaped Widmanstatten carbides are present along with martensite. The photo at the right is an enlarged view of the Widmanstatten carbides within an upper bainite region. The corresponding diffraction pattern is shown in figure (14) with the very faint carbide reflections present near the central spot.

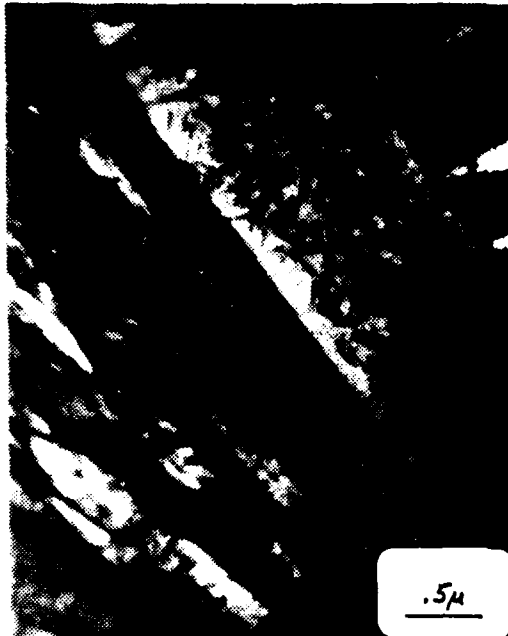
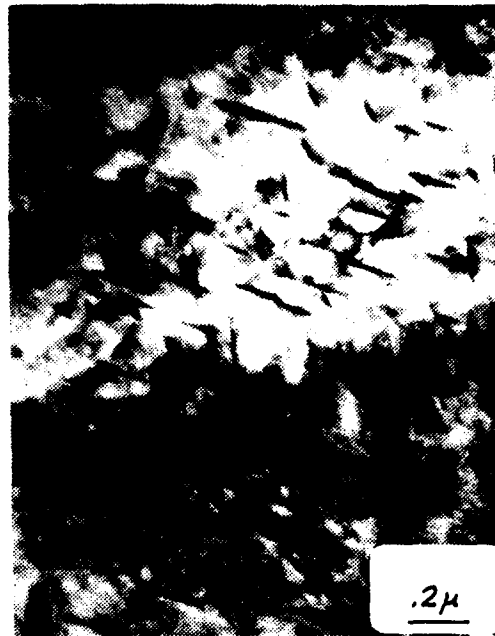
Figure 14

MICROSTRUCTURE AT 2.5mm. AWAY FROM THE FUSION LINE IN REGION 3 WITH THE PHOTO ON THE RIGHT AN ENLARGEMENT OF THE ROD-SHAPED WIDMANSTATTEN CARBIDES PRECIPITATED IN THE UPPER BAINITE ON THE LEFT

SELECTED AREA
DIFFRACTION PATTERN
SHOWING CARBIDES IN
ENLARGED PHOTO AT
RIGHT

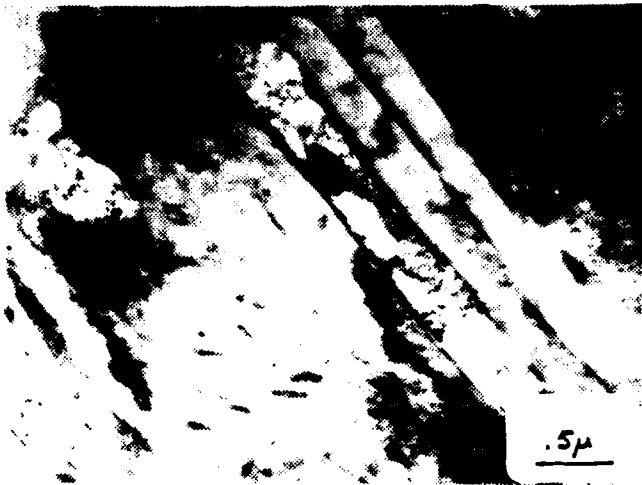
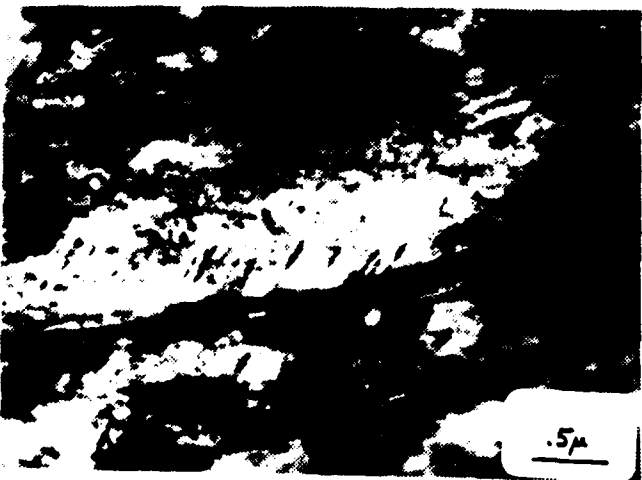
Figure 15

MICROSTRUCTURES AT 1.5mm.
DISTANCE FROM FUSION LINE,
ALL PHOTOGRAPHS AT 22,000X
WITH TEM

The region examined represents the HAZ at a distance of 1.5mm. away from the fusion line (figure (15)). The large spherical carbides are no longer present. The rod-shaped Widmanstatten carbides have replaced the spheroidal carbides in a predominantly bainite I microstructure. Region 2 shows highly dislocated lath martensite with a finer lath spacing than previously observed. Large regions of bainite are the dominant microstructural features in regions 3 and 4 with region 3 showing very few carbides in the bainite in sharp contrast to the high density of rod-shaped Widmanstatten carbides shown in region 4 in the fairly wide bainite lath. Twins are attributed to segregation of alloying elements in the relatively slow cooled weldment, and are not a dominant feature of this section.

The mixture of bainite I - martensite microstructure in the region of the HAZ at 1.5mm. away from the fusion line, (figure (15)), can be reasoned by referring to the isothermal transformation diagram for HY-130 steel, figure (1). For a martensite start temperature (M_s) of 482°C , less than five percent bainite will form in three minutes. Since no large carbides are present in the microstructures, a larger amount of carbon must be in solution than in the previous sections which would lower the M_s temperature, thus allowing a larger amount of bainite to form. The bainite was formed upon cooling from the 1020°C peak temperature experienced in this region during welding and large rod-shaped Widmanstätten carbides were also precipitated within the bainite during the transformation from austenite. Lath martensite is still present in this region, as predicted by the transformation diagram, but the lath spacing is smaller due to the higher cooling rate experienced nearer the fusion line.

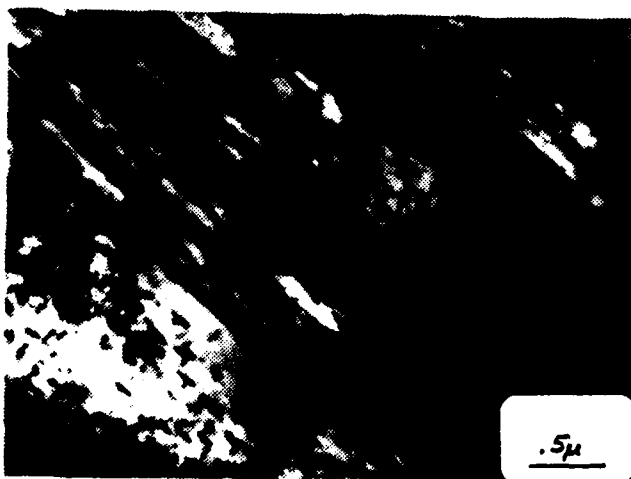
Figure 16

MICROSTRUCTURES AT 1.0mm.
DISTANCE FROM FUSION
LINE, ALL PHOTOGRAPHS
AT 22,000X WITH
TEM

Bainite I comprises a large fraction of the microstructure in regions representative of the HAZ at a distance of 1.0mm. away from the fusion line. (Figure (16)) The large regions of bainite and the associated rod-shaped Widmanstatten carbides are shown in sharp contrast to the highly dislocated lath martensite. Region 3 shows the relatively wide bainitic laths and the narrow martensitic laths with retained austenite being suspected at the lath boundaries. Region 4 clearly shows the rod-shaped Widmanstatten carbides precipitated at dislocations within

The region of the HAZ that is 1.0mm. away from the fusion line, figure (16), is much like that of the previous region with bainite I and martensite being the predominant microstructure. There are large numbers of rod-shaped Widmanstätten carbides precipitated at dislocations within the bainite laths, and a smaller number of rod-shaped

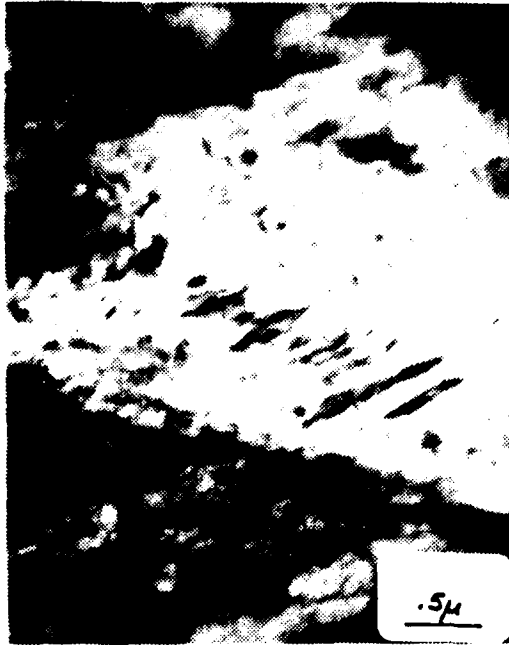
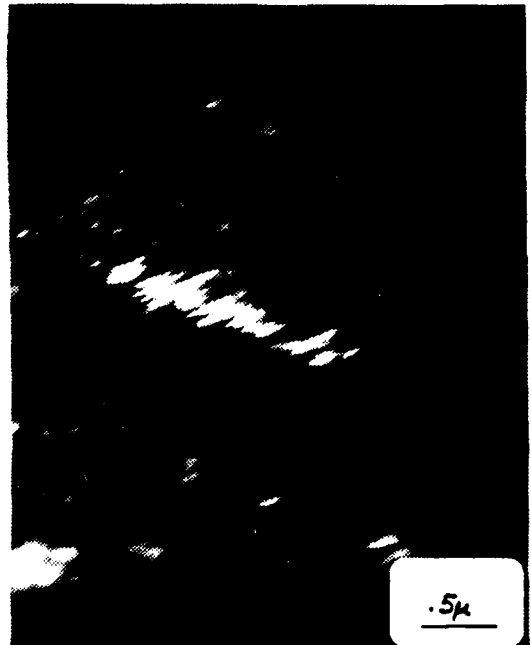
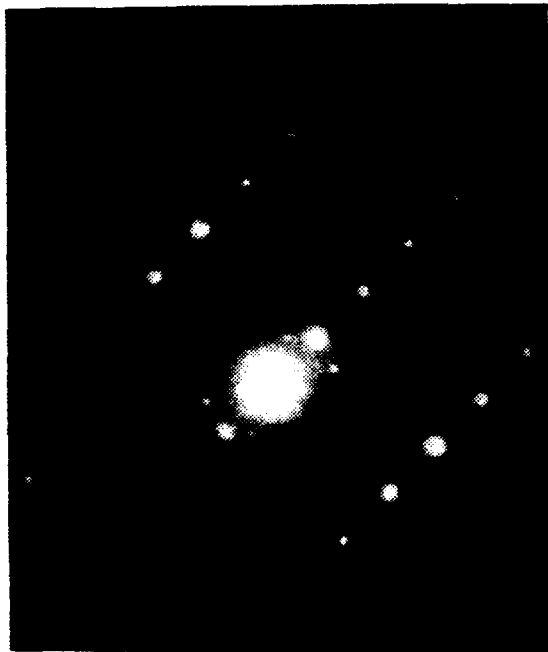
Figure 17

MICROSTRUCTURE SHOWING TWINNED MARTENSITE IN THE UPPER
BAINITE OF REGION 4

SELECTED AREA
DIFFRACTION OF ABOVE
SHOWING TWINNED
MARTENSITE

the wide bainite I laths. Figure (17) shows the dark field-bright field microstructures from a region of section 4 with the presence of twinned martensite in the wide laths encompassing the Widmanstätten carbides. This twinning is not characteristic of such a slow cooled weldment, but is known to occur in bainite I as a result of alloy segregation. [Ref. 11] The associated selected area diffraction pattern reveals this twinned martensite and is shown in the same figure.

carbides appear in the narrow martensite laths, indicating some autotempering may have occurred. Twinned martensite was occasionally found in this region, probably due to alloy segregation, figure (17). There is some retained austenite suspected in this region, which is reasonable when the rapid cooling rate from 1170°C experienced by this region is considered. Chen and Thompson [Ref. 12] illustrate similar micrographs of retained austenite in their work, especially in regions of upper bainite.

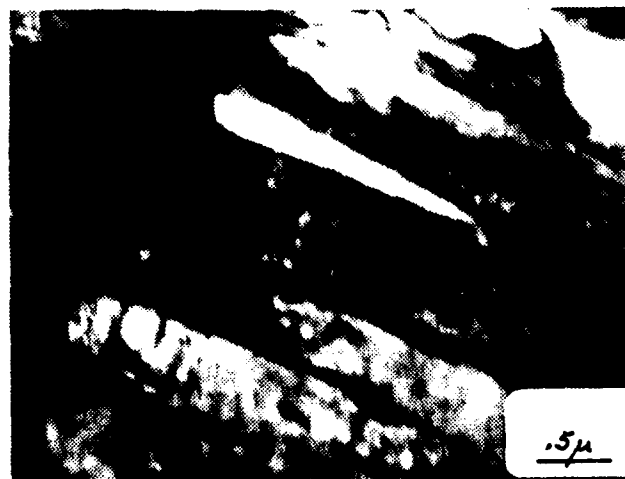
Figure 18

MICROSTRUCTURES AT
FUSION LINE, ALL
PHOTOGRAPHS AT 22,000X

The fusion line region is shown in figure (18) and for the first time. Bainite III (lower bainite) is observed. The acicular bainite laths show some carbides at boundaries and interior regions. The amount of carbides visible has greatly decreased from those seen in other regions of the HAZ, and the laths are narrower and shorter than those of bainite I.

The sections representing the fusion line, as shown in figure (18), are subjected to a temperature of approximately 1536°C. The microstructure consists of primarily lower bainite. Carbides are not visible and, since the temperature (1536°C) would be high enough to ensure complete solutioning of the carbon and the possibility of some mixing with weld metal, the Ms temperature would be lower at the fusion line than for any other region of the HAZ, thus allowing lower bainite to form. The cooling rate in this region is fairly rapid, and is at least 17°C per second given by Sorek, [Ref. 9] which exceeds the 8°C per second cooling rate required for martensite formation as discussed by Holsberg. [Ref. 15] Another explanation for the lower bainite present at the fusion line is that dilution of the base metal (5% nickel) probably occurred, mixing with the weld metal (2.76%nickel) producing a lower hardenability and

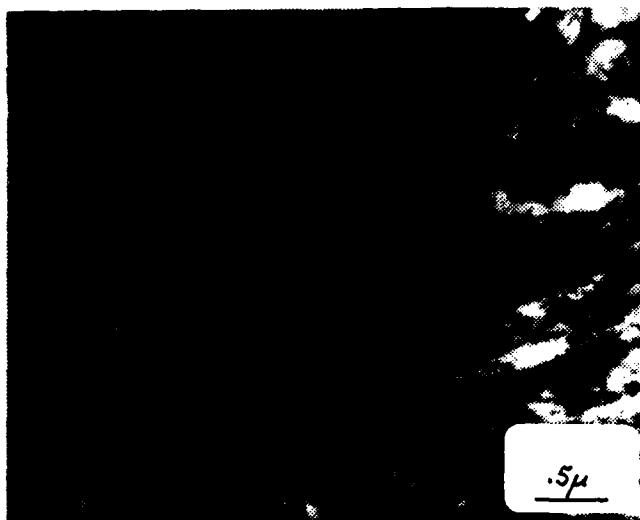
Figure 19

MICROSTRUCTURES IN THE WELD METAL, JUST INSIDE THE
FUSION LINE, ALL PHOTOGRAPHS AT 22,000X WITH TEM

The weld metal just inside the fusion line was examined and figure (19) shows the representative microstructure for this region. The microstructure is predominately bainite III with no carbides visible in the photographs. The lath spacing is wider than that observed in the fusion line region, but the bainite laths are not as wide as those observed in bainite I.

The microstructures representing the weld metal, as shown in figure (19), are similar to the microstructures at the fusion line, thus indicating that the region thought to be weld metal only was actually a similar dilution of weld metal and filler metal. Stoop and Metzbower [Ref. 16] have verified this dilution in the fusion zone by microprobe analysis. Referring to figure (21) showing the weld geometry superimposed on a macro photograph of the etched weldment, it is clear that a region of weld metal only, undiluted with the base metal, lies well inside the fusion line toward the weld center. This would explain the similarity in the microstructures representing the two regions.
