Investigation of Cold Cathode and RF
Excitation
for

Long Life CO₂ Waveguide Lasers
Annual Summary Report
for Contract N00014-79-C-312, P2

by
U. Hochuli
December 1982

Abstract

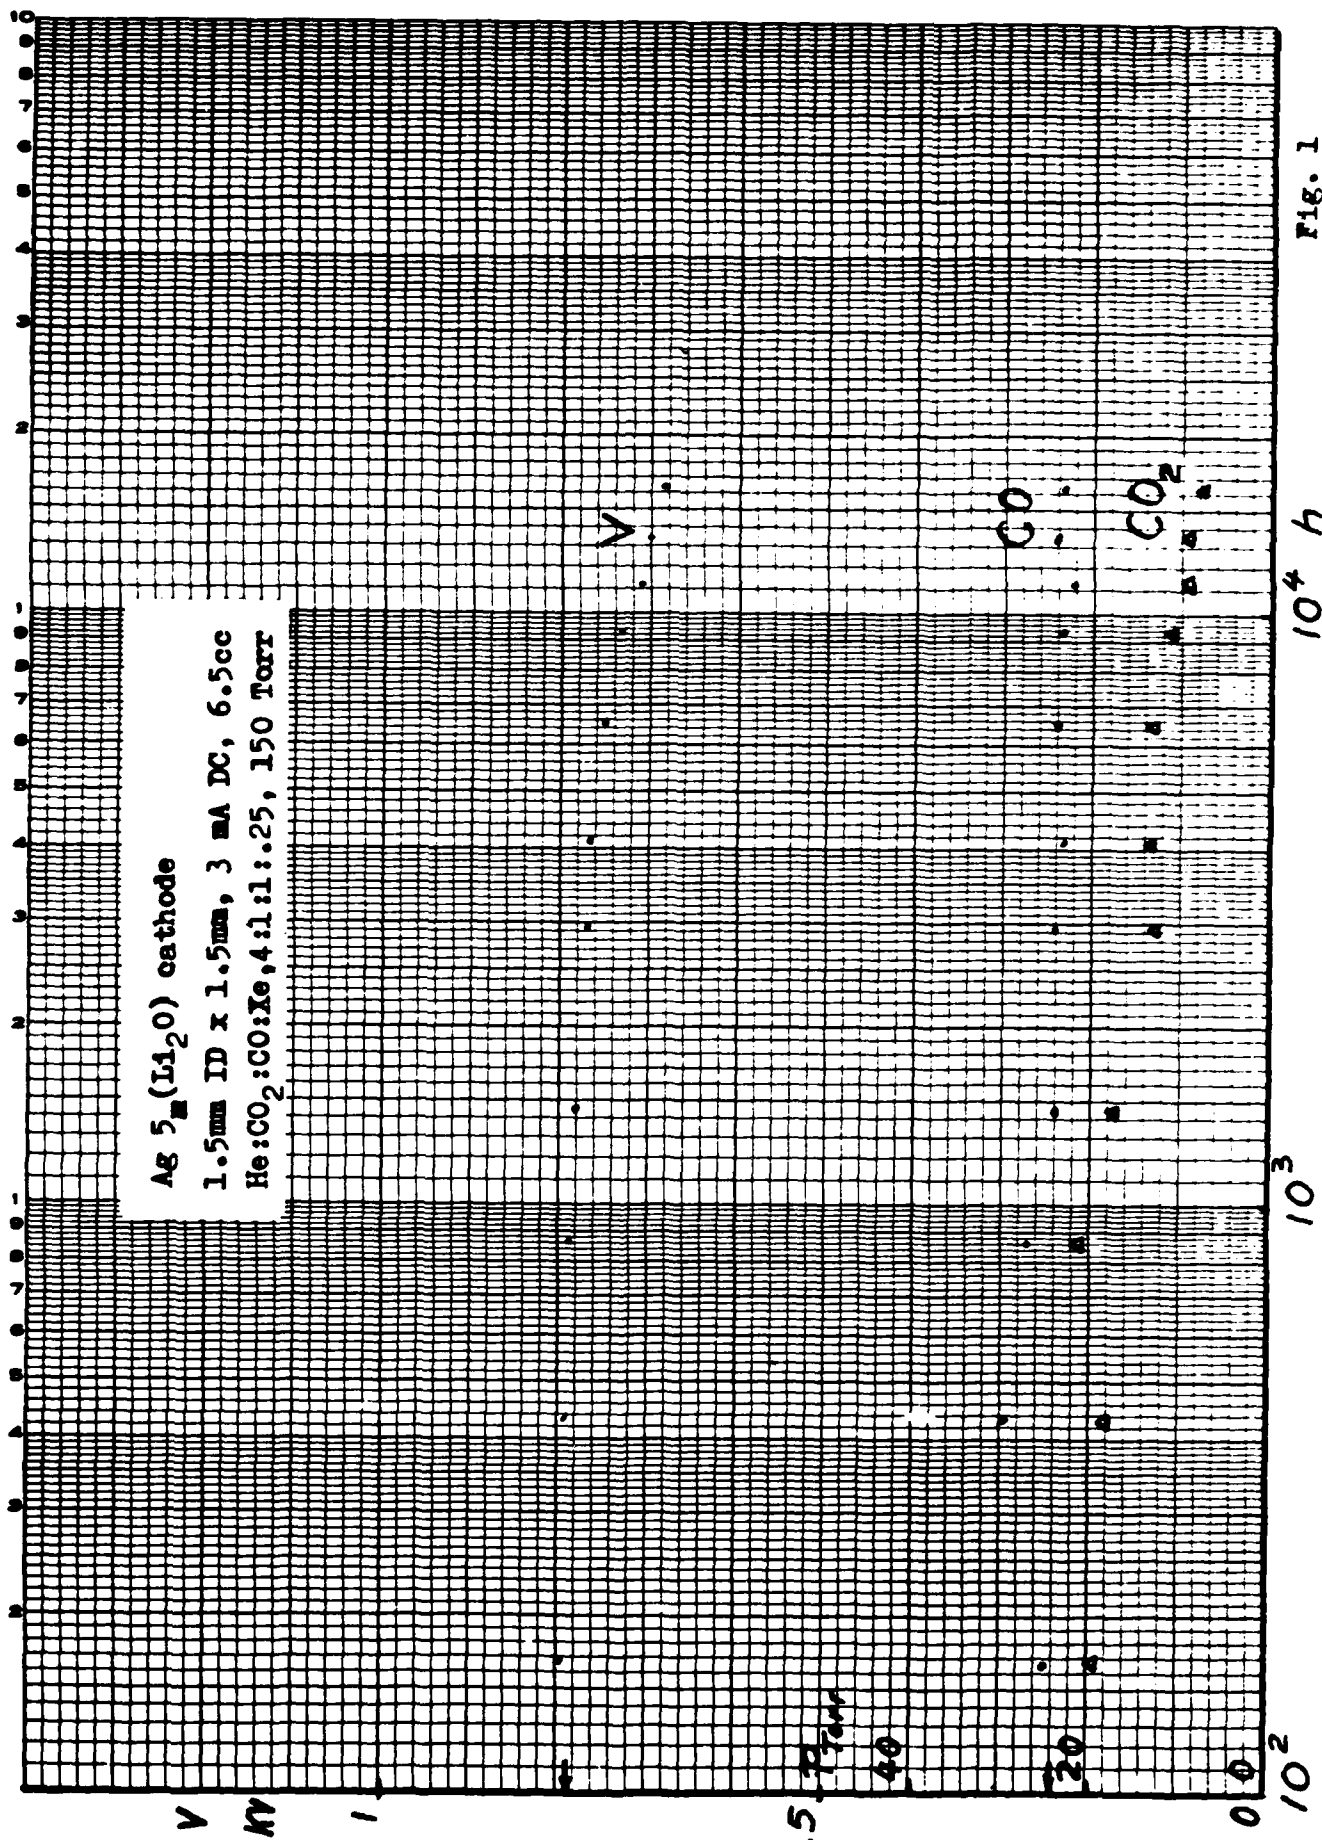
Fig. 1

CO and CO₂ contents, measured by infrared absorption spectroscopy, are shown in Figure 1. These results indicate that the Ag-Li compound cathode used may yield laser life of the order of 10⁴ hours. This result alone does not qualify it as an outstanding cathode. The most pleasant and surprising aspects are its low sputtering rate and the absence of loose sputtering products outside of the cathode cavity. Figure A-2 shows the discharge tube after 20,000 hours of continuous operation. Its glass envelope reveals only a light film formed from sputtering products, with good wall adhesion and the sputtershield is quite clean. Figure A-3 exhibits the cathode assembly and the anode of the dissected discharge tube. The deposits visible on the anode sheet indicate that material transport from cathode to anode had taken place. Figure A-4 shows the cathode assembly, cut in half along the cathode axis. The cathode cavity itself is covered by a burr and can not be seen. The interesting detail, clearly visible here, is the erosion that took place in the throat of the sputtershield. The throat, originally a cylindrical hole, now shows the standing wave pattern caused by plasma oscillations. Regrinding to remove the burr resulted in a cut that is not parallel anymore with the cathode axis but opened the cavity for inspection as shown in Figure A-5. The original shape of the cavity bottom duplicated the drill point used to machine it. The bottom is now well rounded and the removed material has relocated and filled-in the top edge of the cavity. This process apparently took place without forming loose sputtering products.

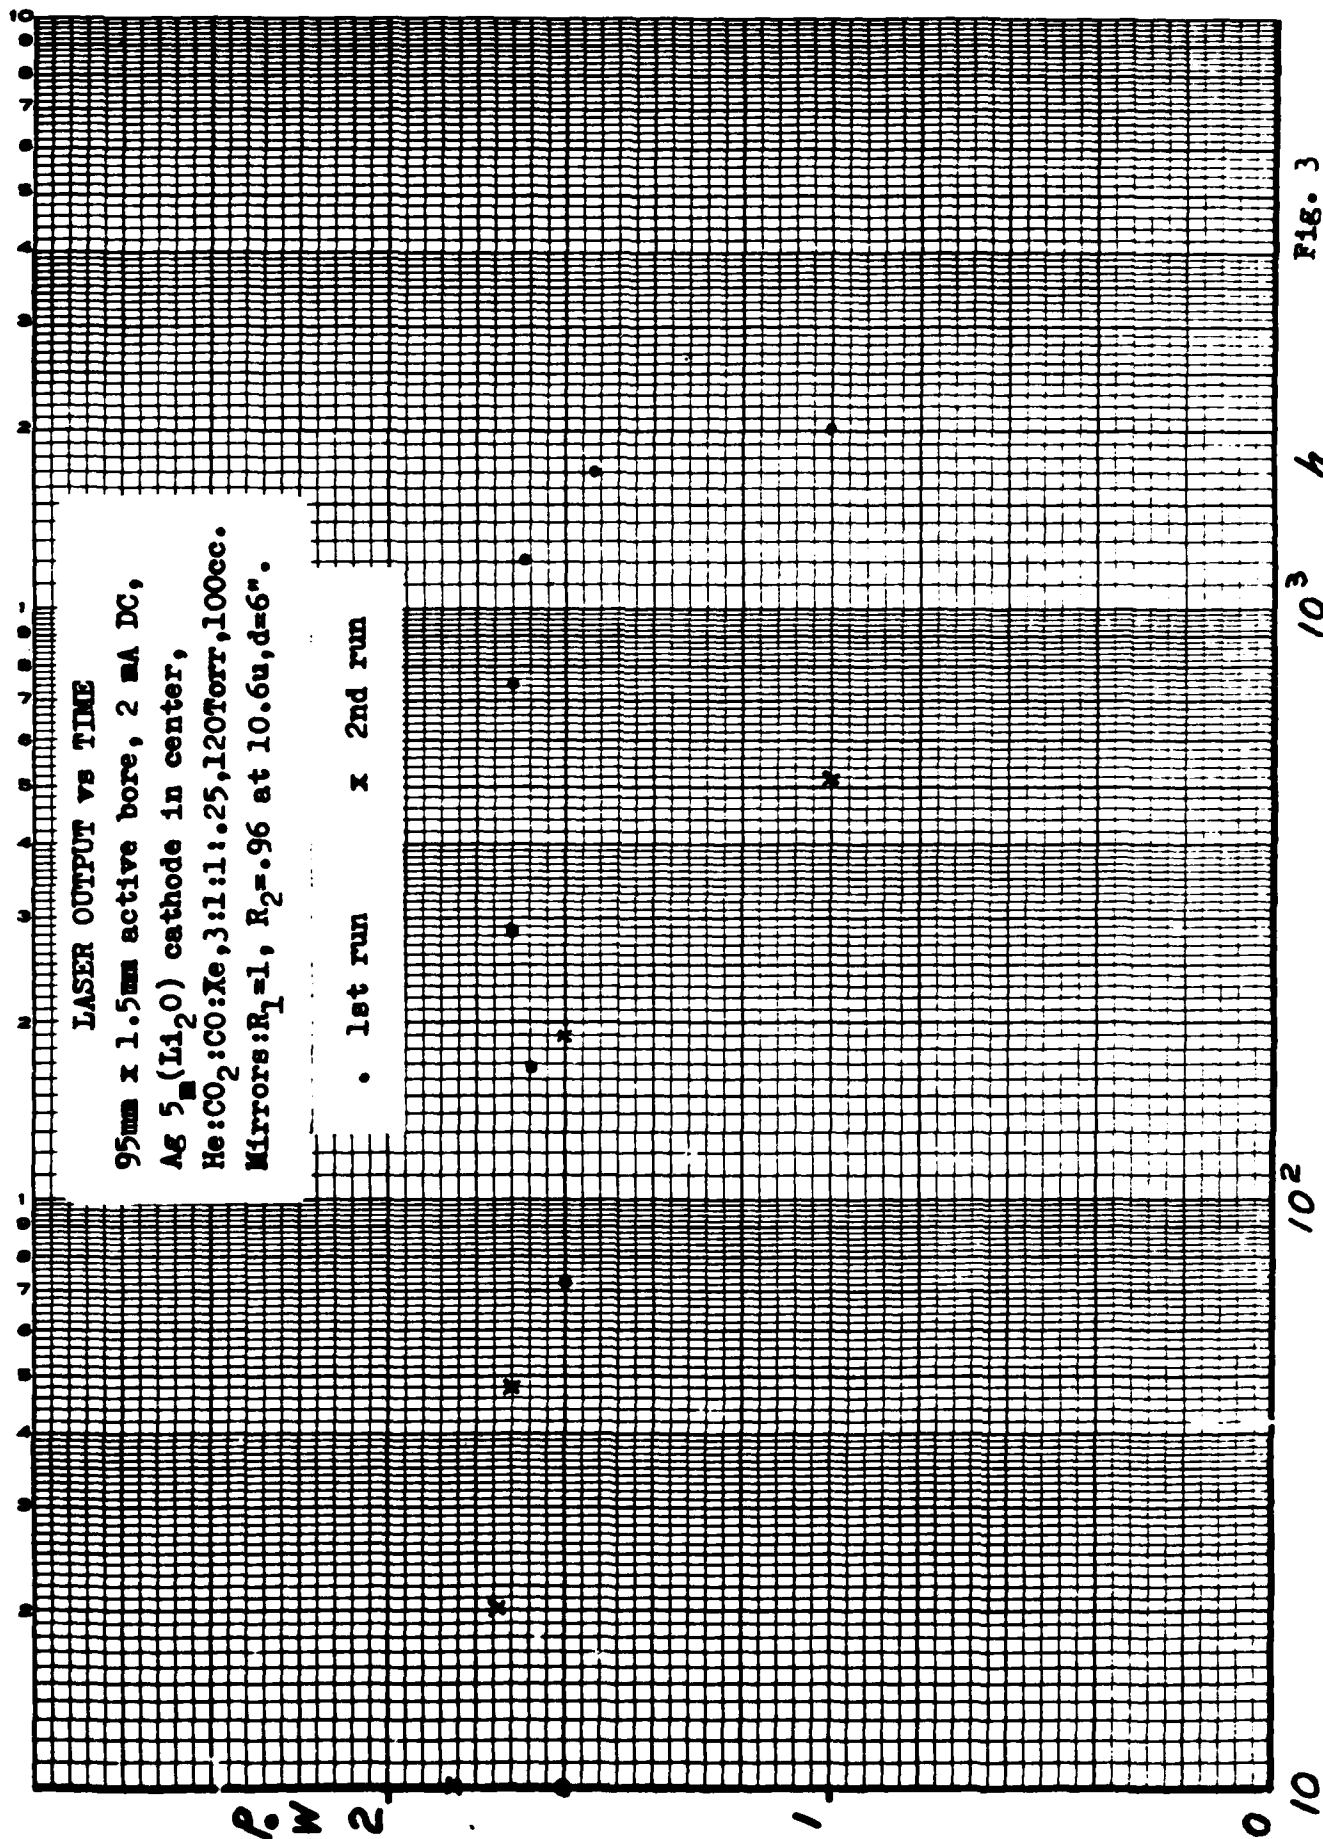
Fig. 3

Two of these structures, shown in Figure A-1 (Crossection shown in Figure 2) were assembled and put on life tests. The first laser had one Pt anode at each bore end and a common 4mA Ag-Li compound cathode in the center. Life test results, shown in Figure 3, indicate a disappointingly low life of 1900 hours for the first run. The laser was then evacuated and refilled for a second test. The initial power output for the second test was slightly higher than for the first test, an indication that so far no serious mirror degradation had taken place. Laser life turned out to be even shorter, only 450 hours. We discovered later that the laser envelope had developed a vacuum leak at one of its seals. Inspection of the cathode indicated fairly heavy erosion. In one place the cathode spot had produced a hole clear through the cathode wall out to the sputtershield. Unfortunately we do not know if the cathode current of 4mA was excessive or if the presence of air was responsible for this result. We felt that this test had failed and no further analysis was made on this laser.

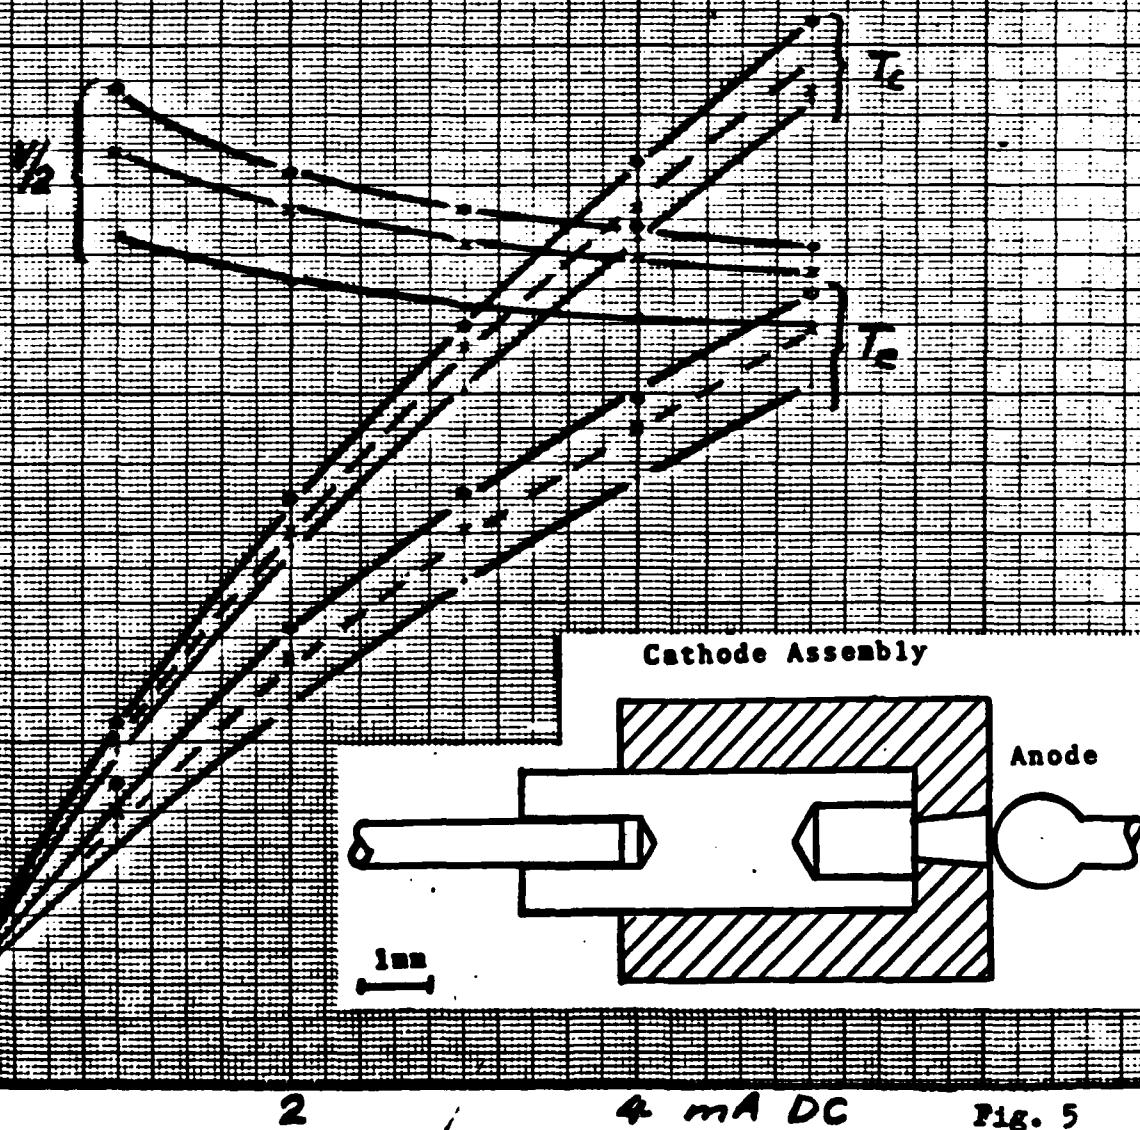
Fig. 5

CATHODE TEMPERATURE vs DISCHARGE CURRENT

Copper cathode

$\text{He}:\text{CO}_2:\text{CO}:\text{Xe}, 3:1:1:.25, 30 \text{ to } 160 \text{ Torr}$

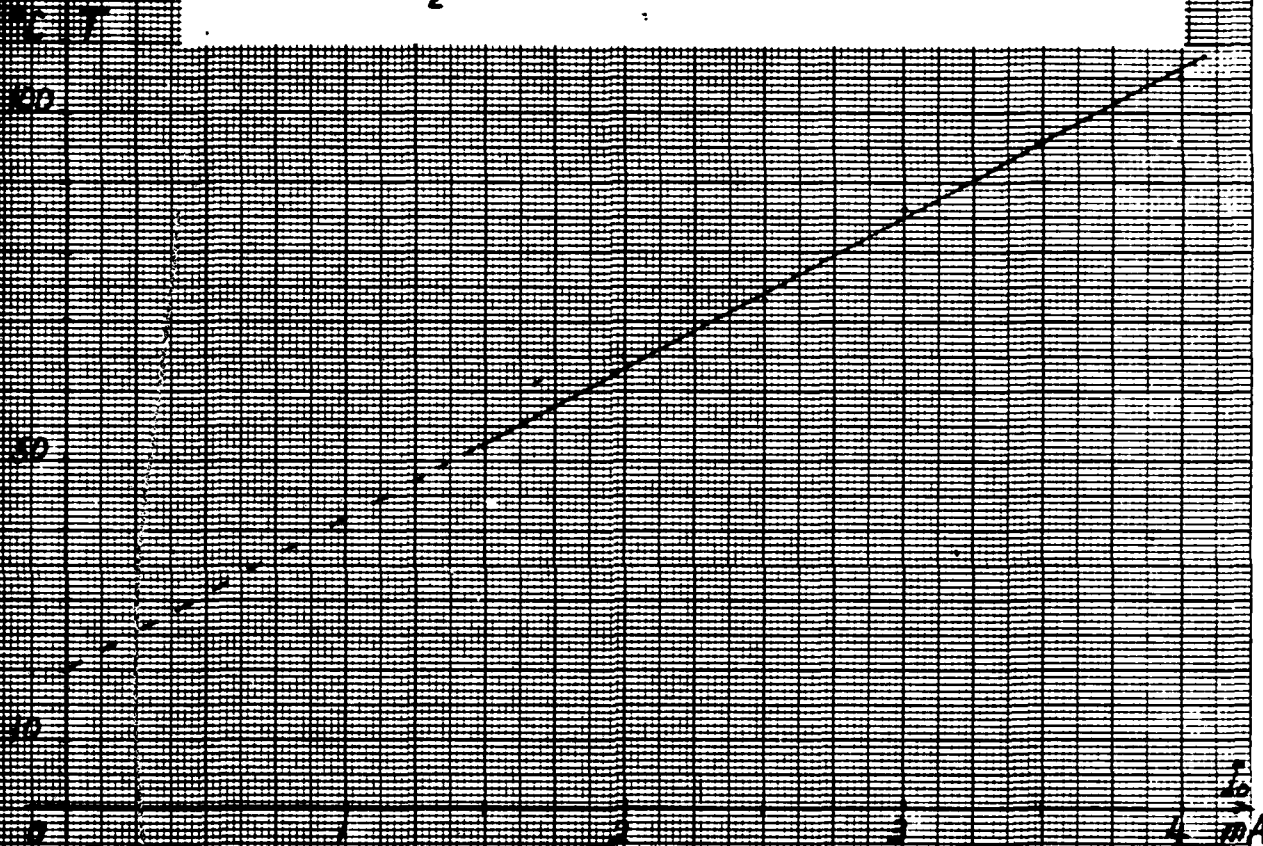
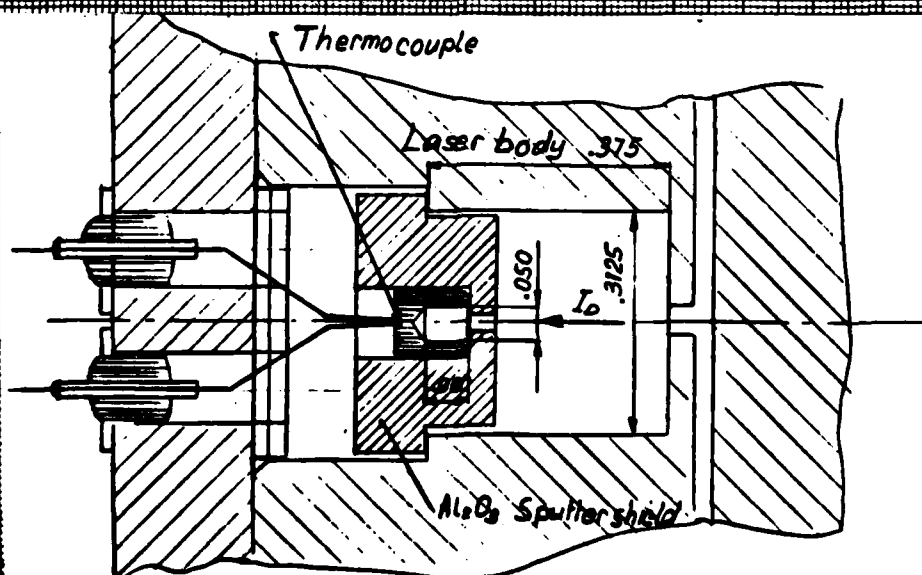
Fig. 6

The laser was then opened and carefully inspected. We found one loose, black particle of roughly 0.03mm in diameter in one of the 0.313" holes in the BeO block that accepts the cathode assembly. Both cathode sputtershields had black front surfaces and even the anode shield showed some black deposits. Figure A-3 allows comparison of these three electrode shields with the one from the discharge tube. These results clearly show that the laser cathodes behaved quite differently from the one in the discharge tube. The most likely explanation is the difference in the cathode temperatures. Figure 5, representative of the discharge tube cathode, shows a cathode temperature of 215°C for a cathode current of 3mA. Temperature measurements of the similar cathode in the well cooled BeO body of the laser are shown in Figure 6 and reveal a cathode temperature of only 63°C.

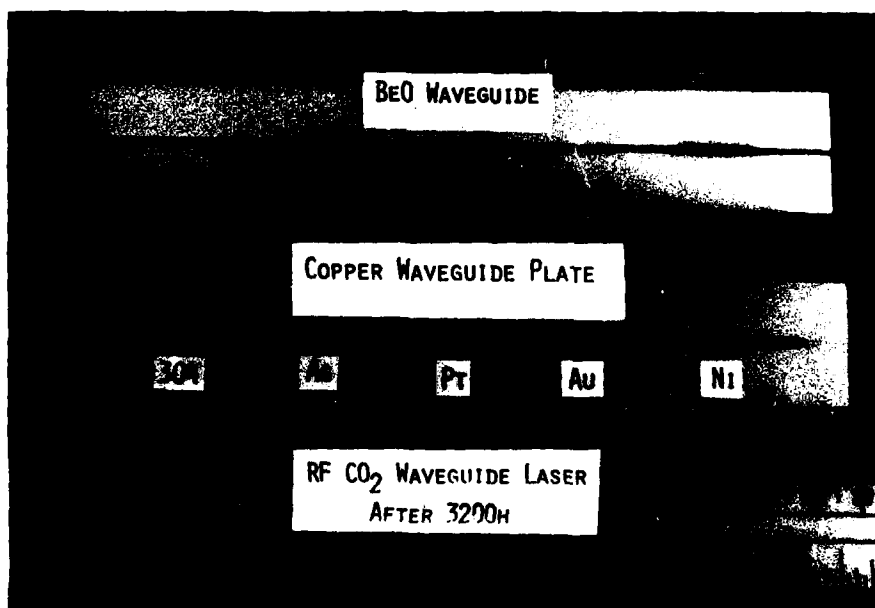
Fig B-5

The laser was then disassembled and a visual inspection of Figure B-5 shows that considerable sputtering had taken place on some electrode surfaces. Ordering the electrode materials according to the visual sputtering deposits we find Pt to have the least, followed by stainless steel, Au, Cu, Ag and Ni. Ni was by far the worst of the tested materials and its sputtering was so bad that even the BeO channel was covered with black NiO. These results were obtained by using a gas mixture containing He, CO_2 , CO and Xe. The electrodes were then repolished, the laser structure cleaned, assembled and refilled with a He- CO_2 -N₂-Xe gas mixture. The performance of this laser is shown in Figure 8. Since no effort was made to optimize the gas mixture and in view of the particular test conditions it would be premature to compare the initial output and the power drop from 2W to 1.3W with the previous result. Refilling the laser restored its initial power output. The structure was then dismantled and the inlaid copper block examined for sputtering. To the naked eye the appearance was practically identical to the previous result shown in Figure B-5.
