USAAVRADCOM-TR-82-D-36

VERIFICATION TESTING OF AN AH-1S WIRE STRIKE PROTECTION SYSTEM (WSPS)

LeRoy T. Burrows

December 1982

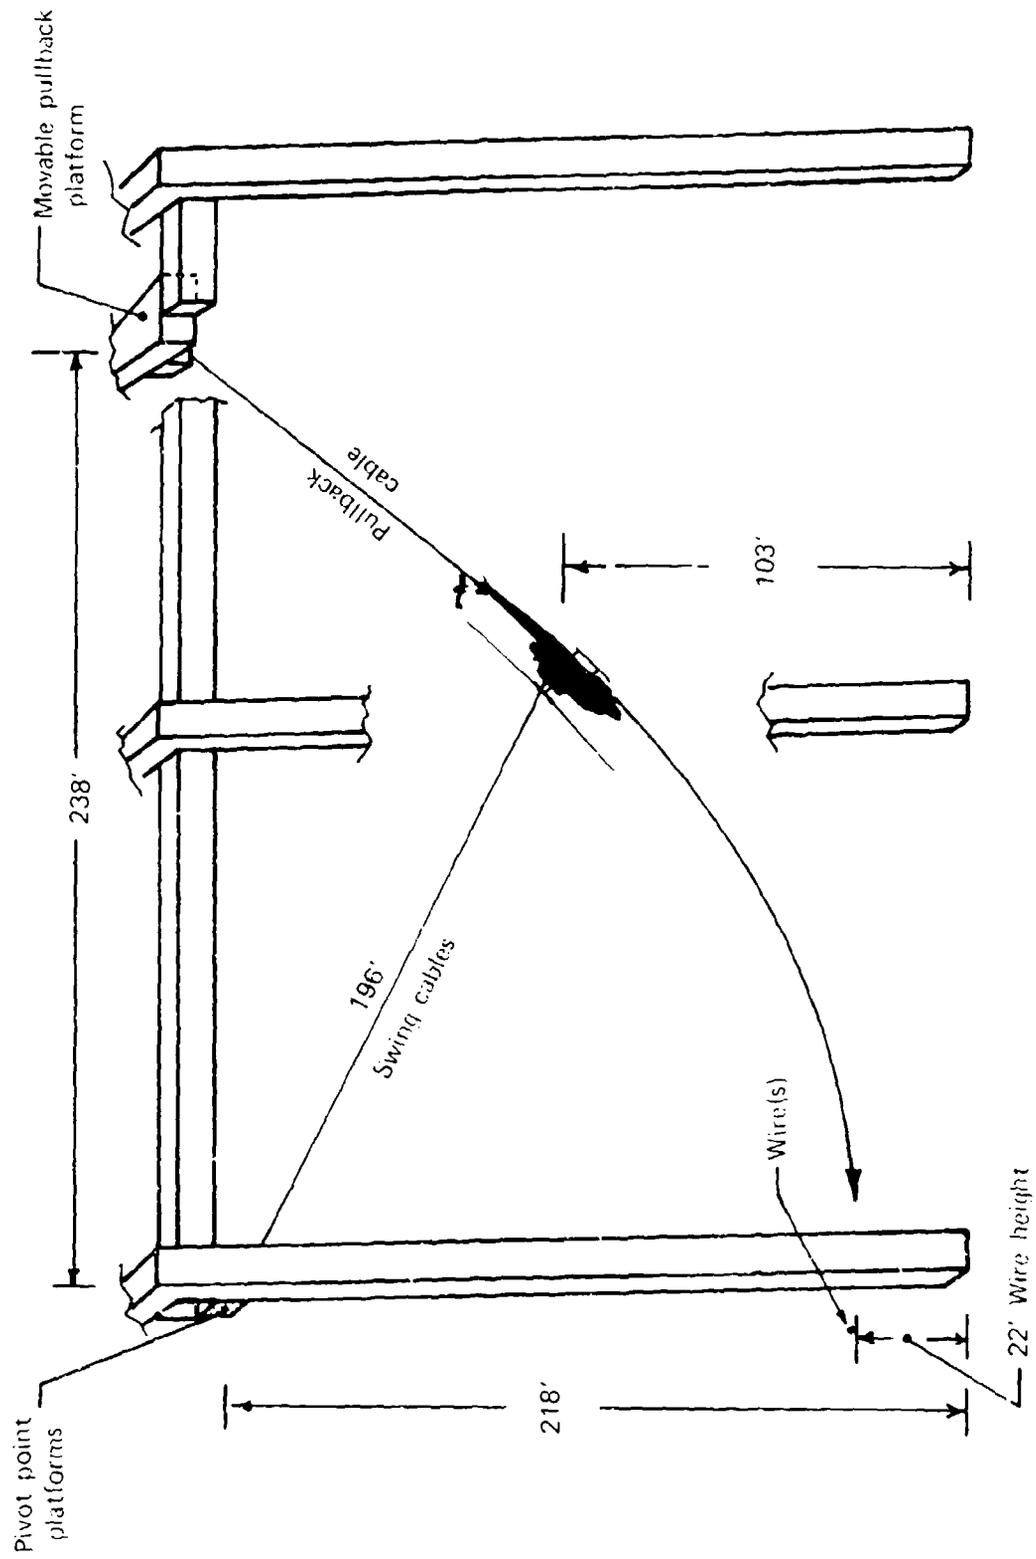
Figure 2. Pendulum swing test apparatus.

The apparatus necessary to conduct a helicopter pendulum swing test is shown in Figure 2. Swing-cable pivot-point platforms located at the west end of the gantry supported the winches, sheaves, and pulley systems that controlled the length of the two swing cables. A pullback platform attached to the underside of the movable carriage supported the winch, sheave, and pulley system that controlled the length of the pullback cable. The swing cables were attached to an I beam spreader bar (Figure 3) that was connected to the helicopter rotor hub and during the pendulum swing, supported the helicopter through the rotor mast, as in free flight. A pullback cable with an electrically operated hook was attached to a specially fabricated fixture placed on the aft end of the tail boom. The I beam spreader bar was employed to prevent the test aircraft from spinning after the swing test and twisting the swing cables.

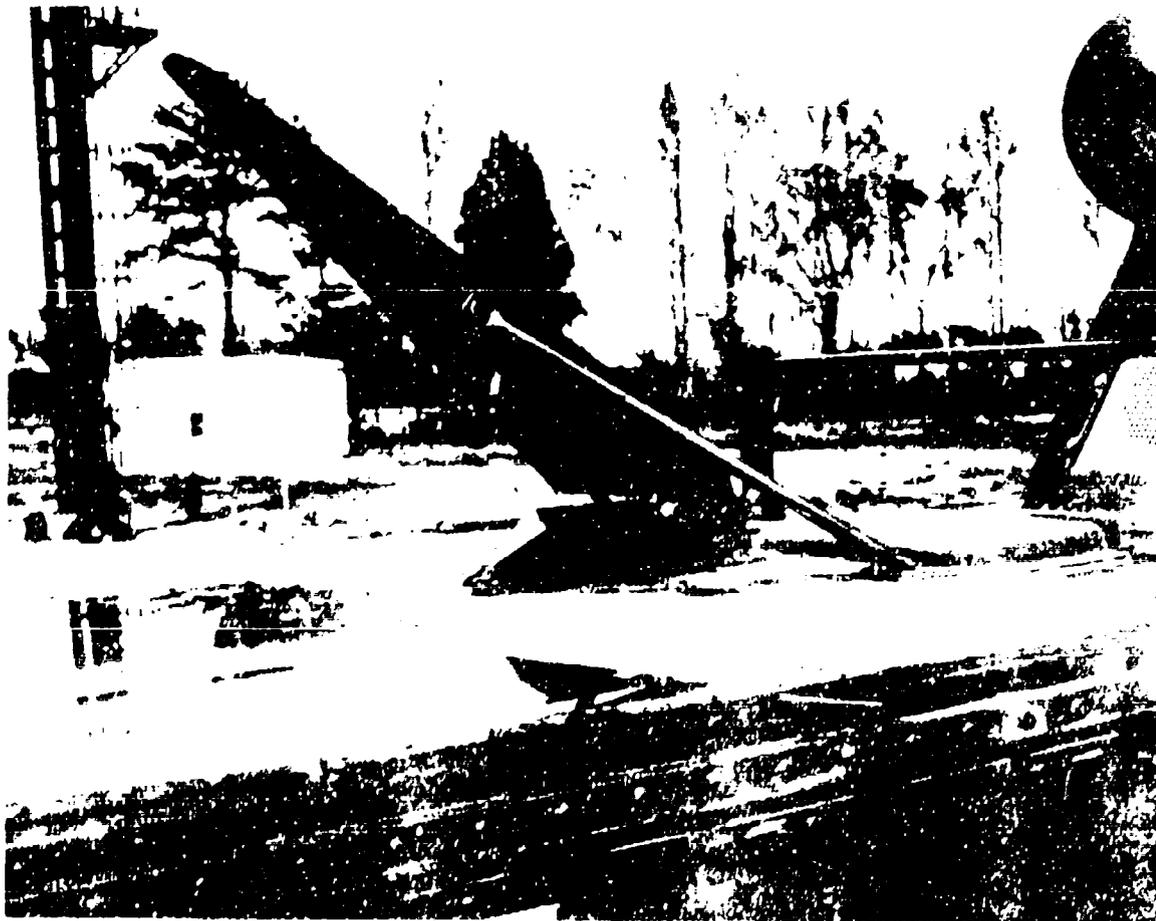
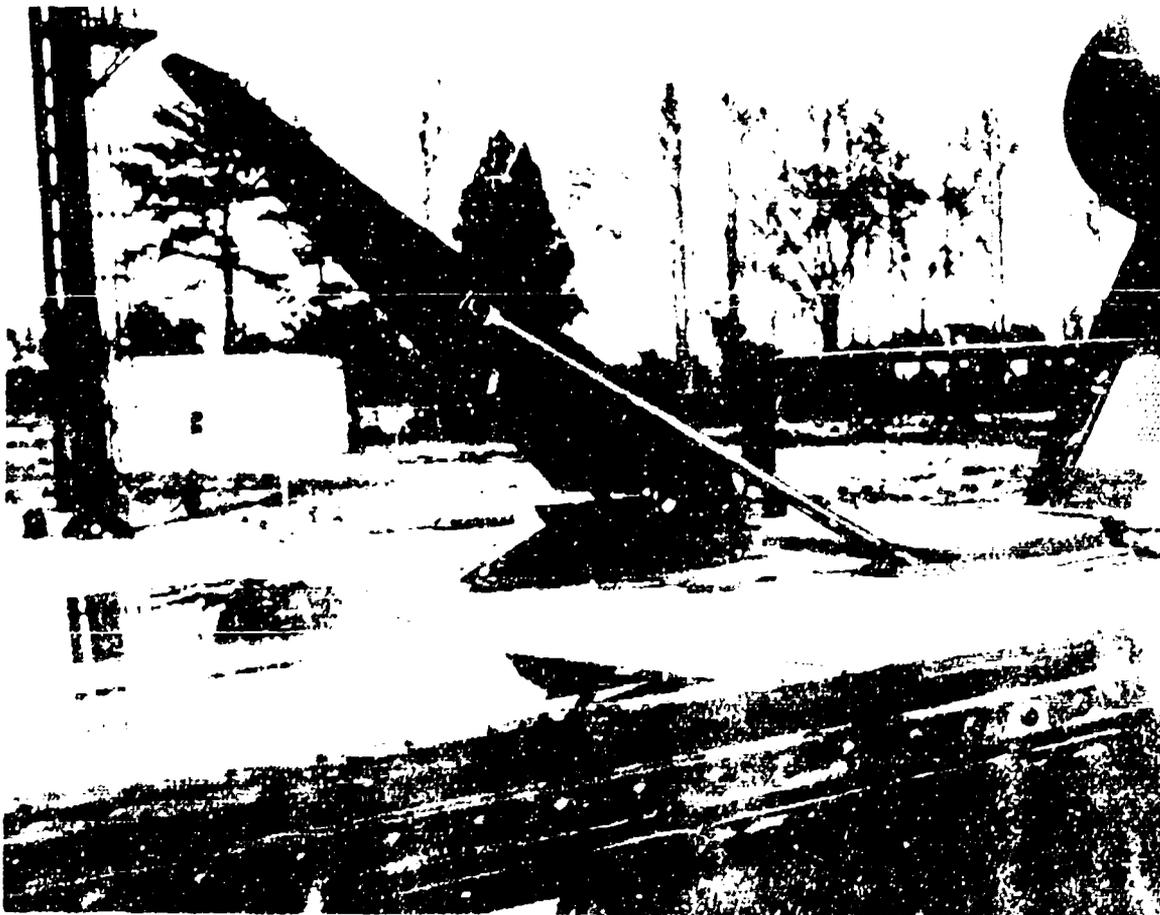
Figure 6. Upper cutter.

The AH-1S WSPS tested has five major components: the upper cutter, which protects the main rotor controls (Figure 6); the TSU deflector, which prevents a wire from snagging on the TSU optics or supporting structure (Figure 7); the chin cutter, which helps prevent a wire from snagging on the 20mm cannon turret (Figure 8); a lower cutter to protect the skid gear (Figure 9); and a deflector with a sawtooth edge insert mounted on the right forward wind shield structure to provide some protection from an air data boom wire snag (Figure 10).

The WSPS is a passive system, having no moving parts. Upon wire impact, the helicopter momentum deflects the wire or cable into the upper, chin, or lower wedge-shaped cutter, which notches it to the extent required for tensile failure.

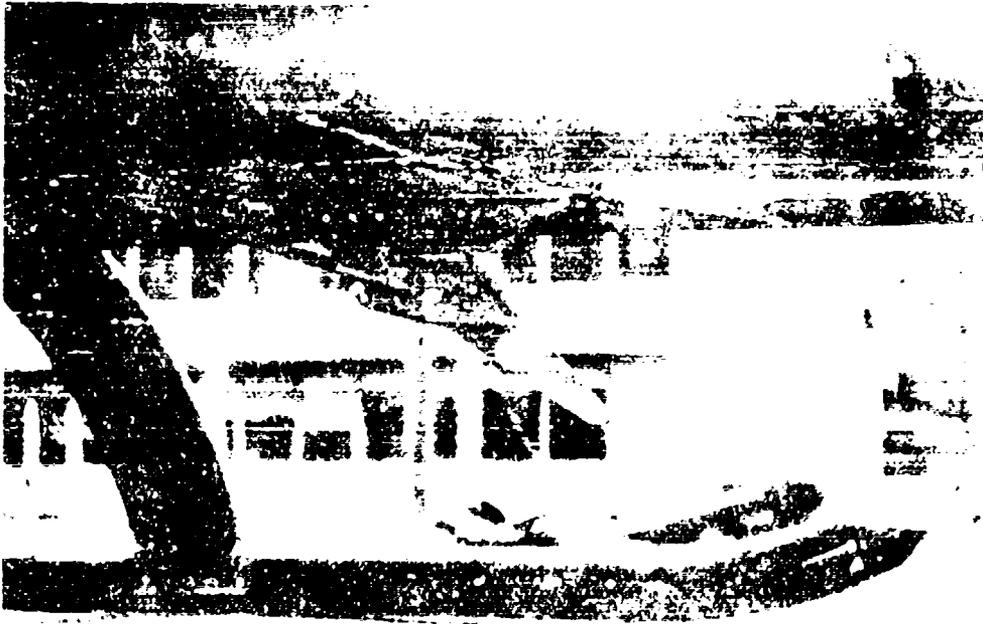
Figure 9. Lower cutter.

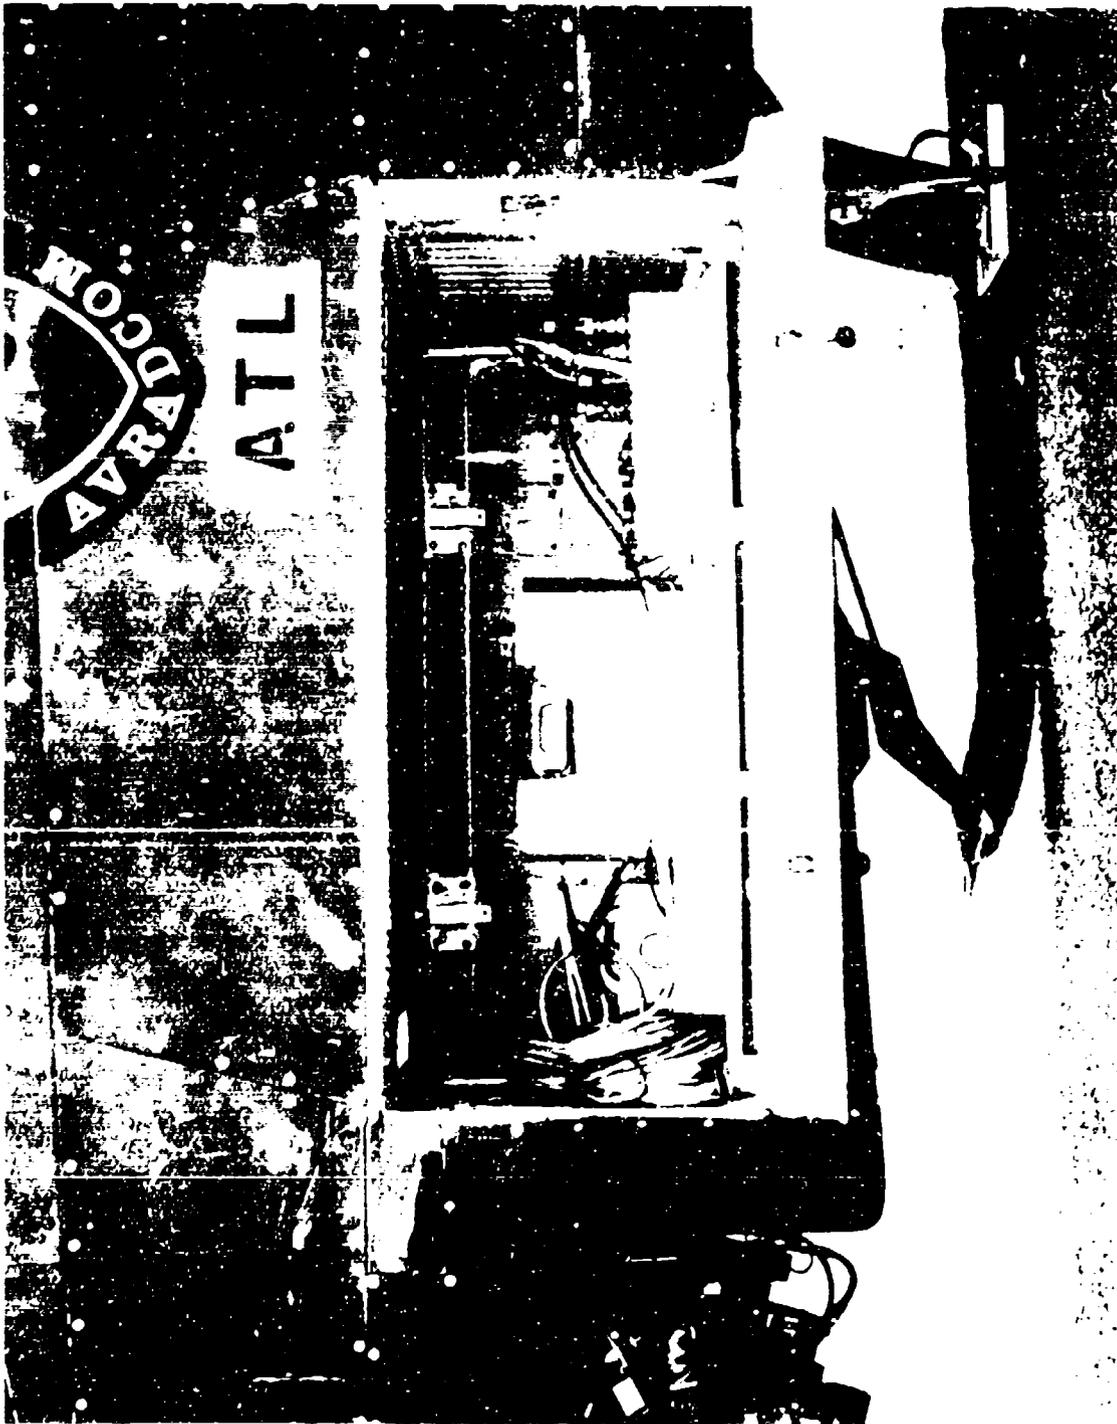
Figure 11. On-board camera circuitry.

Mounts for four high-speed (400 frames/sec) 16mm motion picture cameras were installed on the test helicopter. One mount was placed in the cockpit to provide a pilot's eye view during the tests. The other mounts were placed to permit views of the upper cutter, chin cutter, and lower cutter and were located on the rotor hub, right side of the 20mm cannon turret, and right skid landing gear, respectively (Figure 3). A 10mm wide angle lens was used with all on-board cameras because of its wide field of view and its ability to obtain visual data at close range. These cameras were powered by an on-board NiCad battery and were activated by a lanyard switch through circuitry located in the AH-1S ammunition bay (Figure 11). At the T-minus-3-seconds point of the aircraft release countdown, the lanyard pin is manually pulled, thus permitting camera run-up prior to release.

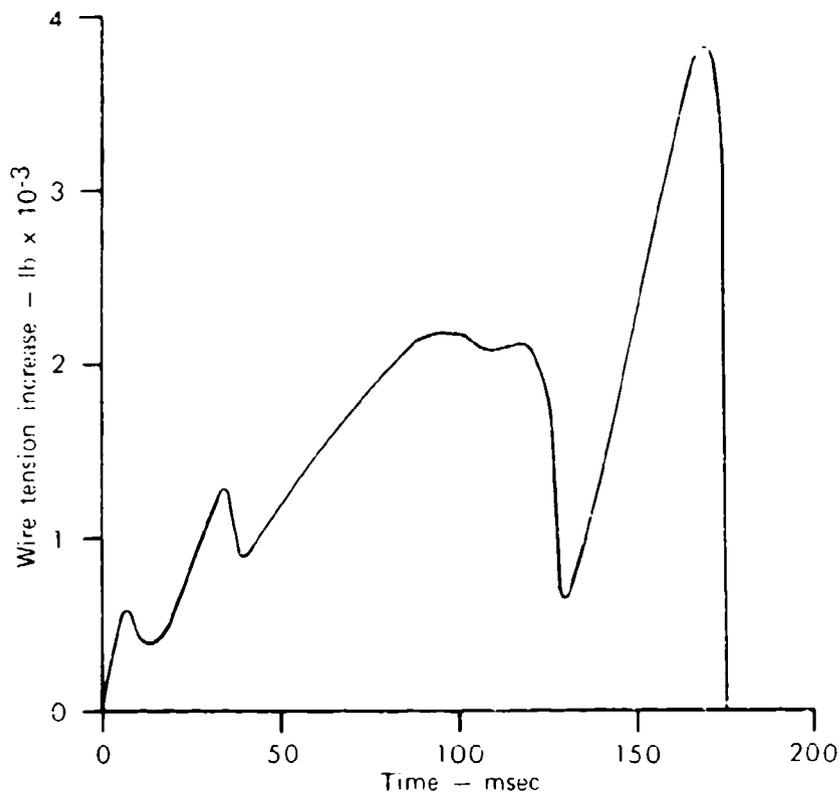
Figure 13. Test 1 wire tension time history.

To obtain a 6-degree nose-down pitch attitude, 350 pounds of ballast was added to the floor of the gunner's seat. The pullback position for the 40-knot test is shown in Figure 12. The wire impact was to be on the aircraft nose after getting by the TSU position indicator, which is a metal rod sticking up approximately 6 inches above the front of the TSU. In this test the wire impacted the TSU position indicator rod, bent it over, and then impacted the aircraft nose. The wire deflected upward to the forward windshield deflector where it gouged out teeth from the sawtoothed blade insert in three places, progressively notching the wire until it broke in tension near the top of the deflector. The left pole wire tension time history given in Figure 13 graphically depicts these events.

To better understand this and like figures from subsequent tests, Figure 13 is explained as follows. Initial impact loading is shown followed by a tension decrease as the wire bounced from the TSU indicator to the nose structure and into the deflector sawtooth edge where a temporary snag provided a steep tension increase. This continued until the wire broke loose of the snag, decreasing tension, and bounced to another area of the deflector with an attendant snag and tension increase. This sequence of events took place one more time, and the wire eventually broke. It should be noted that, even if there are no snags, while the wire is in contact with the aircraft wire tension will increase due to deflection friction and small obstructions, such as screw and bolt heads, and due to the taking up of static slack in the wire.

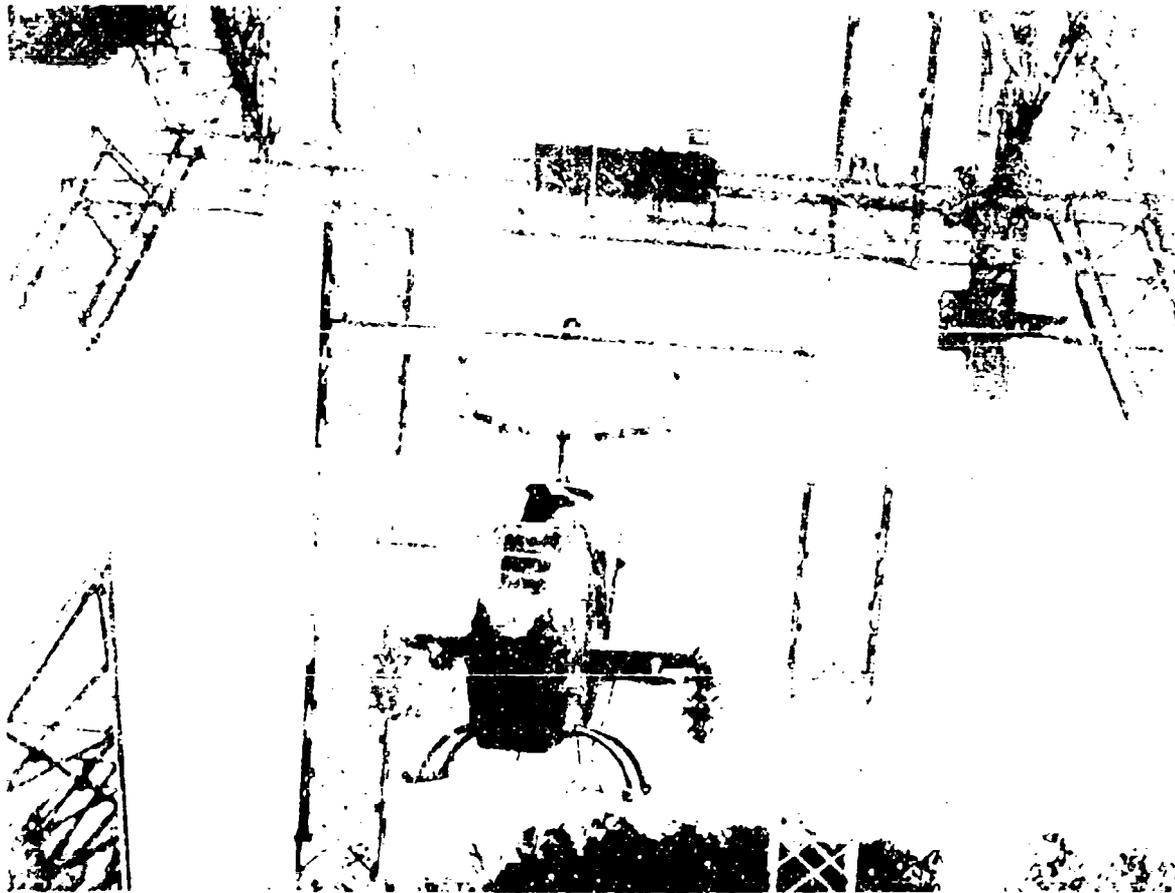
Figure 16. Test 2 wire impact.

The wire impacted about halfway up the forward windshield structure (Figure 16) and deflected into the upper cutter where it was notched and failed in tension (Figure 17). Figure 18 depicts the wire tension time history for this angled wire test. Minor aircraft skin damage occurred at the impact point and, as the wire deflected, on the forward windshield structure (Figure 19). Analysis of the high speed motion picture documentation and Figure 18 showed that the wire stayed in contact with the forward windshield for over one-half of the impact deflection cutting sequence, and that there were minor snags on the left corner edge of the forward and upper windshield structure and the left edge of the upper cutter mounting plate all of which were amplified by the angled wire impact.

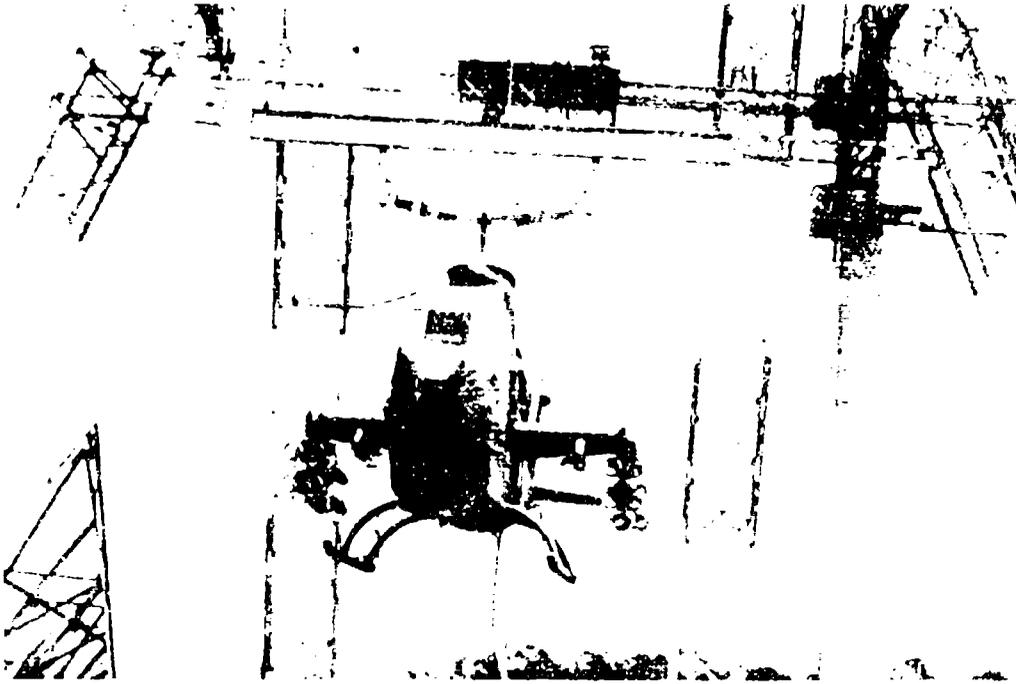
Figure 17. Test 2 wire cut.

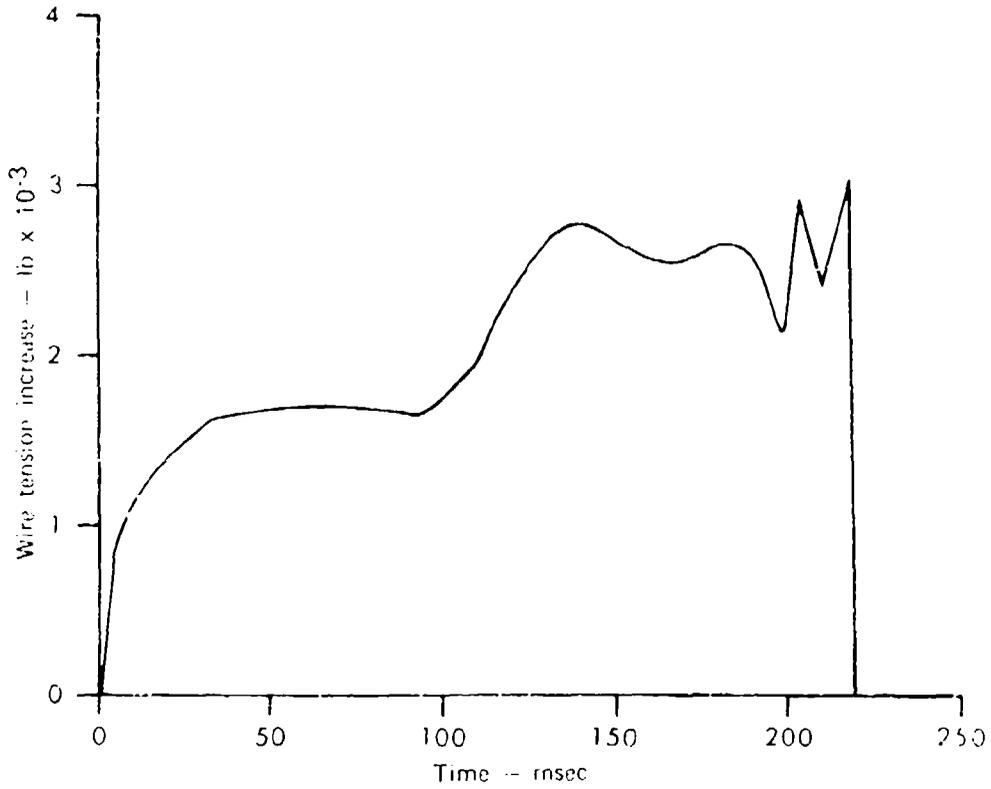
Figure 18. Test 2 wire tension time history.

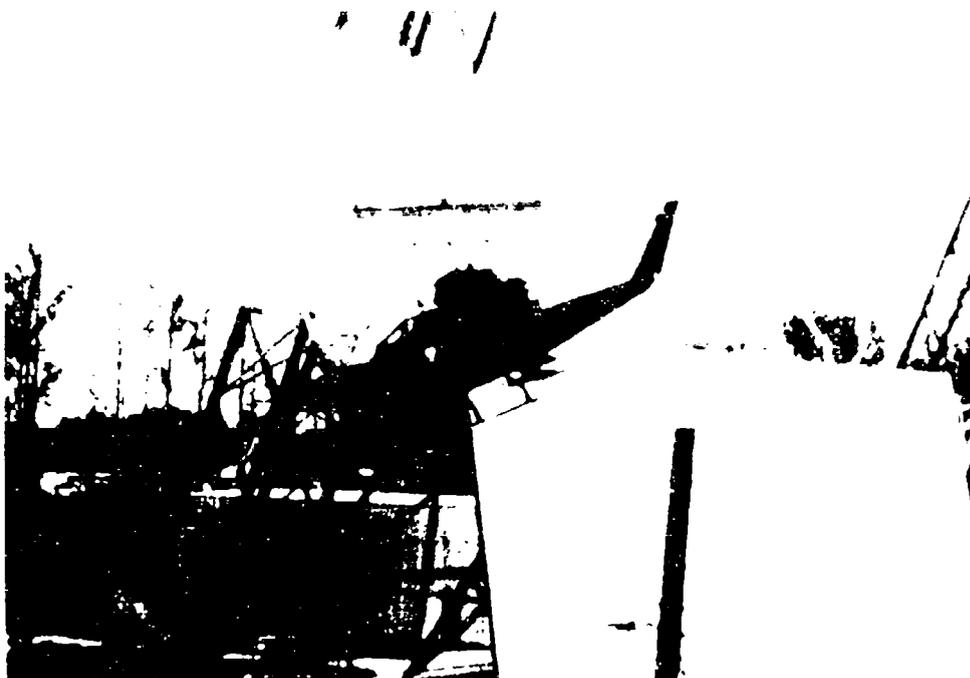
Figure 20. 15-knot test pullback position.

Difficulty was encountered in accomplishing planned test C (15 knot impact) described in Table 1. To obtain the nose-up attitude, ballast was shifted aft, resulting in a tail-heavy aircraft. The pullback platform had been set for the 40 knot test so that the pullback cable was in line with the aircraft cg at the release point. In a test swing without a strung wire, the tail dropped upon release and created a severe unpredictable pitch oscillation that continued throughout the swing. This was largely due to the pullback cable not being in line with the aircraft cg. Attempts to dampen this motion using various aircraft rigging concepts were unsuccessful. The pullback platform was then moved as far back as possible and the pullback cable was run down through a dolly, located on the gantry at a height of 164 feet, to the aircraft, putting the pullback cable almost in line with the aircraft cg at the 15 knot pullback height. Lines were rigged from the swing cable support bar to each skid at fore and aft locations to help damp out any porpoising effect. Swing tests without a wire were again conducted with much less pitch oscillation than earlier encountered. Film analysis showed the pitch variation to then be somewhat repeatable and the maximum pitch attitude to be 8 degrees at the point where the wire would be contacted. Swing cable elongation for this test was estimated to be approximately 1 mm. The pullback position for the 15 knot test is shown in Figure 20.

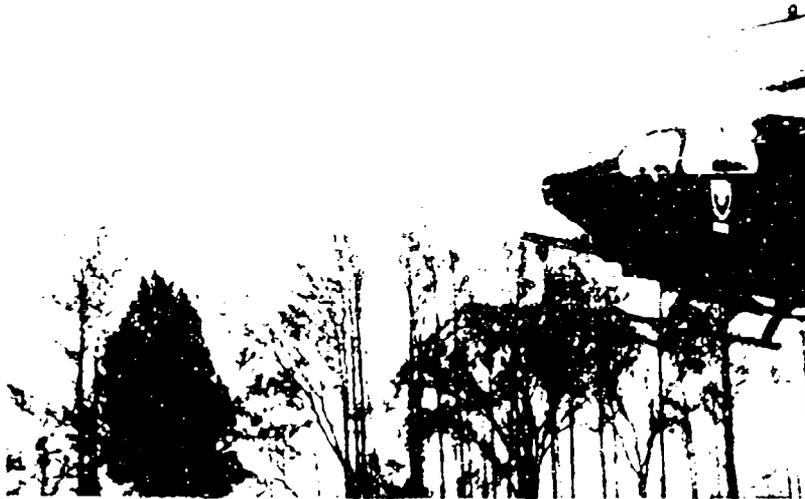
Figure 21. Test 5 wire impact.

In test 5 the wire impacted the TSU deflector (Figure 21) and then deflected into the chin cutter, again resulting in a successful cut (Figure 22). Figure 23 depicts the wire tension time history for this test. Immediately after impact, the wire snagged the TSU optics protective cover mounting screw head, building up a constant tension until it released and deflected to the forward edge of the chin cutter, where it snagged momentarily before entering the cutting surfaces. The TSU structure and the cover screw head received superficial damage.

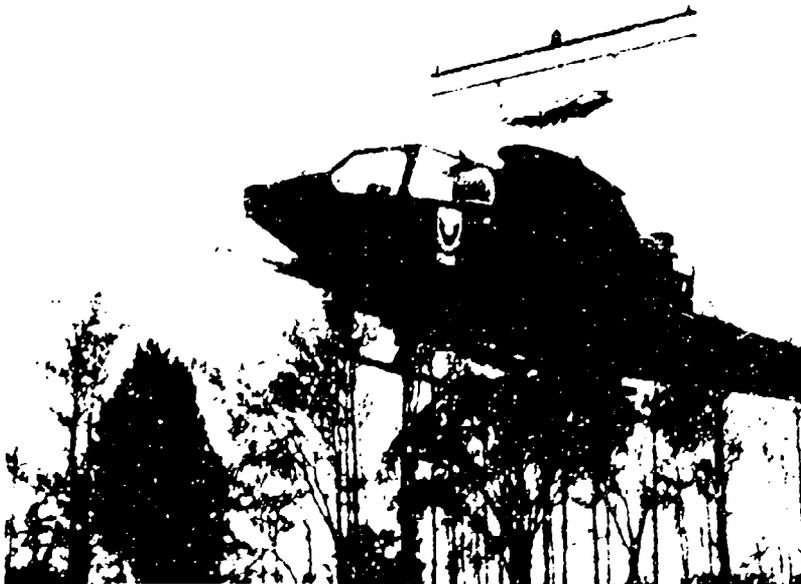
Figure 22. Test 5 wire cut.

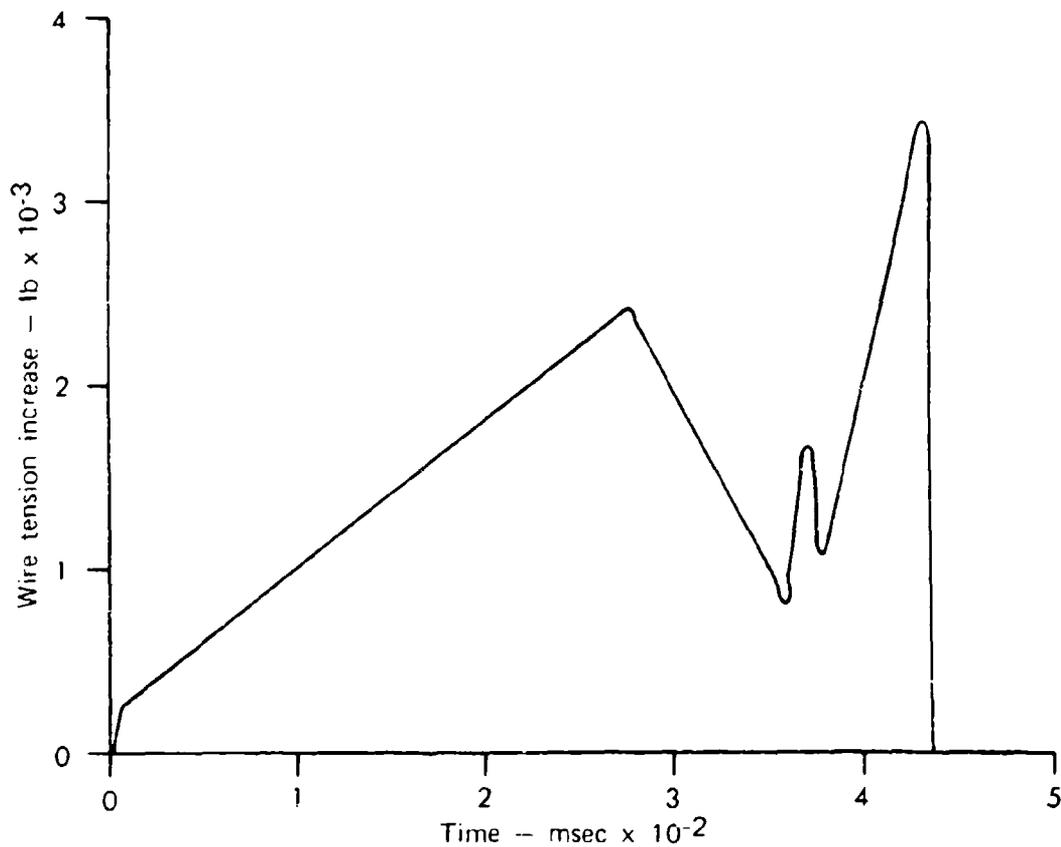
Figure 23. Test 5 wire tension time history.

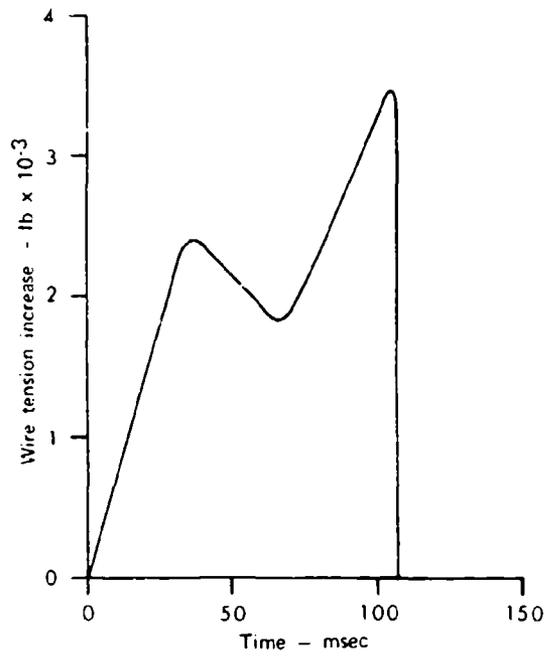
Figure 24. Test 6 wire tension time history.

Figure 24 depicts the wire tension time history. The wire impacted the lower cutter right below its joint with the lower blade insert (Figure 25). This joint proved to be a minor snag area, impeding deflection into the cutting blades. When the wire let go it entered the blades and was notched and broken (Figure 26).

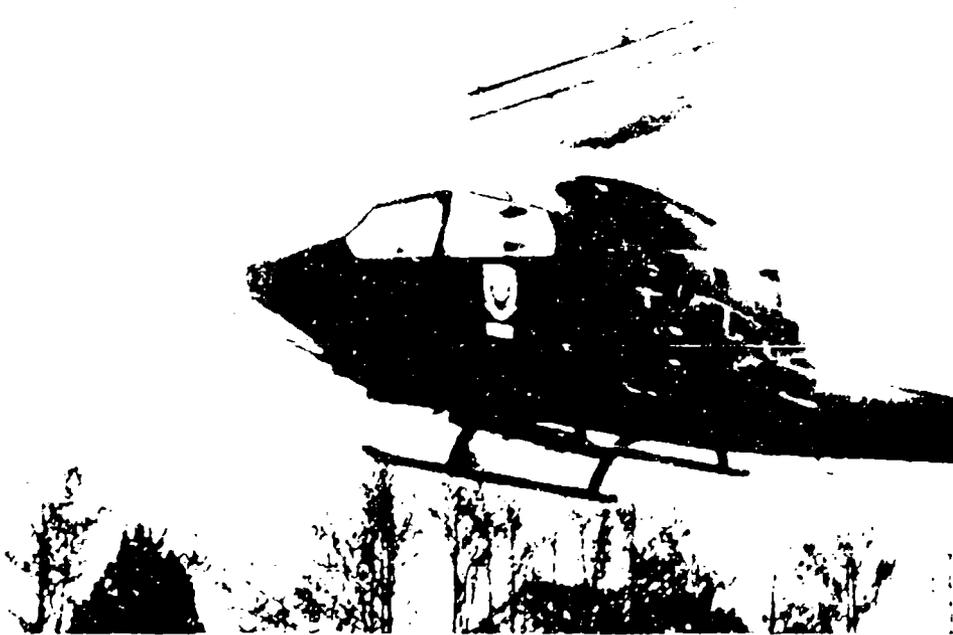
Figure 25. Test 6 wire impact.

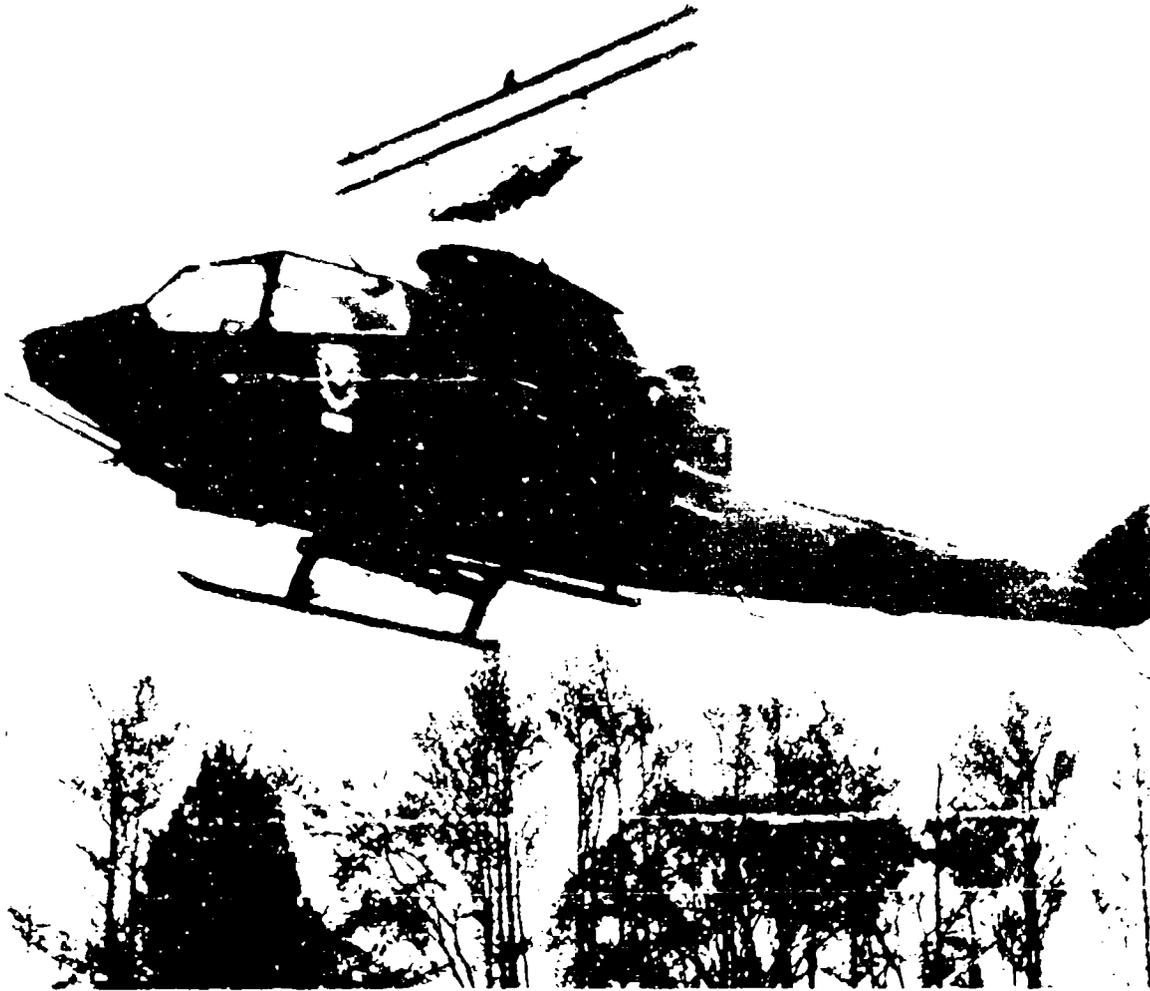
Figure 26. Test 6 wire cut.
