TECHNICAL REPORT GL-82-12

# MOBILITY ASSESSMENT OF THE ROLAND WHEELED VEHICLE SYSTEM

## Report 1 RESULTS OF FIELD TESTS

November 1982  
Report 1 of a Series

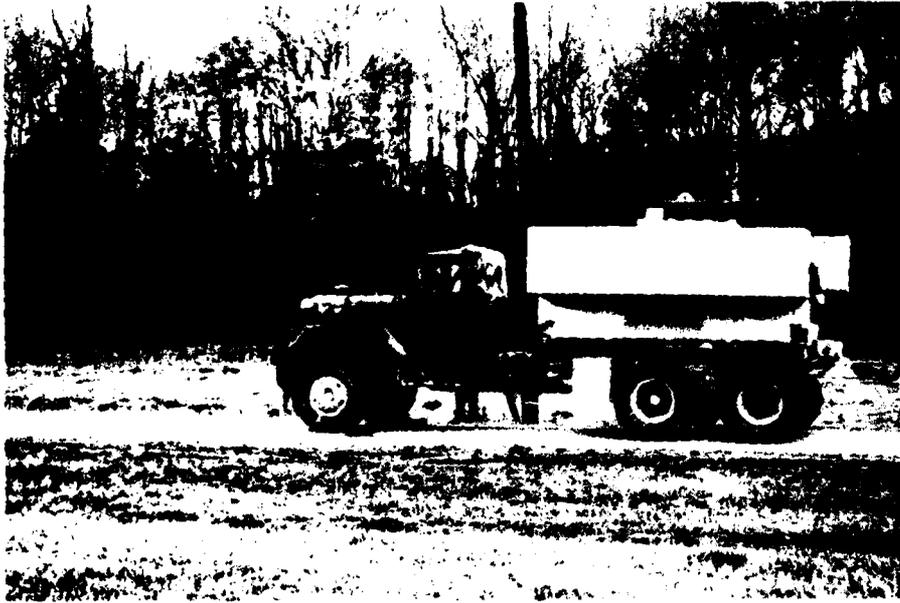
Figure 1. ROLAND Wheeled Vehicle system with simulated fire unit

5. The ROLAND Wheeled Vehicle system tested in this study (Figure 1) was a modified M812A1 6x6 cargo truck chassis fitted with a simulated (weight, center of gravity, and size) fire unit. The test vehicle was tested at a gross weight of 50,239 lb\* and with 11x20 tires inflated to a recommended cross-country pressure of 75 psi in the front (No. 1 axle) tires and 55 psi in the tires of the No. 2 and 3 axles. Appendix B presents the method by which the test vehicle's center of gravity was determined. General vehicle data are presented in Table 1. The vehicle data required for the AMC-74X mobility model are presented in Report 2.

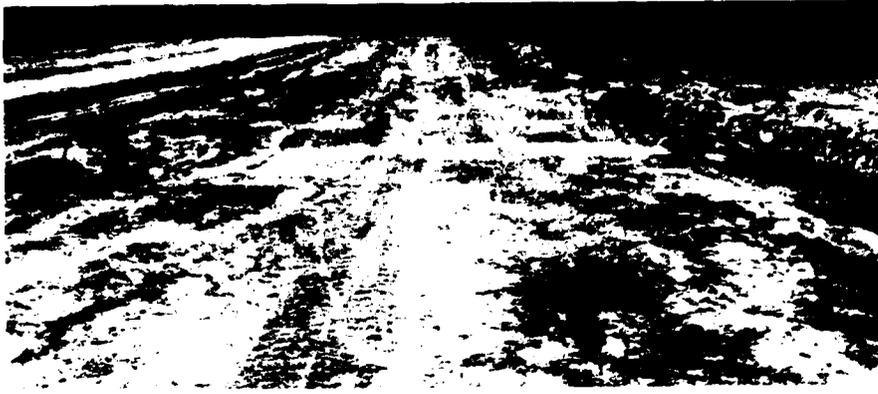
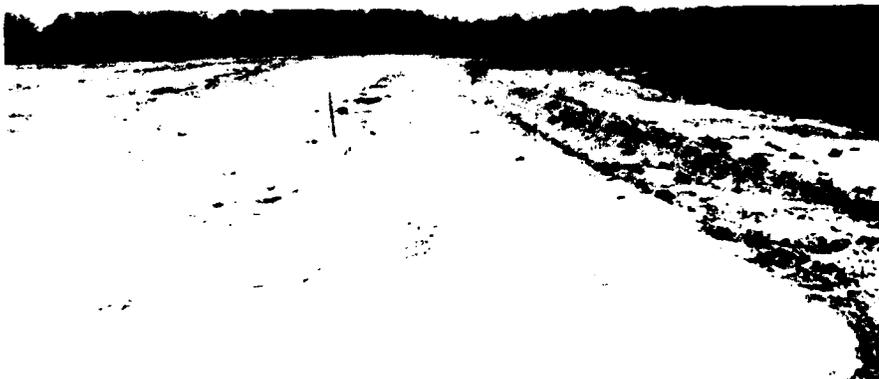
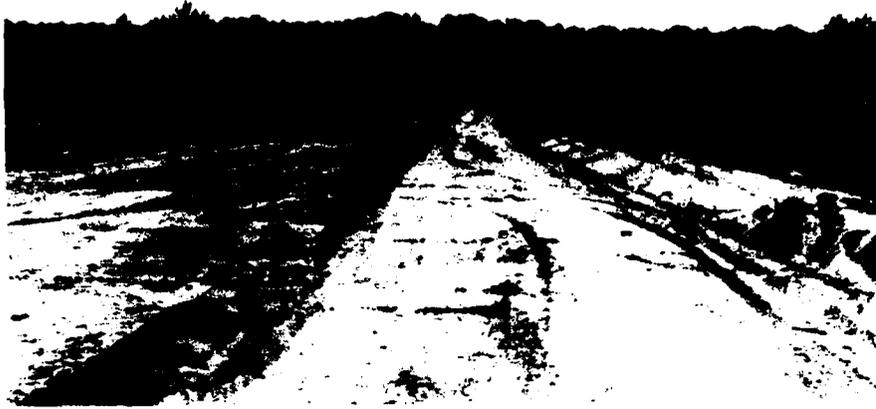
Figure 3. Ride test courses (Continued)

a. Course 1

b. Course 2

c. Course 4

d. Course 8

e. Course 9

6. In selecting courses to develop the ride relations, courses were sought whose surfaces were firm and of approximately constant roughness throughout without evident pattern (i.e., had essentially random variations in local elevations). Also, each course was relatively level (no slope) for about 300 ft. Five courses were developed with individual roughness ranging from relatively smooth to rough. The locations of ride test courses are shown in Figure 2, with photographs of these courses presented in Figure 3.

7. The surface roughness of test courses 1, 2, and 4 was constructed in 1980 based on surface profiles measured from natural cross-country terrain. First, construction equipment was used to develop the basic surface roughness. Then dry cement was spread over the surface, mixed in, and wetted. A tracked vehicle was used to pack the courses. The surface of the courses was permitted to weather naturally. Finally, an M151 1/4-ton and an M35A1 2-1/2-ton truck with known vibrational response over similar natural terrain were used in turning the courses to natural cross-country random roughness. The soil type of the courses was lean clay (CL-ML), as classified by the Unified Soil Classification System (USCS). Test course 8 established in this same area was graded to provide the smoothest course. Course 9 was selected in natural terrain in the same area as courses 1, 2, and 4. The ground surface of course 9 was naturally weathered and considered to be realistic cross-country terrain.

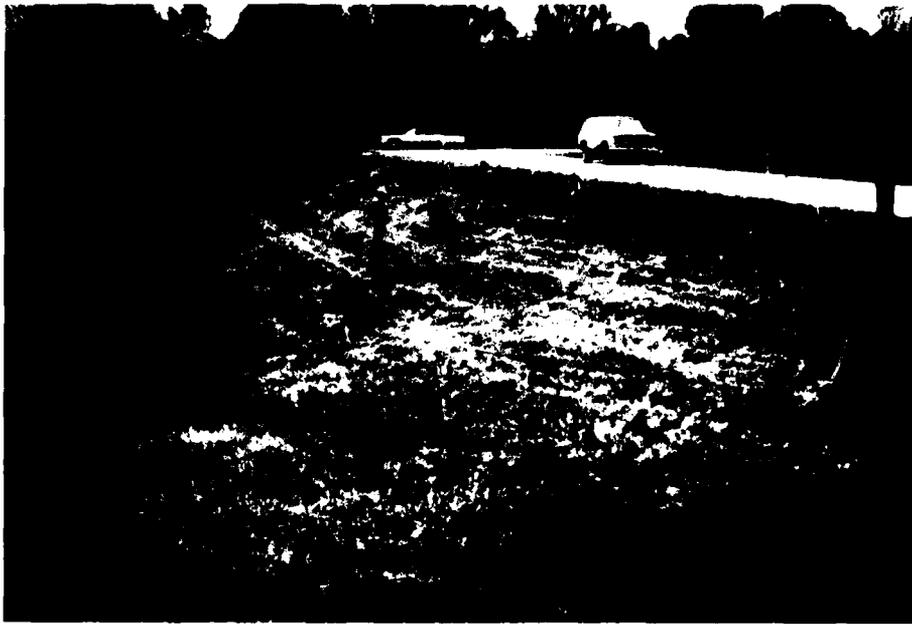
Figure 4. View of slopes 4, 4a, 4b, and 4c

10. The side slope tests were conducted at various locations on the WES reservation. Views of test courses 4, 4a, 4b, 4c, and 9 are shown in Figures 4 and 5. A summary of the measured cone index data along with a general description of surface conditions are shown in Table 2. All slope courses were on well-drained grass-covered surfaces. The slopes were relatively firm, but substantial rainfall had occurred two days prior to testing and wet spots were still present on slope 4c as indicated in Table 2. For safety reasons the configuration of the test vehicle was altered for the slope tests by removal of a portion of the simulator mass. This was compensated for by the addition of outriggers to prevent vehicle overturning. No weight or center of gravity change resulted from this alternate test configuration.

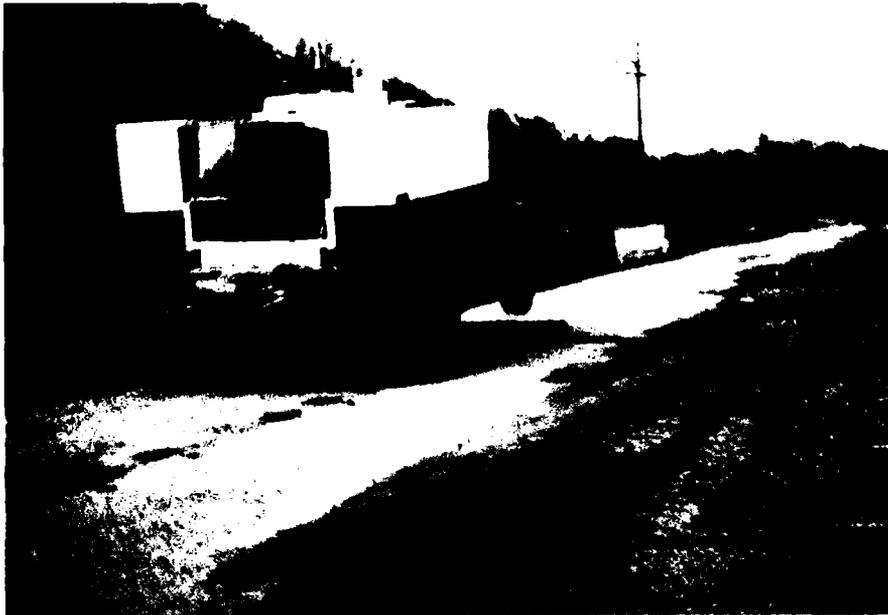
Figure 6. ROLAND Wheeled Vehicle airborne on obstacle test No. 77

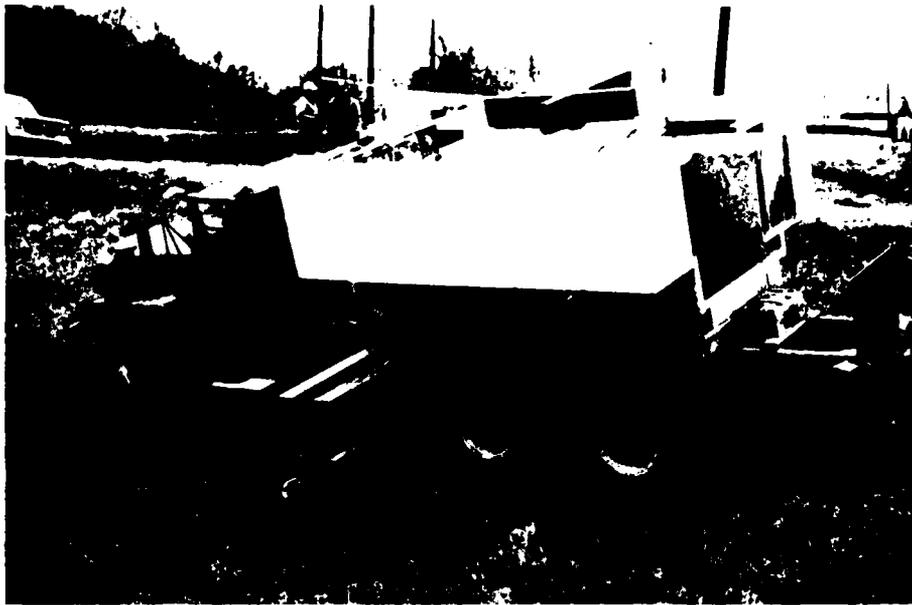
Figure 7. View of the ROLAND Wheeled Vehicle after it slid down the 23.5-percent slope and stopped (Note outriggers were installed for safety purposes.)

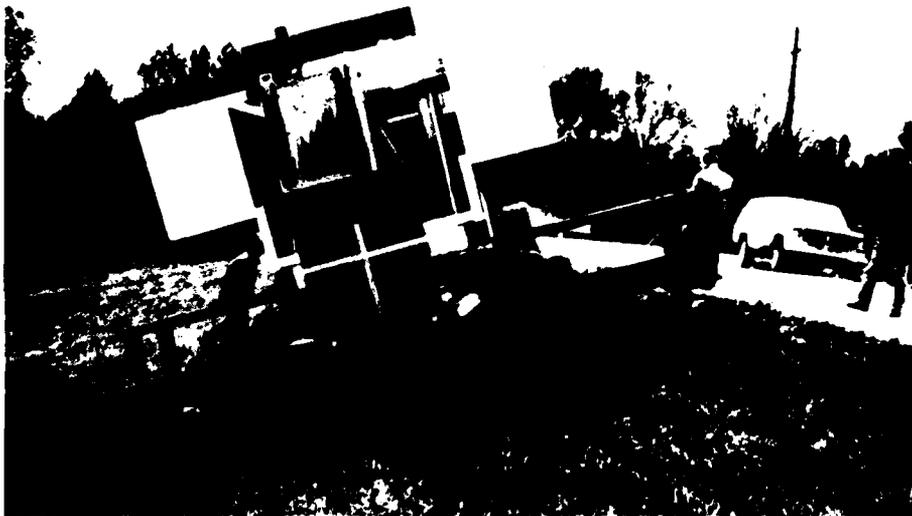
Figure 8. View of the ROLAND Wheeled Vehicle negotiating a 30.1-percent slope at a speed of approximately 5 mph (safety skids were never in contact with the ground)

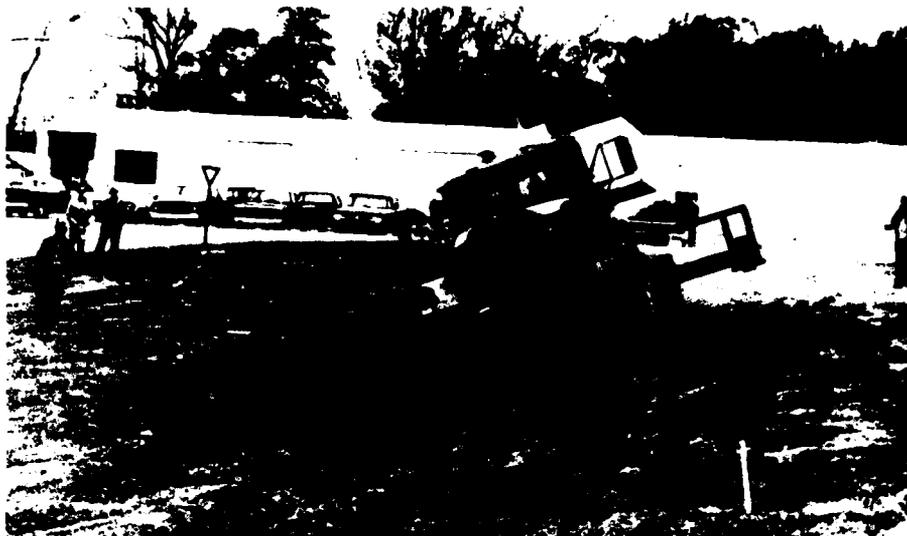
Figure 9. View of the ROLAND Wheeled Vehicle negotiating a 22.8-percent slope with an 8-in. obstacle superimposed on the uphill half of the slope

of the vehicle slipped downslope as it passed over the obstacle. Figure 9 shows the test vehicle negotiating the 22.8-percent slope with the 8-in. obstacle superimposed on the uphill half of the slope. At the higher speed of 11.1 mph, although there appeared to be no instability problems, the front wheels of the vehicle came off the ground and slipped several inches down the slope, indicating the vehicle was out of control for an instant. Although the test driver indicated he experienced no control problems, observation of these tests indicated that the maximum safe speed in this case over an 8-in. obstacle on a 23-percent slope appears to be approximately 6 mph.

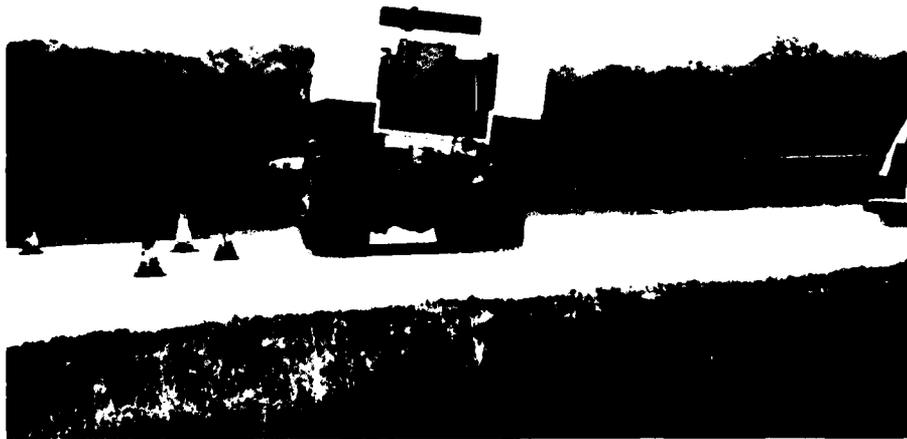
Figure 10. View of the ROLAND Wheeled Vehicle negotiating the 107-ft turning radius at 18.2 mph

41. Turn tests were conducted on three prescribed radii: 60, 107, and 200 ft. A summary of the measured data is presented in Table 8. The tests on the 107-ft radius were conducted on the asphalt surface at the Vicksburg Municipal Airport. A view of the vehicle negotiating the 107-ft turning radius is shown in Figure 10. The other tests were conducted on the asphalt surface of the Howard Brothers' parking lot. The maximum safe speeds recommended by Boeing Aerospace Company (see Figure A1) for the three radii were 16, 20, and 30 mph, respectively. However, due to the unavailability of a long approach, the maximum speed attained on each radius was 11.9, 18.2, and 23.8 mph, respectively. A comparison of vehicle speed to turning radius is shown in Plate 29. Also shown in this plate is the calculated maximum safe speed versus turning radius. No instability problems were noted by the test engineer or the test driver.

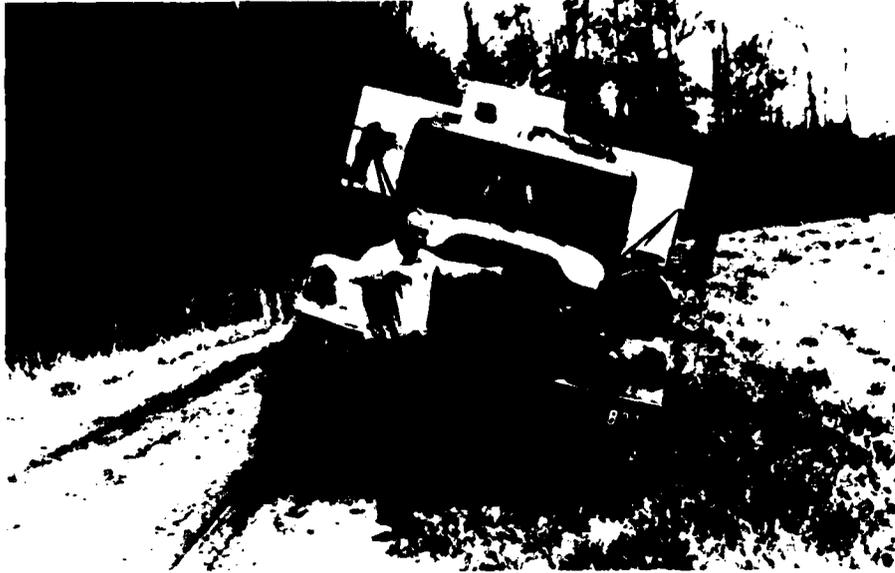
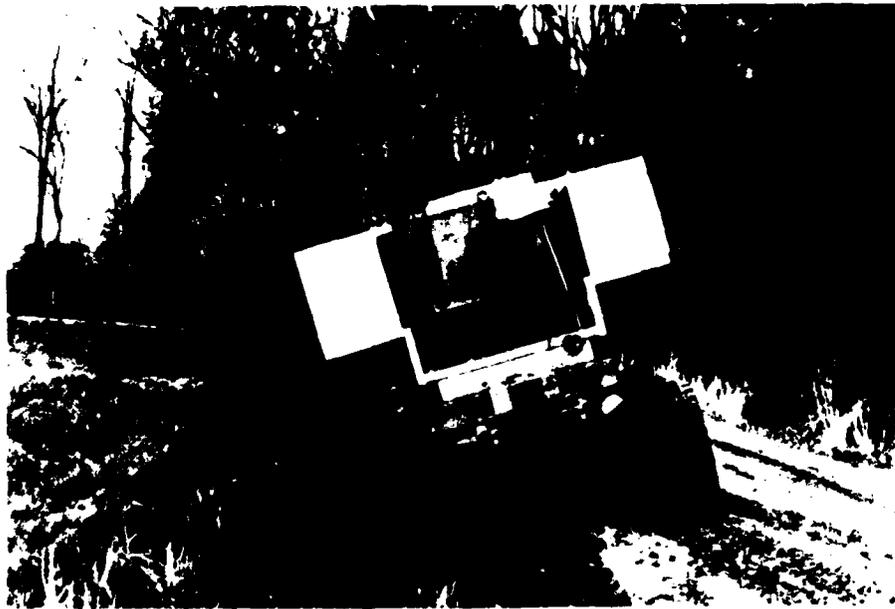
Figure 11. Views of the ROLAND test vehicle  
after the driver ran off the levee

a. Front view

b. Rear view

43. During this test program observations were solicited from the test personnel to answer some specific questions. The questions and answers are presented in Table 10. One significant event occurred during driver familiarization prior to the start of testing. While practice driving on a gravel road on top of a levee, a Boeing driver drove the test vehicle too far to the left side and ran off onto the side of a levee (see Figure 11). The left side of the vehicle was on a soft soil (0-6 CI = 50) and the right side was on the firm levee (0-6 CI > 750+). The rear of the vehicle tilted approximately 20 deg to the left. The test drivers and test director felt the vehicle might have turned over if the rear bogies had not bottomed on the firm levee.
