M1 Winter Tank Test
(Traction Devices)

F I N A L R E P O R T

R. L. Smith
Keweenaw Research Center
Michigan Technological University
Houghton, Michigan 49931

October 1982

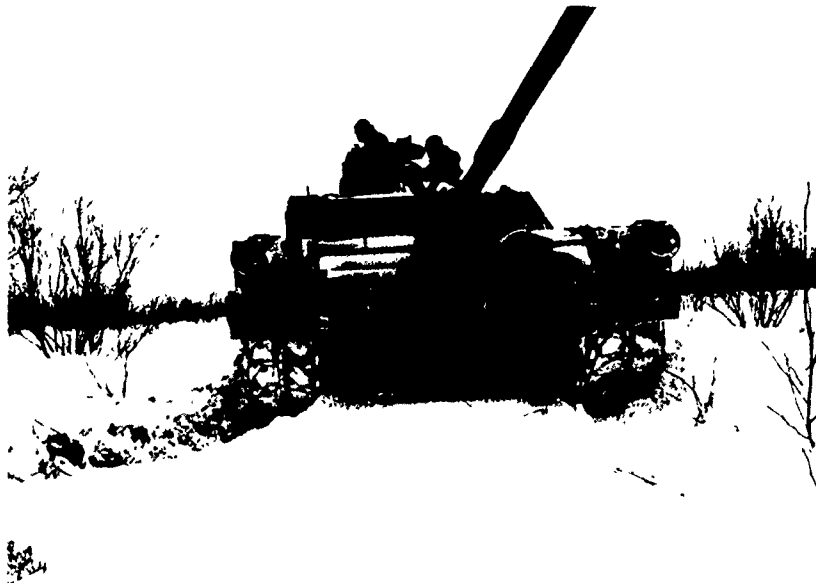
Figure 8. Deep Snow Mobility Test. Snow compacted by tank hull.

Turning ability was limited with the T156 track, because of sluggish steering and vehicle drifting. Linear motion including starting and stopping, was no problem. With the installation of the ice shoes or studs, the turning mobility and steering response was improved. Figure 8 shows the vehicle in deep snow. Note the snow compacted by the hull.

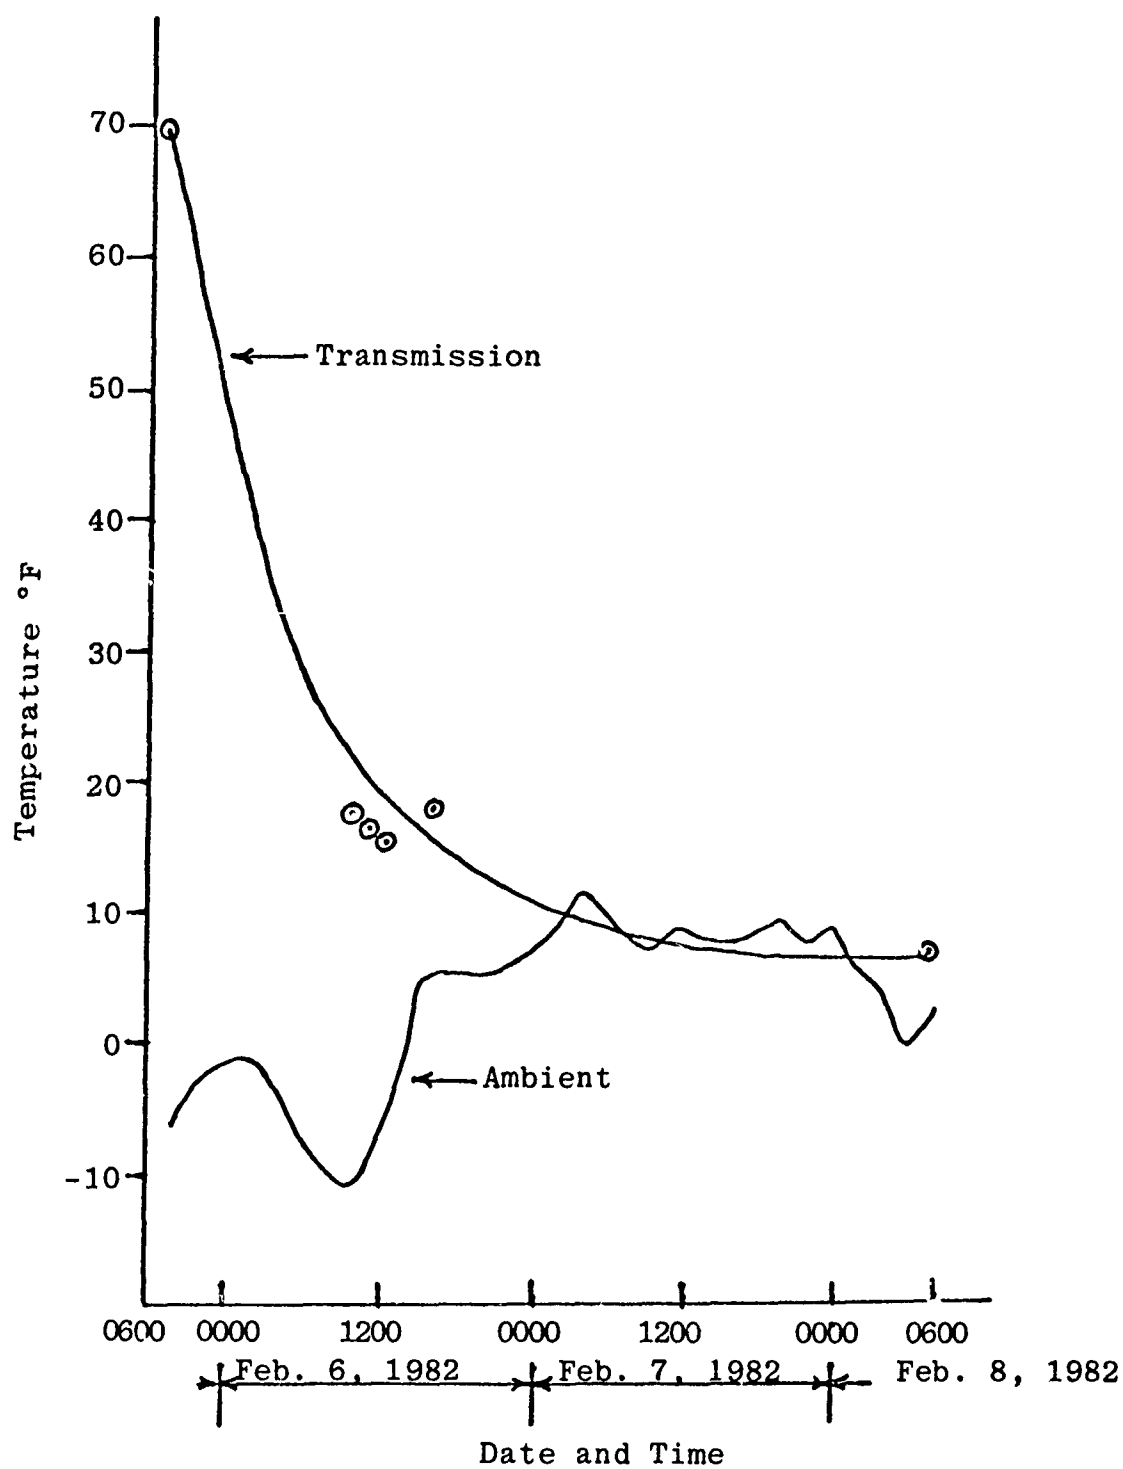
Figure 18. Transmission and Ambient Temp vs Time

A transmission cold soak was performed over a 60-hour period. It required approximately 24 hours for the transmission temperature to drop from 70°F to 10°F (ambient temperature). Figure 18 shows the transmission and ambient temperature versus time.
