NAVAL POSTGRADUATE SCHOOL

THESIS

AN INVESTIGATION OF THE CORROSION
SUSCEPTIBILITY OF FLAME-SPRAYED AND
ELECTRIC-ARC SPRAYED ANODIC METAL COATINGS
OF ALUMINUM, ZINC, AND
AN ALUMINUM-ZINC ALLOY

March 1983

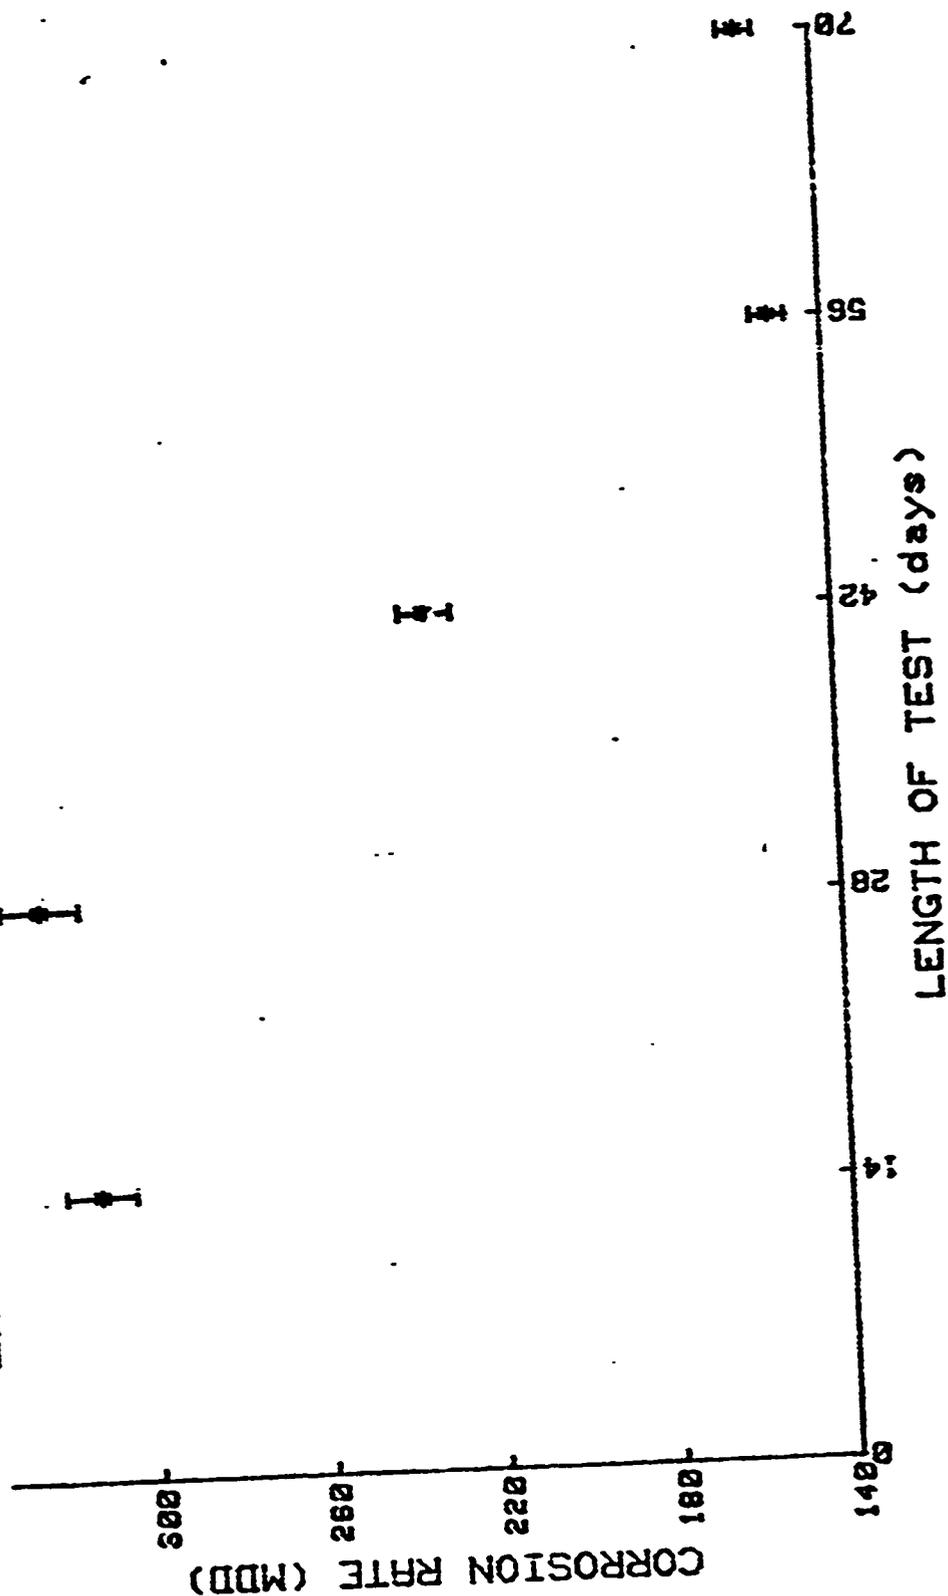
Zn A.S. COUPON CORROSION RATES (PIML)

Figure B.62 Plot of Zn A.S. Corrosion Rate

The immersion/emersion corrosion rates were calculated as described in Appendix A upon the bi-weekly removal of one coupon of each coating of Zn and Alloy A.S.; the results of these calculations appear in Table IV. Graphs depicting the change in corrosion rate during test interval for the coupons showing a weight loss are displayed in Figures B.62, B.63, and B.64. It can be said that the corrosion rates for both Zn coatings generally decreased as time progressed. As was predicted by the results of the PDP test, the Zn F.S. was less susceptible to corrosion than the Zn A.S. The Alloy F.S. fell victim to the corrosive attack of the electrolyte, yet the Alloy A.S. showed a weight gain, albeit one decreasing with time. This is depicted in Figure B.65. Both Al coatings showed weight gains consistently during the test. The bi-weekly weight gains are displayed in Table III, Appendix B, and presented graphically in Figures B.66 and B.67. This weight gain is caused by the products of corrosion filling the pores of the coating and forming an additional protective barrier for the substrate, [Ref. 21].

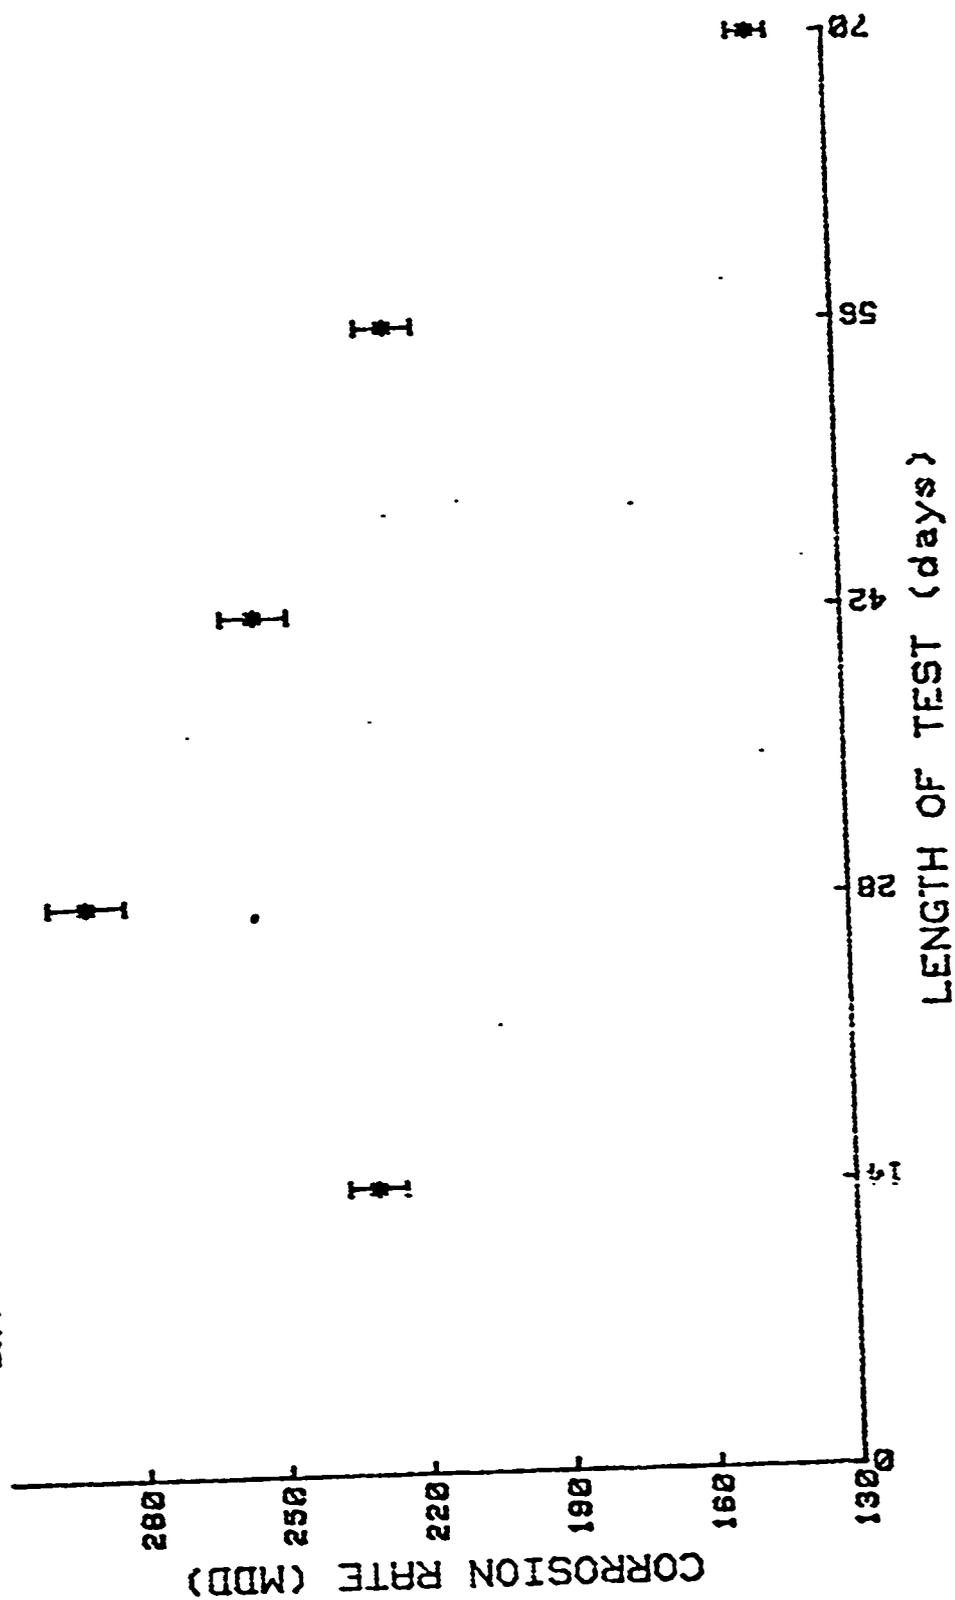
Zn F.S. COUPON CORROSION RATES (PIML)

Figure B.63 Plot of Zn F.S. Corrosion Rate

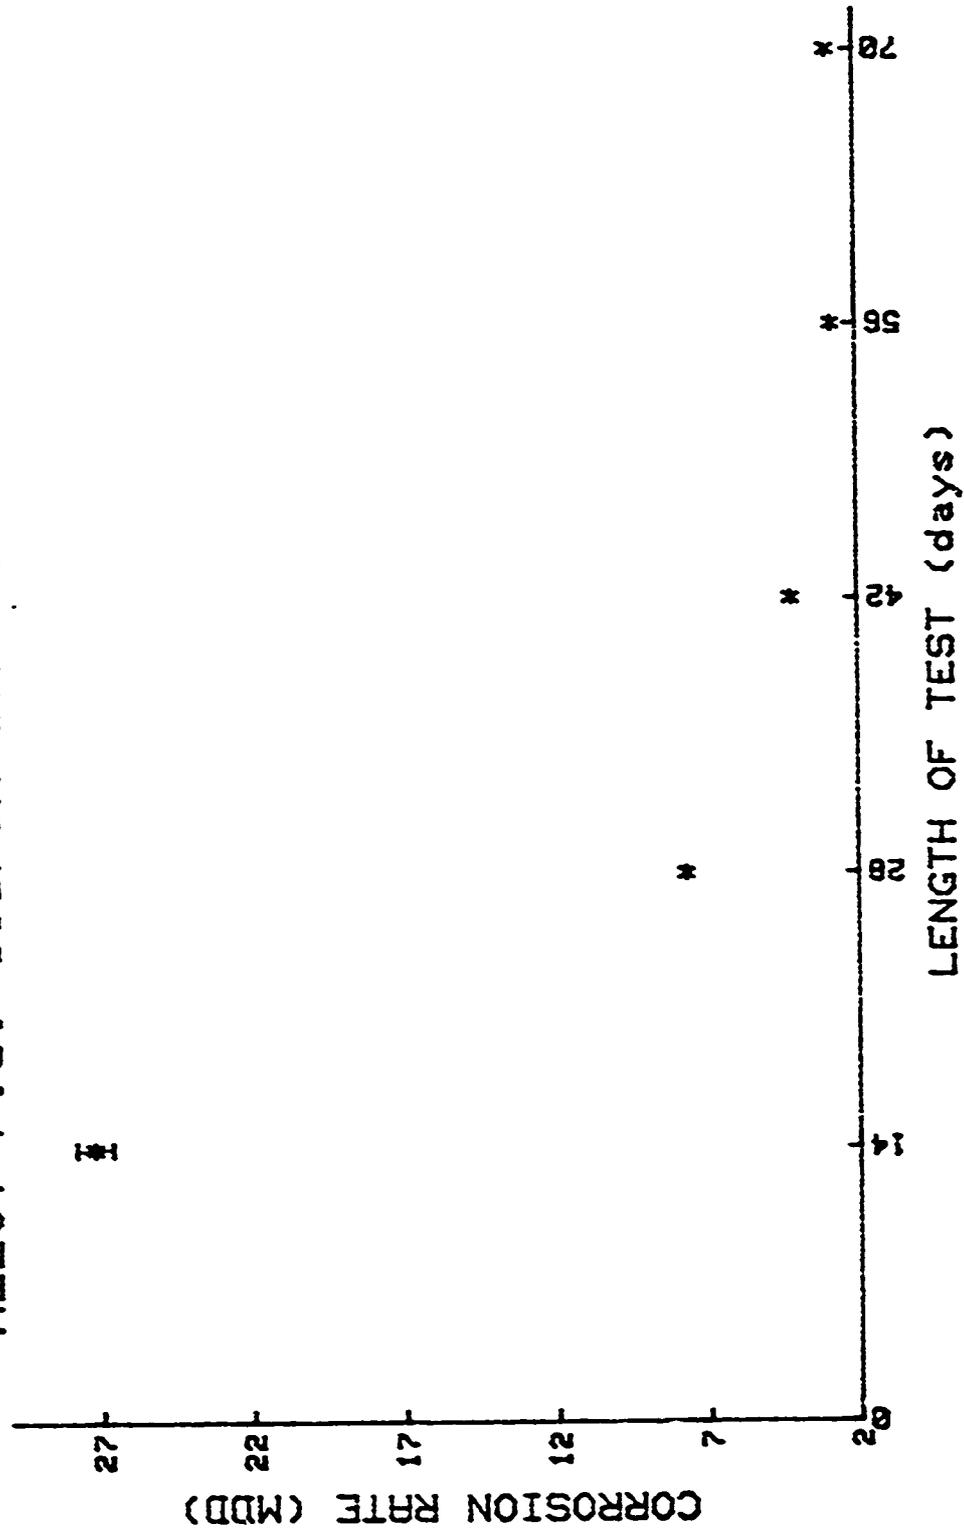
ALLOY F.S. COUPON CORROSION RATE (MDD)

Figure B.64 Plot of Alloy F.S. Corrosion Rate

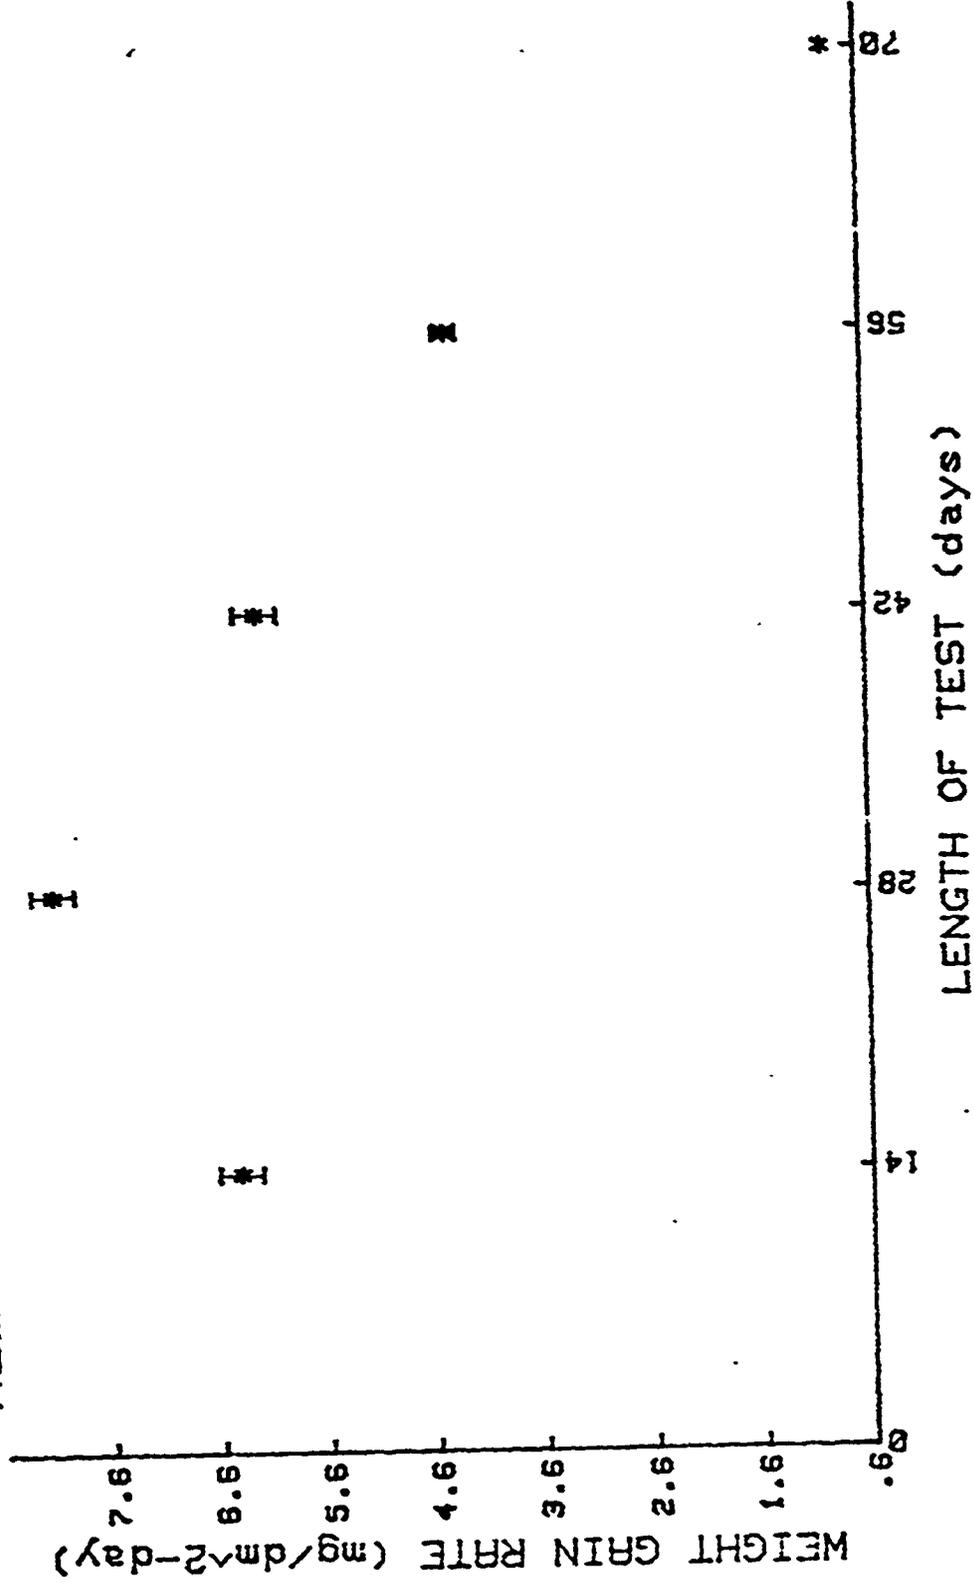
ALLOY A.S. DAILY WEIGHT GAIN RATE (PIML)

Figure B.65 Plot of Alloy A.S. Daily Weight Gain

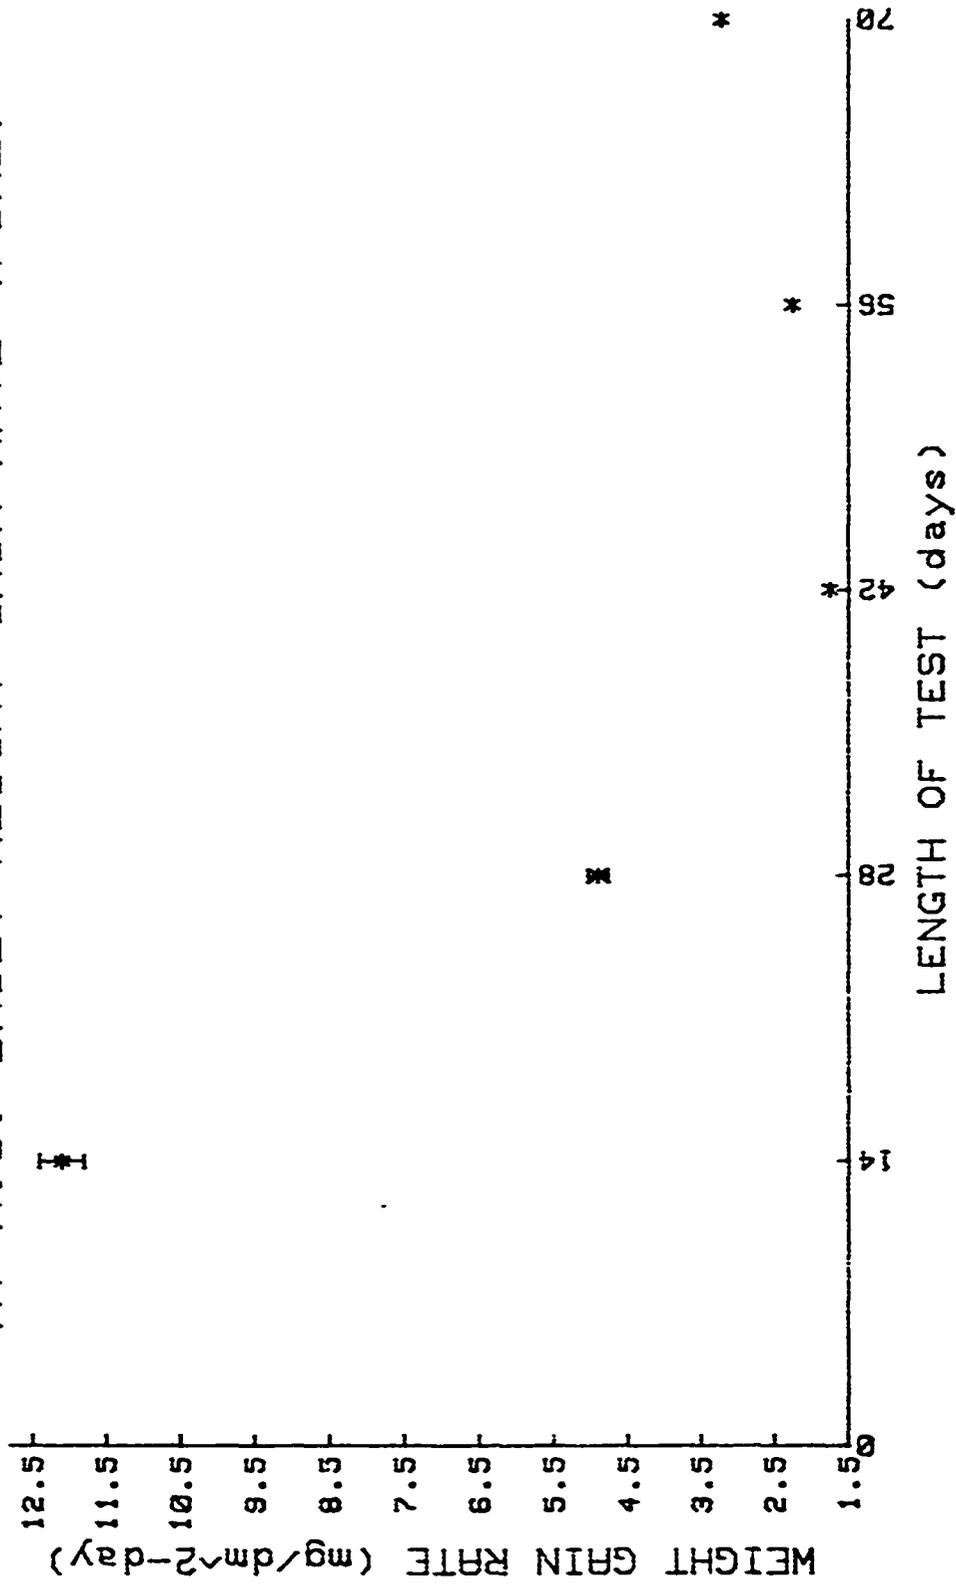
AI A.S. DAILY WEIGHT GAIN RATE (PIML)

Figure B.66 Plot of AI A.S. Daily Weight Gain

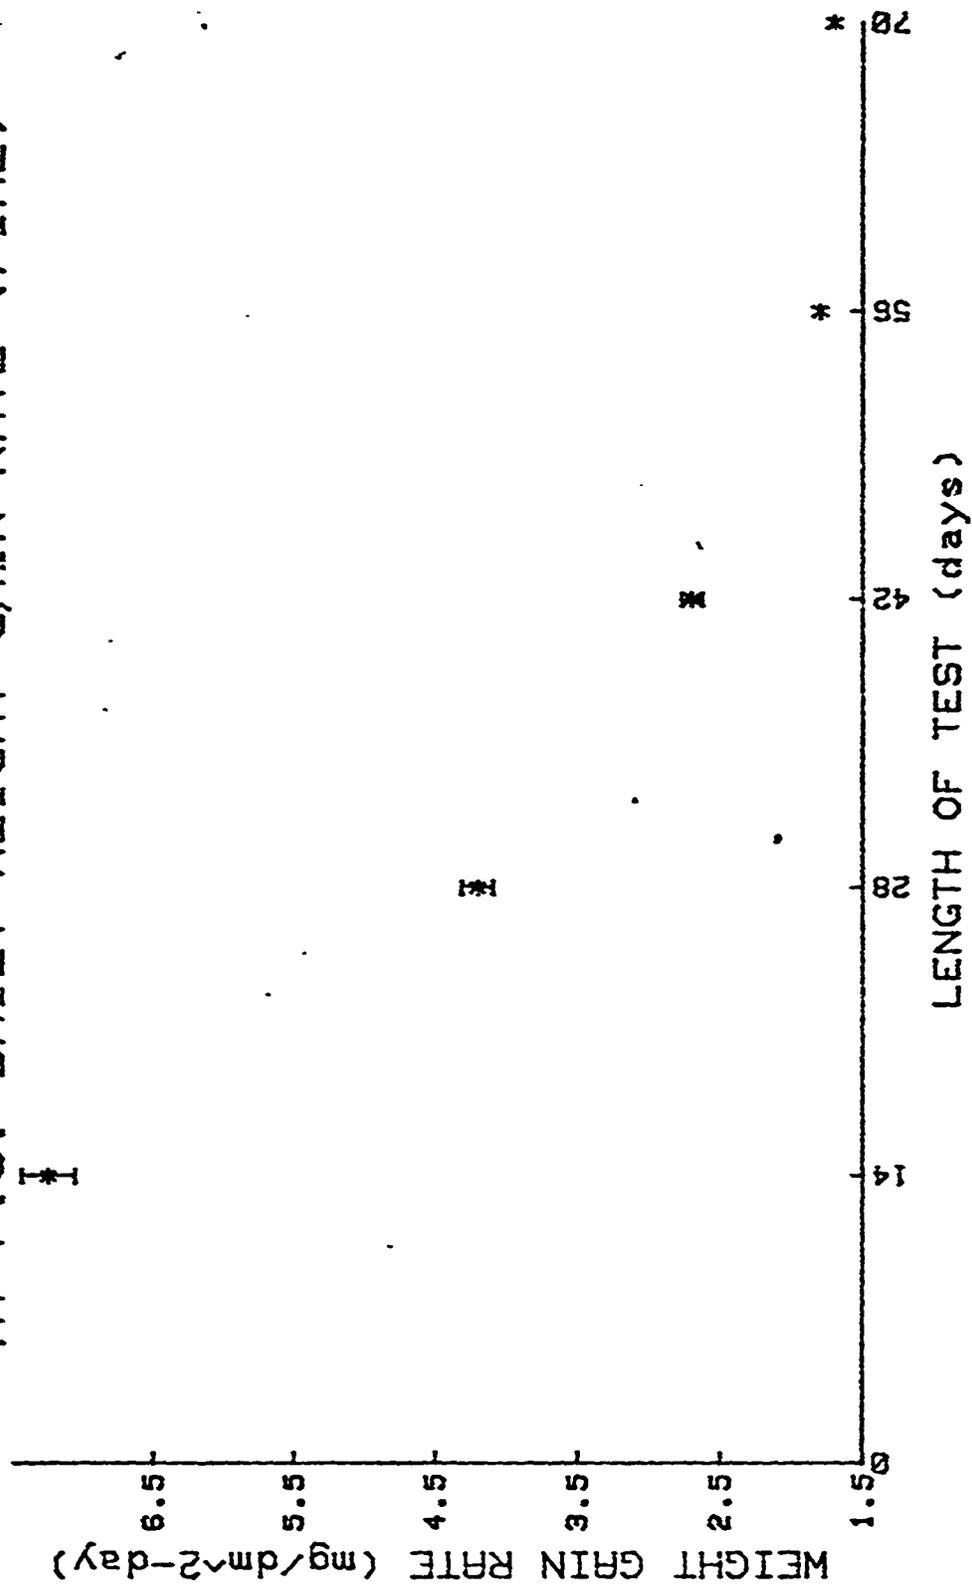
AI F.S. DAILY WEIGHT GAIN RATE (PIML)

Figure B.67 Plot of AI F.S. Daily Weight Gain

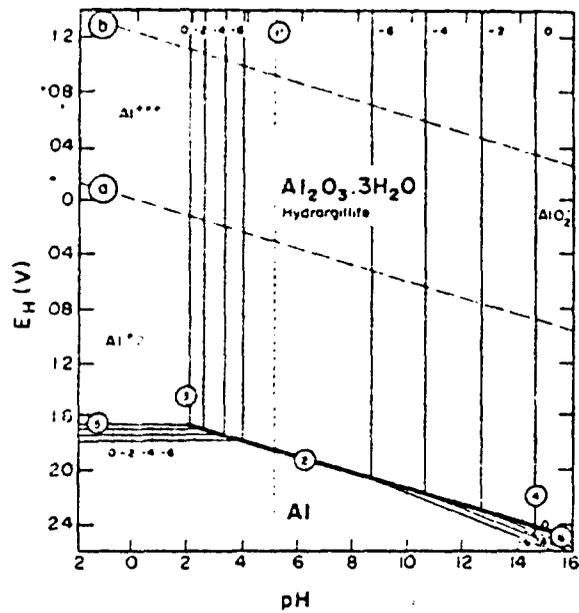
Figure B.95 Pourbaix Diagram for Aluminum

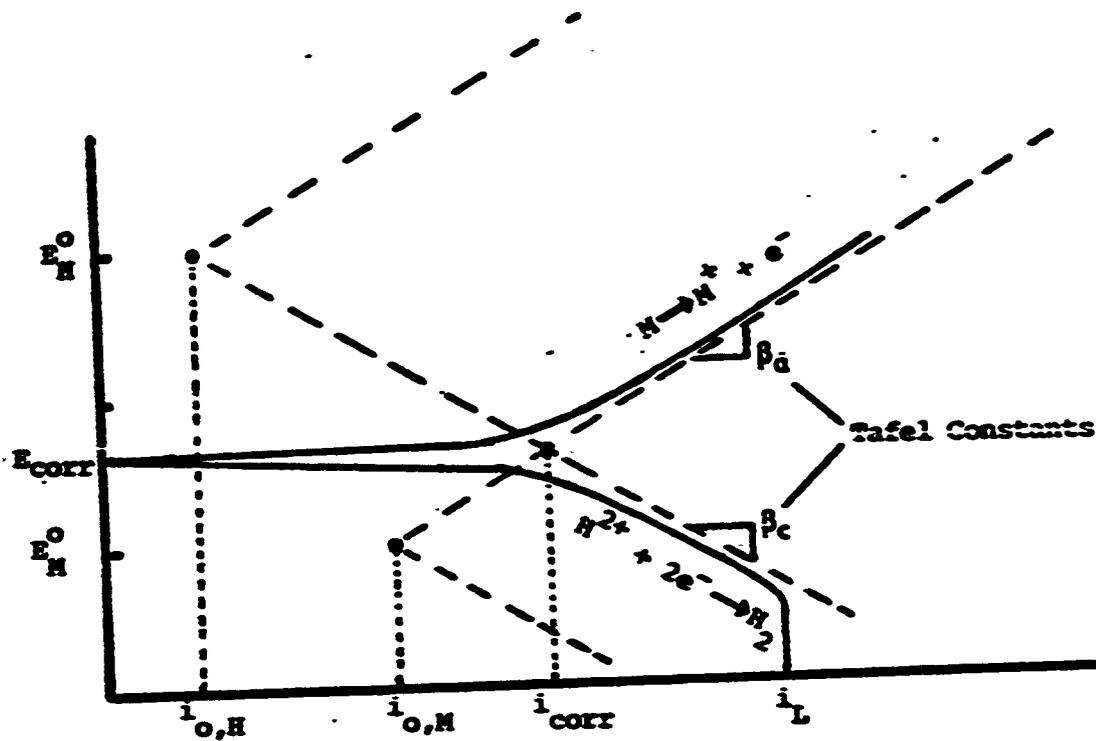
Figure B-1. Schematic Representation of Potentiodynamic Polarization Curve

Figure B.97 Schematic Representation of a PDP Curve
