A CULTURAL RESOURCES RECONNAISSANCE
OF THE SUSUPU CHAIAN KANOA FLOOD
CONTROL STUDY AREA,

SAIPAN, MARIANA ISLANDS

Pacific Studies Institute

March, 1980

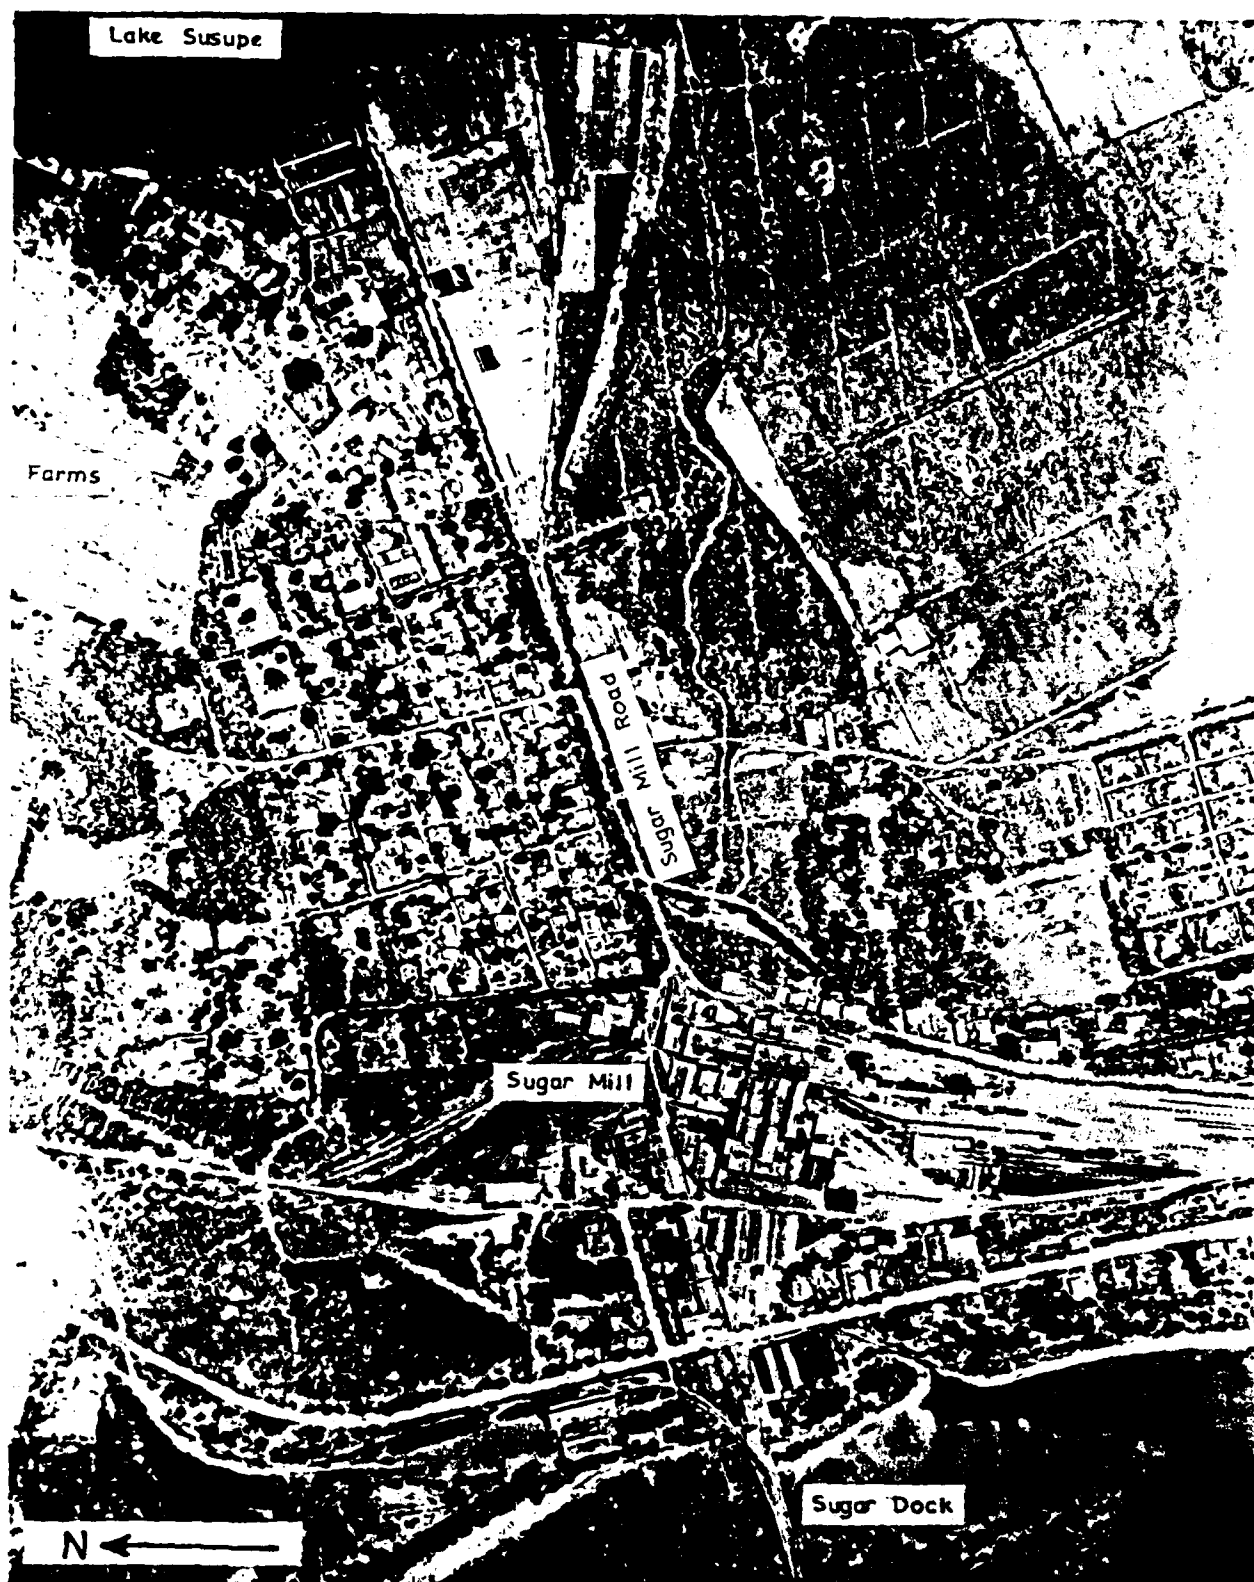
Figure 4: Pre-War Aerial Photograph of Chalan Kanoa Farming Area and Sugar Factory

supports and wells were found scattered in the area north and west of Lake Susupe. These and other fragments of miscellaneous debris are all that remains of farms that for the most part were constructed during the Japanese administration (visible in Figures 4 & 6). Like the concrete slabs, these remains are not historically valuable in themselves, but further investigation in the area may shed light on the day to day agricultural practices of the pre-war period.

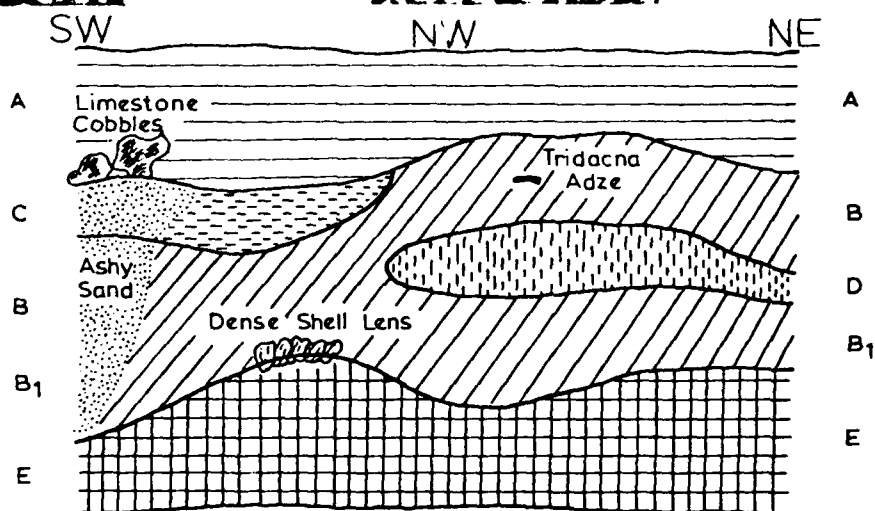
FIGURE 14. STRATIGRAPHY FOR TEST EXCAVATION 1

- A -- 7.5 YR 5/2 Sandy loam containing Plainware, shell, and modern debris.
 B -- 10 YR 6/2 Loamy sand containing Plainware and shell.
 B₁ -- 10 YR 7/3 Sand containing Plainware, shell, and charcoal fragments.
 C -- 7.5 YR 7/2 Sand containing Plainware, shell, and occasional fire cracked limestone cobbles.
 D -- 2.5 Y 7/4 Compacted sand containing occasional shell and Plainware.
 E -- 2.5 Y 8/4 Loose sand containing occasional Plainware and shell.

Level 10: 90-100 cm, soil - 2.5 Y 8/4 loose sand. There is abundant shell in level 10, but pottery is quite rare. The shell in this level is unweathered as is the shell in level 9. The concentration of shell possibly associated with the hearth is no longer present, nor is the hearth itself, as may be seen in the profile (Figure 14).

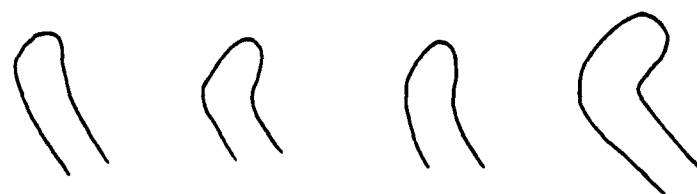
FIGURE 15. RIM SHERDS RECOVERED FROM TEST EXCAVATION 2.
