# Technical Report 867

## STUDY OF FISH BITE ON THE AN/BQR-15 TOWED ARRAY

November 1982

Prepared for  
Western Electric Co.  
Greensboro, NC 27420

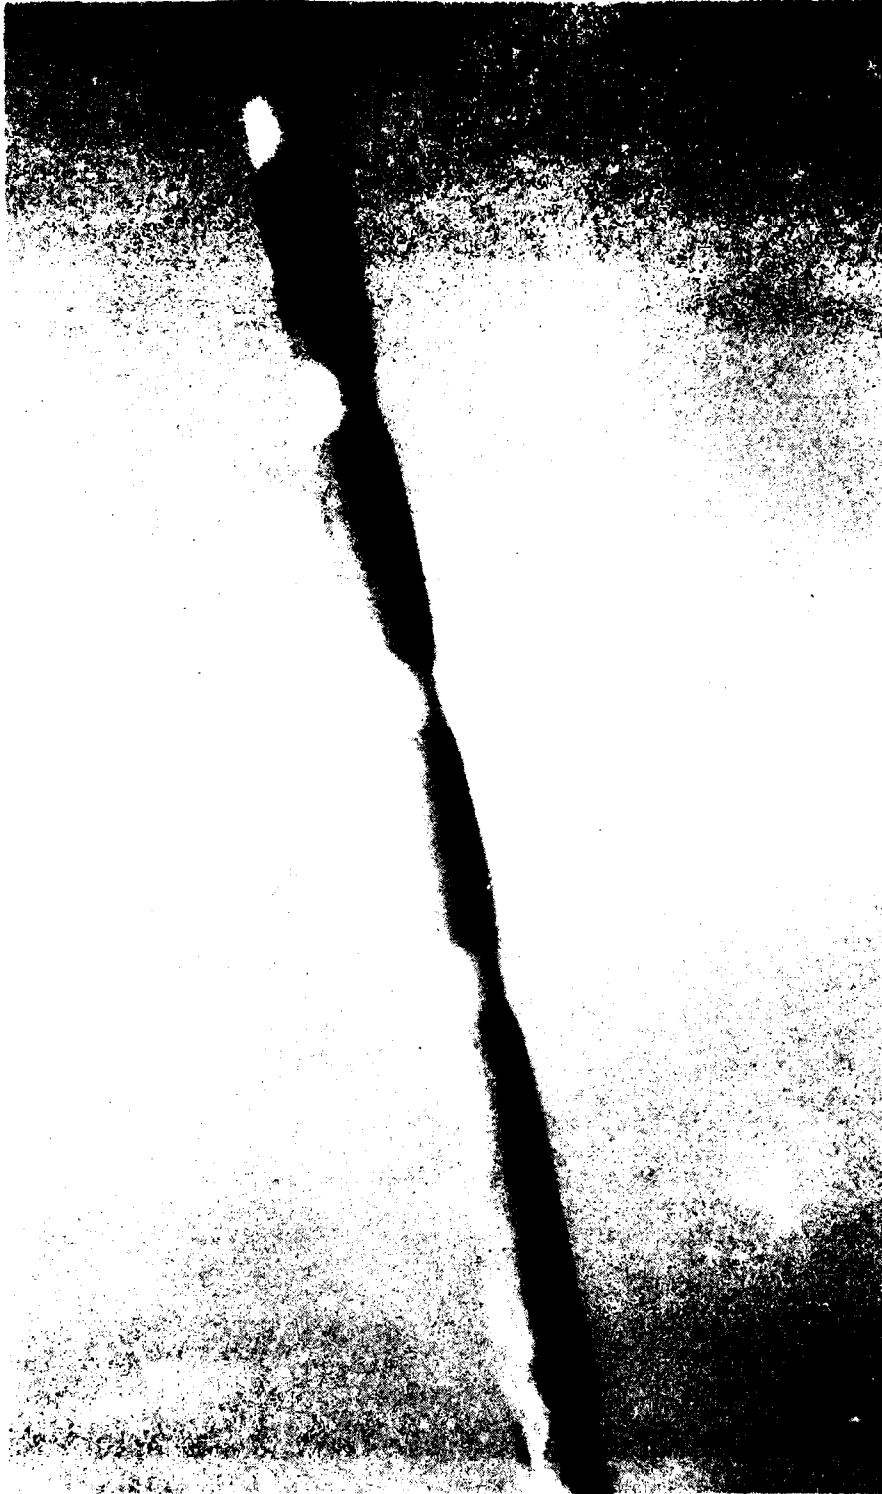
Due to its coating, the large array showed up better than the thin array because its contrasting plastic couplings showed up dark (fig. 7). The tape wrappings on the VIM of the large array were visually very prominent underwater (fig. 8).

Figure 8. Underwater picture of the VIM of the large array shows the high visibility of the tape wrappings.

While no bites were detected during this part of the work, underwater photographs of both arrays revealed parts that may attract sharks visually. The titanium couplings of the thin array appear shiny under water, and the tape wrappings on the VIM of the large array also show up prominently.

It would also be useful to test the feasibility of attracting sharks to invulnerable parts of the arrays by changing the visual appearance of the arrays. This will be important if other countermeasures are not effective.

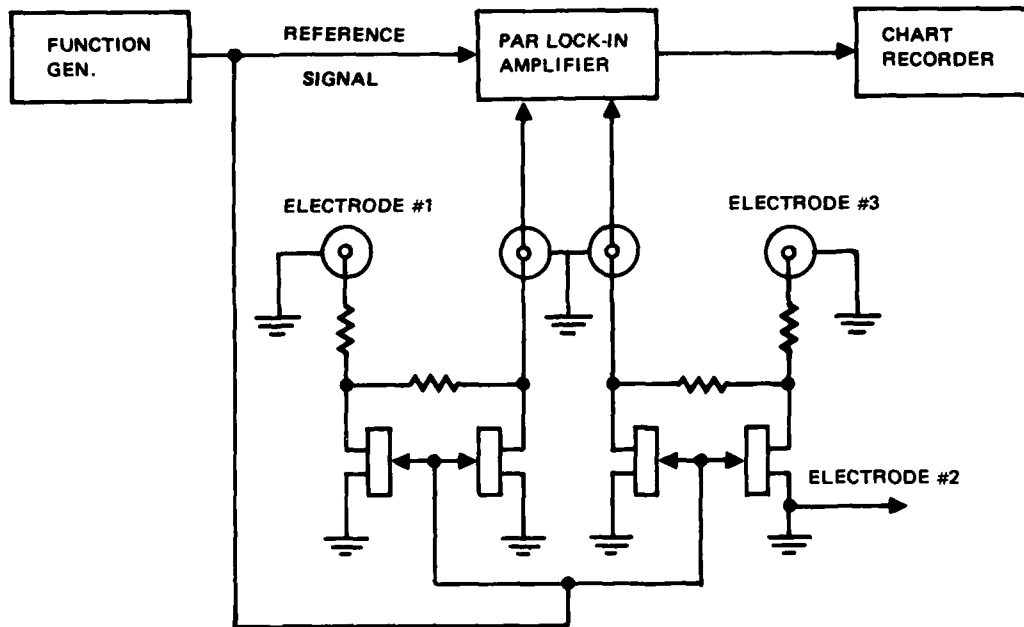
Figure A-1 shows the circuits used to measure the galvanic electric field of the thin array's titanium coupling. The center electrode (electrode 2) was connected to the ground shields of the coaxial cables and also connected as close as possible to electrodes 1 and 3 to reduce noise pickup.

In this arrangement, the function generator (Hewlett-Packard Model 3300A), operating with square wave output at 10 Hz, switches the Field Effect Transistors (FET) on for 50 ms and off for 50 ms. When the FETS are on, electrodes 1 and 3 are shorted to ground (electrode 2). When they are off, electrodes 1 and 3 are switched to the A and B inputs of the Princeton Applied Research (PAR) model HR-8 lock-in amplifier. This arrangement keeps the electrodes from drifting in potential, since they are shorted together half the time. It also allows the use of a lock-in amplifier to minimize external noise pickup.

- NOTES: 1. ALL RESISTORS ARE 12 k $\Omega$   
 2. ALL FETs ARE 2N3819 P-TYPE FETs

Figure A-1. Circuit diagram of field-measuring electronics.
