# Evaluation of Precision Approach Path Indicator (PAPI)

Bret Castle

Prepared By  
FAA Technical Center  
Atlantic City Airport, N.J. 08405

April 1983  
Final Report

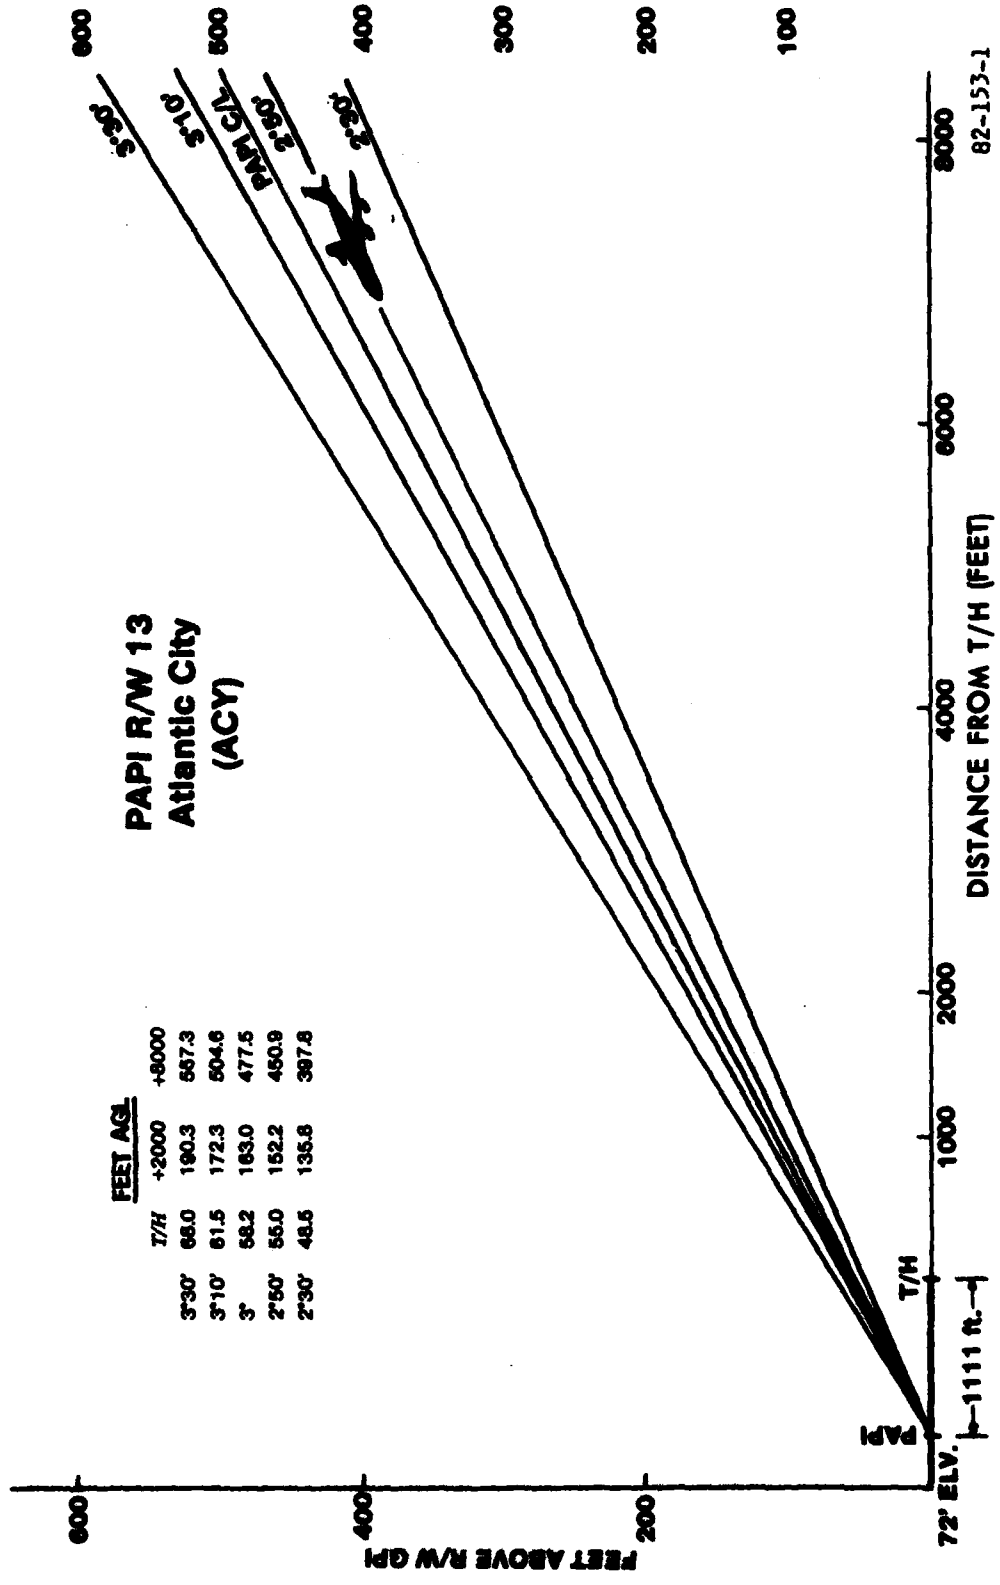
82-153-1

**PAPI R/W 13  
Atlantic City  
(ACY)**

FEET AGL	
T/H	+8000
3-30'	66.0
3-10'	61.5
3'	58.2
2-50'	56.0
2-30'	48.6
PAPI G/L	190.3
	172.3
	163.0
	152.2
	135.8
	604.6
	477.5
	450.8
	397.8

FIGURE 1. PAPI APPROACH PATH (SIDE VIEW)

The PAPI system consists of a bar of four light units (three lamps per unit) facing the approach end of the runway. Each unit is set at a slightly different angle (20 minutes apart) and emits a beam of high intensity light, the upper half showing white and the lower half showing red. Figure 1 depicts a side view of the signal sectors in the approach zone. As seen by the approaching pilot, it consists of a bar of four quick transition red/white light units whose on-glidepath signal (usually 3°) is two red and two white lights (figure 2). When the aircraft is slightly below glidepath (between 2° 50 minutes and 2° 30 minutes), the signal changes to three red and one white light. When the aircraft is further below glidepath (below 2° 30 minutes), a fly-up signal of four red lights is seen. Conversely, deviations above the glidepath will cause the red light units to turn successively white. In this configuration, the lights can be seen at about 5 miles from the threshold of the runway (in unlimited visibility) and the on-glidepath signal depth gradually reduces to approximately 6 feet at the threshold.

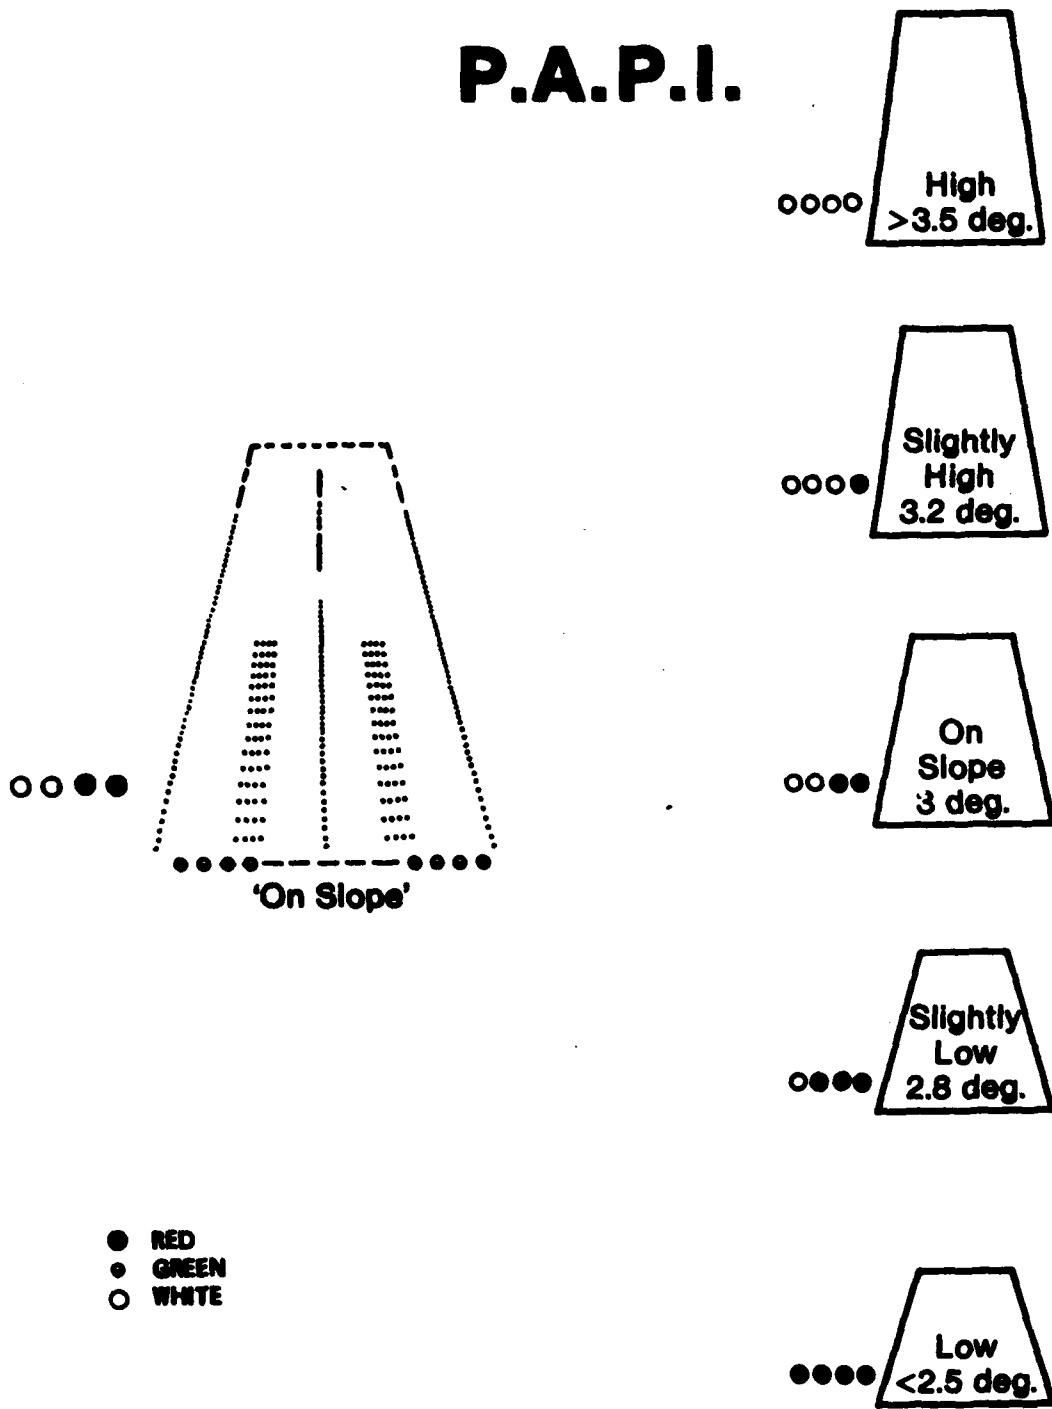
82-153-2

FIGURE 2. APPROACH PATH ILLUSTRATION

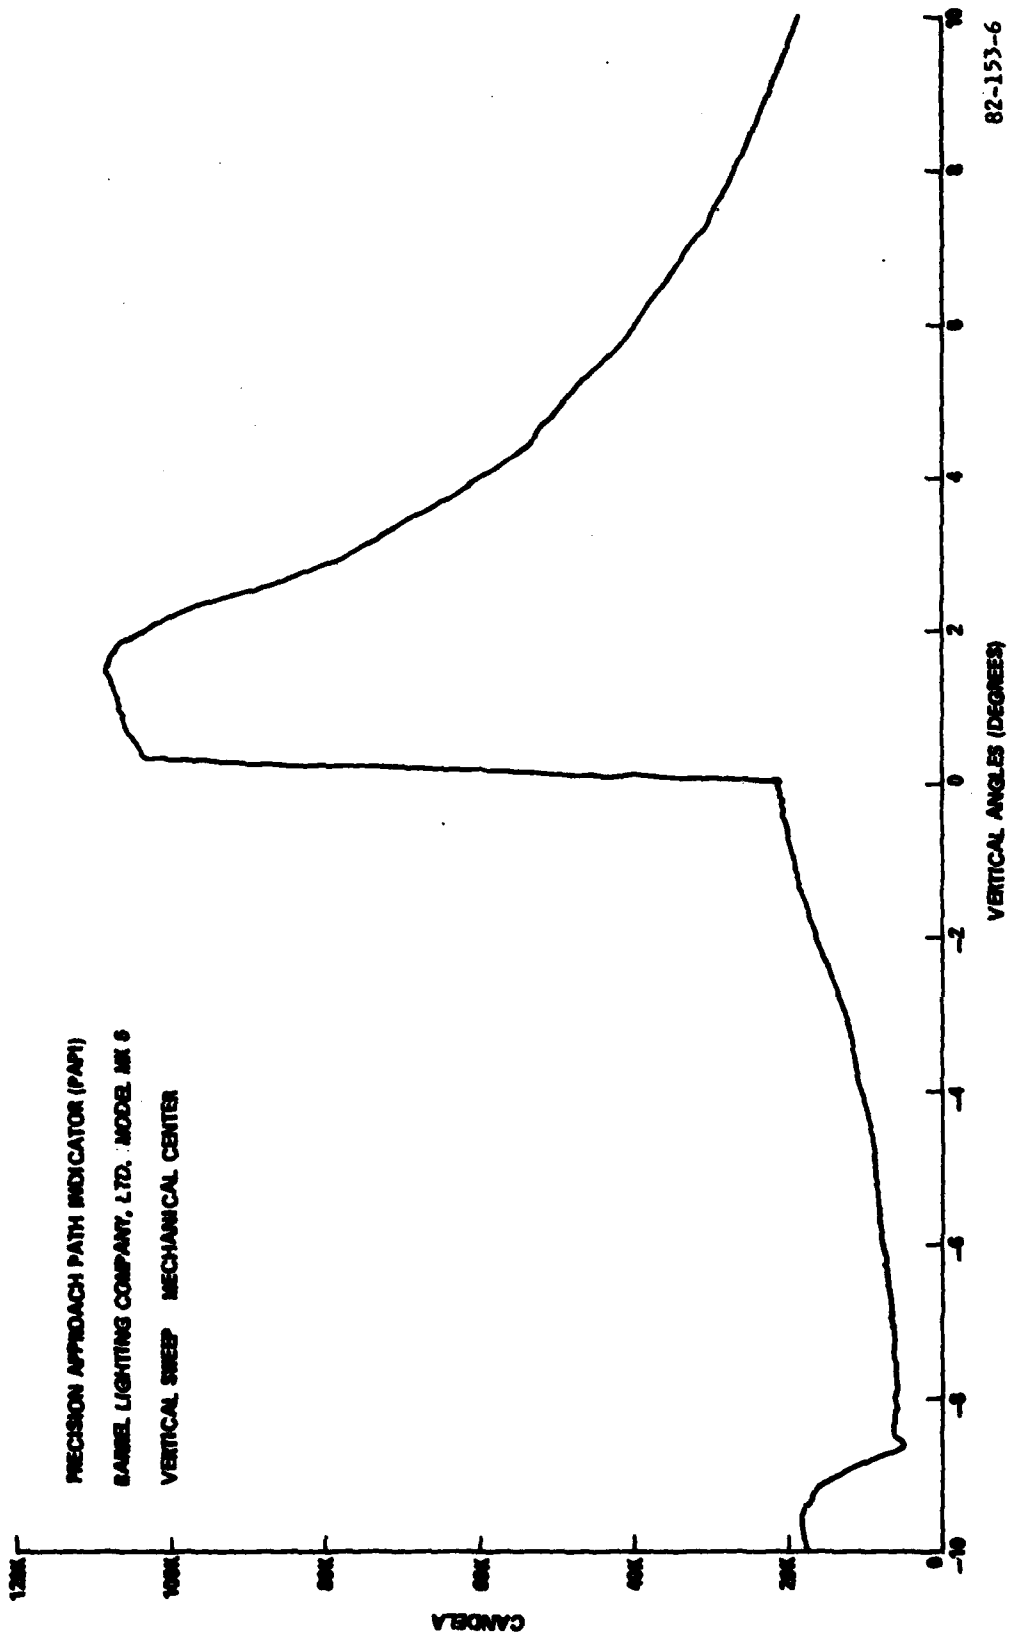
82-153-6

FIGURE 6. VERTICAL INTENSITY DISTRIBUTION CURVE

Photometric measurements were made on the Barrel Lighting Co. PAPI fixture. The lamps are standard 30 volt, 200 watt, 200PAR locomotive lamps. Horizontal and vertical intensity distribution measurements were obtained for the units. Figure 6 shows the vertical beam distribution of both the red and the white signals of one PAPI unit when measured from minus 10 degrees to a plus 10-degree elevation. It also displays the quick transition (approximately 3 minutes of arc) from one color to the other. Figures 7 and 8 show the horizontal intensity distribution of the white and red signals, respectively, taken at peak beam intensity. The peak intensity of the white signal, occurring at 1.5° elevation, was 112,000 candelas and the peak intensity of the red signal, occurring at 0° elevation, was 22,000 candelas. Transmittance tests were made on the red filters of the Barrel unit, and

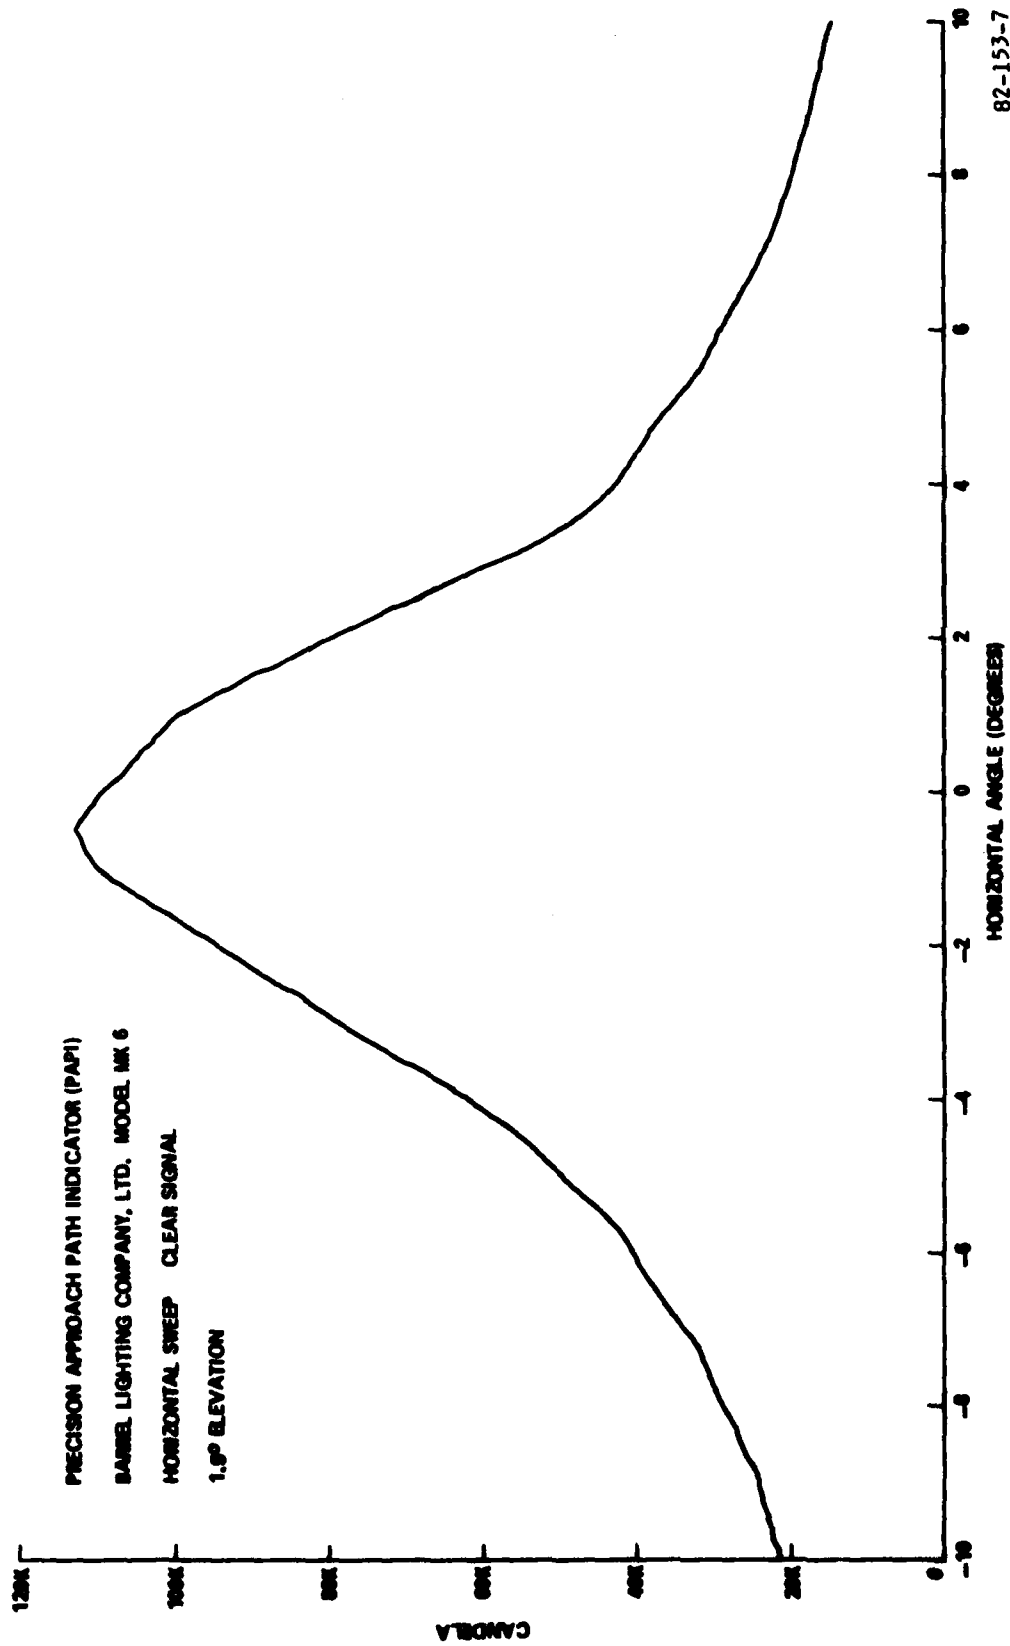
82-153-7

FIGURE 7. CLEAR SIGNAL INTENSITY DISTRIBUTION CURVE

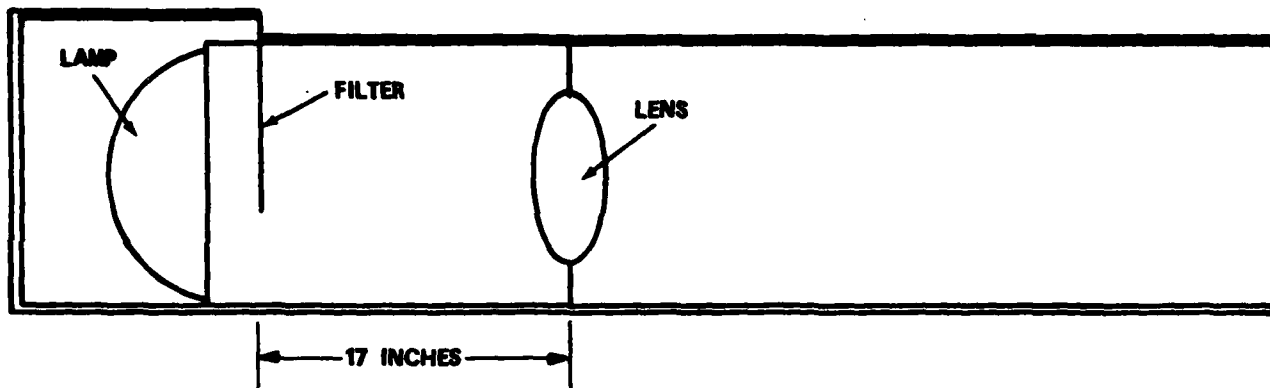
The "open slot" model mounting arrangement of the optical components included unfluted red filters in their normal mounting positions, with the 6-inch lenses mounted at the focal length, 17 inches forward of the red filters. The normal 2-inch slotted front face of the VASI box was completely removed, leaving the front of the box open.

OPEN SLOT MODEL

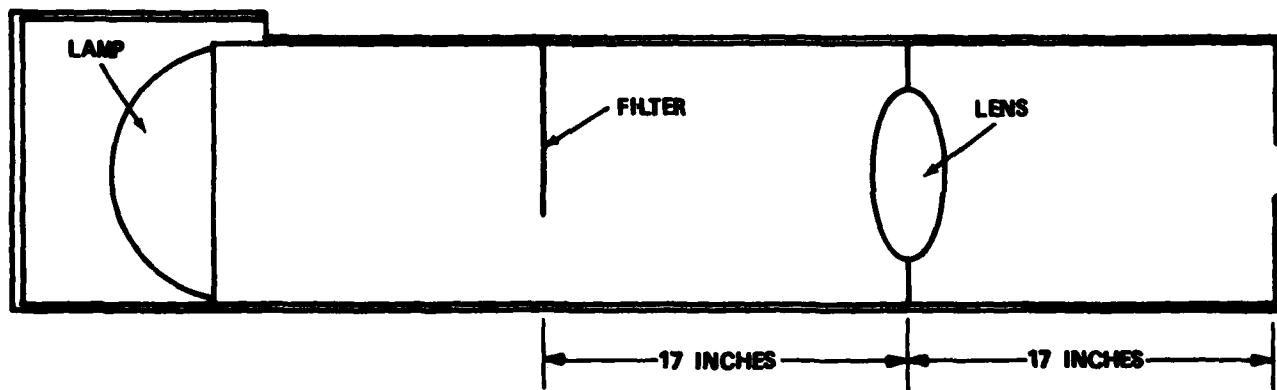
82-153-10

The "narrow slot" model design required that the 6-inch lenses be moved forward so that the focal length plane was coincident with the normal 2-inch slot on the front of the box to insure maximum signal emission through the 2-inch slot. The lens,

NARROW SLOT MODEL

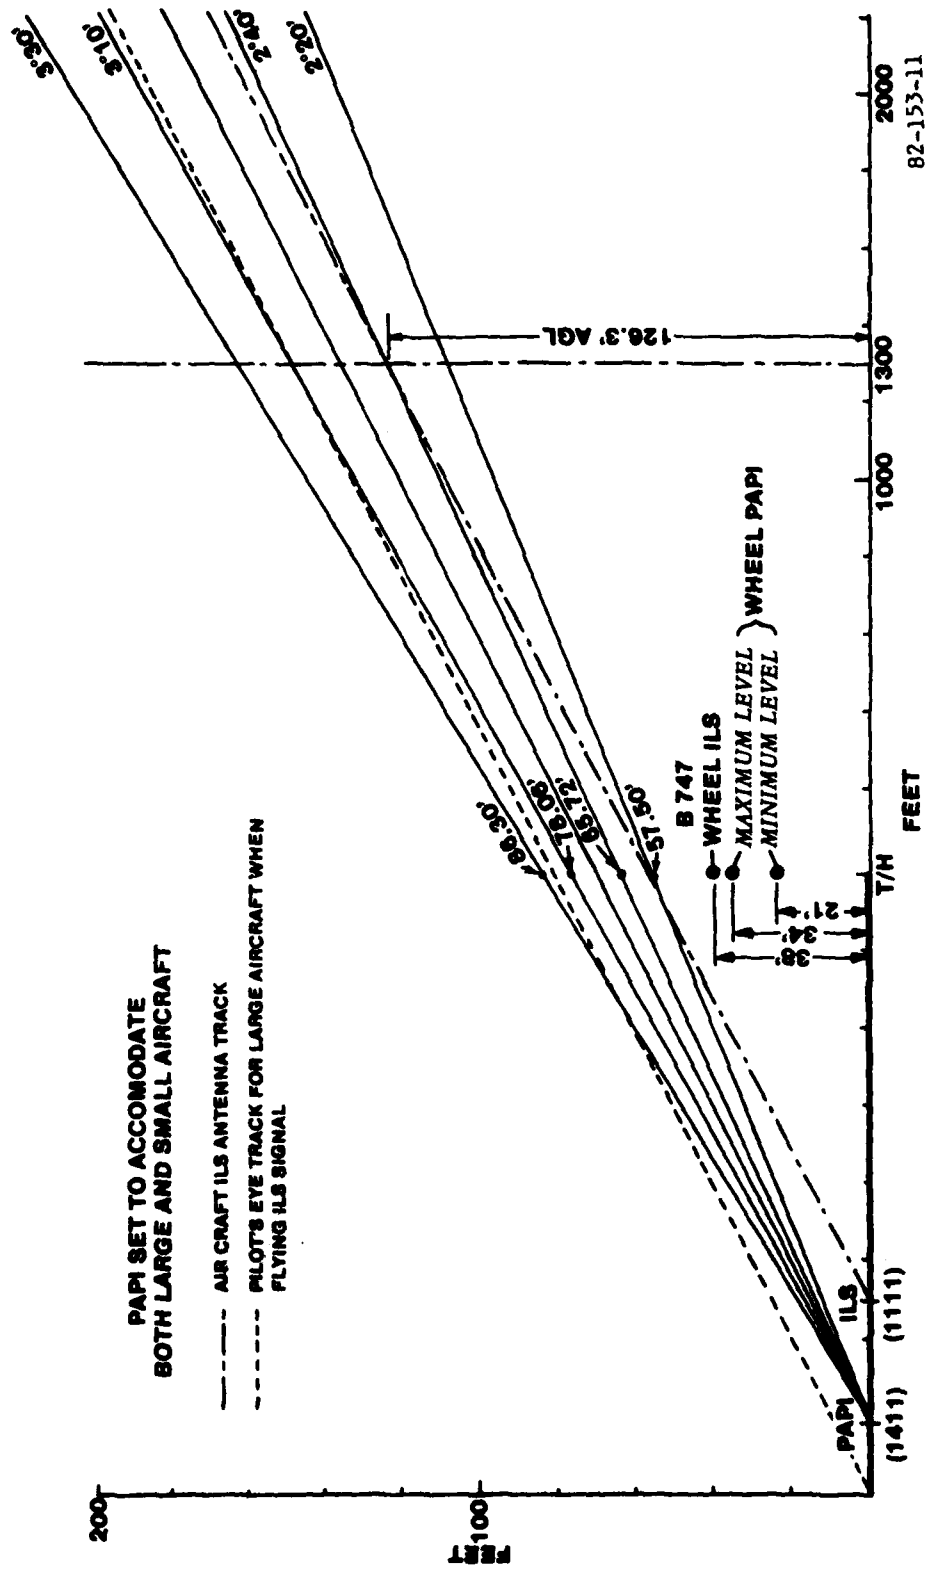
FIGURE 11. TYPICAL PAPI APPROACH PATH WITH ILS

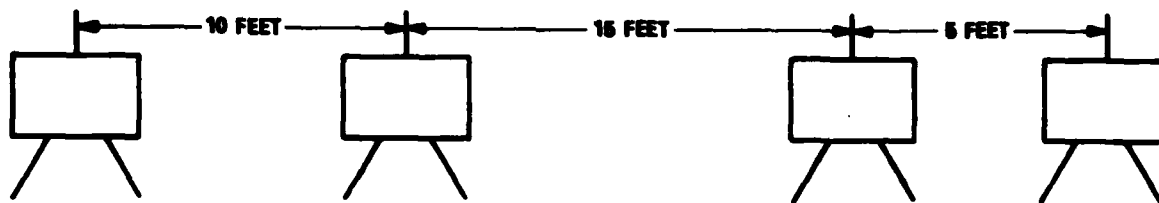
Additional flight testing was conducted to determine whether PAPI signals could be readily seen and resolved with individual PAPI units installed closer together than specified by the British (minimum spacing of 33 feet). Four Barrel PAPI units were installed at the Technical Center in the configuration shown below.

The spacing of the experimental arrangement was so constituted that individual pairs of units could be energized, in turn, to provide lateral spacings of 5, 10, 15, 20, 25, and 30 feet as desired. Approaches were flown, from extreme range, with an Aero Commander 680 aircraft, a Bell 206L helicopter, and a Sikorski S-76 helicopter to determine the maximum distances (range) at which signals from two PAPI light units could be resolved and identified as two distinct light sources. Known landmarks on the ground and distance measurement equipment (DME) in the aircraft were used to observe and record maximum resolution ranges for pairs of PAPI units with lateral spacings as indicated above. A conservative approach was taken in this test and resolution ranges were not established until the lights were judged to be sufficiently distinct so as to insure that an unfamiliar pilot could clearly determine that individual lights from the PAPI system could be seen separately. The flight tests were conducted in VFR weather conditions, in daylight and at night, with at least 4 1/2 nautical miles of visibility.

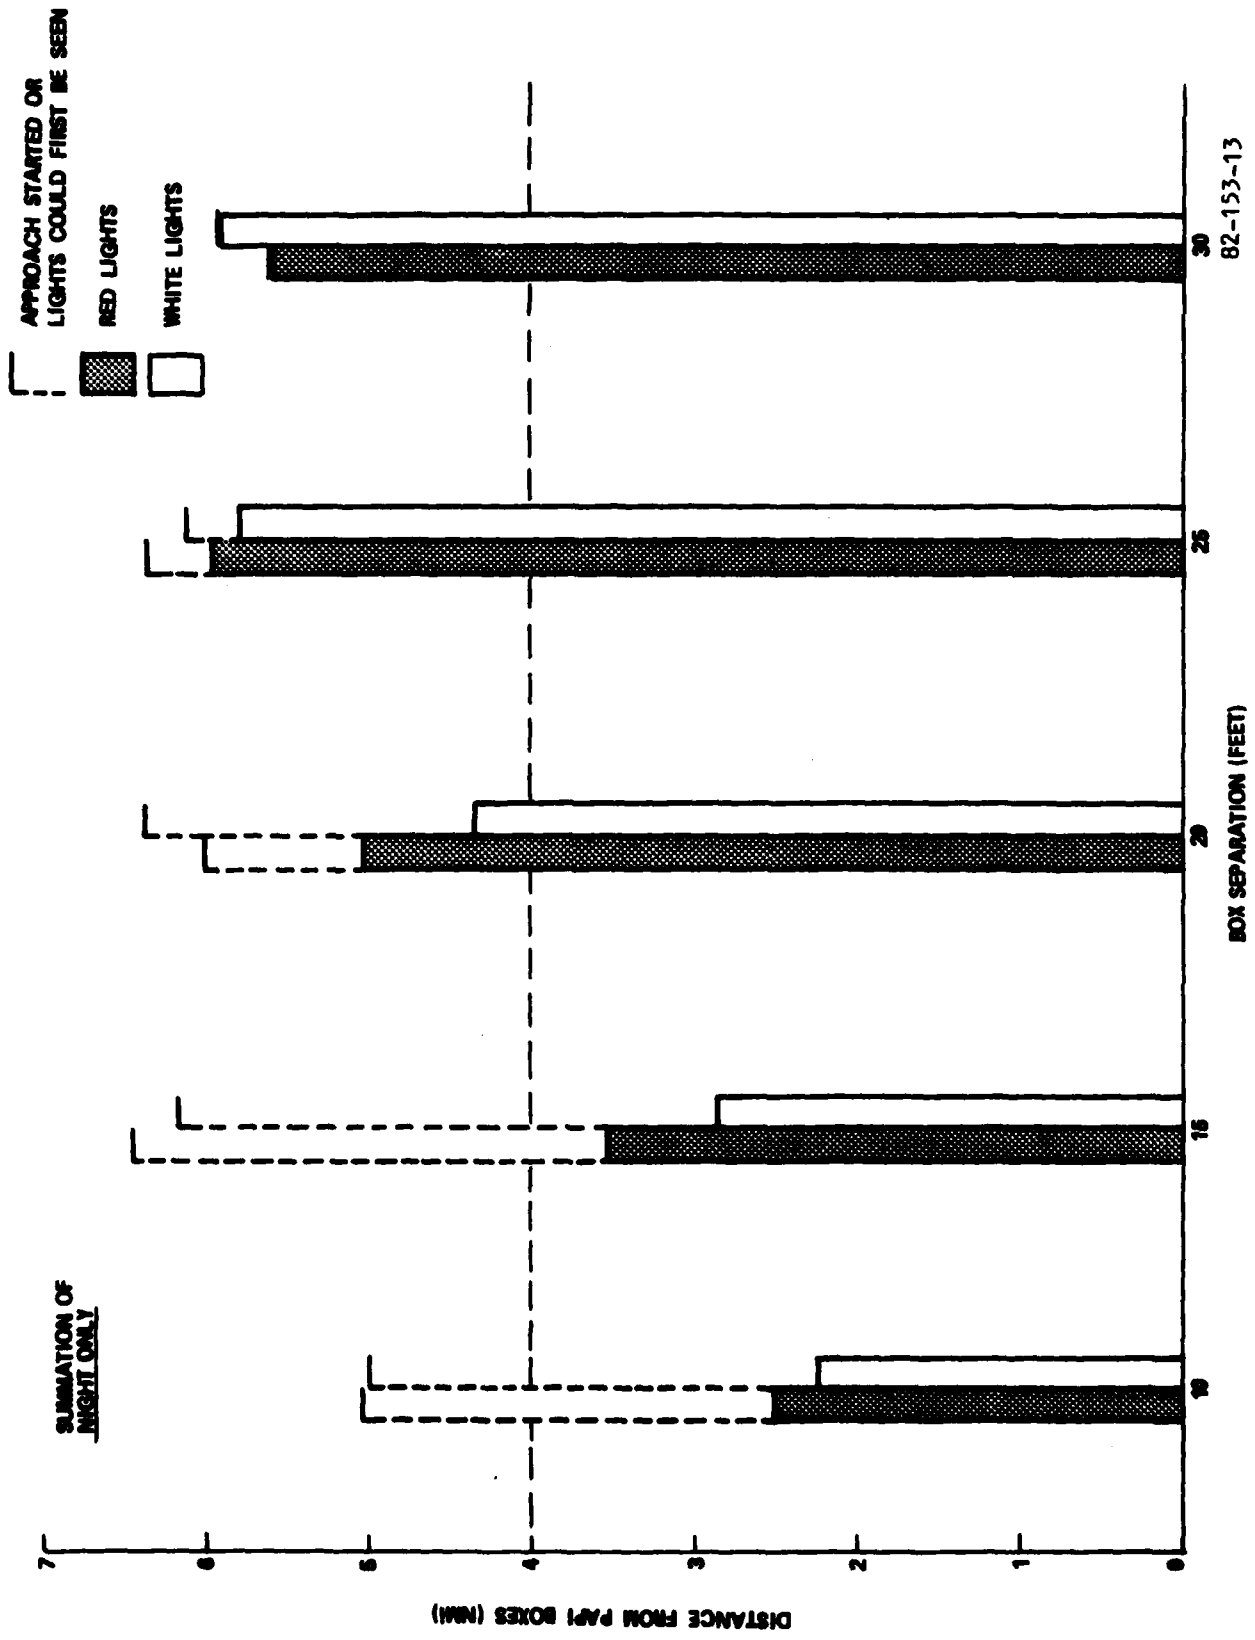
82-153-13

**NIGHTTIME TEST RESULTS.** (Figure 13). Power supply current, at night, was set at 3.8 amperes, midway between the current values for intensity steps 2 and 3 on the standard five-step regulator. It had been determined, during the previous night flight testing of the PAPI system, that this intensity was preferred by the majority of pilots who flew the PAPI at the Technical Center. In each test session, it was determined that the pilots, at night, were able to resolve individual PAPI red and white light signals with spacing as close as 20 feet at ranges of 4 nautical miles. FAA Advisory Circular AC 150/5340-25, "Visual Approach Slope Indicator (VASI) Systems," specifies 4 nautical miles as the minimum useable range for a standard four-box VASI. Lateral spacing of less than 20 feet resulted in determined resolution ranges of less than the required 4 nautical miles and were judged to be inadequate.

FIGURE 13. GRAPH OF NIGHTTIME RESOLUTION TESTS

It follows from the above determinations, with regard to both night and day conditions, that lateral spacing of PAPI units installed at smaller General Aviation airports could be reduced to as little as 10 feet and still provide adequate guidance within ranges of 2 to 3 miles from the runway threshold.

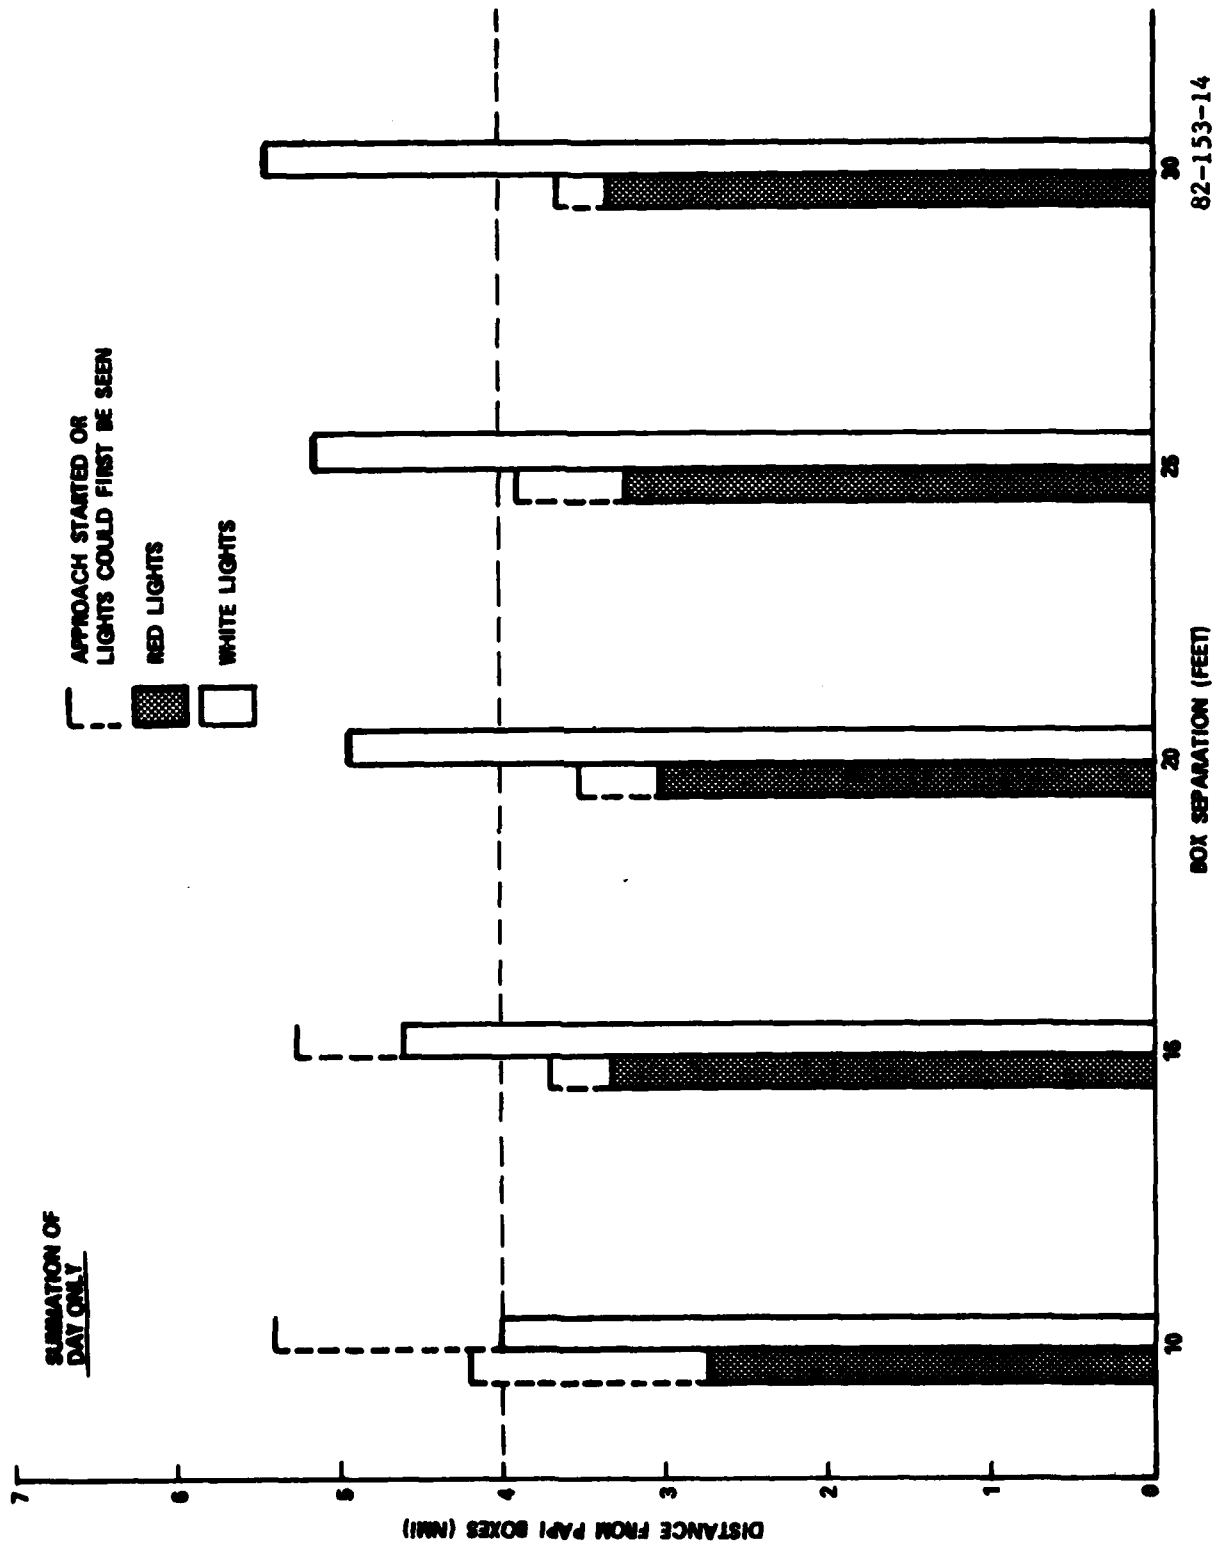
82-153-14

**DAYTIME TEST RESULTS.** (Figure 14). Power supply current, during daytime, was set at 6.6 amperes which is the current value for intensity step 5 on the standard five-step regulator. Pilots were barely able to resolve the PAPI red light signal at 4-nautical mile range with the greatest lateral spacing of 30 feet. In fact, resolution ranges for the red signals were relatively constant at slightly greater than 3 nautical miles, regardless of lateral spacings less than 30 feet. This should not be construed to mean that a full four-box PAPI system could not be used at a 4-nautical mile range, in daylight, since a pilot familiar with the system could easily determine his long range relationship to glide path by counting the discernible white lights of the system.

The average resolution range of the PAPI white lights, during daytime, exceeded 4 nautical miles even when the lateral spacing of PAPI units was as close as 10 feet.

FIGURE 14. GRAPH OF DAYTIME RESOLUTION TESTS

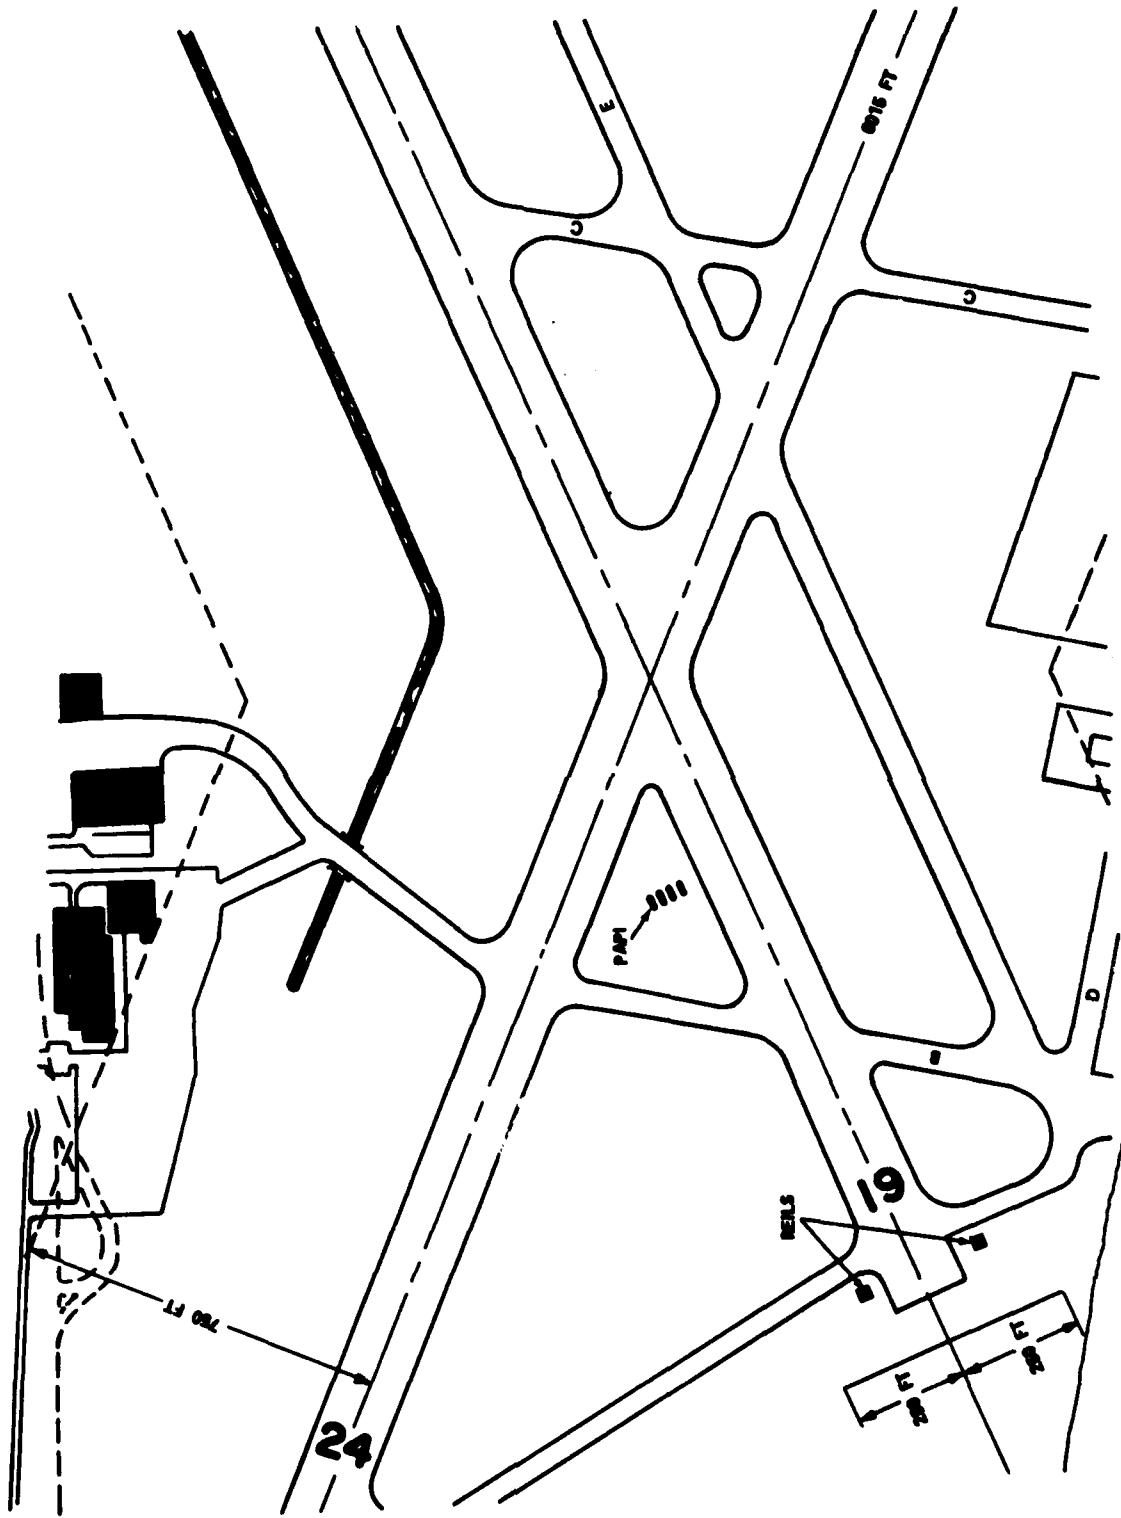
FIGURE C-1. PAPI LAYOUT AT TETERBORO

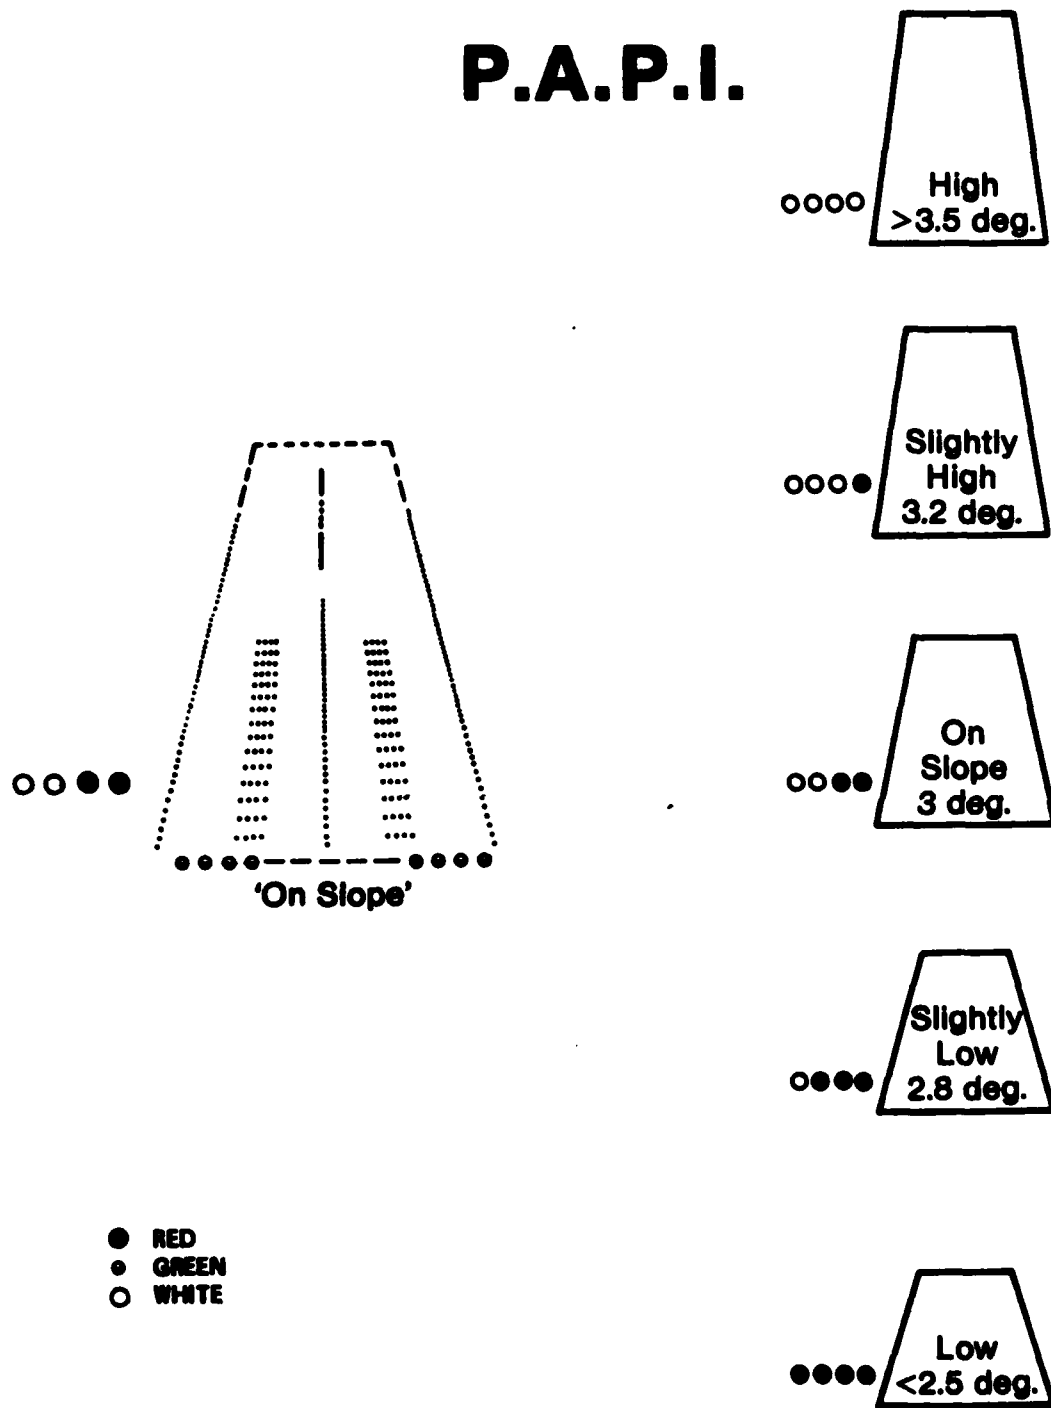
82-153-2

FIGURE C-3. DESCRIPTIVE DIAGRAM

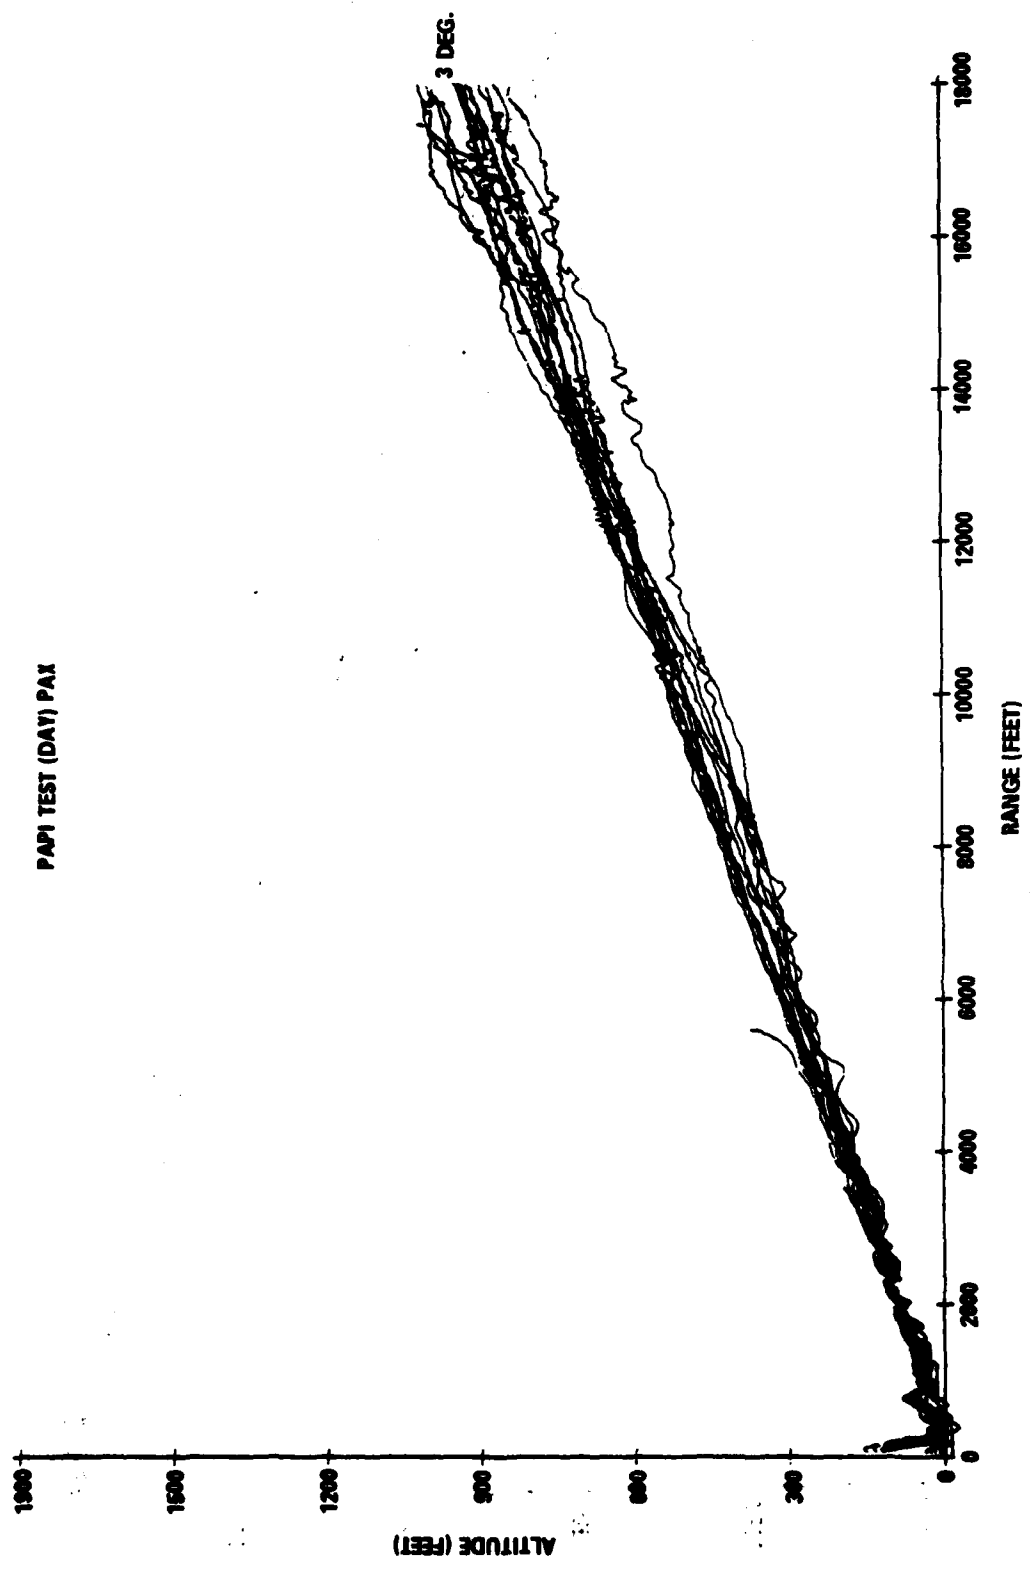
FIGURE D-3. PAPI TWO-BOX DAY TESTS

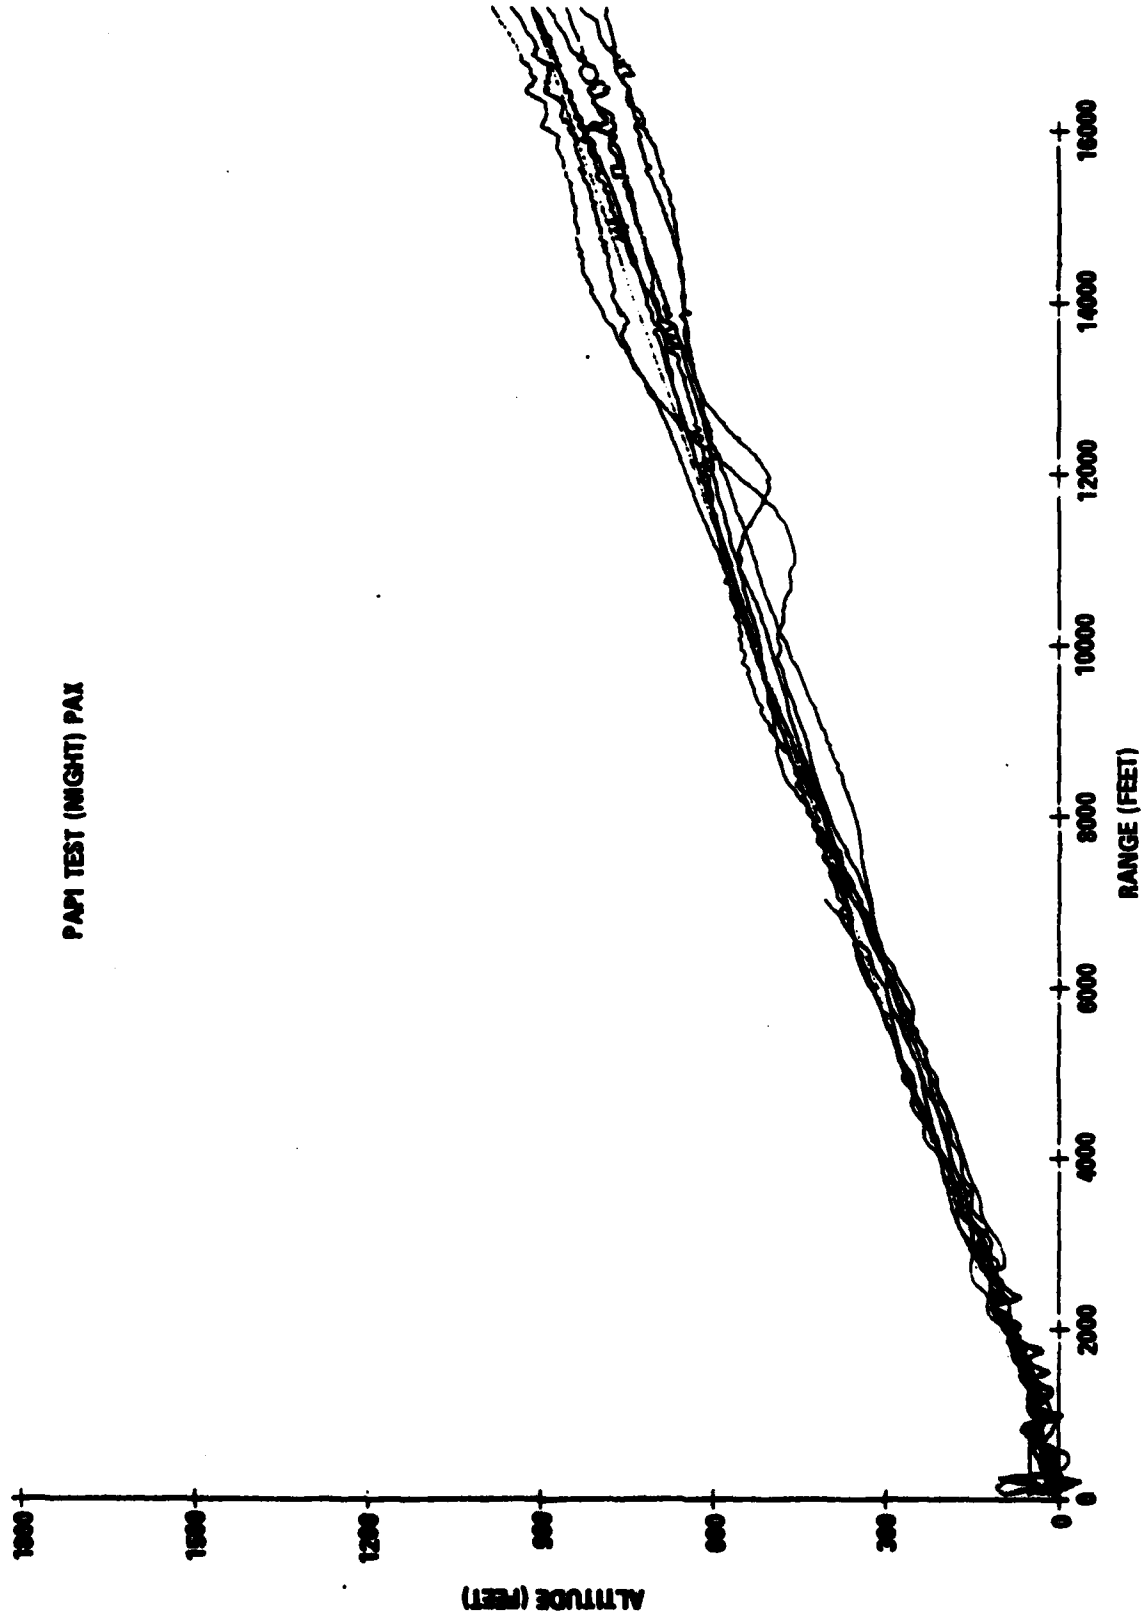
FIGURE D-4. PAPI TWO-BOX NIGHT TESTS
